**ROYAL COMMISSION OF INQUIRY INTO BUILDING FAILURE CAUSED
BY CANTERBURY EARTHQUAKES**

CTV BUILDING COLLAPSE

**STATEMENT OF EVIDENCE OF R. GRANT WILKINSON IN RELATION TO CTV BUILDING
DATE OF HEARING: COMMENCING 25 JUNE 2012**

**OFFICE BUILDING
249 MADRAS STREET**

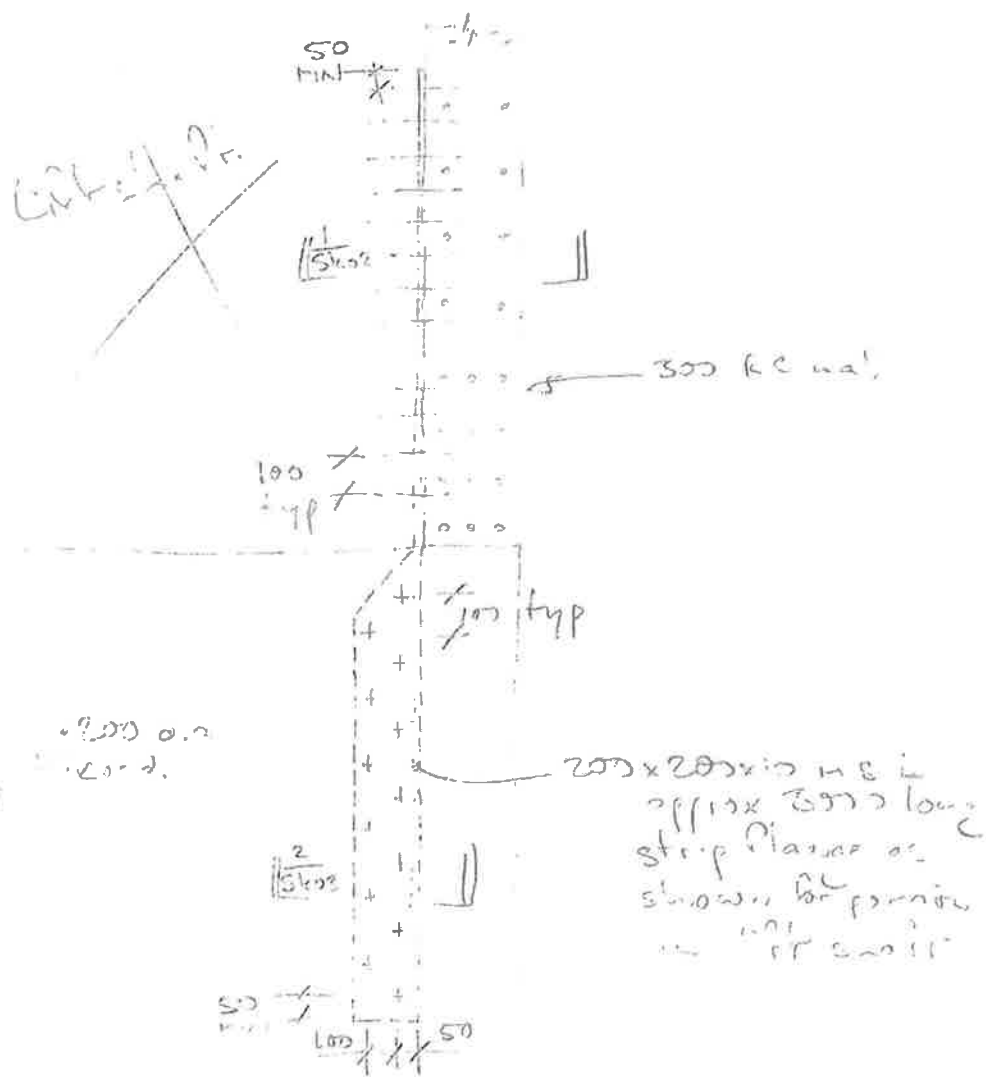
An area of concern however has been discovered in the connections of the structural floor diaphragm to the shear walls. While this is not a concern on the coupled shear wall to the south of the building, connections to the walls at the North face of the building are tenuous, due to penetrations for services, lift shafts and the stairs, as detailed on the drawings.

- 15 John Hare did some calculations and sketches for remedial ties for the purpose of establishing a budget cost for remediation work so that the client could have a rough estimate of the cost of that work. Mr Hare's sketch allowed for the insertion of a steel connecting angle to both of the affected walls at levels 2 to 6 in the building, a total of 10 angle ties. Mr Hare's sketches were not intended to be for construction. **BUI.MAD249.005 .19/20/21.**
