ROYAL COMMISSION OF INQUIRY INTO BUILDING  
FAILURE CAUSED BY CANTERBURY  
EARTHQUAKES

THE CTV BUILDING COLLAPSE

STATEMENT OF EVIDENCE OF GRAEME SMITH  
IN RELATION TO THE CTV BUILDING

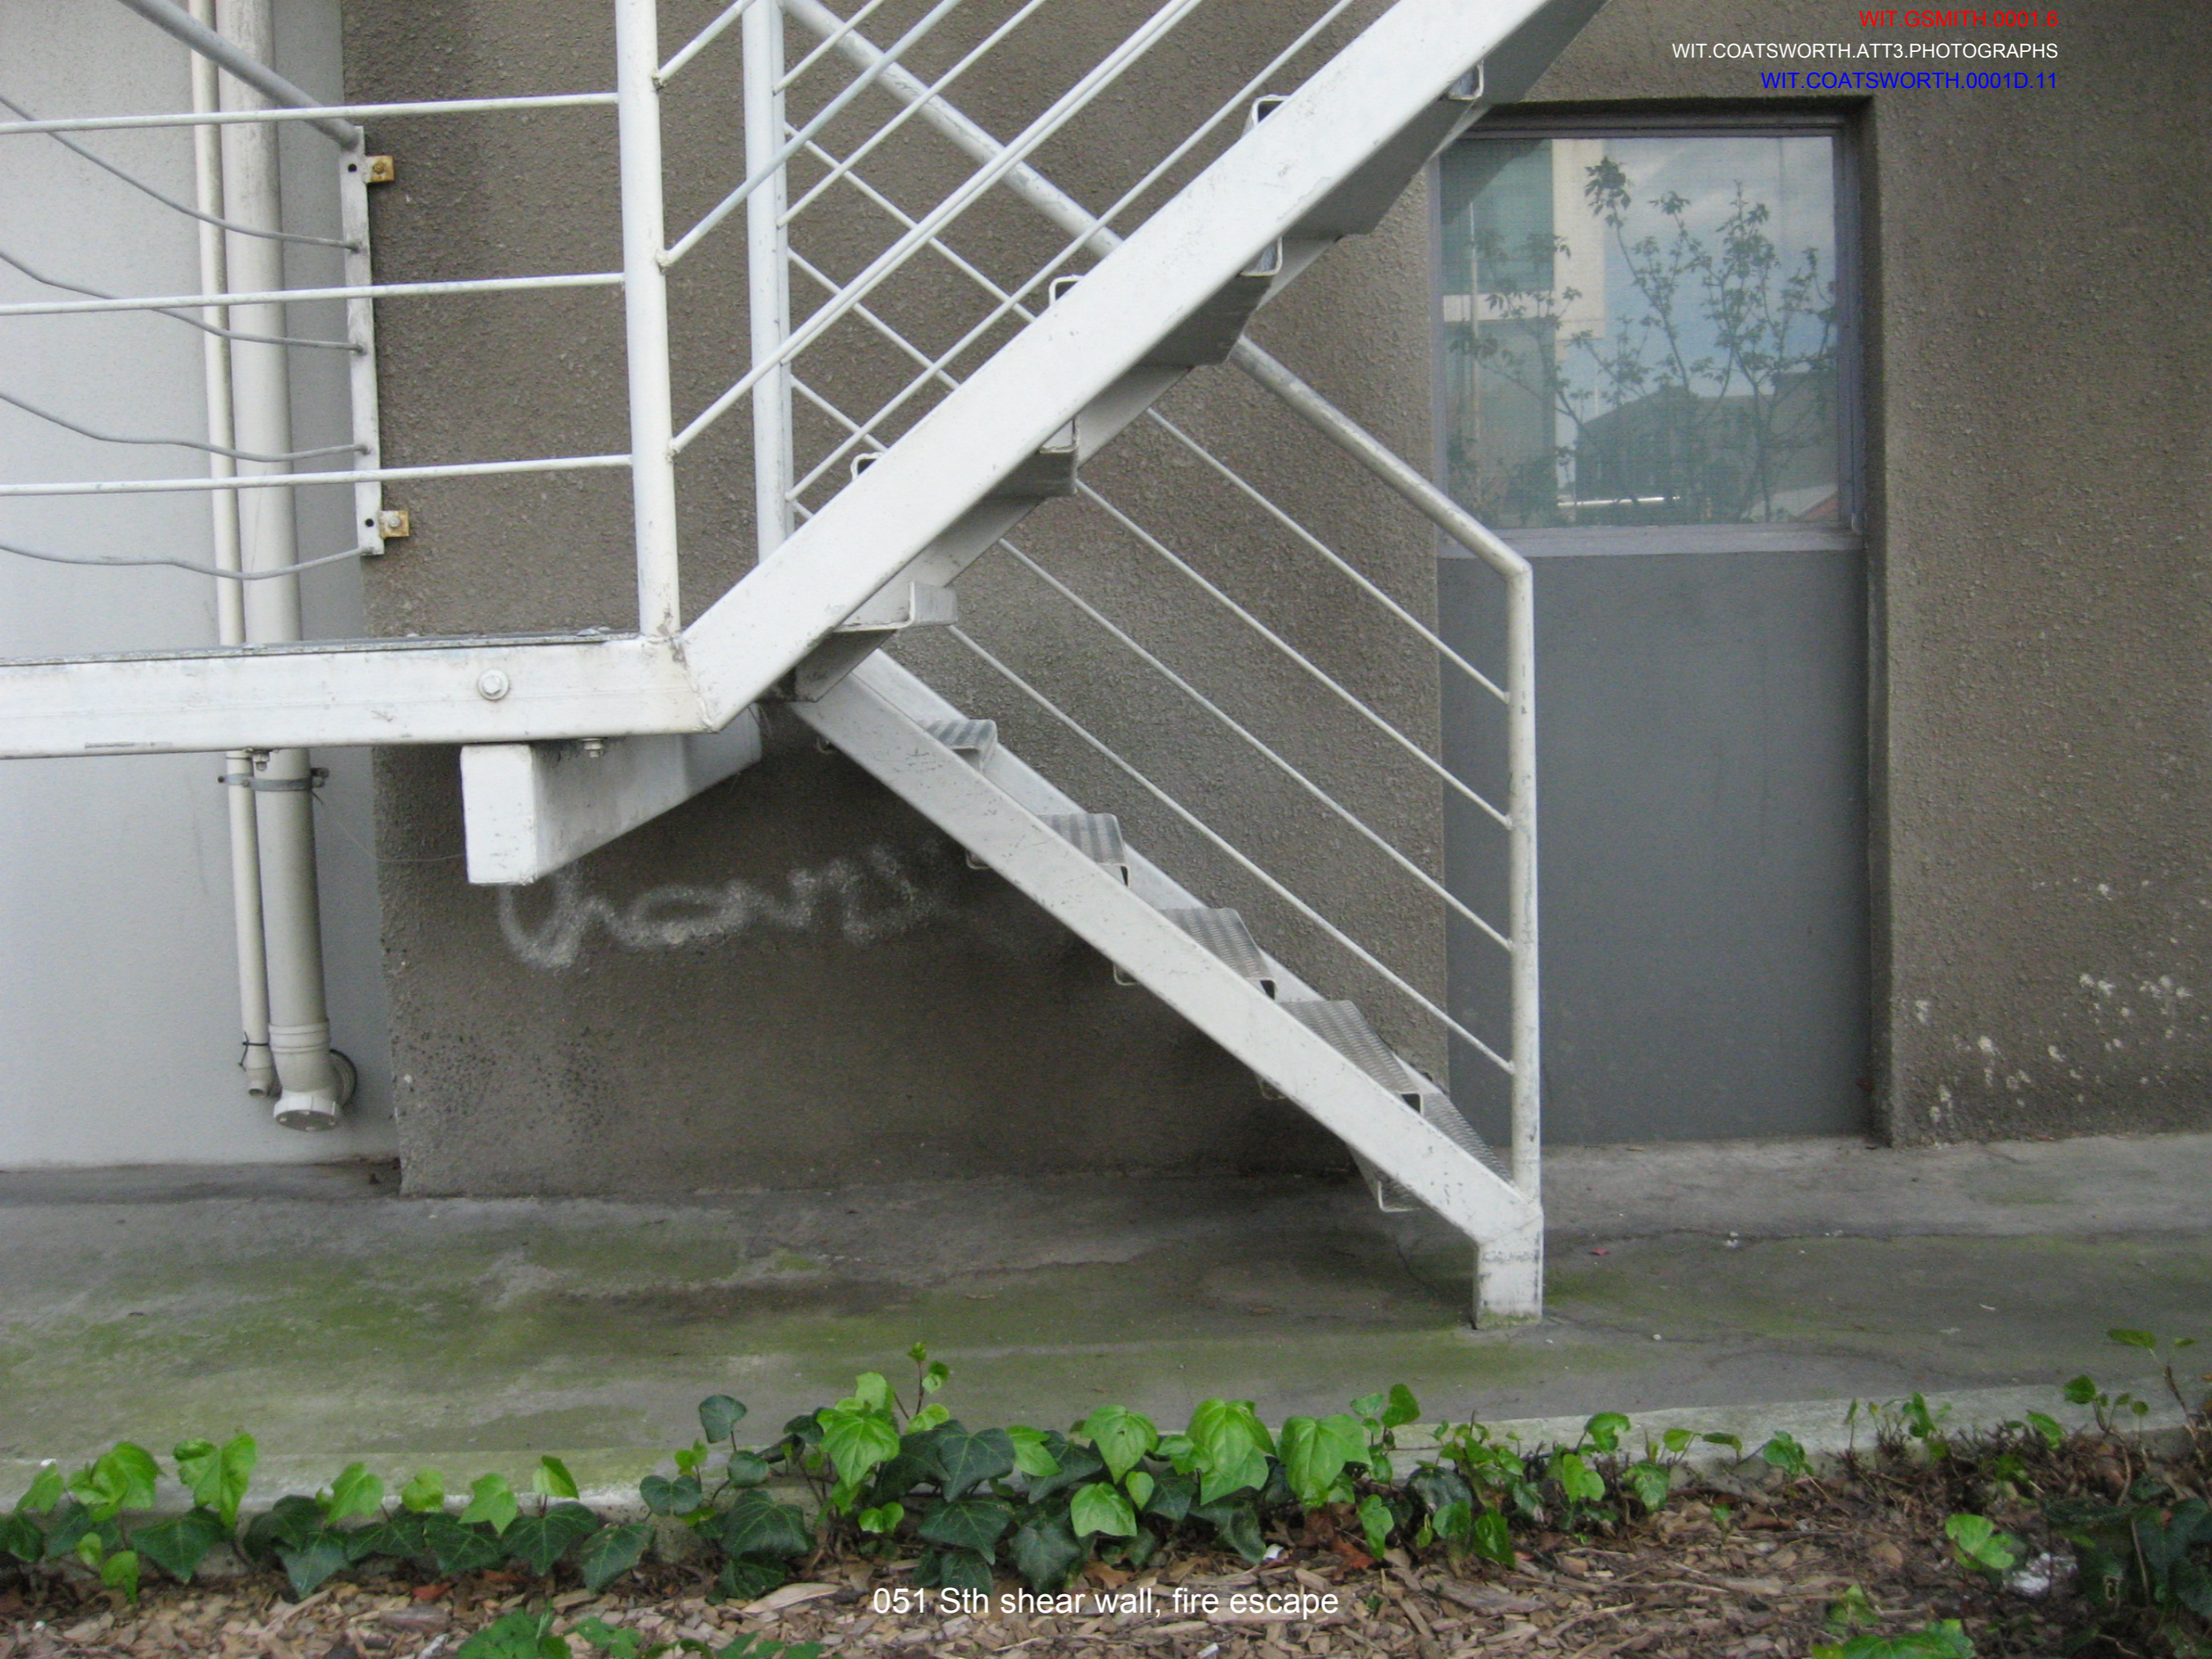
051 Sth shear wall, fire escape

12. I recall on my second visit looking inside looking at a vertical crack in the plasterboard which was covering the South Coupled Shear Wall and which ran from the ground floor through to the floor above.

13. I did not see this crack on the outside of the building, however, the exterior of both the South and North Shear Walls were covered with a textured coating which meant that it was very difficult to see any cracking from the outside. I did not inspect whether this crack continued into higher floors as this was not referred to in the CPG report. I could not access the outside of the South Coupled Shear Wall via the fire escape any higher than the first floor (Level 2) due to a locked gate blocking access to any higher levels. I recall that when I was looking at this crack I was behind the reception area for CTV on the ground floor and the room I was in had a lot of routers, servers and post production electronic equipment in it. The first floor room above this was someone's office. I needed to go behind a desk to observe the crack.
