**ROYAL COMMISSION OF INQUIRY INTO BUILDING  
FAILURE CAUSED BY CANTERBURY  
EARTHQUAKES**

**THE CTV BUILDING COLLAPSE**

**STATEMENT OF EVIDENCE OF STEPHEN KISSELL  
IN RELATION TO THE CTV BUILDING**

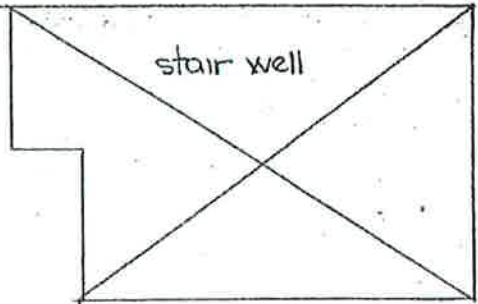
9. I have been shown a picture of part of a drag bar which remained attached to the wall of the lift well **[BUI.MAD249.0190.56, top right photo]** and asked whether I remember seeing any. I have also been shown a plan of the North Core and it has been explained to me where one might expect to see them. The areas pointed out to me are marked on the plan attached and marked "A" **[BUI.MAD249.0033.29.SK]**. I do not recall seeing any drag bars but they were not something I was looking out for.

10. I noticed a crack in the foyer on Level 6. The location of this crack is marked on the plan attached and marked "A" **[BUI.MAD249.0033.29.SK]**. It was underneath the window on the eastern wall by the lift. It ran from under the windowsill diagonally towards the corner of the lift. Its width was approximately 3 millimetres, but it's hard to recall exactly how wide it would have been. I have seen a lot of damage in buildings but thought that this crack was serious because of its width and because it was on a diagonal. It appeared as though there wasn't a lot of strength in the wall which concerned me.

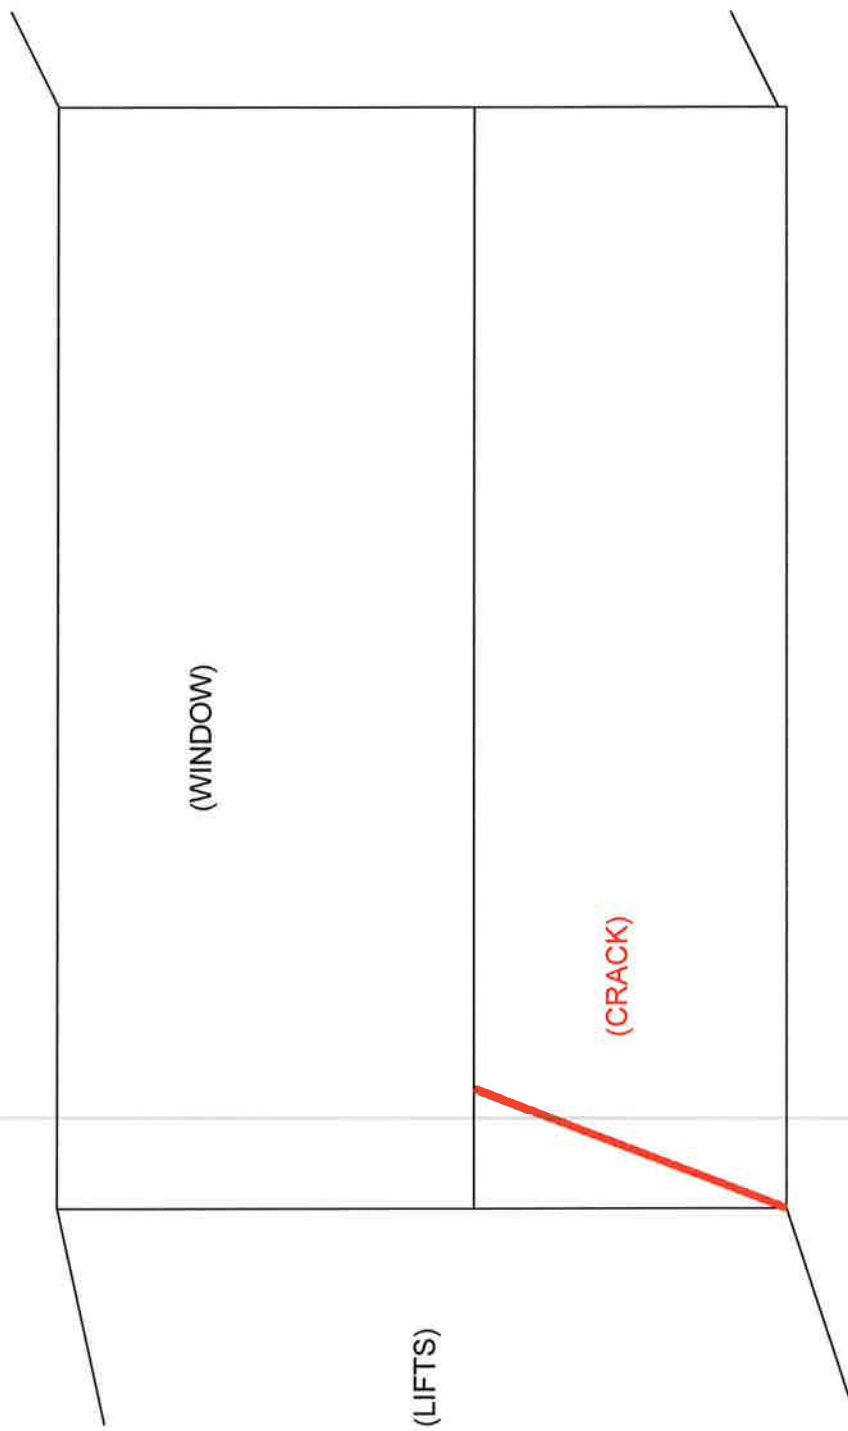
"B"

11. I have drawn a sketch of the crack that I saw. This is attached and marked "B". The location of the crack and its dimensions is approximate only.
12. I cannot remember whether I pointed this crack out to Graeme or whether I discussed my concerns with him.

this being said, I can confirm that the crack I saw on Level 6 ran under this window in a downward, diagonal direction towards the lift. Unfortunately, the placement of the crack is out of shot in the photographs of Level 6. However, I can confirm that the crack I saw underneath the window was similar to, if not slightly worse, than the crack that can be seen running horizontally across the pillar in the photograph of Level 6.
