**ROYAL COMMISSION OF INQUIRY INTO BUILDING  
FAILURE CAUSED BY CANTERBURY  
EARTHQUAKES**

**THE CTV BUILDING COLLAPSE**

**STATEMENT OF EVIDENCE OF PHILLIP REYNISH  
IN RELATION TO THE CTV BUILDING**

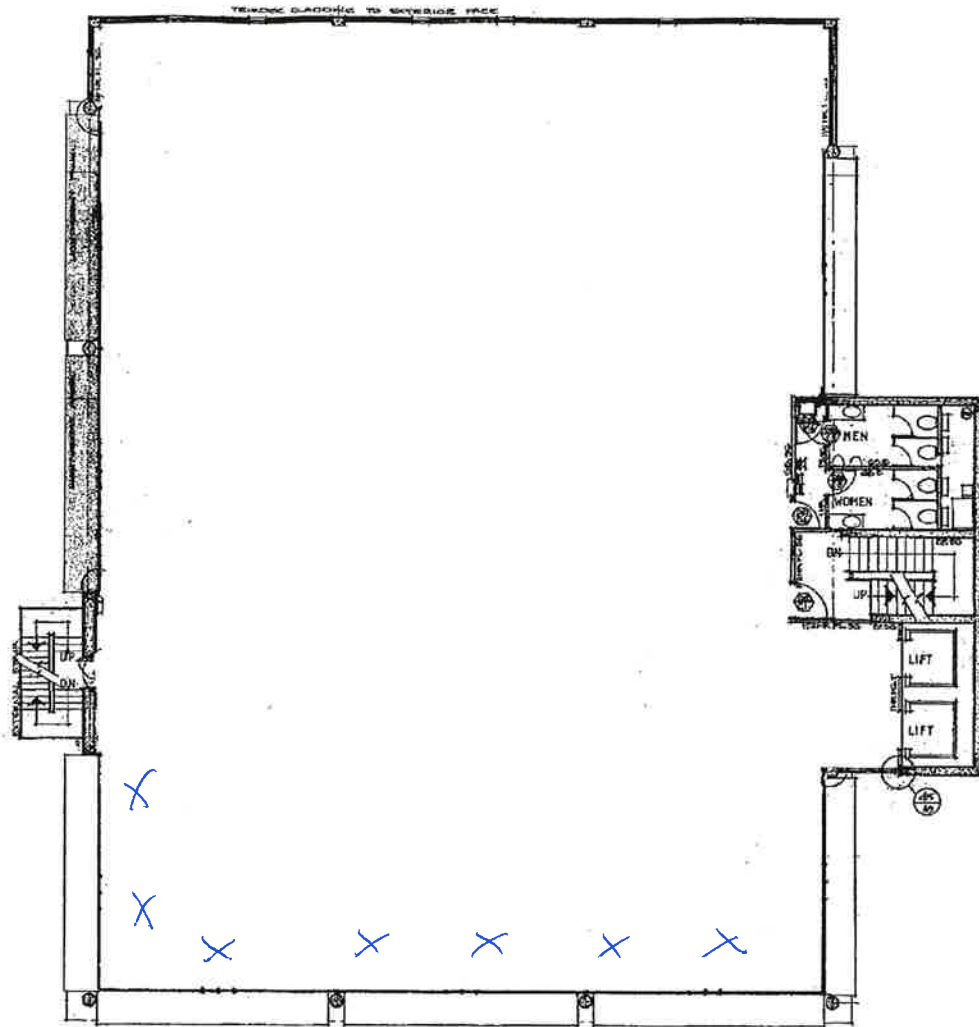
"A"

9. While I was on Level 6 I noticed large gaps around the perimeters of the windows along the eastern and part of the south side of the Building. I have marked on a plan the areas I am referring to with crosses. This is attached and marked "A".

X - windows with gaps  
between the steel and  
concrete frames

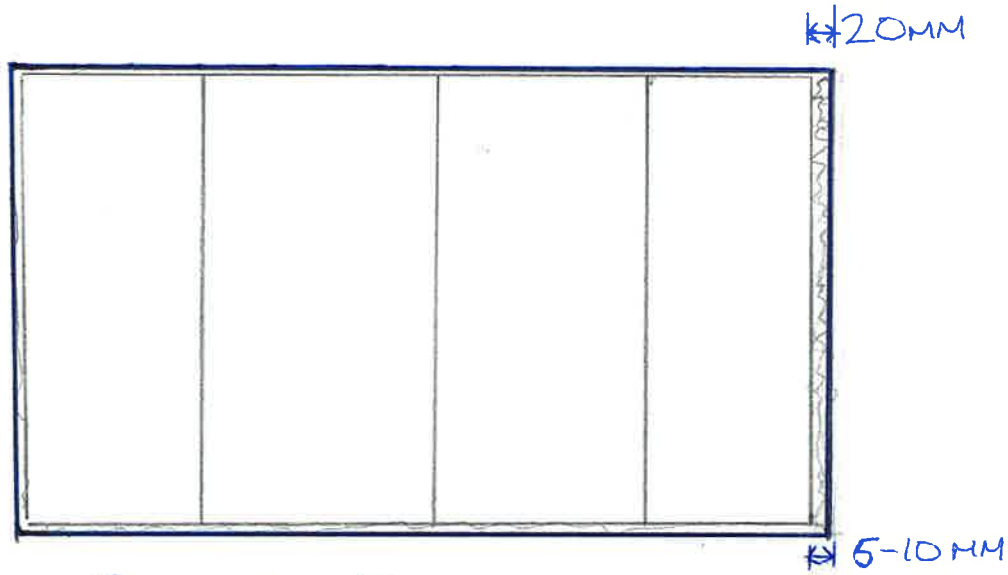
Fig 1

10. The join between the steel window frame and the concrete window opening is generally filled with silicone but in some places the steel window frame had pulled completely away from it and you could feel a draft. I have drawn an example of what I saw. This is titled Figure 1 in the attachment marked "B".

11. The gap was along the right hand side of the window frame and appeared to be larger at the top than at the bottom. I would estimate the gap at the top of the window frame as about 20 millimetres, and the gap at the bottom between 5 and 10 millimetres. This gap concerned me because I took it to mean that the Building was no longer square and it was leaning away from the stairwell and lift tower.

mw GAP BETWEEN (FILLED WITH SILICONE).

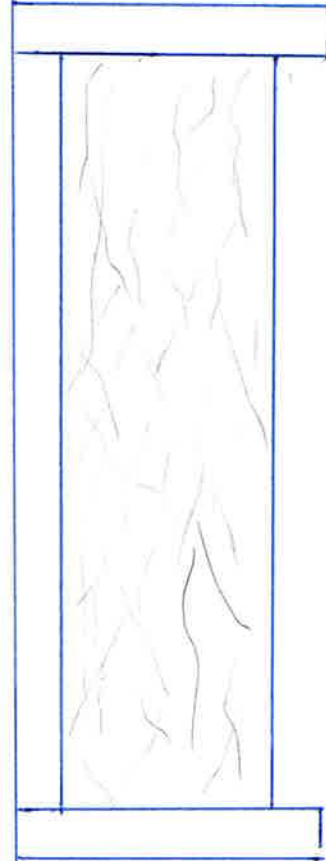
Fig 2.

the time the earthquake occurred. The reason we were instructed to water-proof them was because they had fine, hairline cracks throughout them. I have drawn an example of what I saw. This is titled Figure 2 in the attachment marked "B".

14. These cracks didn't concern me because I had seen this type of fine cracking in concrete before.
