ROYAL COMMISSION OF INQUIRY INTO BUILDING  
FAILURE CAUSED BY CANTERBURY  
EARTHQUAKES

THE CTV BUILDING COLLAPSE

STATEMENT OF EVIDENCE OF PETER HIGGINS  
IN RELATION TO THE CTV BUILDING

Damage Report

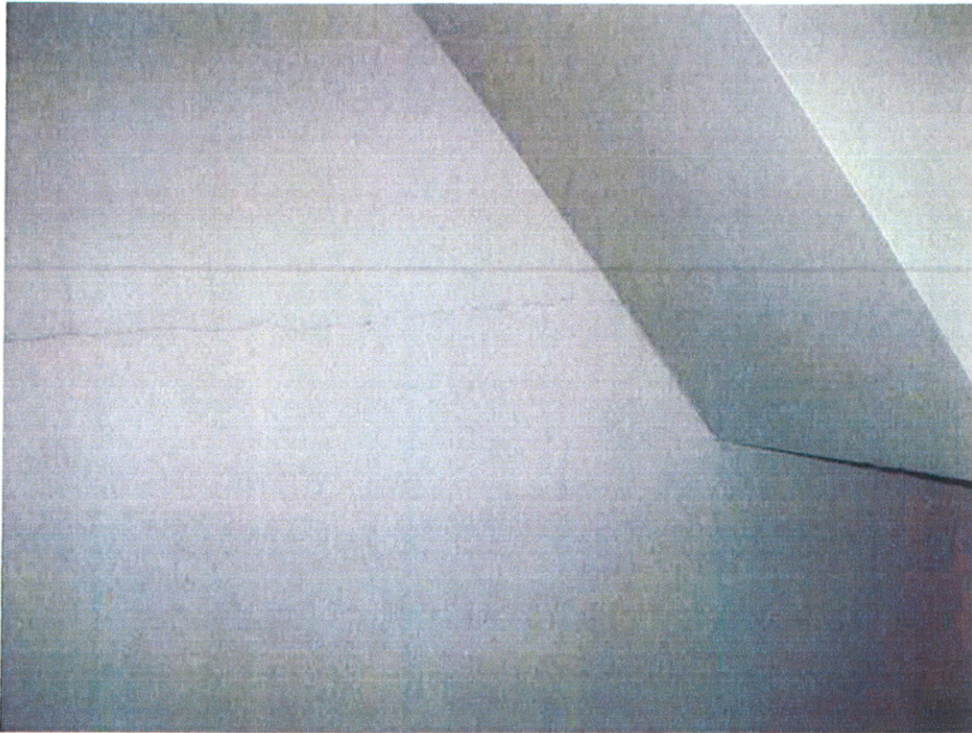
11. The cracks that I observed in the stairwell walls were generally horizontal and were consistent with construction joints as illustrated in photograph 3 in the CPG Report **[BUI.MAD249.0082.14]**. My recollection is that there was a thin plaster render over the concrete in the stairwells which had cracked with the joint movement and this render would need to be removed along the crack line for setting up and injection of the construction joints. I saw cracks on both sides of the stairwell as well as in the North Shear Wall.

Photo 3 Cracking in floor level construction joints in stair well

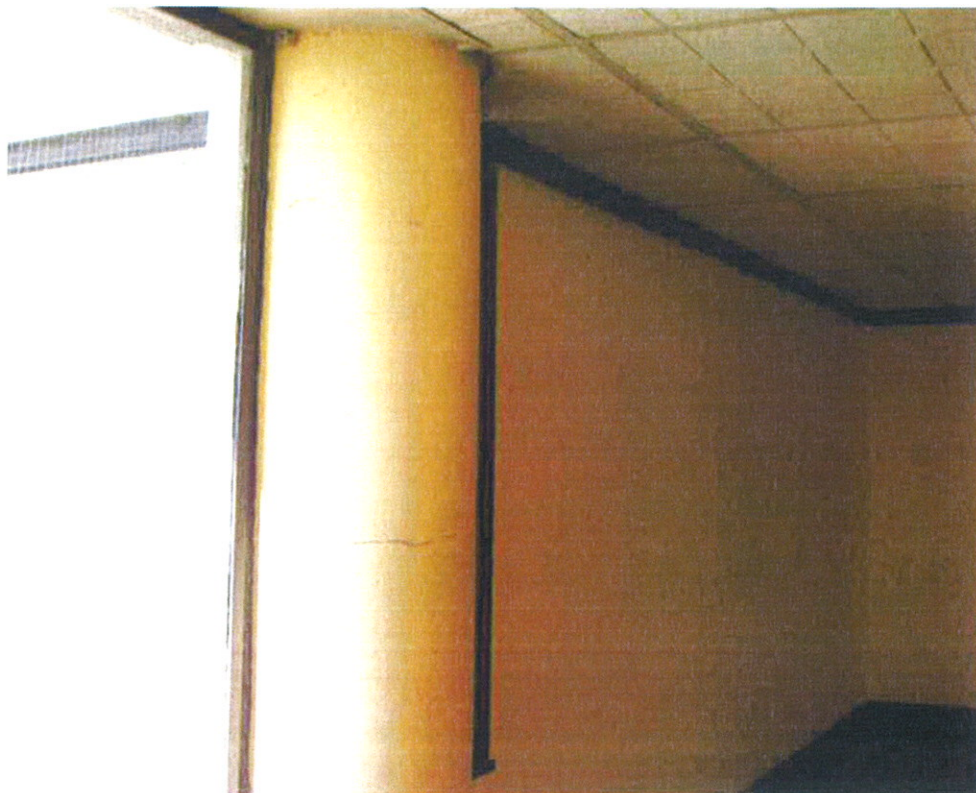
12. The cracked column and adjoining beam that I inspected on Level 6 outside the lift shaft appears to be the same column that appears in photograph 4 of the CPG report **[BUI.MAD249.0082.14]**. I have recorded six horizontal circumferential cracks in this column with concrete spall in the overhead lintel beam adjoining this column approximately 1200-1500mm out from the face of the column above the window. I have provided the Royal Commission with a scanned photograph which I took of this column and the adjoining beam and I have drawn along the lines of the cracks with a pen **[BUI.MAD249.0454]**. I have not been able to find the original photograph in my records.

Photo 4 Cracking in top storey column adjacent to lift lobby.

In addition to the epoxy injection requirement the 5<sup>th</sup> Floor overhead beam is likely to require minor breakout of defective concrete and reinstatement with a structural mortar.

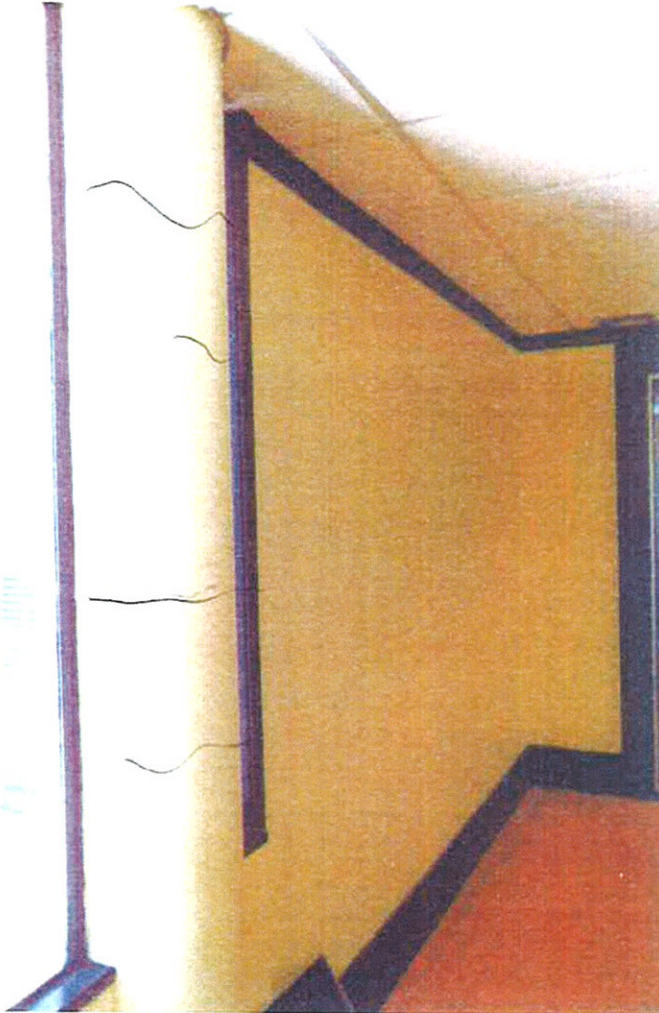
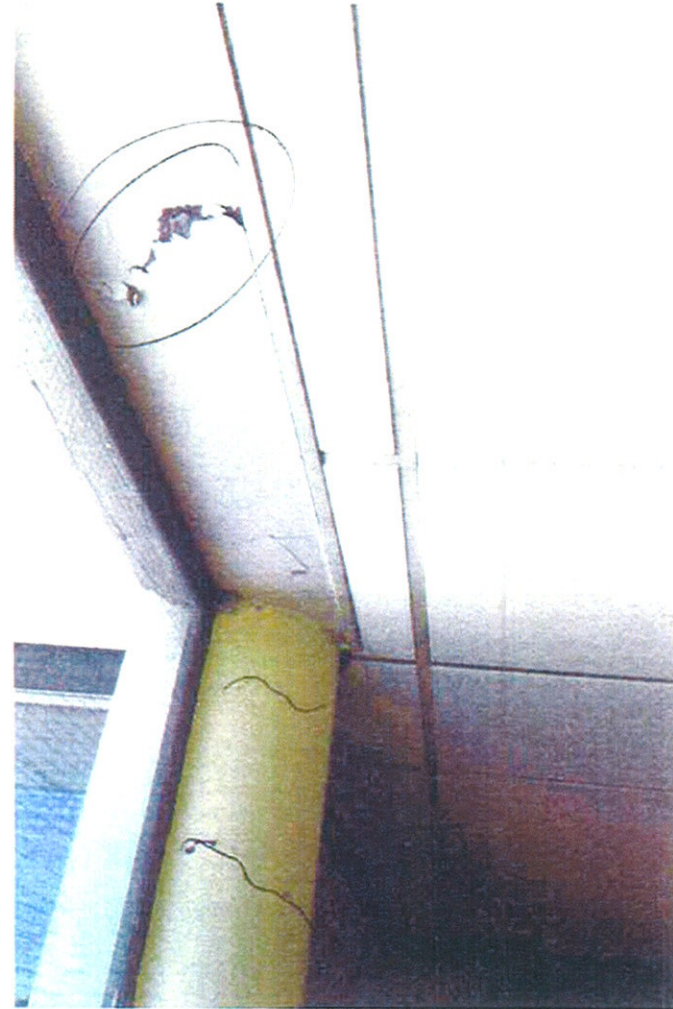
L5. Approx 500  $\phi$  x 6 cracks circumferential.  
Bear lintel overhead.

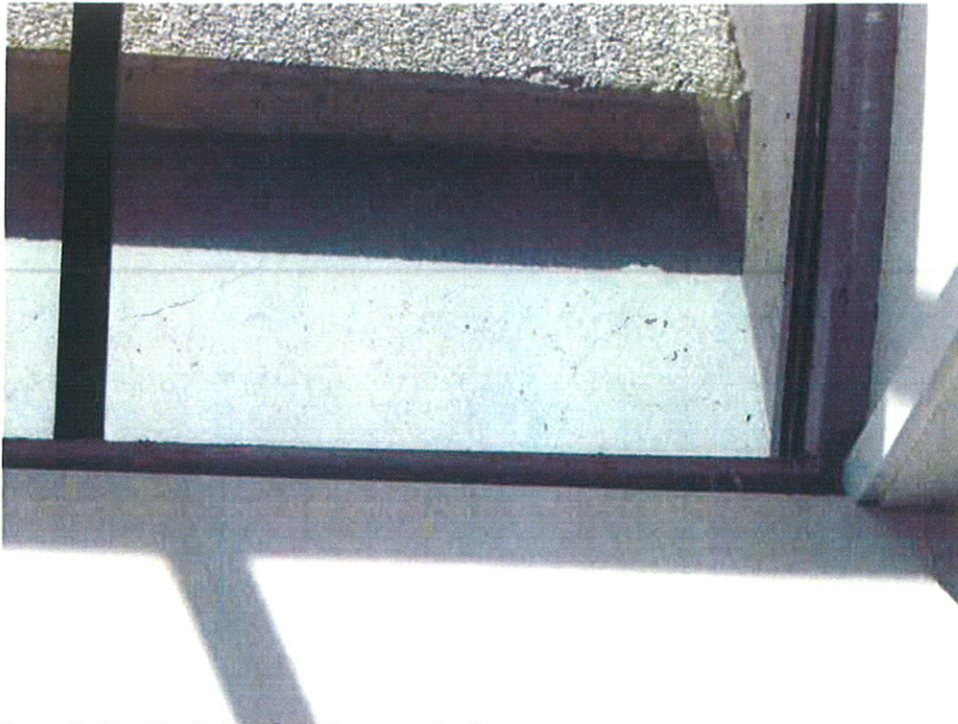
13. I have also recorded that the Level 2 beam on the North elevation over the entry off Madras Street had five near vertical or diagonal cracks in it above the glass entry area of approximately 1 metre. This is shown in photograph 5 of the CPG Report **[BUI.MAD249.0082.15]**.

Photo 5 Cracking in first floor beam north elevation over entry.

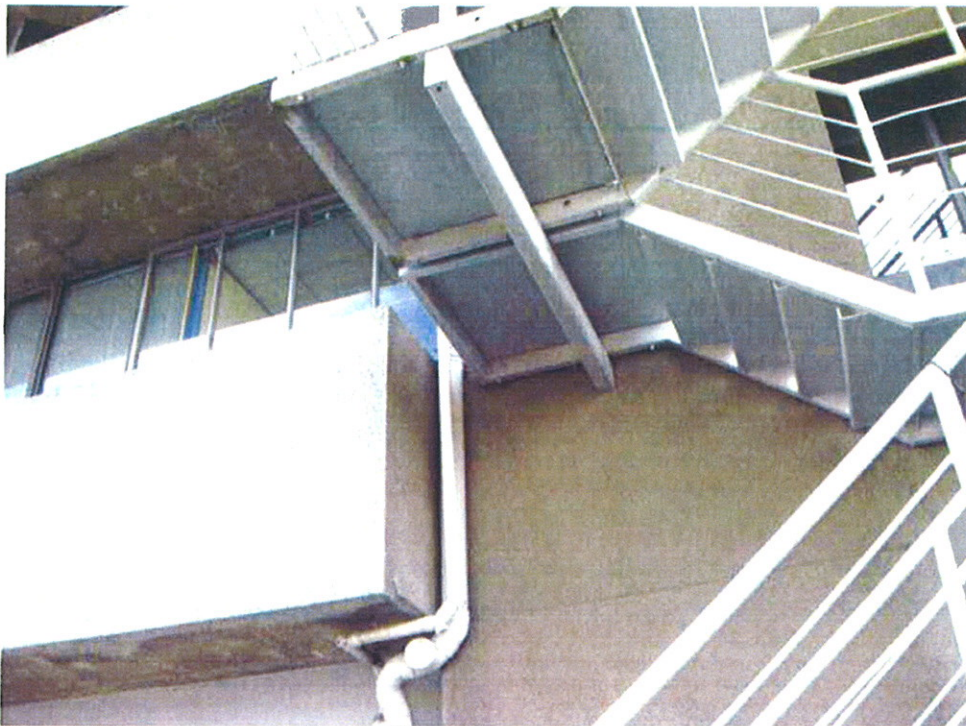
Photo 6 Spalling of plaster off ends of spandrel panels.

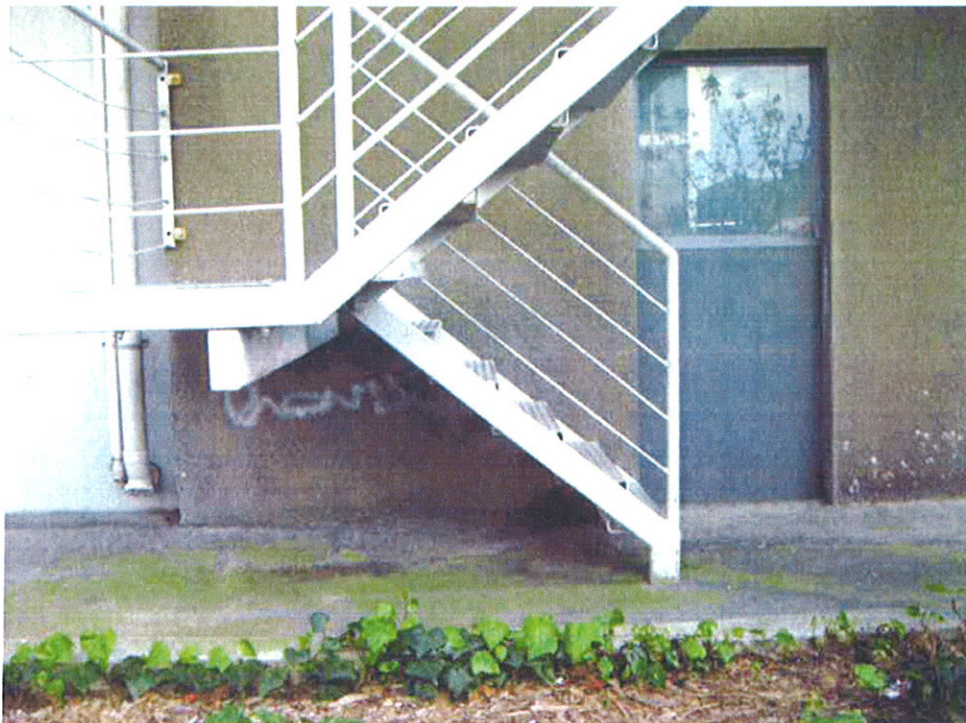
14. My notes also record that the South Shear Wall had one fine, near vertical or diagonal crack in the wall adjacent to the fire escape landing of approximately two metres. This is the same area shown in photograph 2 of the CPG report **[BUI.MAD249.0082.13]**.

Photo 2 Cracking in south shear wall (not visible in photo) under fire escape landing
