CTV Building Collapse Technical Investigation

Canterbury Earthquakes Royal Commission

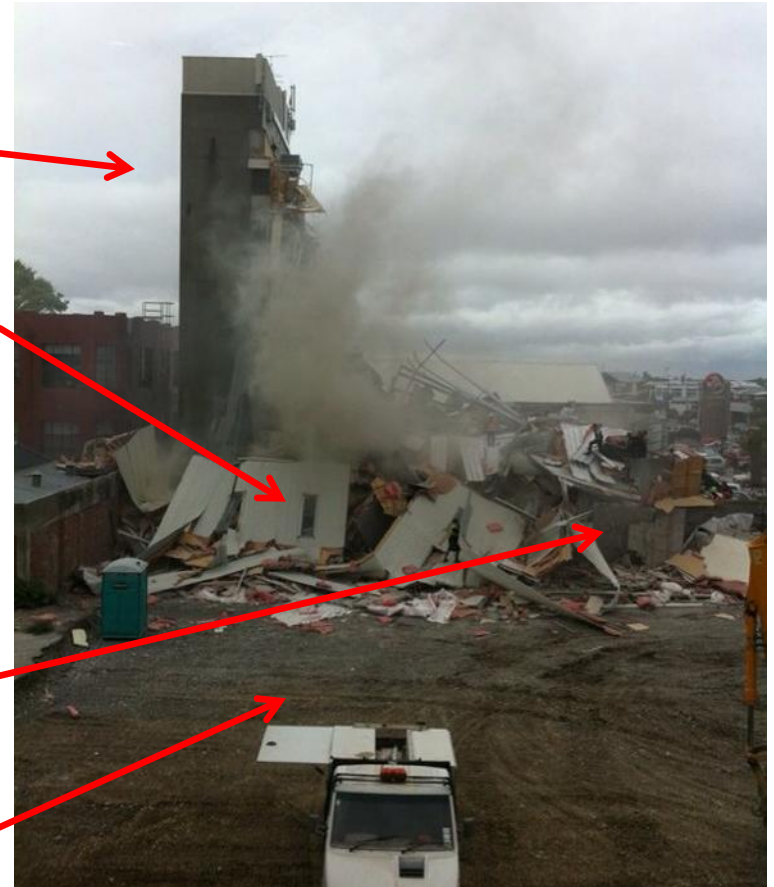
- View from west
 - Fire just started near north end
 - Level 4 to 6 cladding pushed north
 - Little debris otherwise on this side
 - Diagonal cracking to masonry infill
 - No liquefaction

View from Les Mills from west Immediately after the collapse

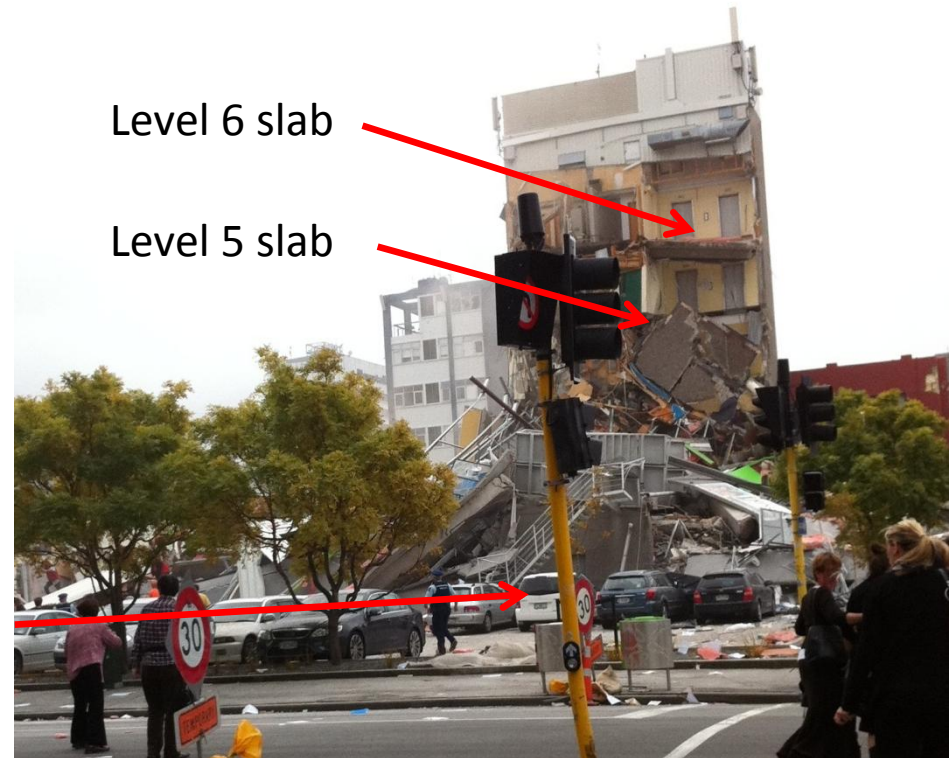
- View from South
 - Prior to fire starting
 - Level 5 slab hanging from North Core
 - Level 6 slab supported by drag bars
 - No debris south of the building
 - Cars parked in front of South Wall undamaged

View from Cashel Street from south Immediately after the collapse

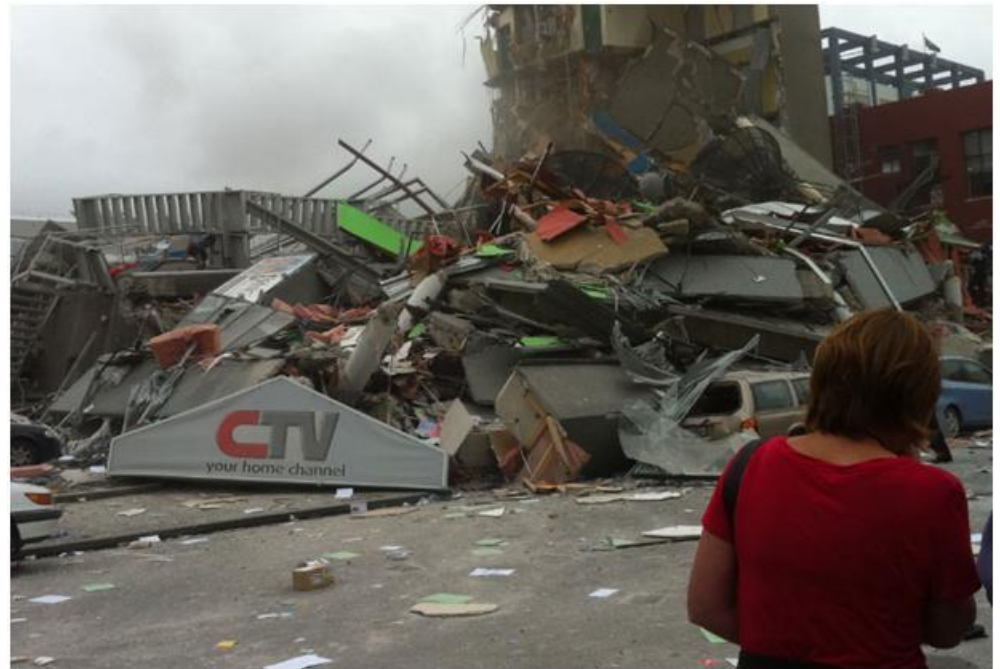
- View from southeast
 - Smoke from fire in background
 - No liquefaction
 - Slight eastward throw
 - Cars in Madras Street crushed by edges beams and Spandrel panels
 - Columns fractured

View from southeast Immediately after the collapse

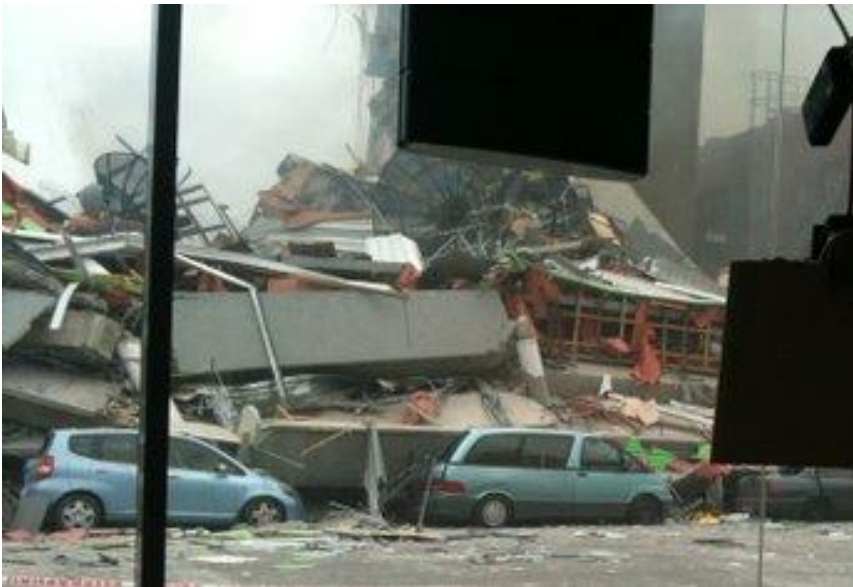
- View from East Lines 2 to 4
 - Smoke from fire in background
 - No liquefaction
 - Cars in Madras street crushed
 - Columns fractured

View from Blackwells from east Line 2 to 4 shortly after the collapse at 1:21 pm

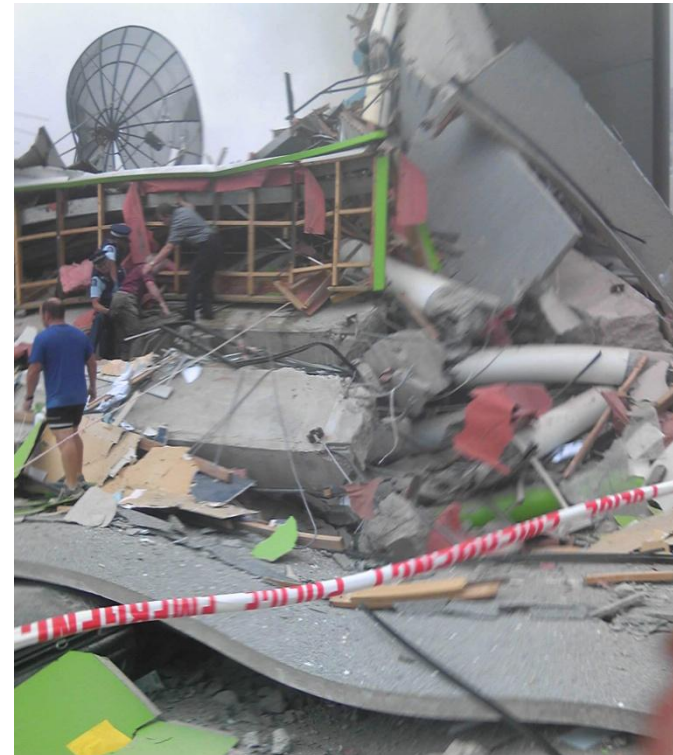
View from east at Line 4 North Core immediately after the collapse at 1:00 pm

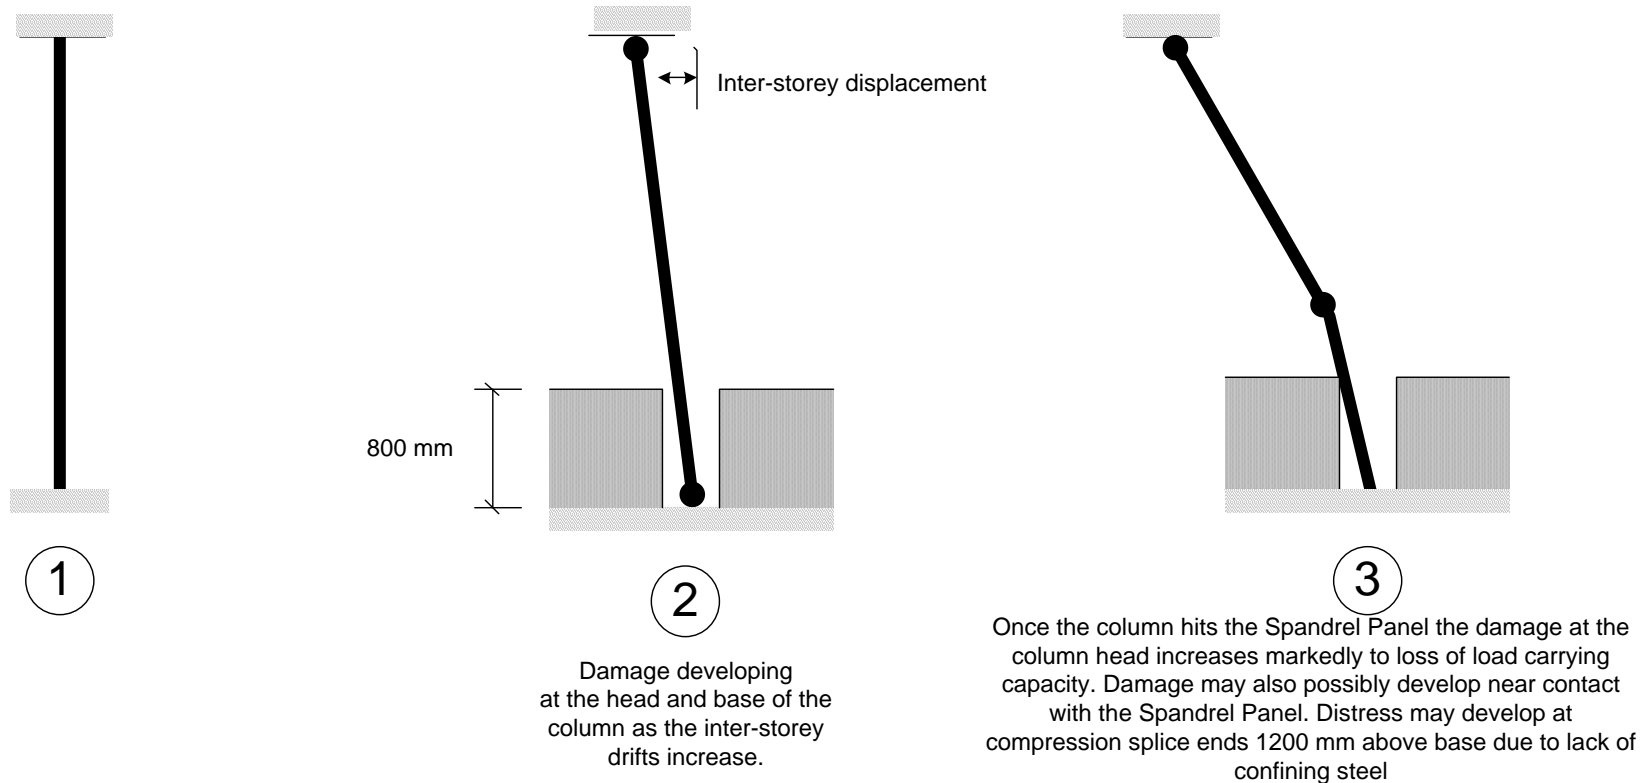
- Possible East and North face column damage sequence

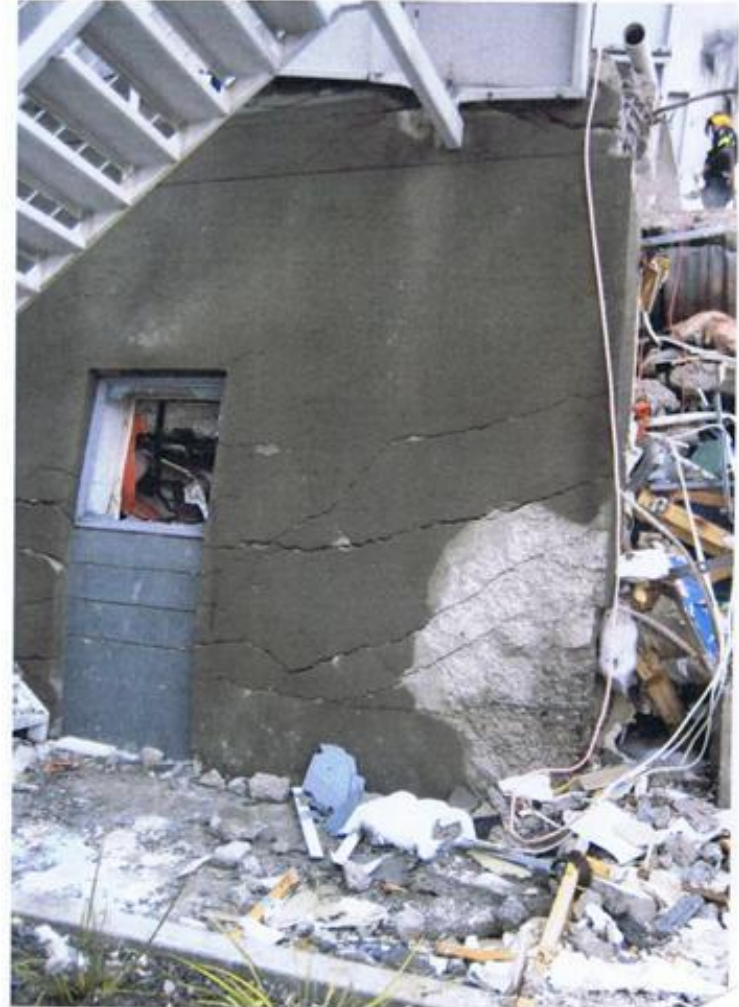
- South Wall
 - Heavy compression spalling at east end
 - Fan like flexural cracking
 - Cantilever behaviour
 - Masonry infill of door

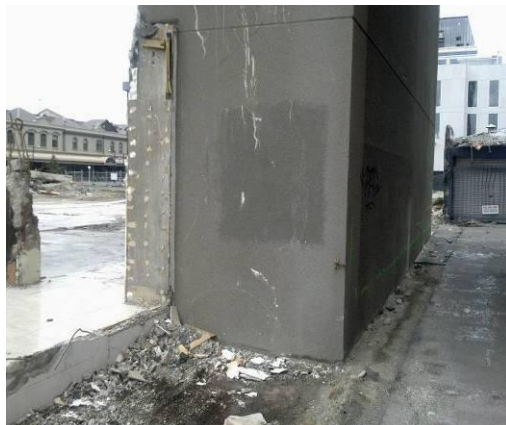
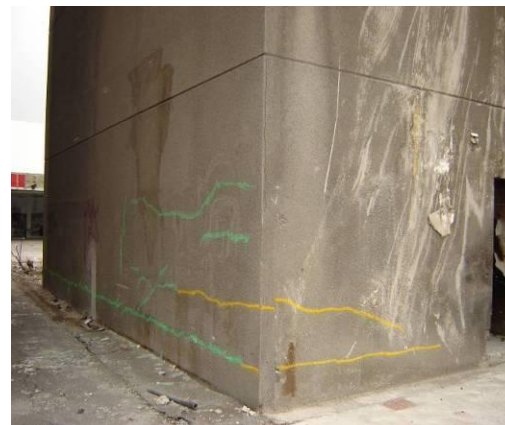
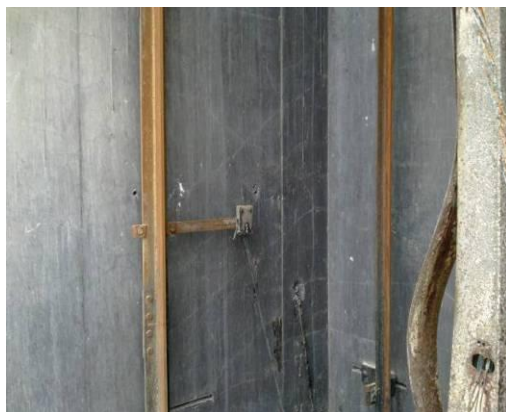
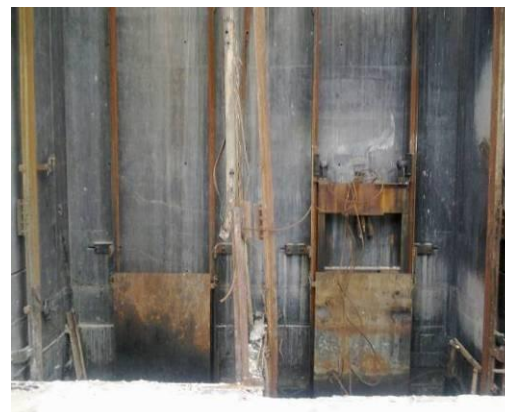
- Hairline cracking to North Core
- Fire effects on inner faces

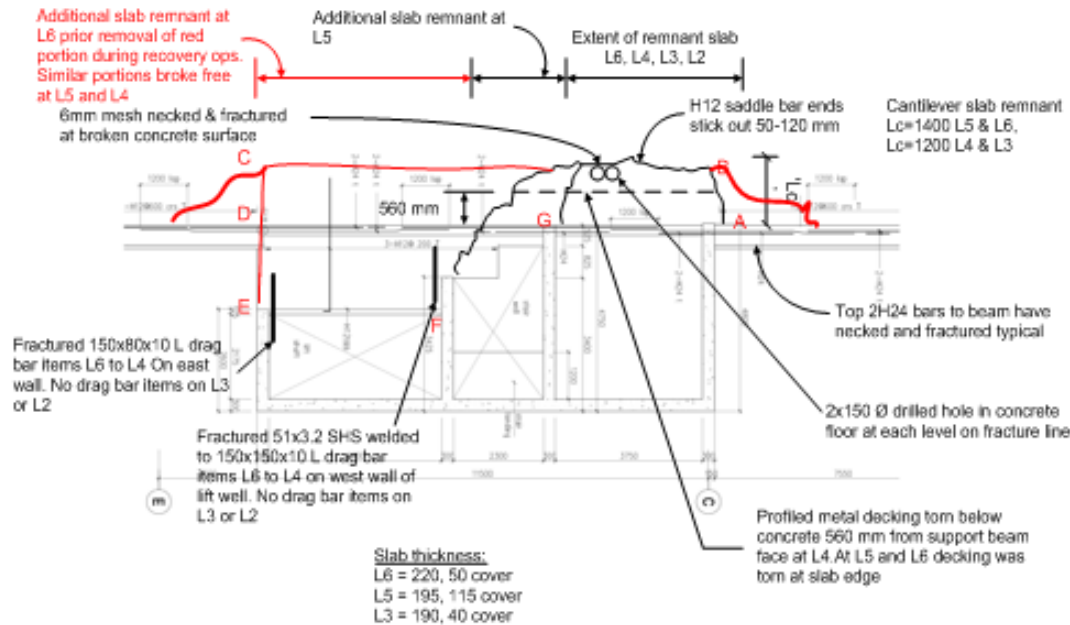
- Drag Bars at Levels 4 to 6
- Slab broken away at end of saddle bars
 - 1200 mm south of beam
- No or little slab reinforcing connection to some walls

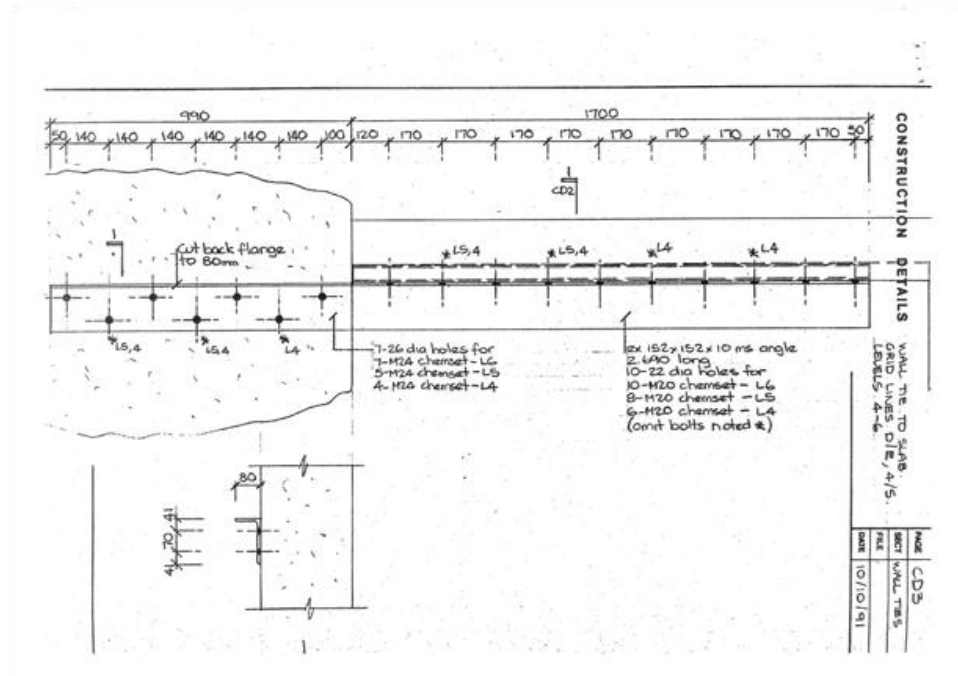
- Drag Bars connection to some walls

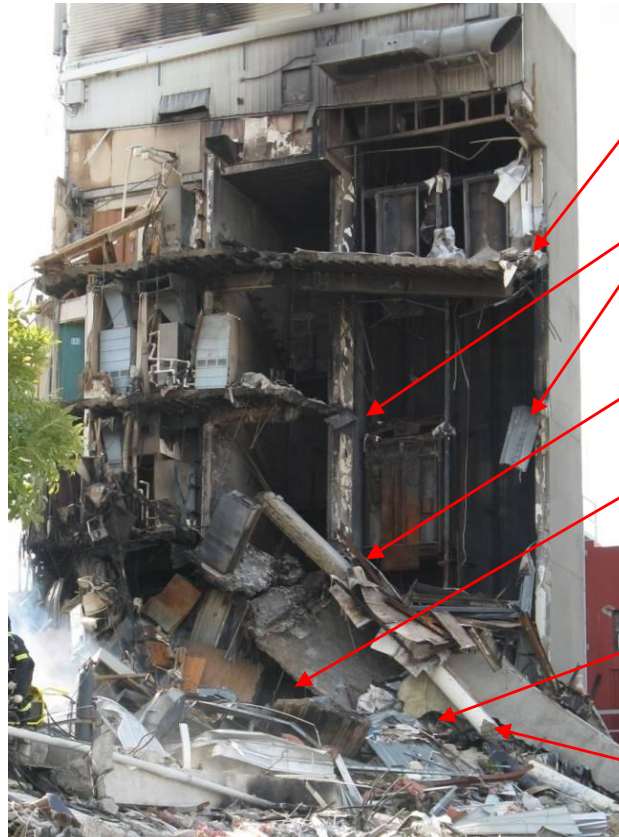
L6 Drag Bar still attached to and holding up slab

L4 slab failure along ends of H12 saddle bars 1200mm off Line 4 similar to L5 and L6

Failure surface runs diagonally from inside face of edge beam to the ends of the slab saddle bars

Column Line 4 D/E L4-5 and L5-6 with beam-column joint pullout at L5

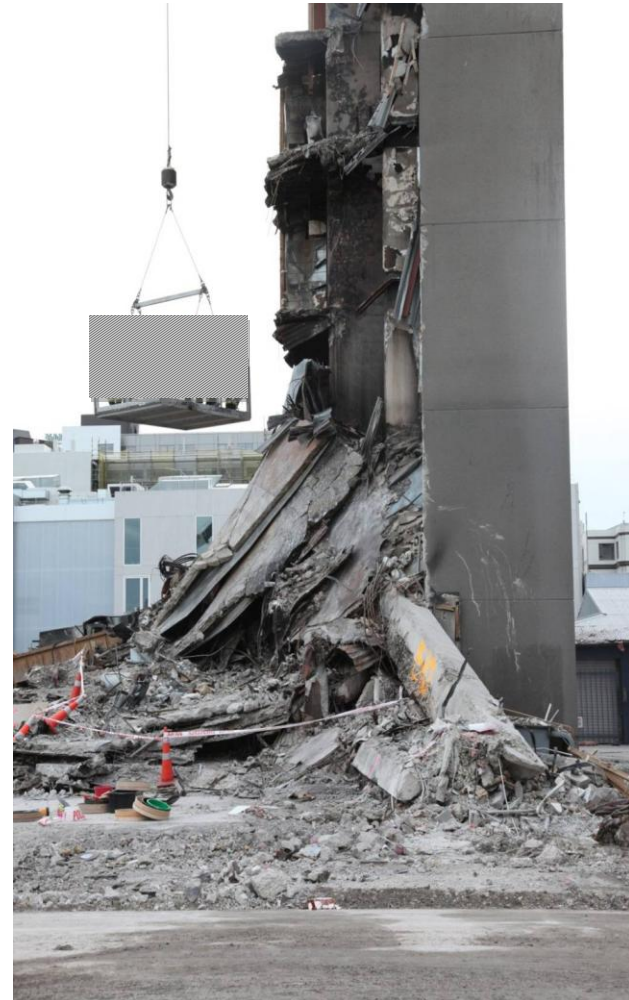
- Slabs leaning against North Core
- Indicates loss of support along Line 3 prior to breaking off North Core

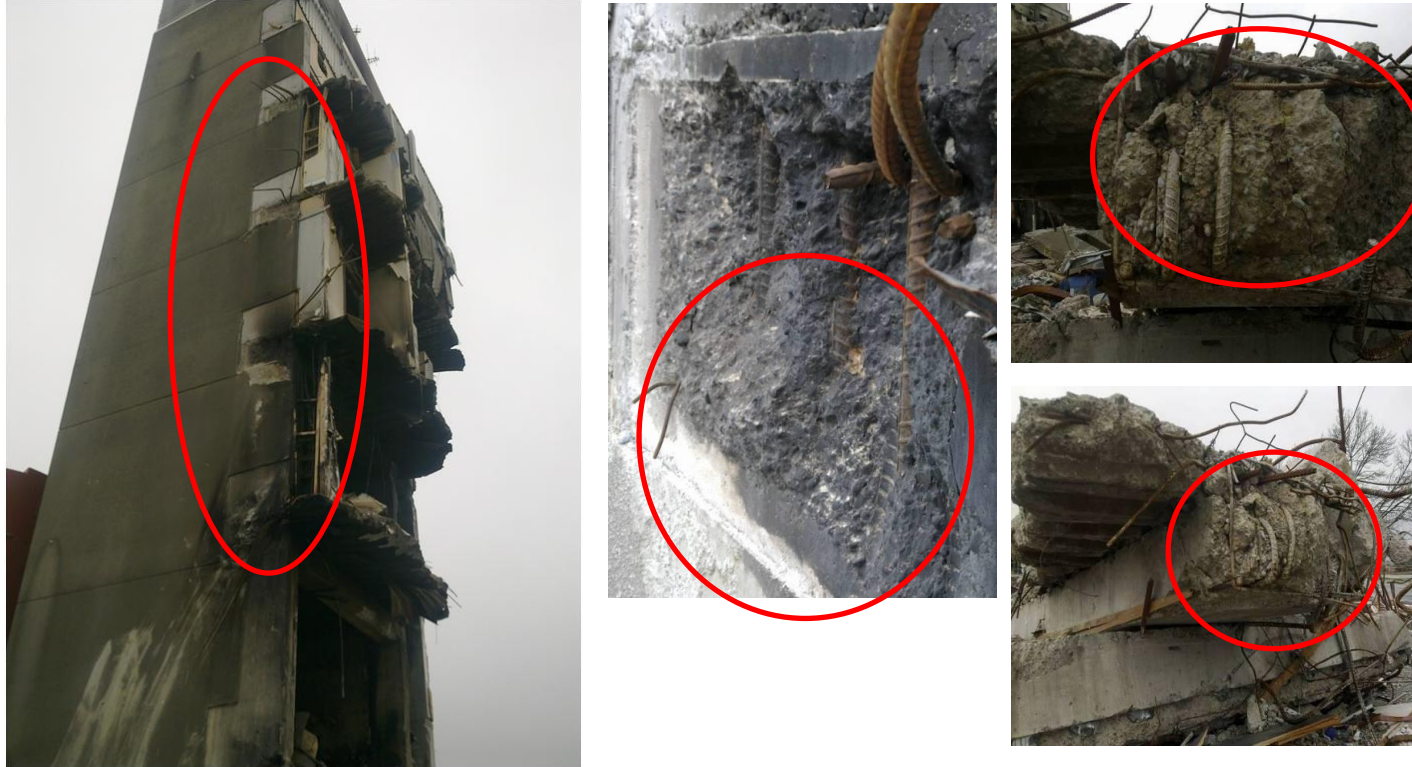
- Beam bottom bars not cast into North Core L3 to L6
 - Non-compliant

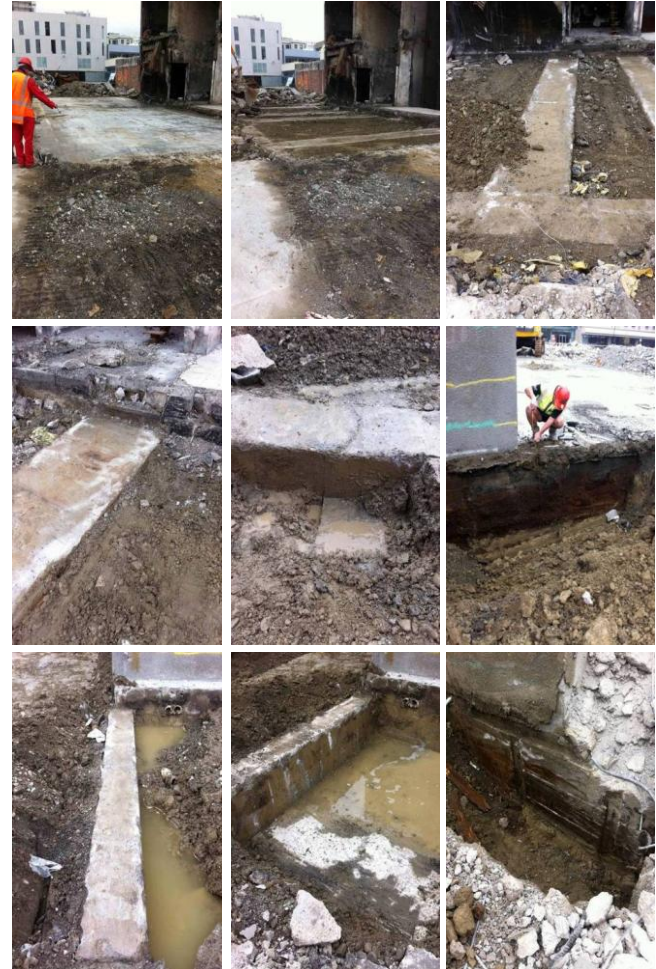
- No liquefaction was found adjacent to the foundations.
- No signs of uplift
- No signs of damage to the foundation beams

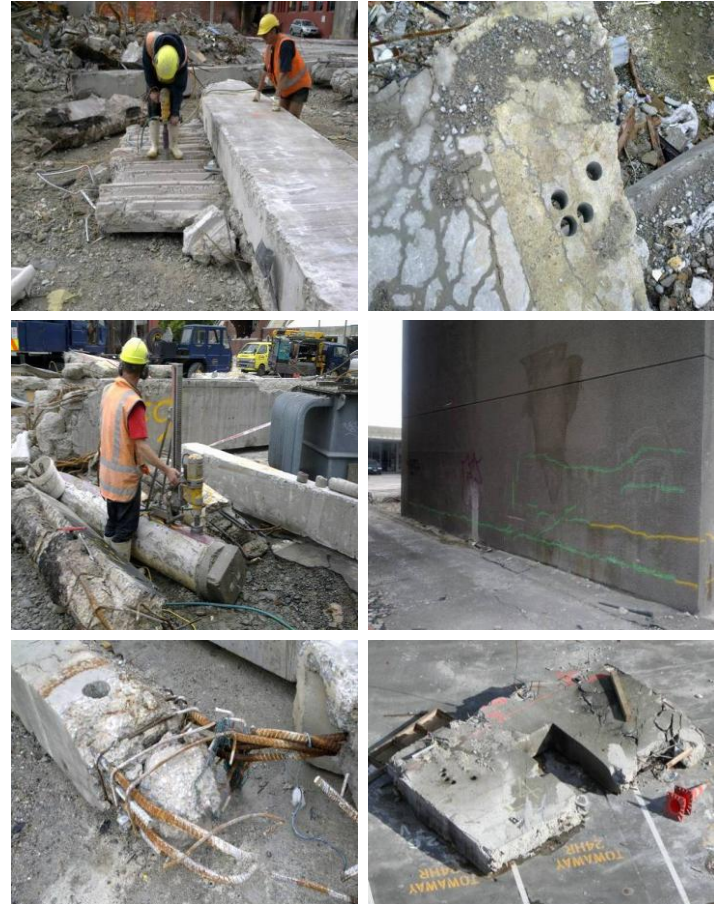
- Wall Concrete
 - Satisfactory
 - Localised door head issue
- Slab Concrete
 - Satisfactory
- Beam Concrete
 - Satisfactory
- Column Concrete
 - Non-compliances

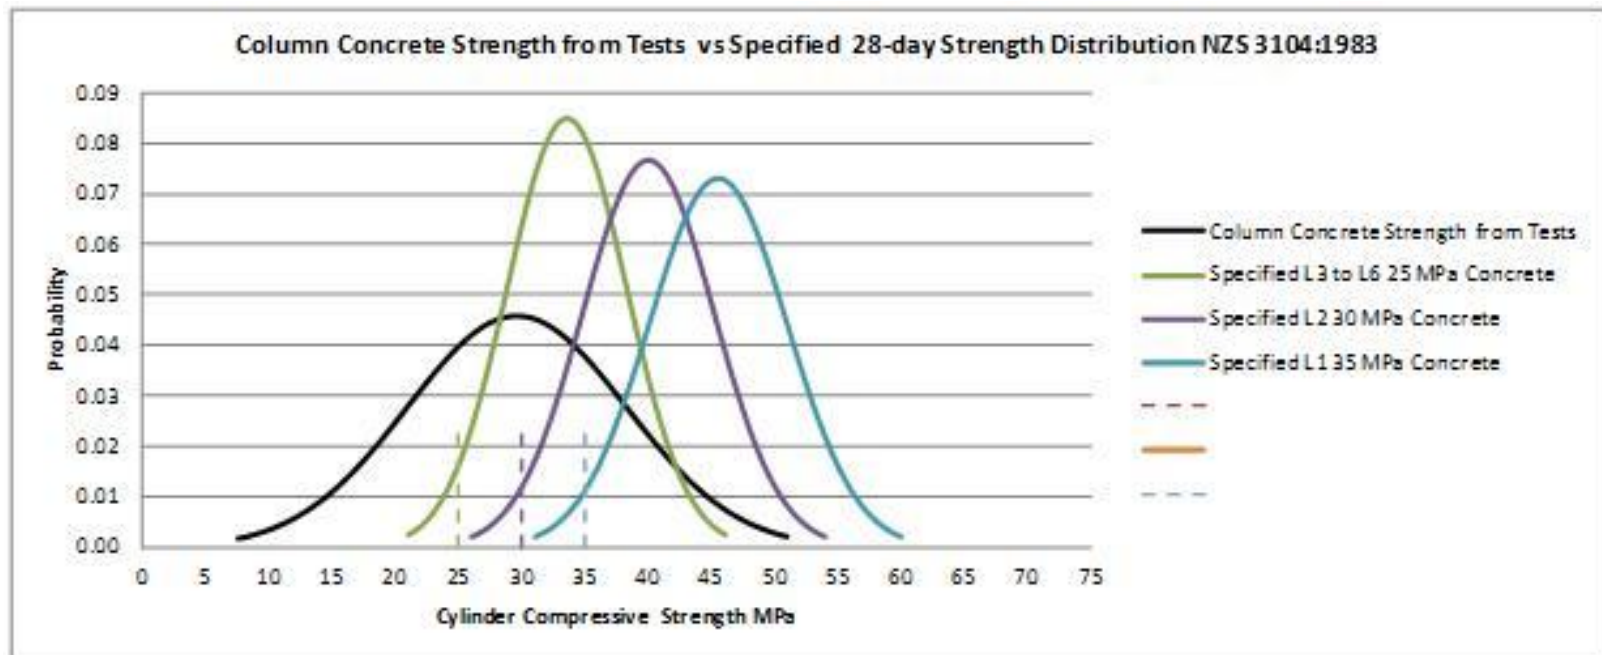
- This indicates that the concrete in a significant proportion of the columns may have had strengths less than the minimum specified

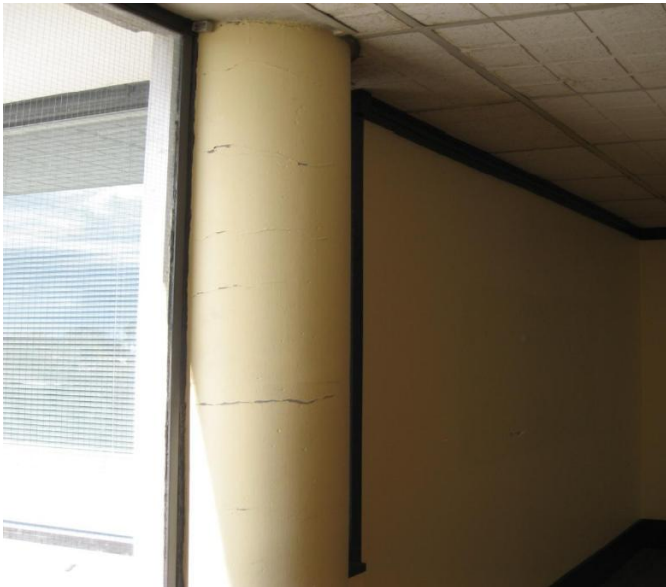
Column cracking Level 6

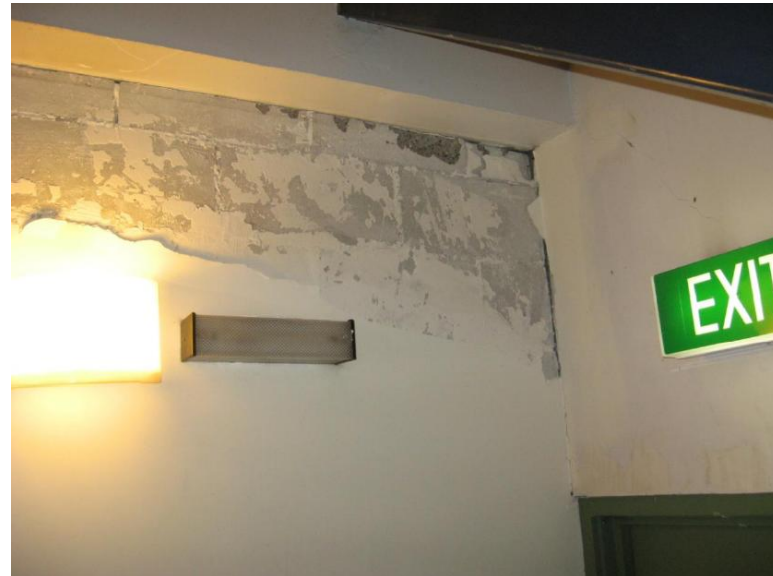
Spalling plaster at masonry wall

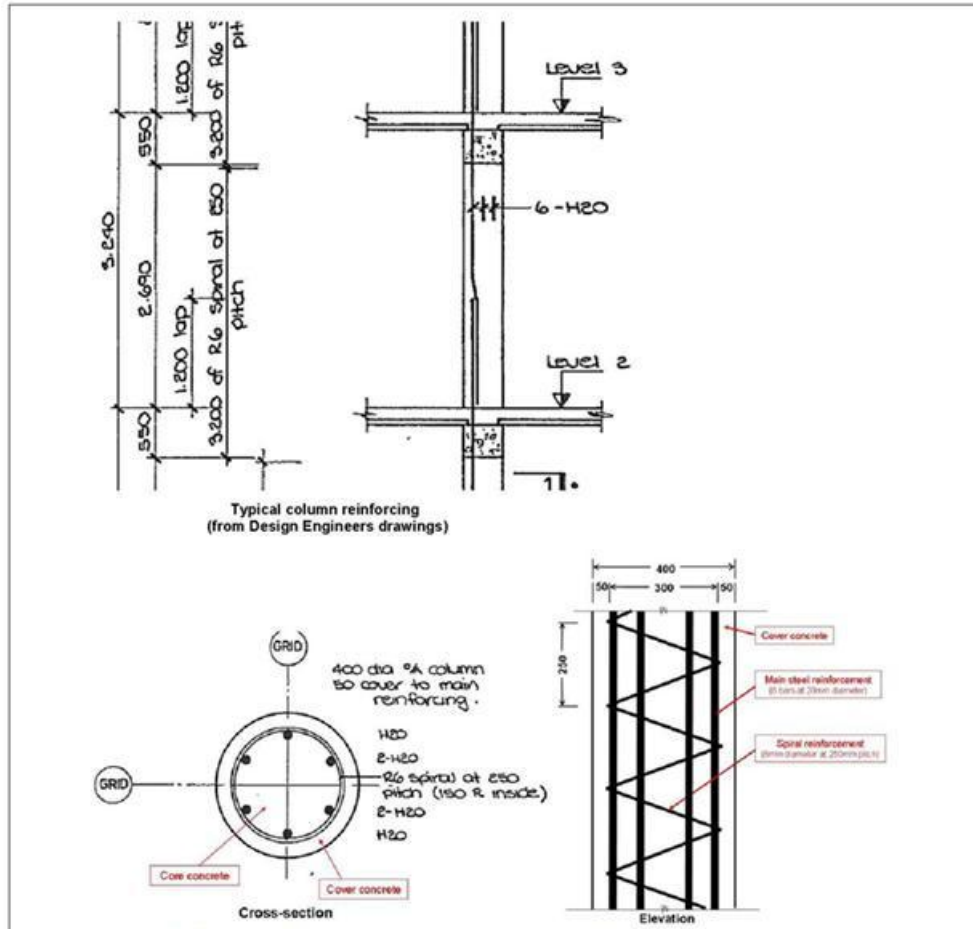
- Same reinforcing in all main building columns
- Light spiral binding R6 @ 250 centres
 - Non-compliant
- Rectangular columns on Line A only

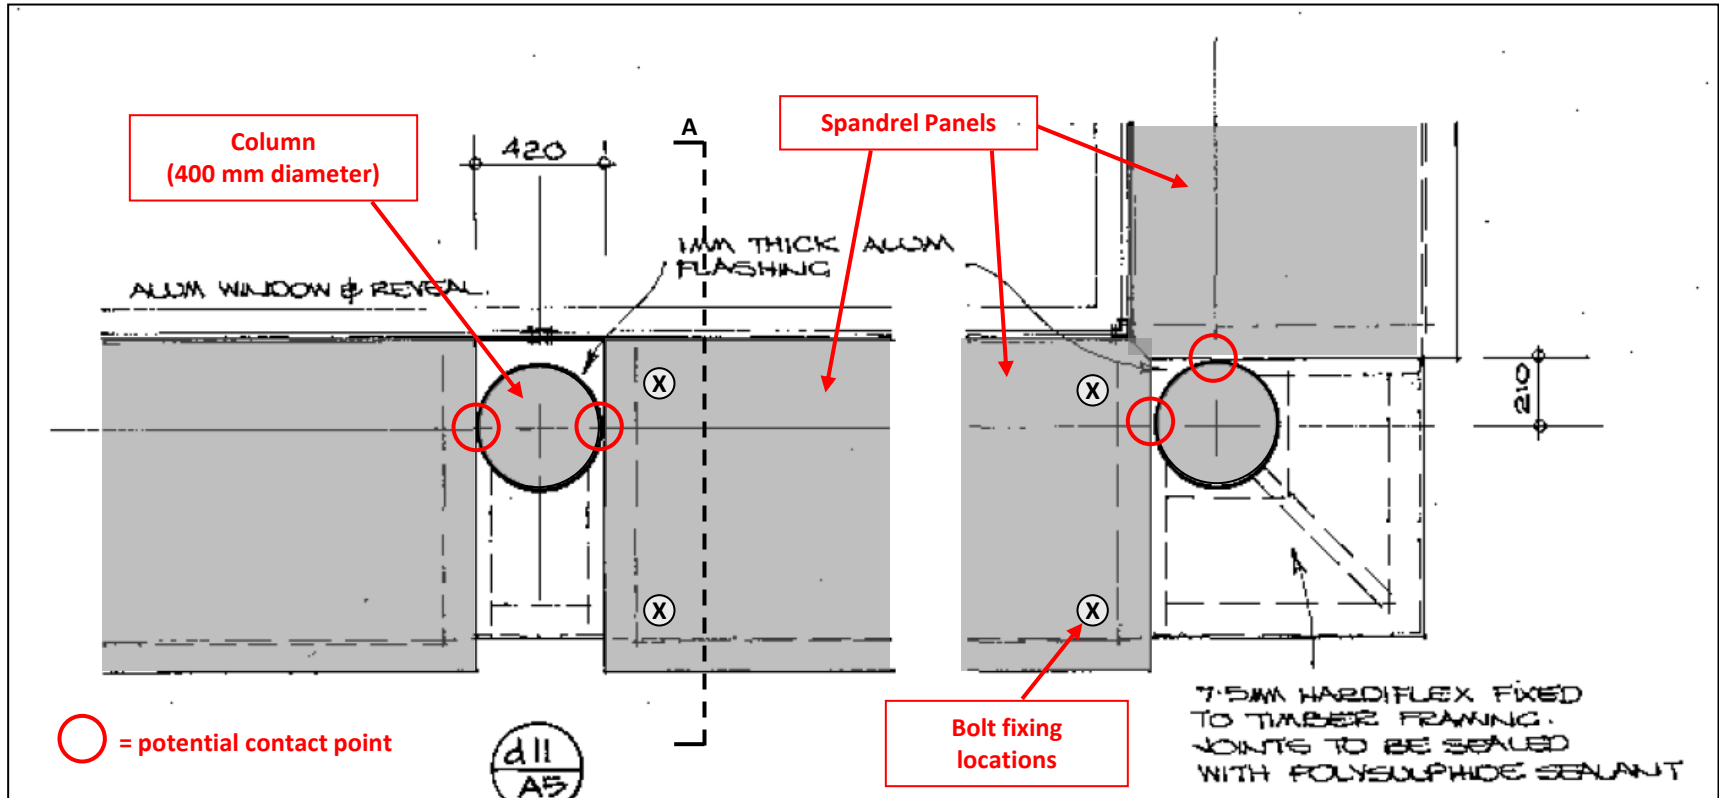
Non-compliant : no seismic gaps specified between columns and Spandrel Panels

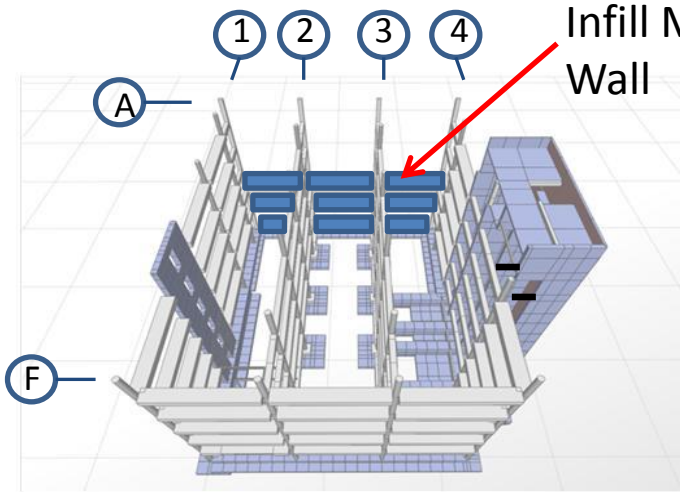
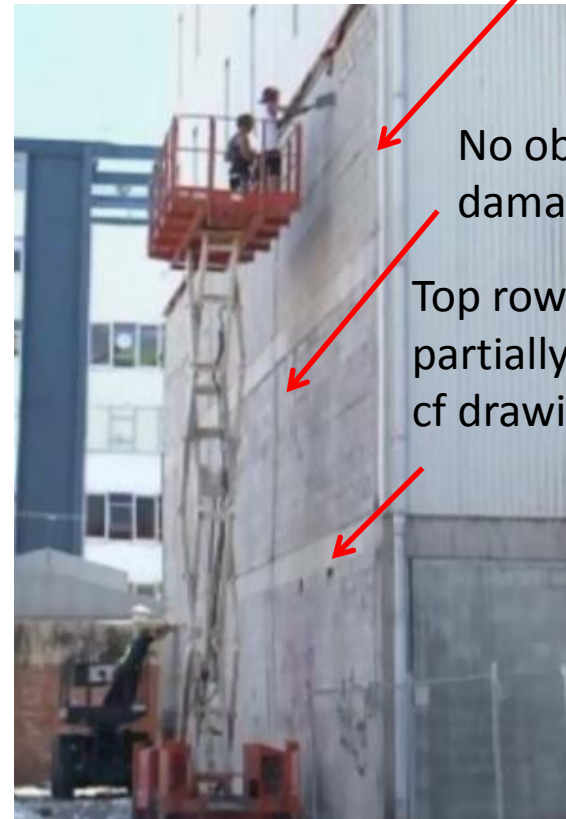
- Drawings showed
 - Grouted top row of masonry at each floor
 - 25 mm gaps on sides at columns
- Workers outside just before collapse found
 - Top rows partially grout filled
 - No gaps on sides at columns on outer face
 - No obvious damage from September eq.
- Staff inside found
 - Sealant and gaps on sides at columns
