# CTV Building Collapse Technical Investigation

Canterbury Earthquakes Royal Commission

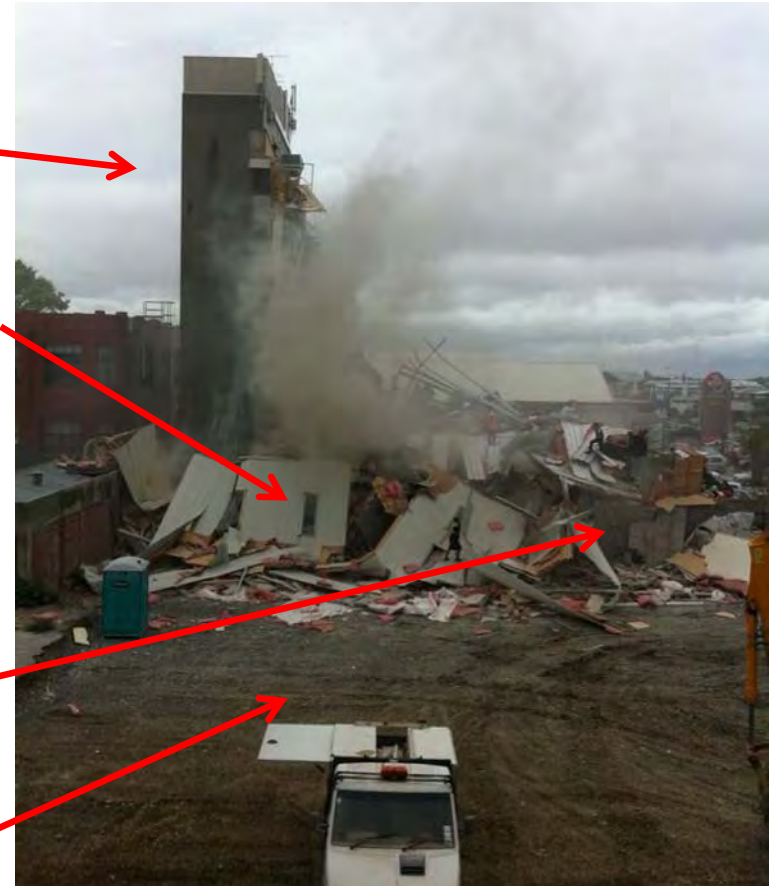
View from Les Mills from west Immediately after the collapse

- View from west
  - Fire just started near north end
  - Level 4 to 6 cladding pushed north
    - Little debris otherwise on this side
  - Diagonal cracking to masonry infill
  - No liquefaction

North Core

Level 4, 5 and 6 Cladding

Level 2 masonry with diagonal cracking

No liquefaction

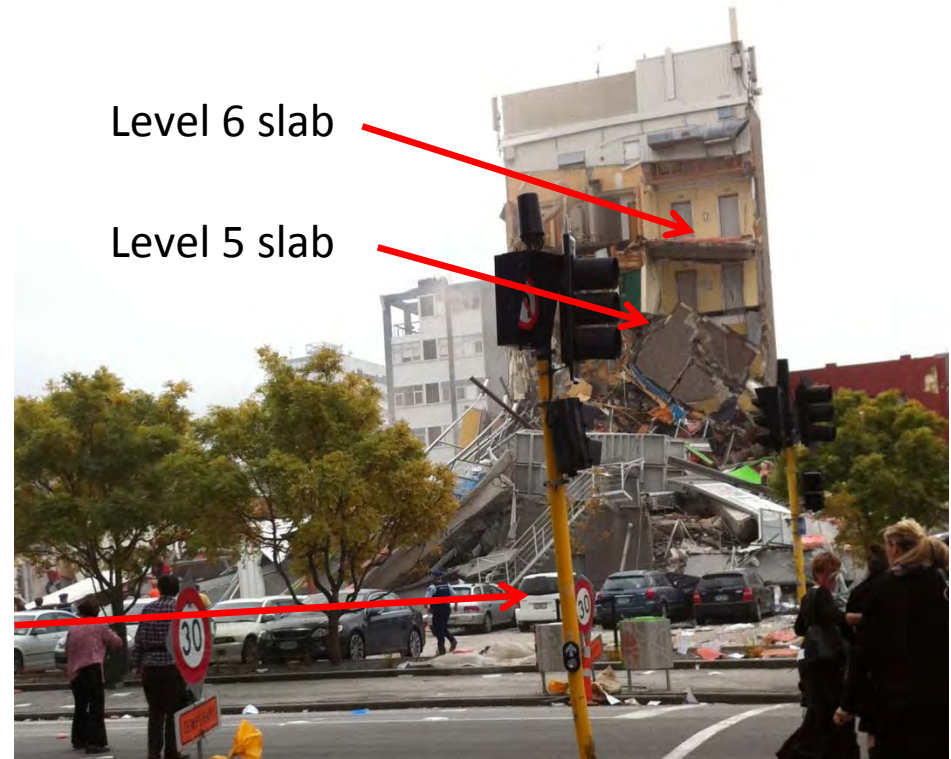
View from Cashel Street from south Immediately after the collapse

- View from South
  - Prior to fire starting
  - Level 5 slab hanging from North Core
  - Level 6 slab supported by drag bars
  - No debris south of the building
    - Cars parked in front of South Wall undamaged

Cars undamaged  
on South face

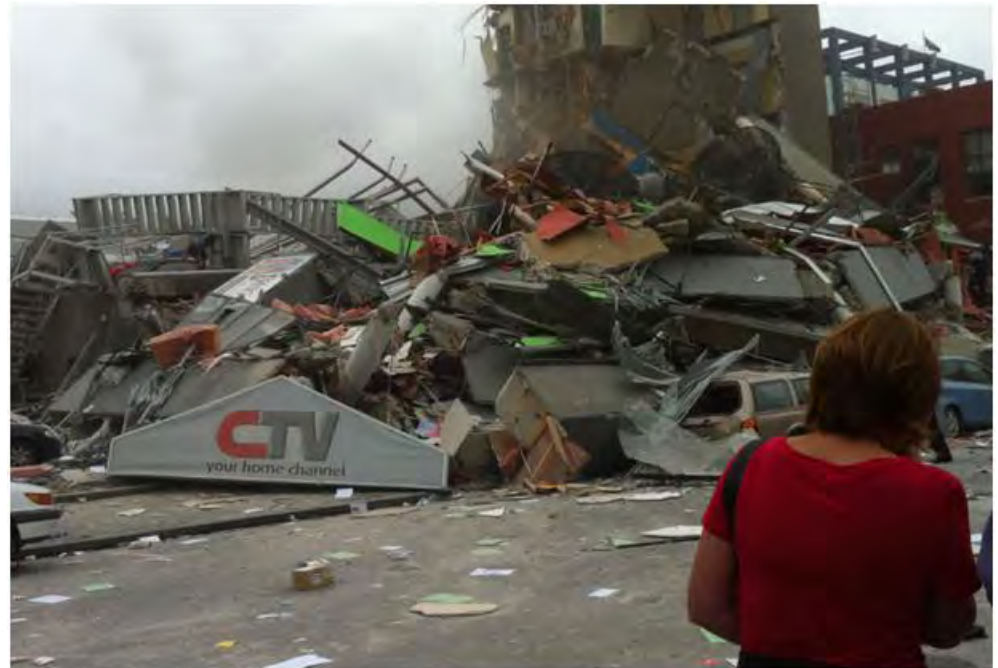
View from southeast Immediately after the collapse

- View from southeast
  - Smoke from fire in background
  - No liquefaction
  - Slight eastward throw
    - Cars in Madras Street crushed by edges beams and Spandrel panels
  - Columns fractured

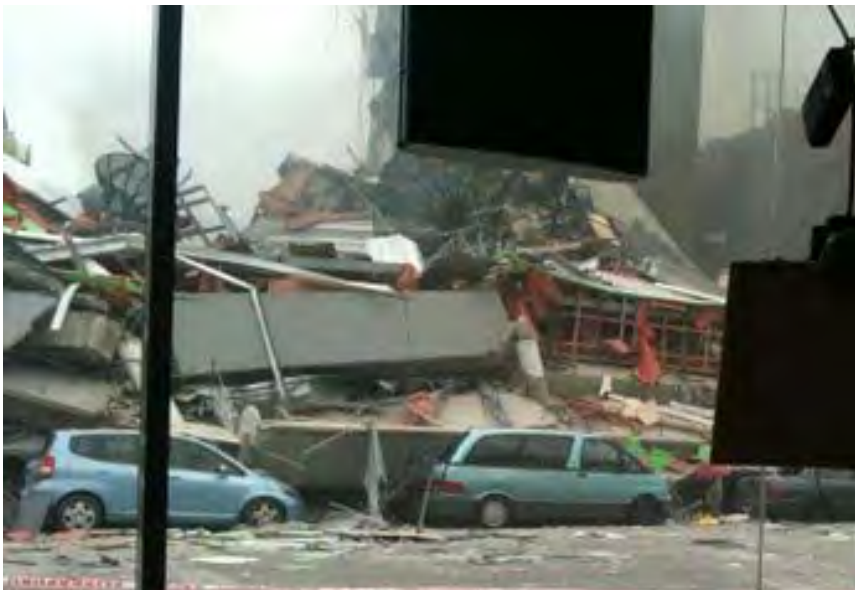
View from Blackwells from east Line 2 to 4 shortly after the collapse at 1:21 pm

- View from East Lines 2 to 4
  - Smoke from fire in background
  - No liquefaction
  - Cars in Madras street crushed
  - Columns fractured

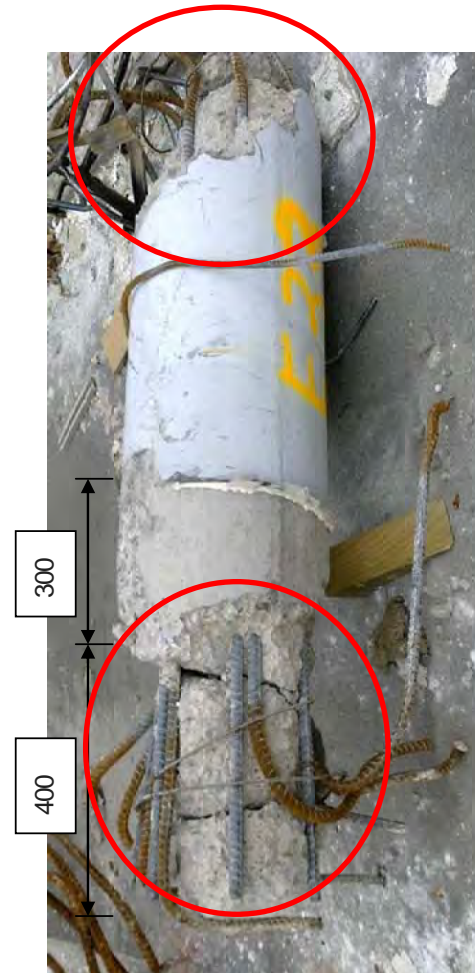
- Column Hinging
  - Base
  - Mid-height
    - Vertical reinforcing steel termination zone
    - Spandrel Panel contact?
  - Head

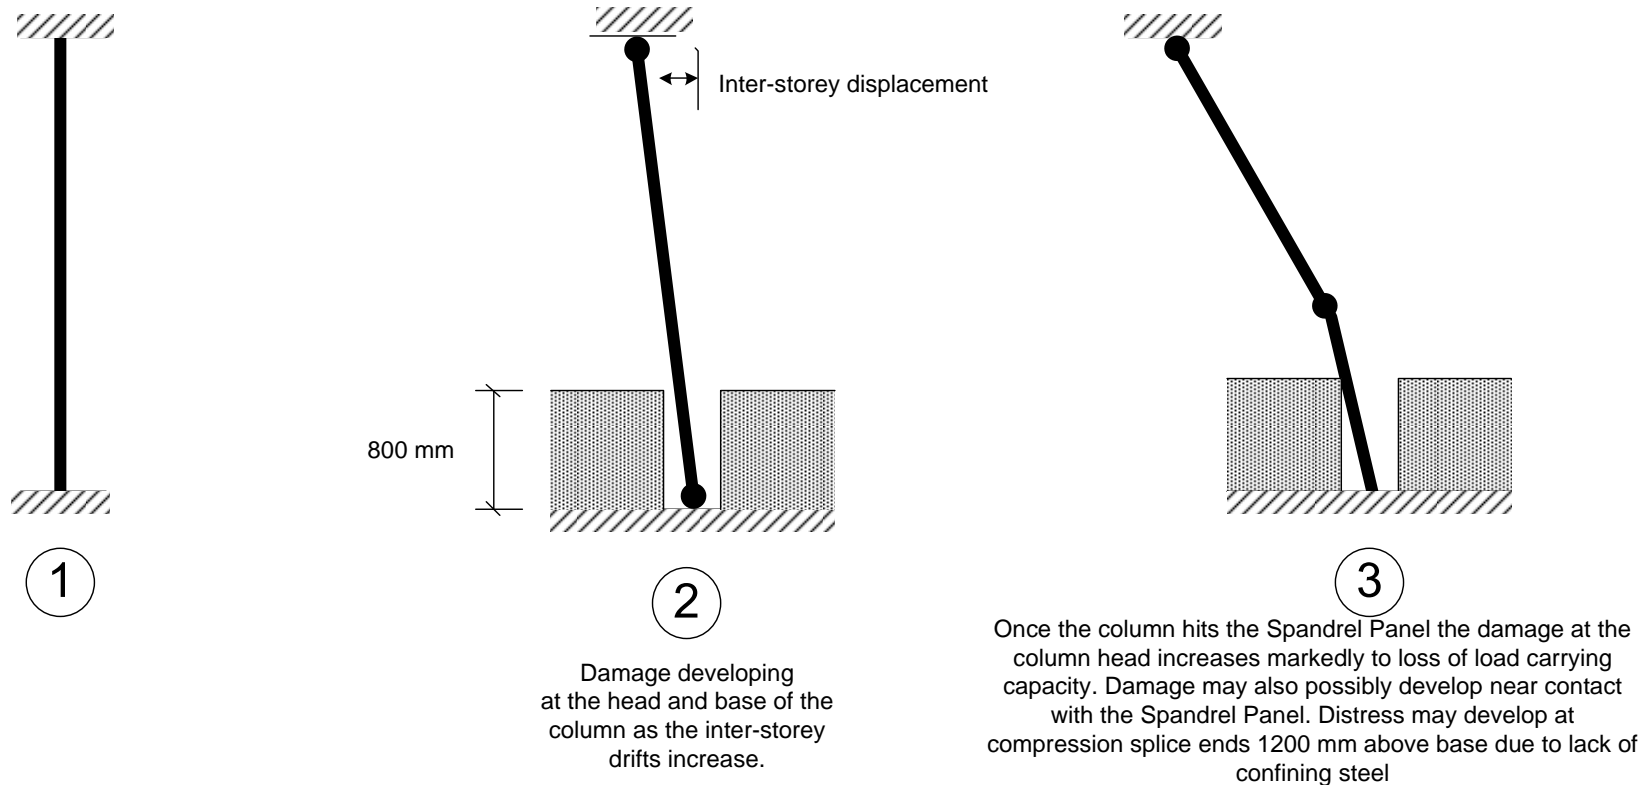
- Possible East and South face column damage sequence

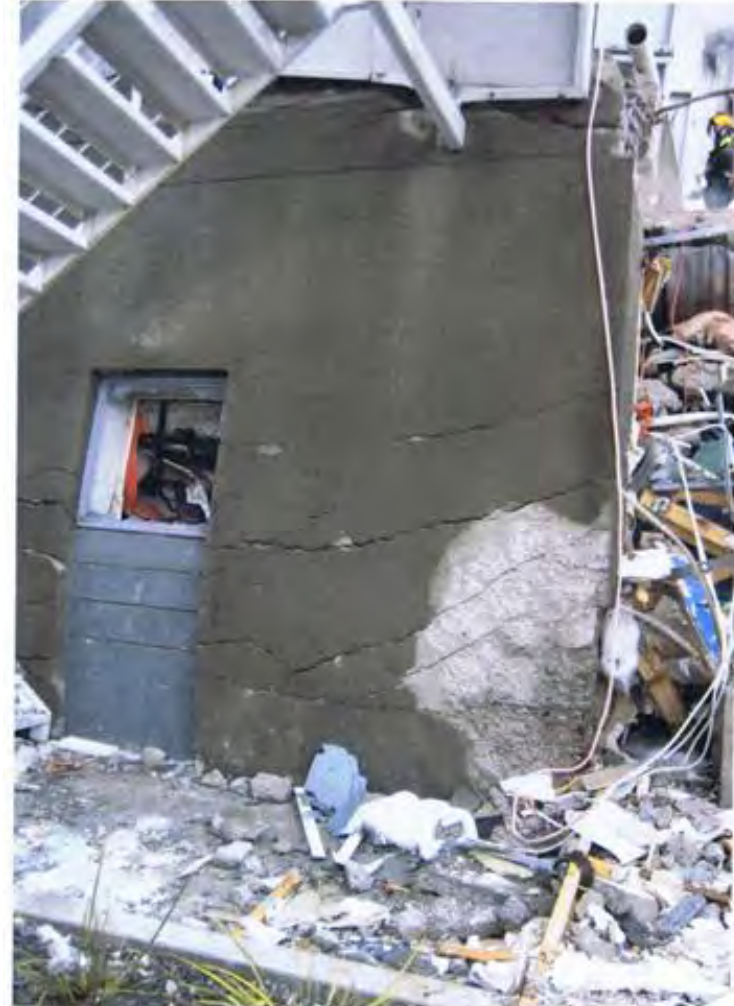
- South Wall
  - Heavy compression spalling at east end
  - Fan like flexural cracking
    - Cantilever behaviour
    - Masonry infill of door

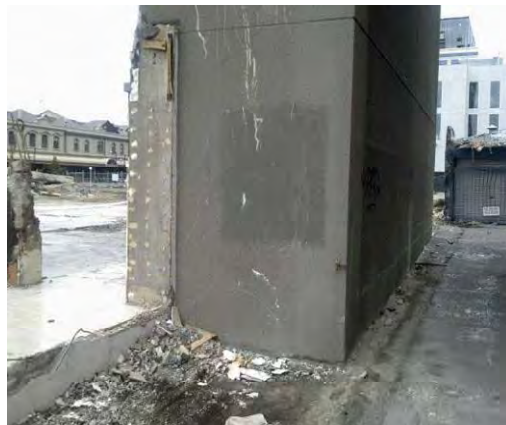
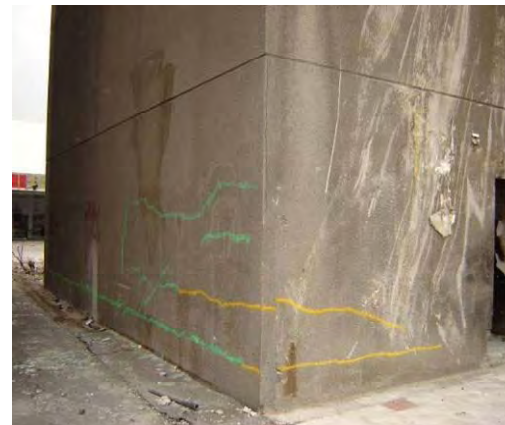
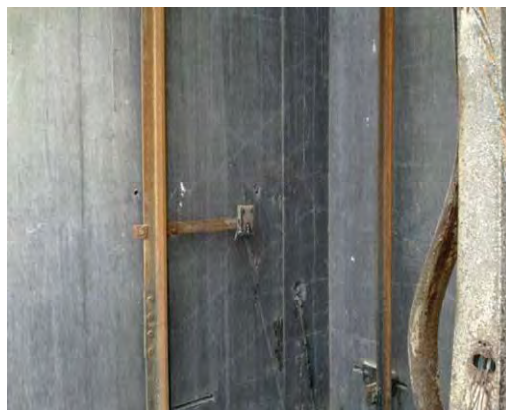
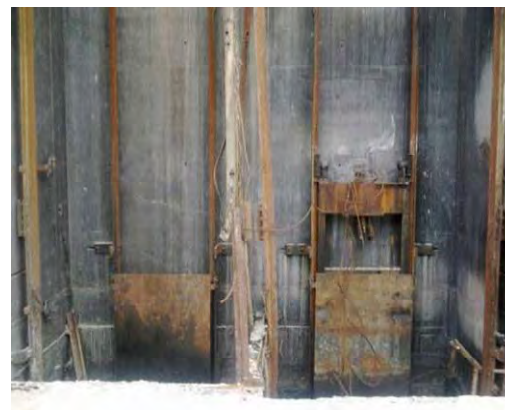
- Hairline cracking to North Core
- Fire effects on inner faces

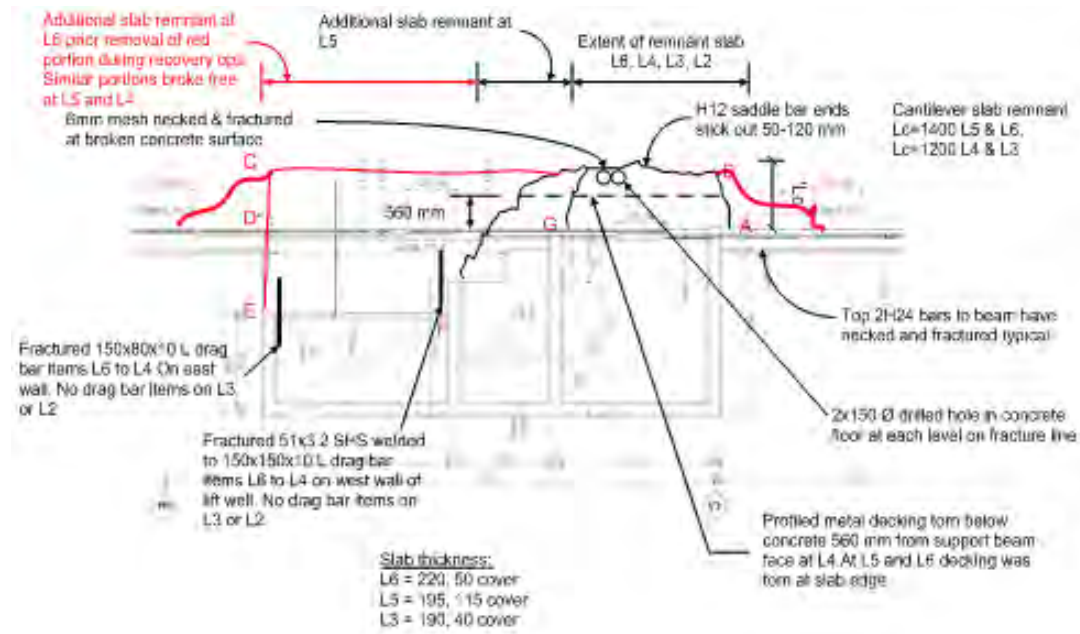
- Drag Bars at Levels 4 to 6
- Slab broken away at end of saddle bars
  - 1200 mm south of beam
- No or little slab reinforcing connection to some walls

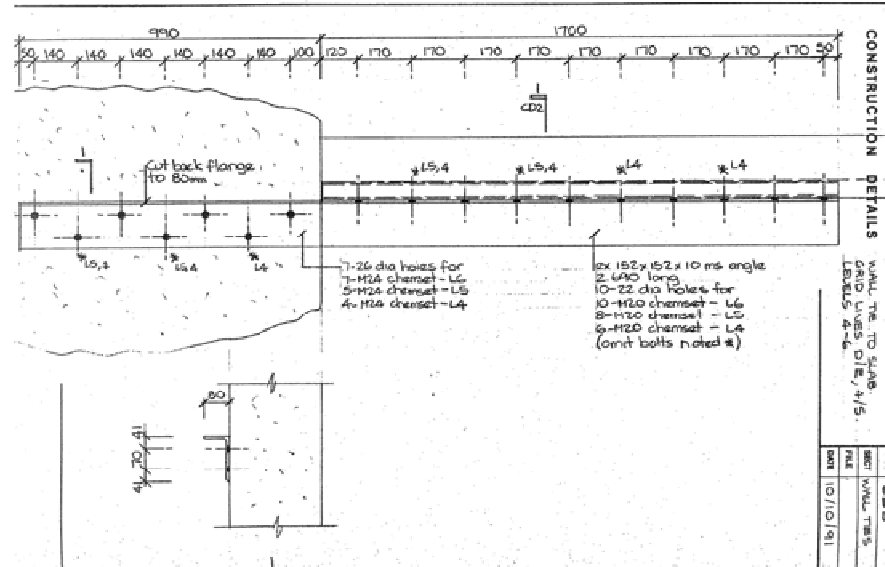
- Drag Bars connection to some walls

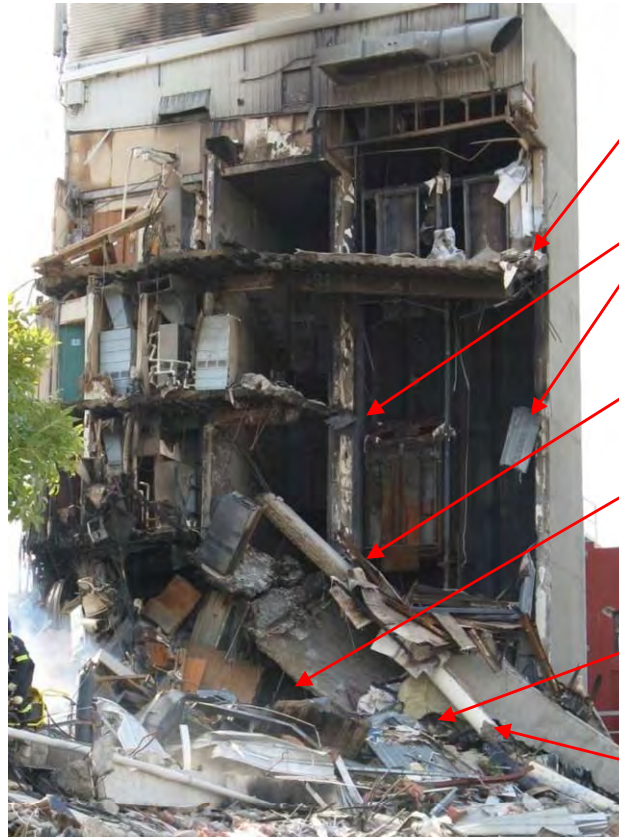
L6 Drag Bar still attached to and holding up slab

L5 Drag Bars

L5 Line 4 precast concrete beam after L5 slab has rotated off

L4 slab failure along ends of H12 saddle bars 1200mm off Line 4 similar to L5 and L6

Failure surface runs diagonally from inside face of edge beam to the ends of the slab saddle bars

Column Line 4 D/E L4-5 and L5-6 with beam-column joint pullout at L5

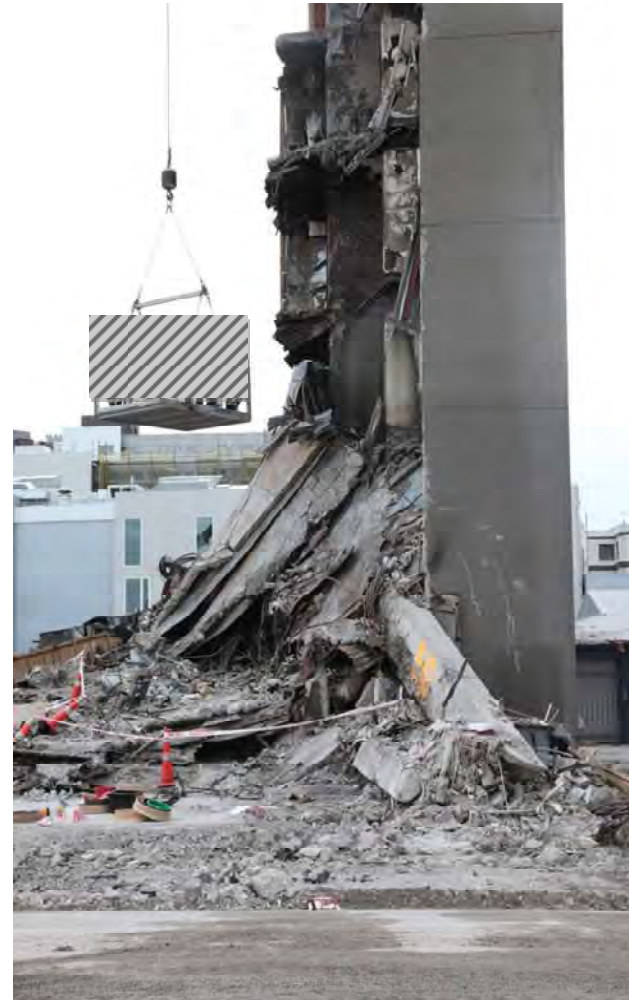
- Slabs leaning against North Core
- Indicates loss of support along Line 3 prior to breaking off North Core

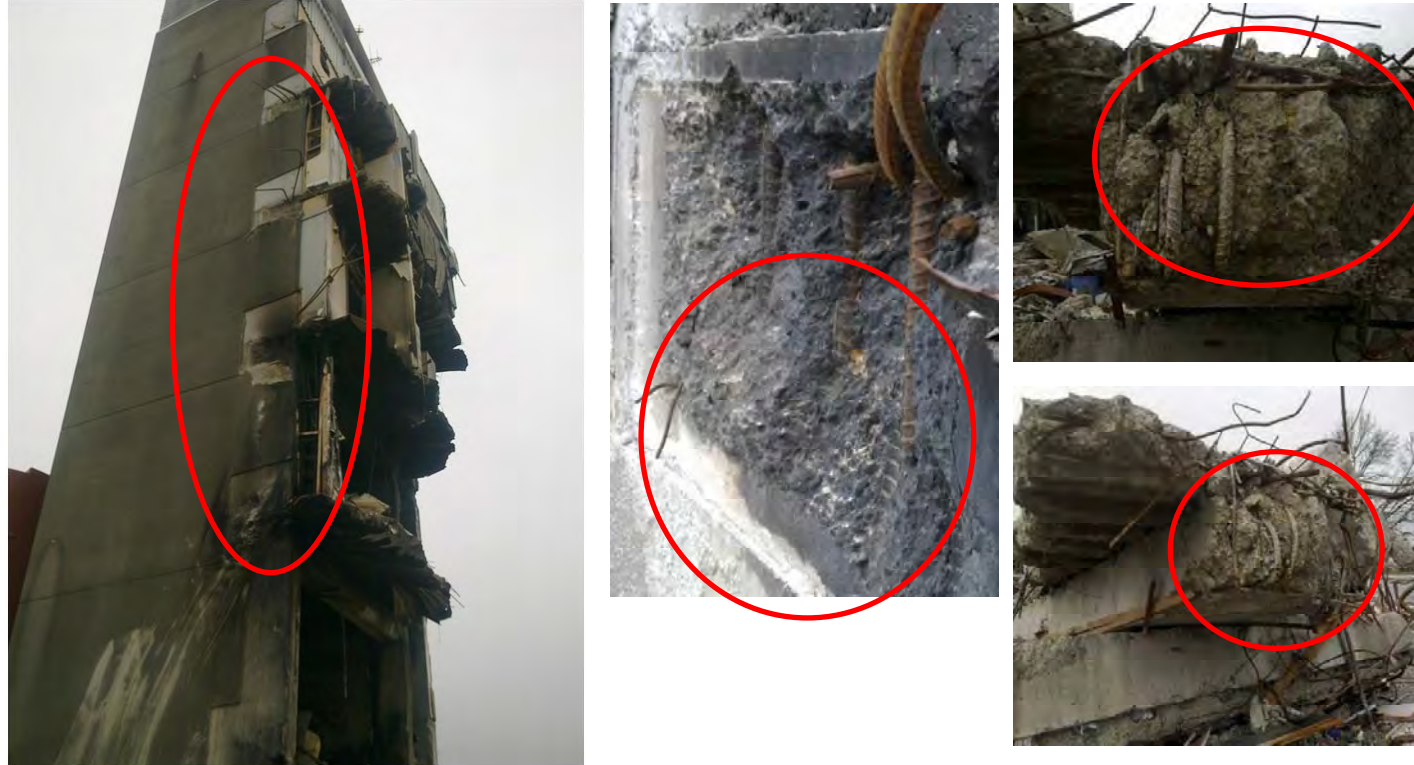
- Beam bottom bars not cast into North Core L3 to L6

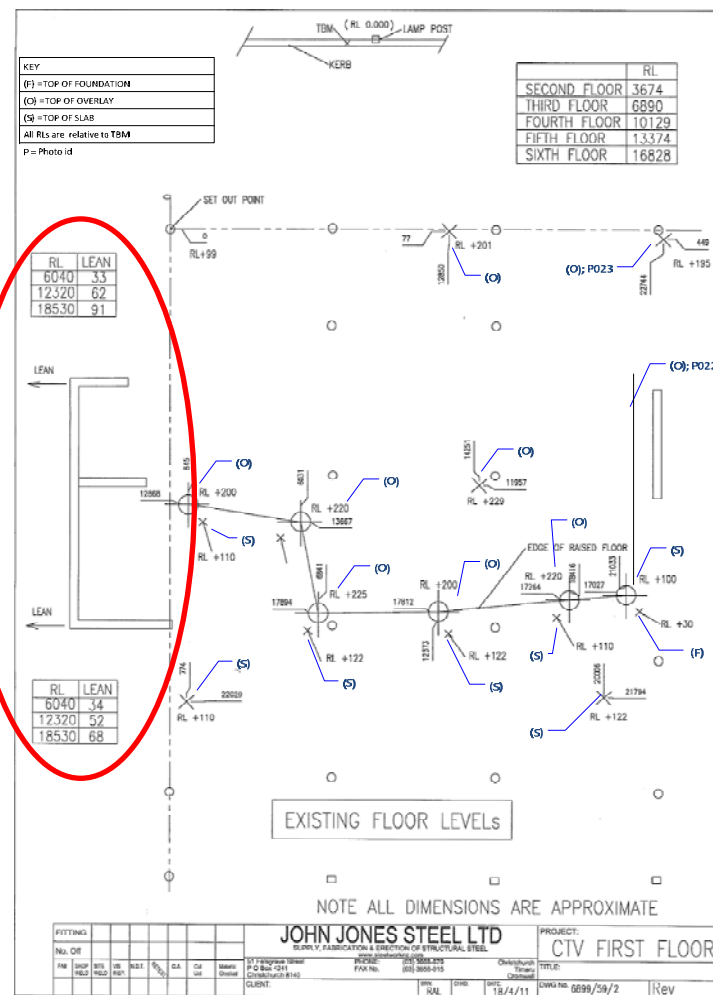
- No sign of settlement of the ground floor
- North Core had a northwards displacement
  - More at the eastern end

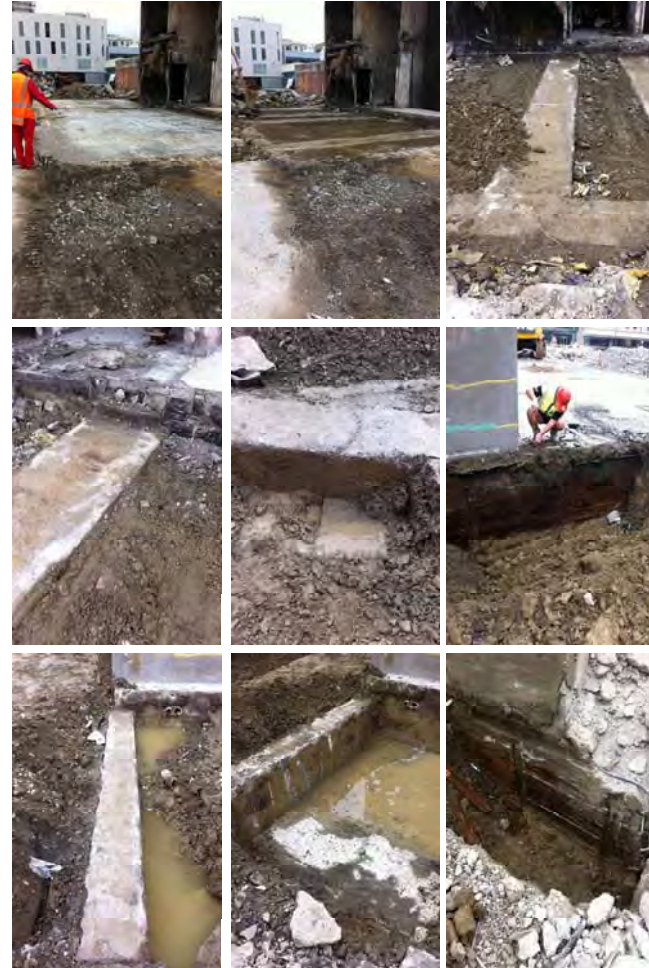
- No liquefaction was found adjacent to the foundations.
- No signs of uplift
- No signs of damage to the foundation beams

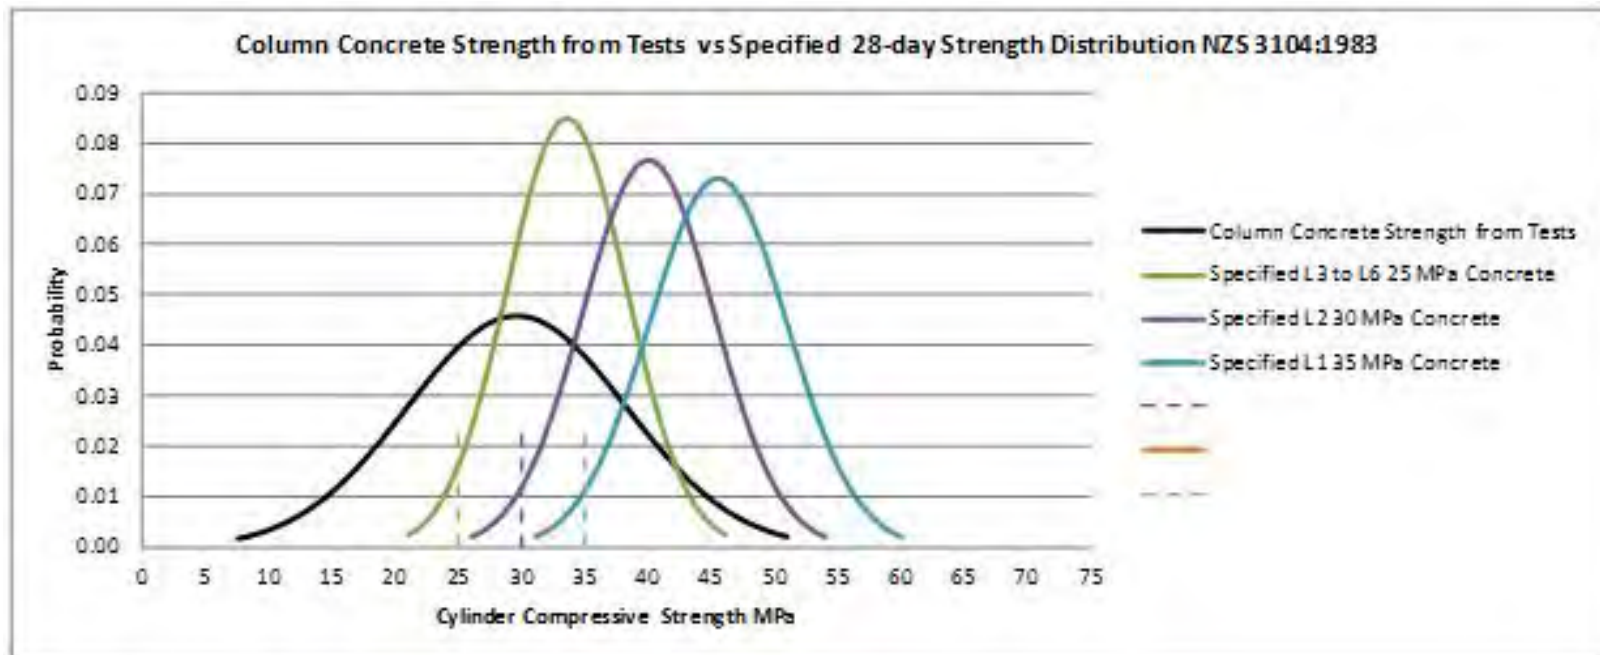
- Concrete in a significant proportion of the columns may have had strengths less than the minimum specified
- It was decided use minimum specified + 2.5 MPa for analyses and check sensitivity

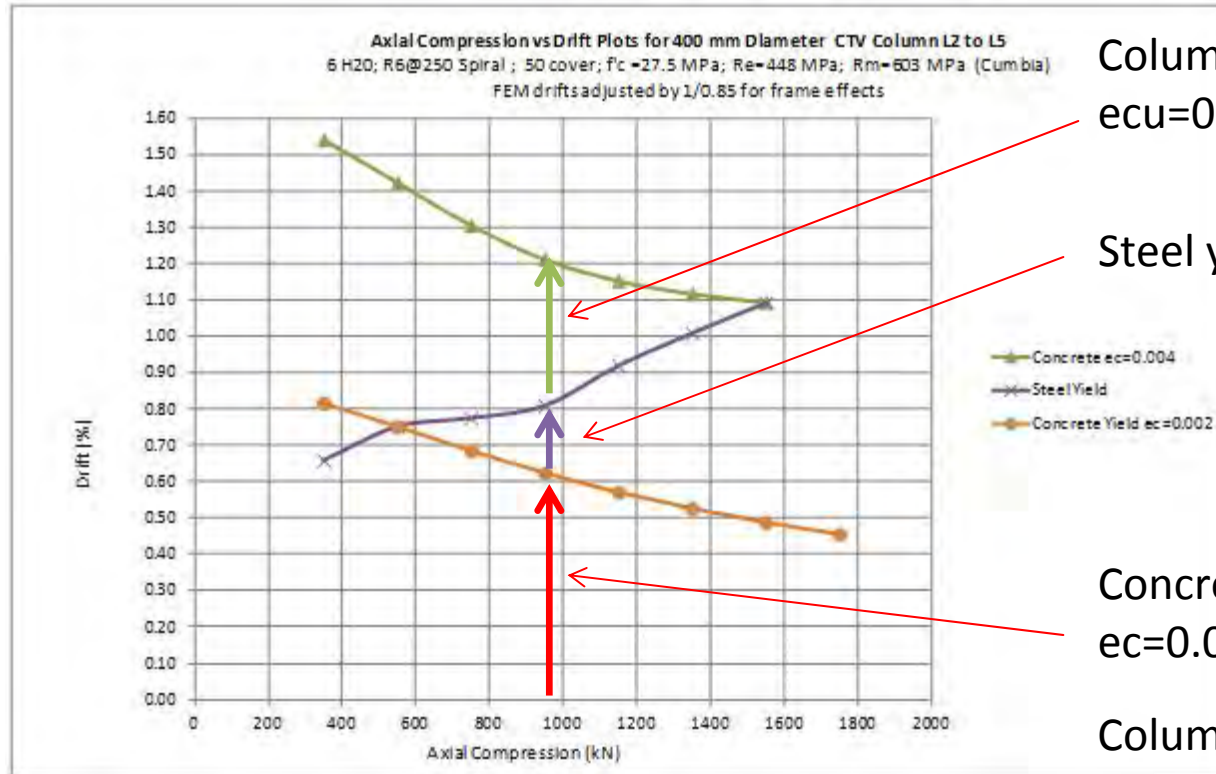
Column F/2 Level 2  
with 995 kN axial load

Column failure limit  
 $ecu = 0.004$  at 1.20% drift

Steel yield at 0.80% drift

Concrete yield limit  
 $ec = 0.002$  at 0.60% drift

- At average tested concrete strength of 27.5 MPa
- Drift capacity reduces with increased axial load from vertical acceleration
  - Table 13 for C/1 and Table 14 for F/2 axial loads and drift limits

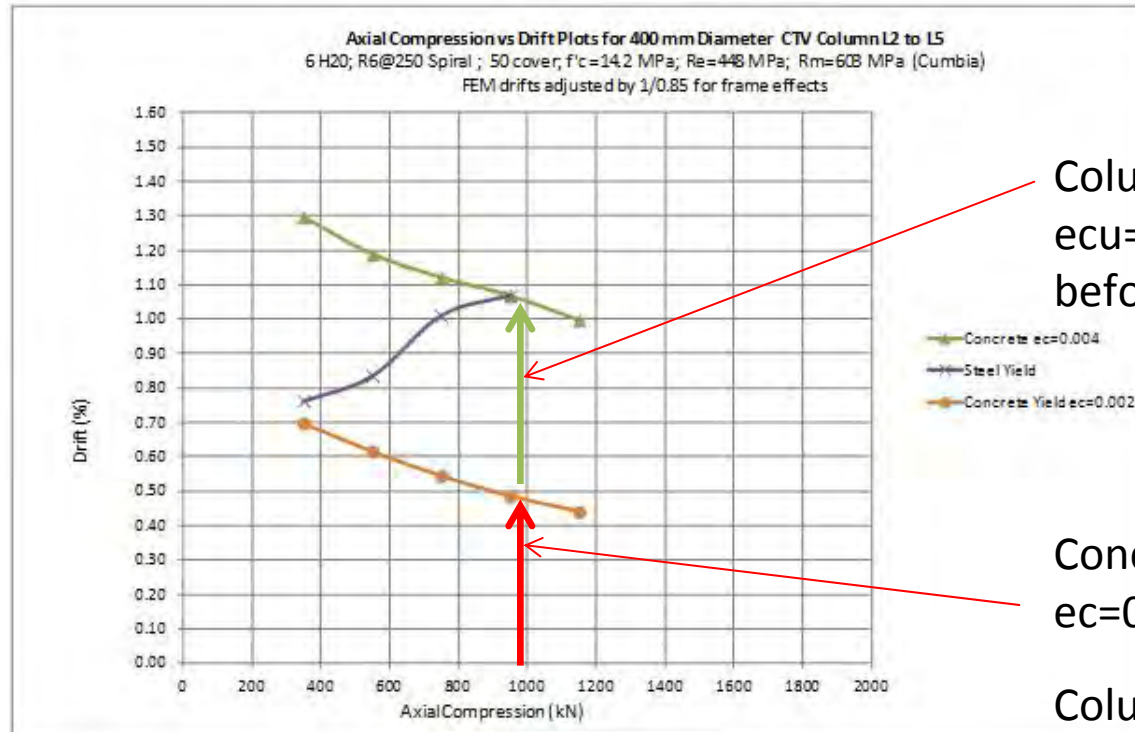
Column F/2 Level 2  
with 995 kN axial load

Column failure limit  
 $ec=0.004$  at 1.05% drift  
before steel yields

Concrete yield limit  
 $ec=0.002$  at 0.48% drift

- At lower 5%ile tested concrete strength of 14.2 MPa
- Drift capacity reduces with reduced concrete strength

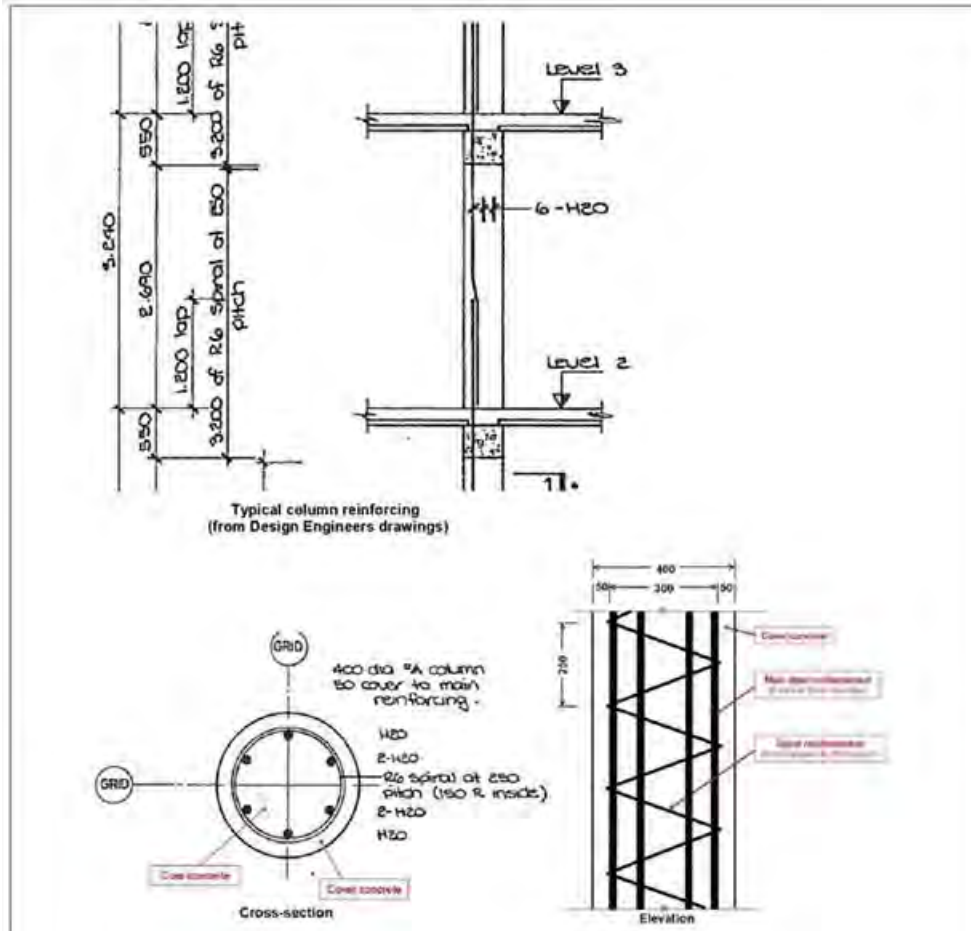
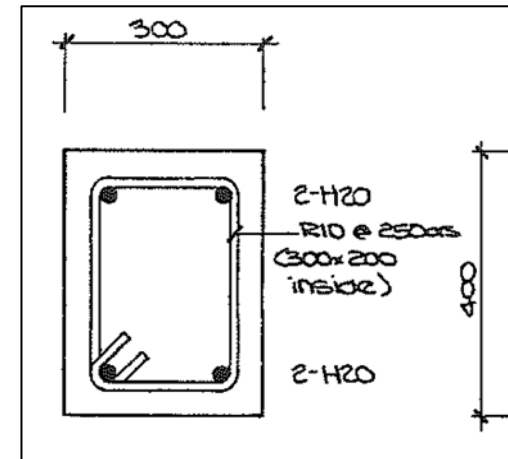
- Same reinforcing in all main building columns
- Light spiral binding R6 @ 250 centres
  - Non-compliant
- Rectangular columns on Line A only

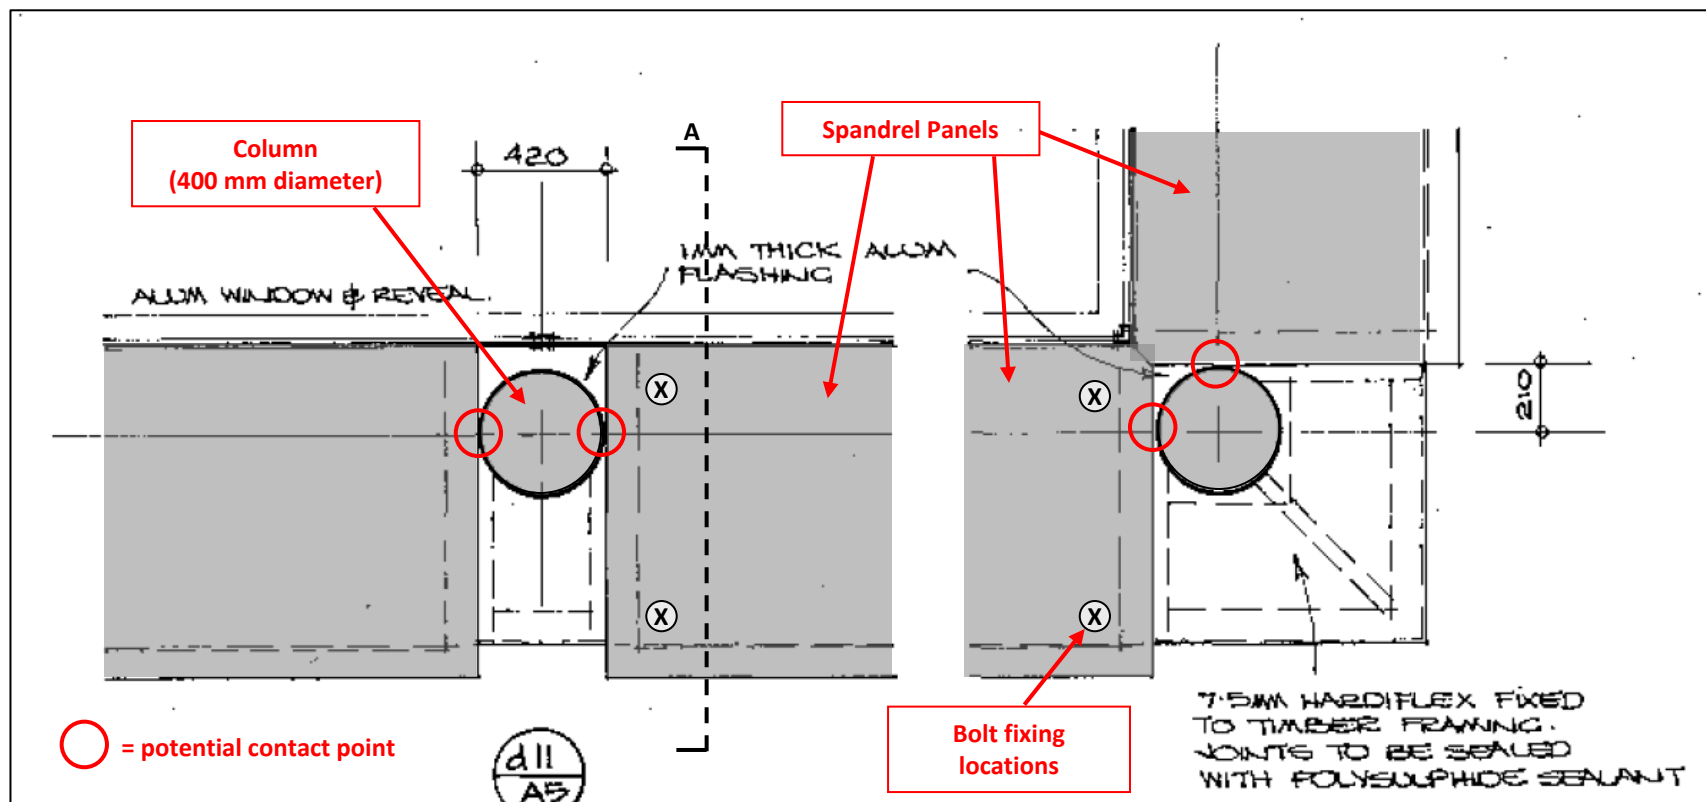
**Non-compliant : no seismic gaps specified between columns and Spandrel Panels**

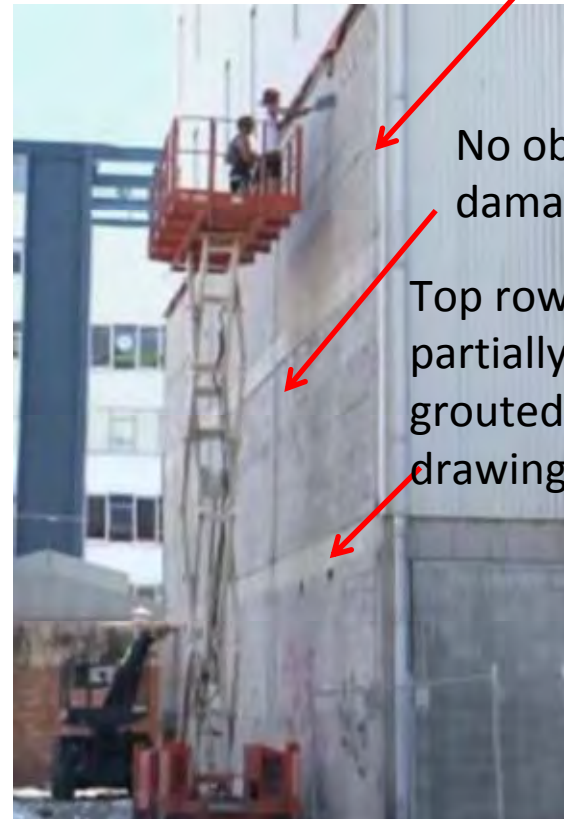
Workers preparing wall for cladding just prior to Eq (CTV News)

- Drawings showed
  - Grouted top row of masonry at each floor
  - 25 mm gaps on sides at columns
- Workers outside just before collapse found
  - Top rows partially grout filled
  - No gaps on sides at columns on outer face
  - No obvious damage from September eq.
- Staff inside found
  - Sealant and gaps on sides at columns

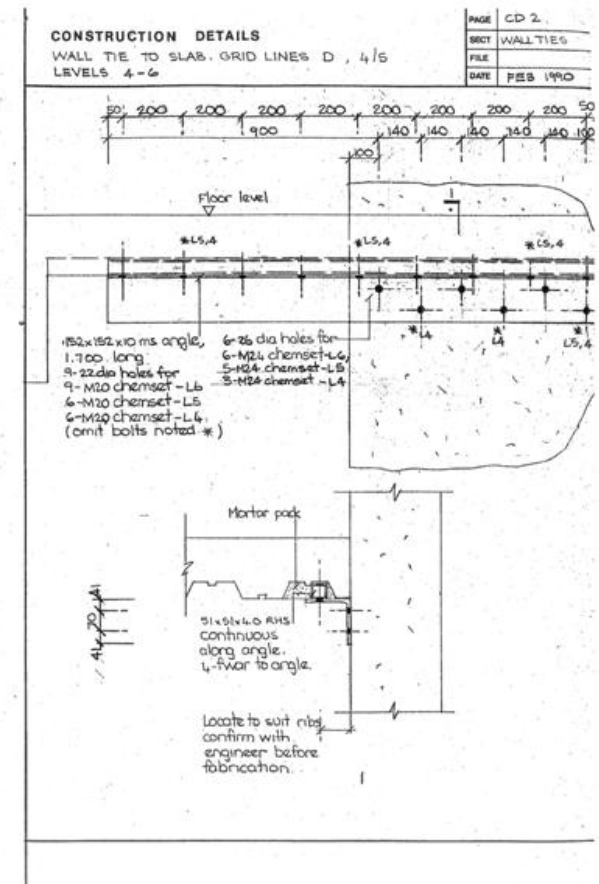
Drag Bars Level  
4, 5 and 6

- Construction of building 1986-1987
- Design defect found in 1990
  - Building could separate from North Core in an Eq.
- Remedial work using Drag Bars designed in 1991
  - Steel angles epoxy bolted into walls and underside of slabs
  - No Drag Bars designed or installed at Level 2 or 3
  - Unable to sustain full design response of the structure
- No Building Consent application on Council files
