CTV Building - GF calculations relating to possible collapse scenarios

Further to Clark Hyland's DBH Report on the CTV Bldg collapse, I think the points below could have received a little more attention in that report - or offer alternative views to some of the report findings.

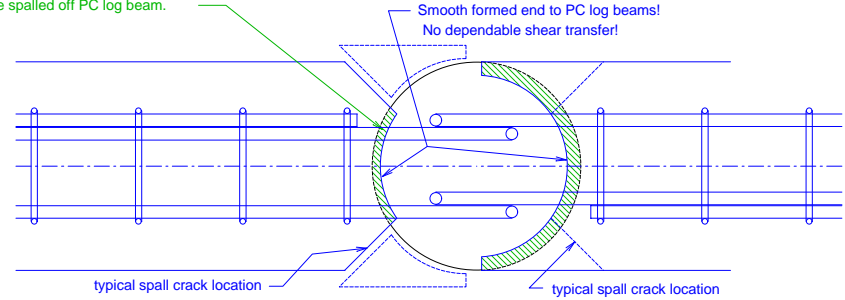
PLAN SECTION 2-2 - INTERIOR BEAM-COLUMN JOINT
 (ALLOWING 10mm CONSTRUCTION TOLERANCE)

And the bearing stress calculated above assumes columns and beams were built **and located** in PERFECT accordance with the plans. It is quite conceivable that the 25mm bearing width detailed on the drawings could have ended up being much lower. Allowing for just 10mm construction tolerance, support area at one beam end could easily have been as low as $A_{\min} := 3510\text{mm}^2$. (see CAD File: *CTV Bldg - Interior Beam-Column Joint - GF 20120215.dcd*)

This would have resulted in an unfactored bearing stress in the order of $\frac{0.5P_g}{A_{\min}} = 41 \cdot \text{MPa}$

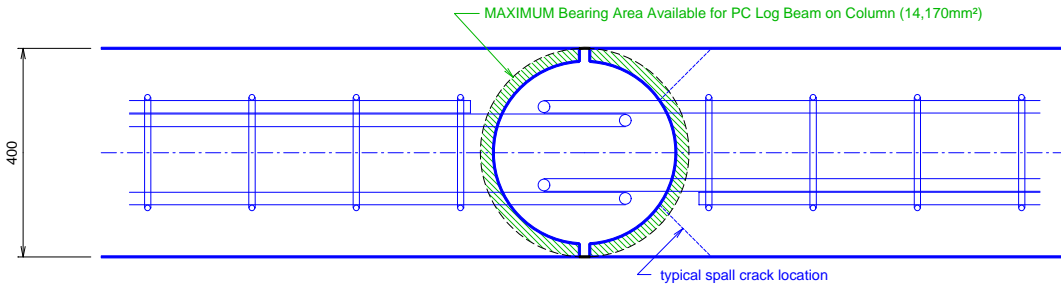
PLAN SECTION 3-3 - INTERIOR BEAM-COLUMN JOINT
 (ALLOWING 10mm CONSTRUCTION TOLERANCE + CORNER SPALLING)

If the outer corners of the log beams have spalled off (all the POST-collapse specimens exhibited this situation - and there was no confining steel detailed to prevent this occurrence - see Point 3 below), the available bearing area reduces significantly. Many of the beam ends were left with less than 200mm width at the bottom after the corners had spalled off.

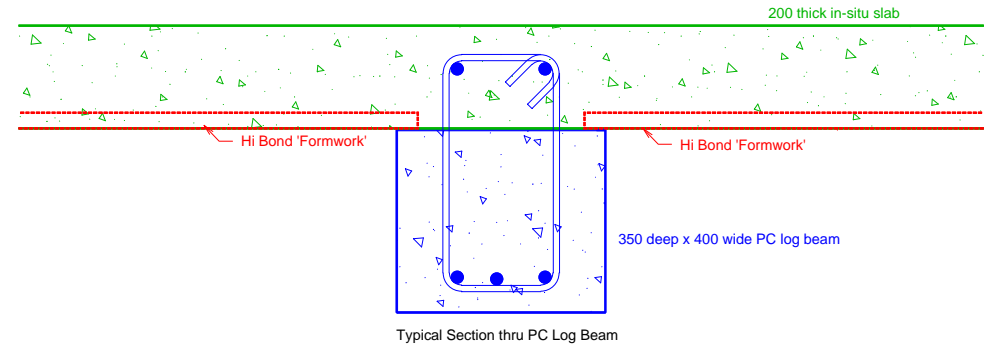
PLAN SECTION 1-1 - INTERIOR BEAM-COLUMN JOINT
 (AS DESIGNED)

Post collapse photos show that the ENDS of the precast units were made with a very smooth formed finish. Consider also that with very little inter-storey drift, the vertical joint between a beam end and the column core concrete would, on one side, be opening up below slab level (since the bottom longitudinal beam bars were inadequately anchored beyond that joint) - reducing any available friction on the curved vertical beam end face to zero AND reducing what was initially designed as a very narrow seating width (for the precast beam on the column cover concrete below). If all this single floor dead load is transferred through the 25mm wide (as designed) seating for the precast log beams on the 400Ø column, we would have a bearing stress of at least:

$$f_p := \frac{P_g}{\pi \cdot \left[(0.2\text{m})^2 - (0.175\text{m})^2 \right]} = 9.8 \cdot \text{MPa}$$

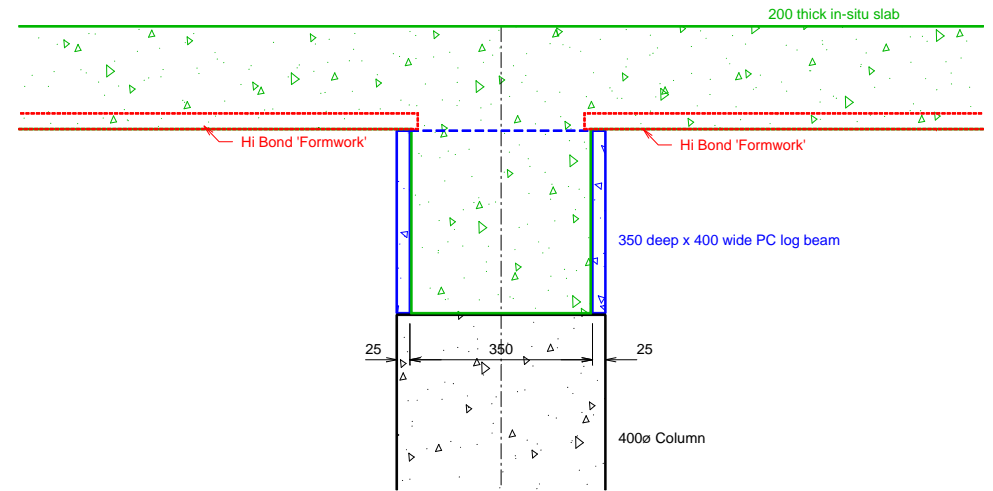
LONGITUDINAL SECTION - TYPICAL INTERIOR BEAM-COLUMN JOINT

End stirrups in precast log and shell beams were often not located close enough to the end of precast - i.e. too far away from column centreline. Some measured up to 300mm! (See photo DSCF 6888). This exacerbates the condition discussed in Point 1 above.
