**Figure 1 Remains of CTV Building at Burwood**

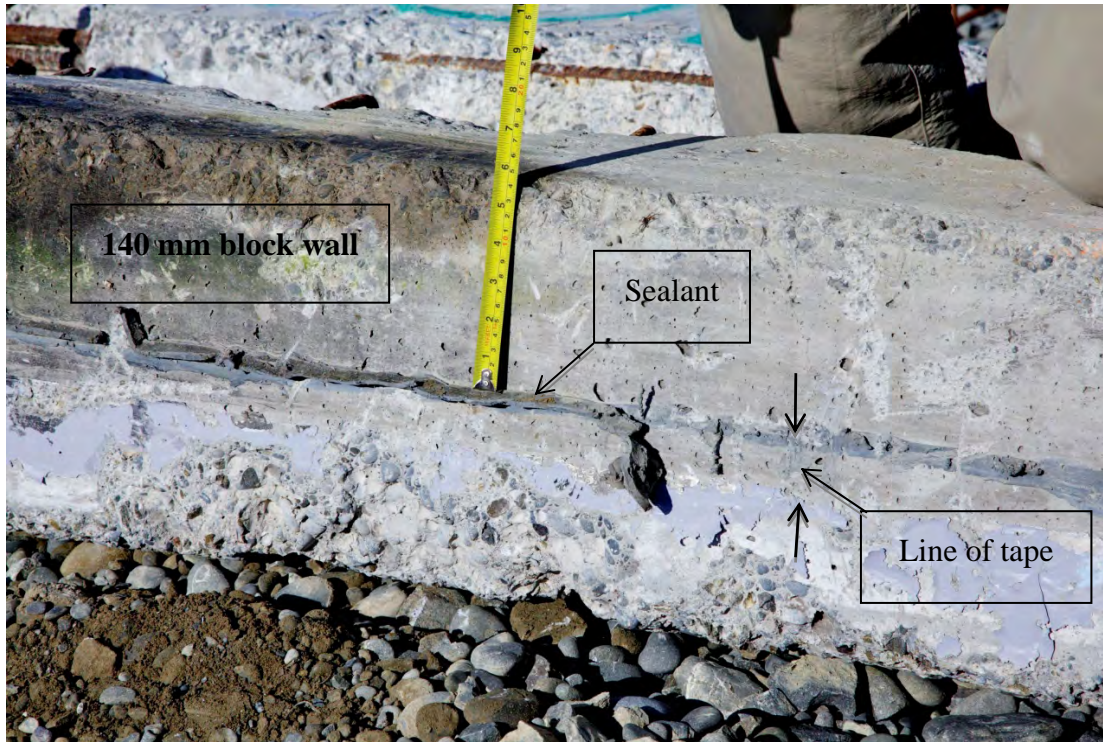
a) Remnant of sealant on face of rectangular column

**Figure 2 Remnant of sealant between the rectangular columns and western the block wall**

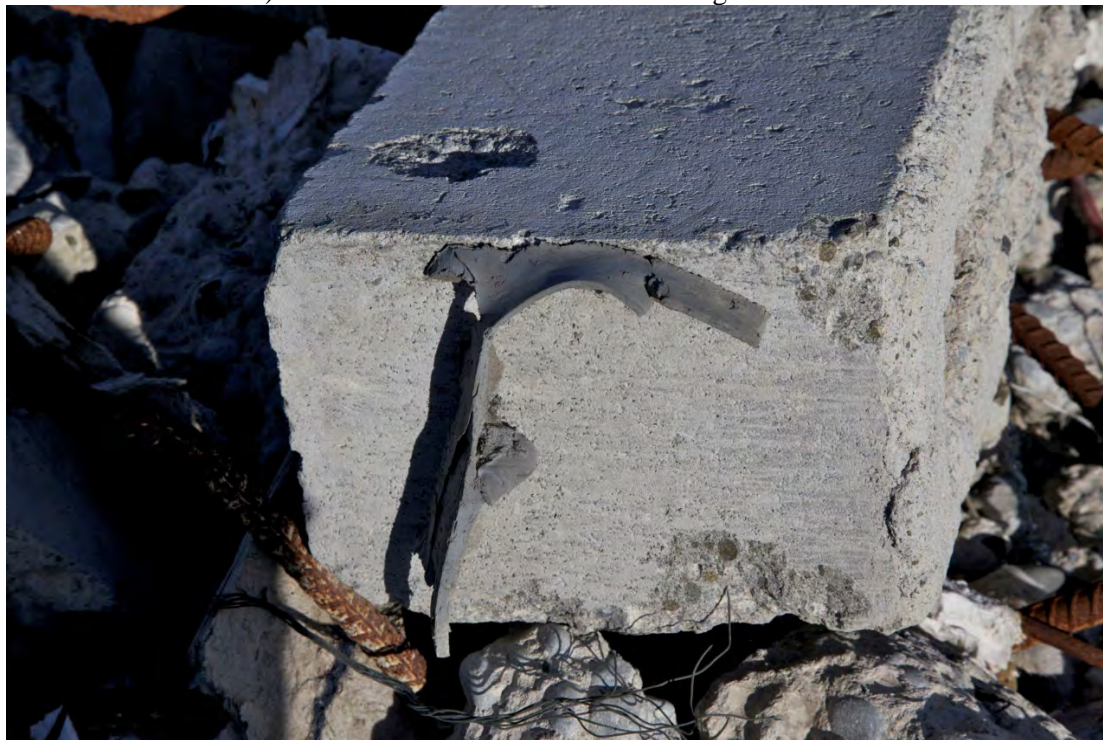
b) Remnant of sealant on reinforced core filled blocks

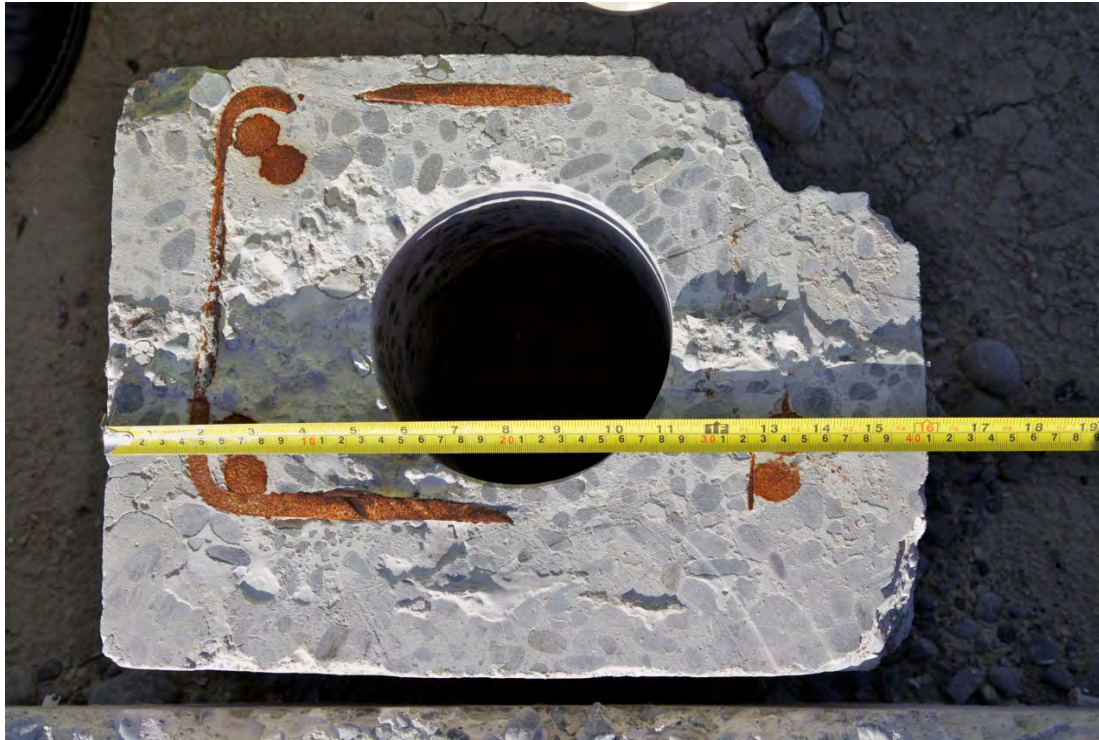
(a) Cross-section of a rectangular column with cored hole

**Figure 5 Examples of columns with low and high cover**

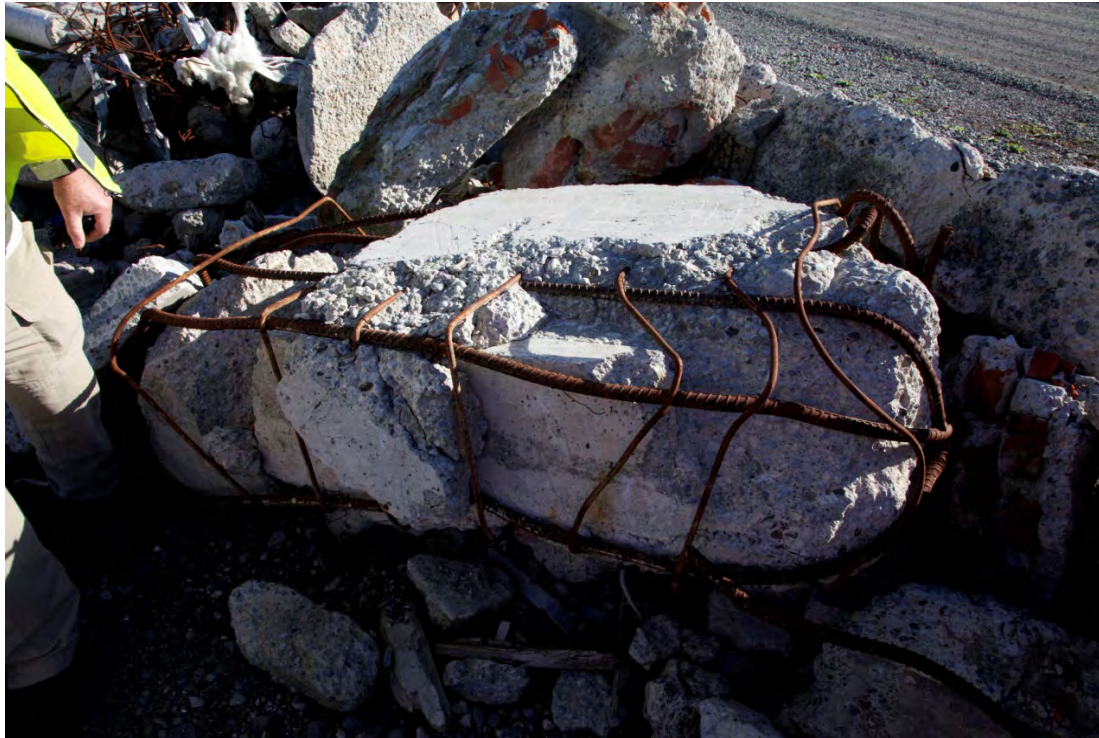
(a) Overview of edge beam showing shell beam broken away from the infill concrete

**Figure 7 An upside down broken edge beam**

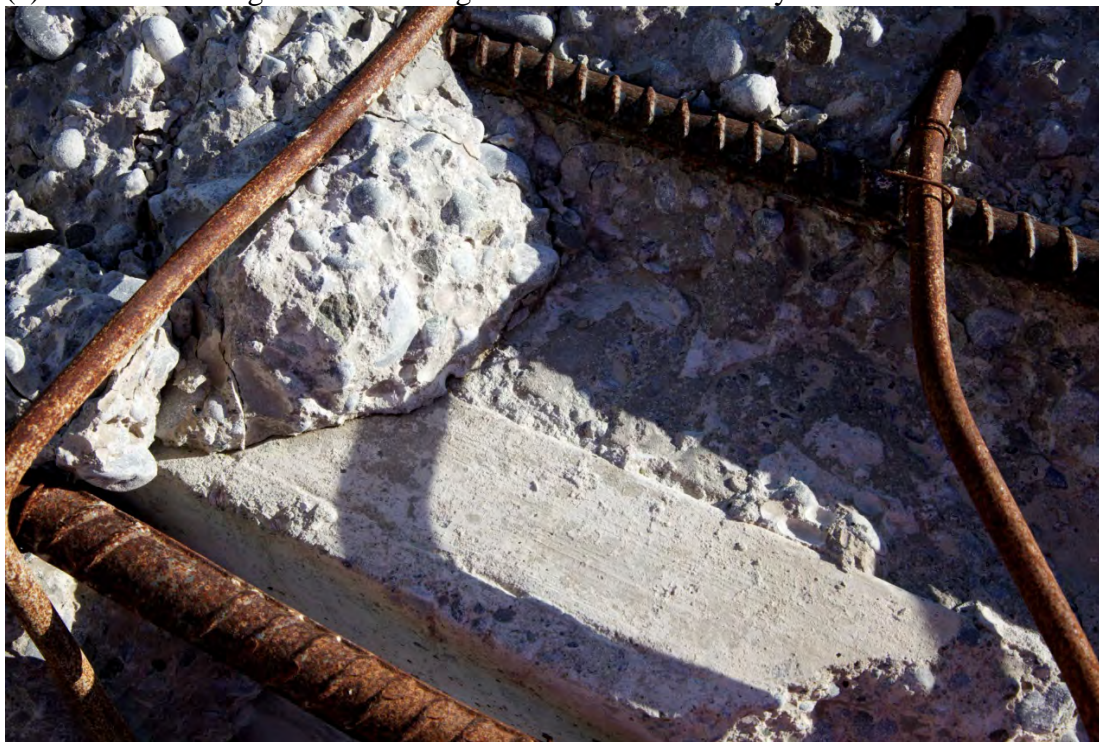
(b) Close-up of smooth and rough surfaces of infill concrete. The concrete of the shell beam had been broken to reveal the shell beam reinforcement.

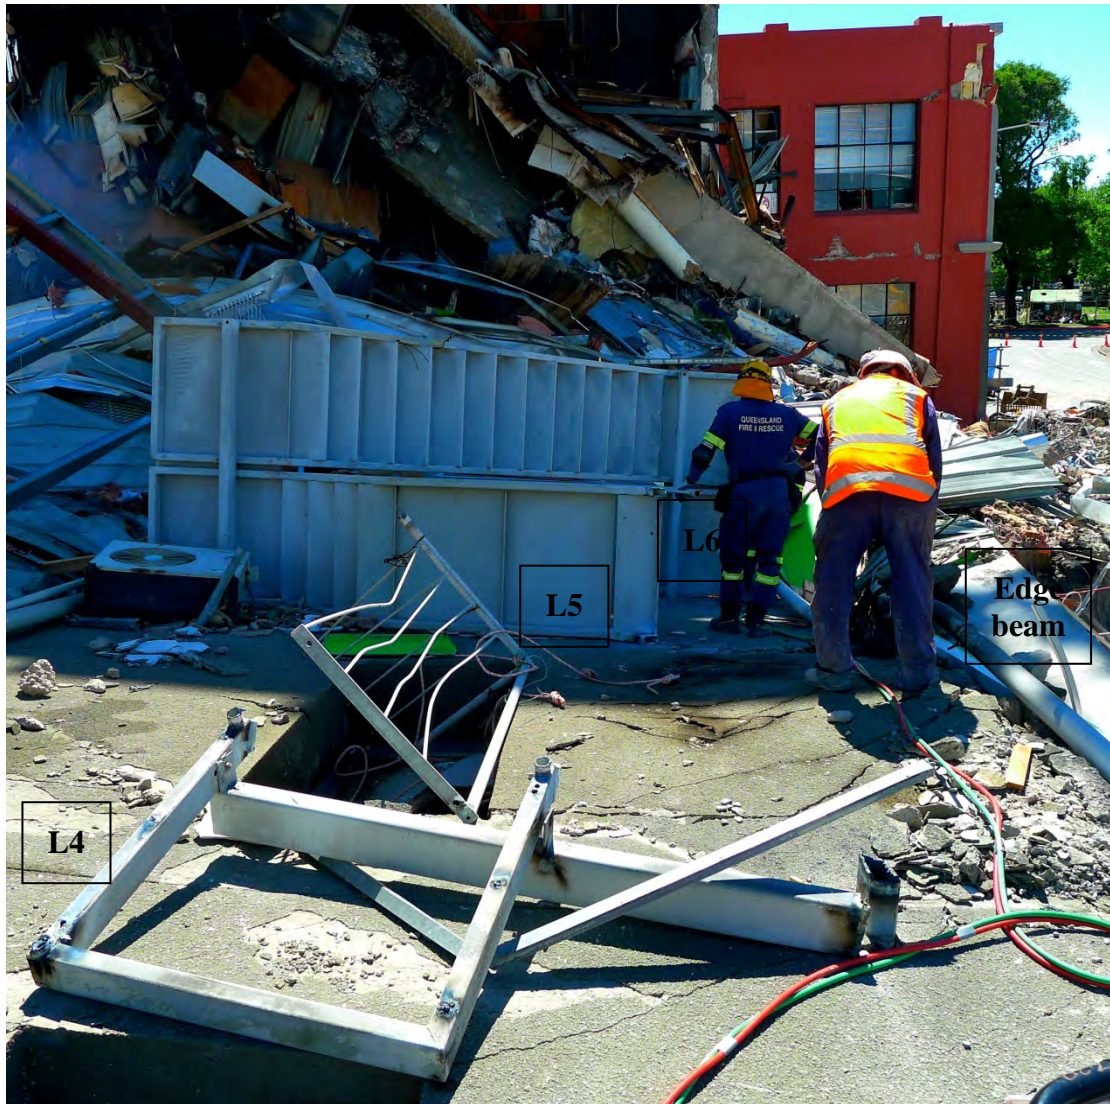
Figure 8 View of South Wall during operations to remove escape stair (Photo by John Reid)

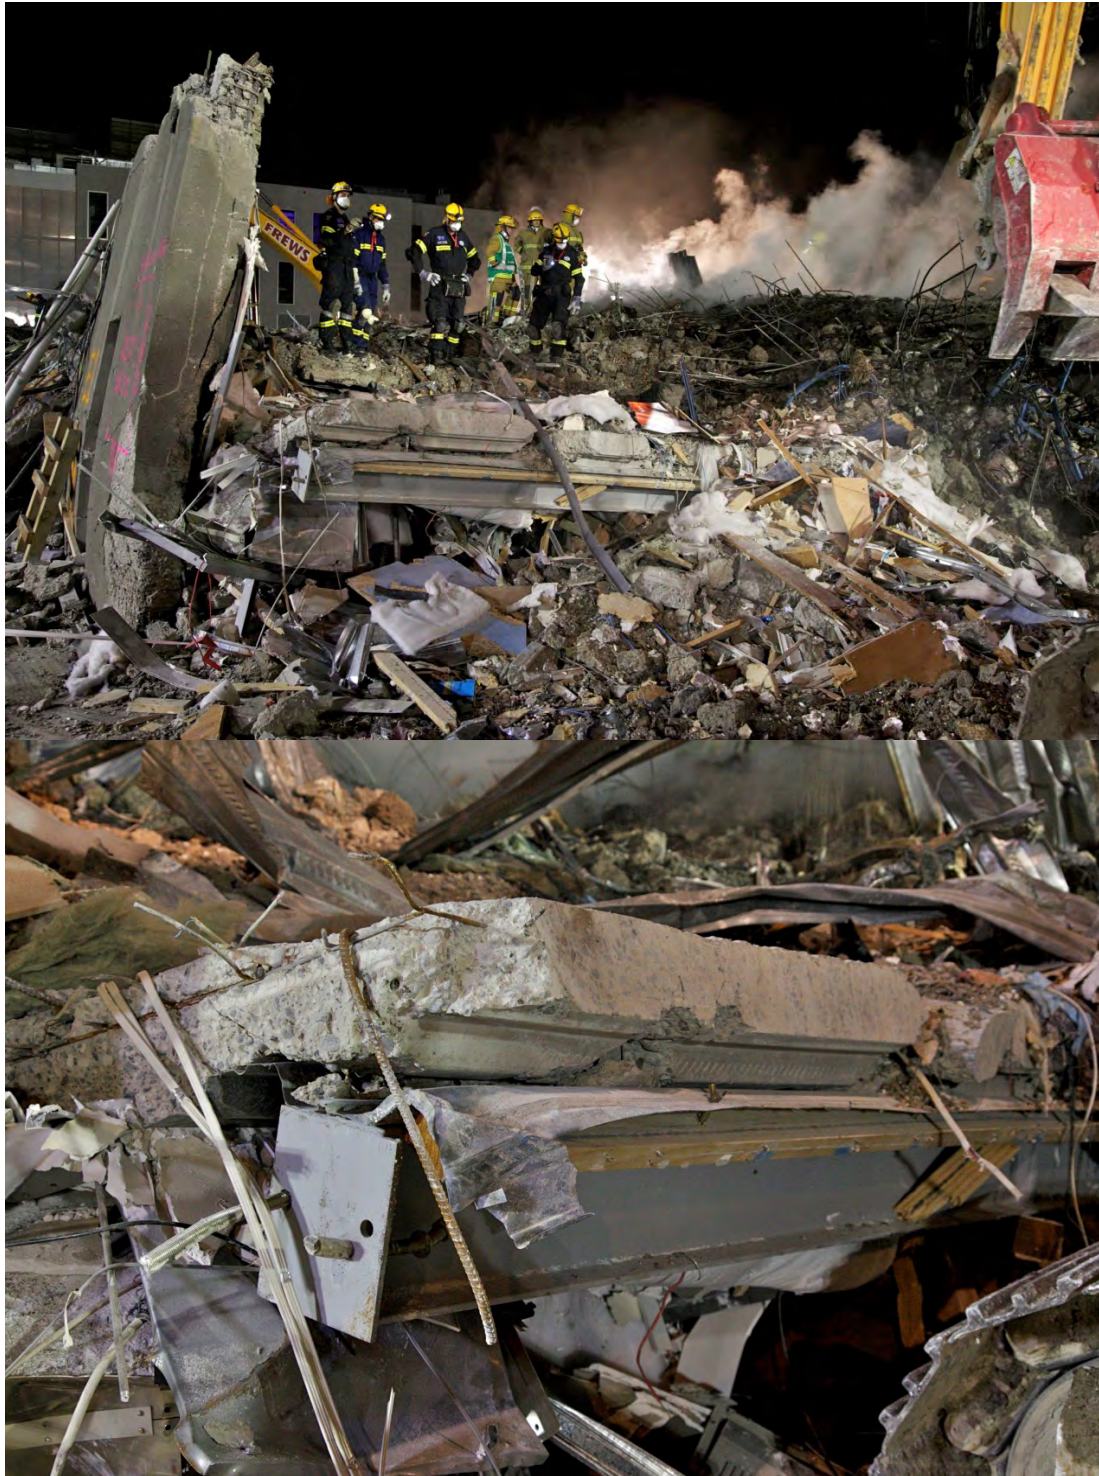
**Figure 9 Steel trimming beam: Level 2, south-east corner of the Building**
