Additional thoughts

Additional thoughts since presentation was prepared

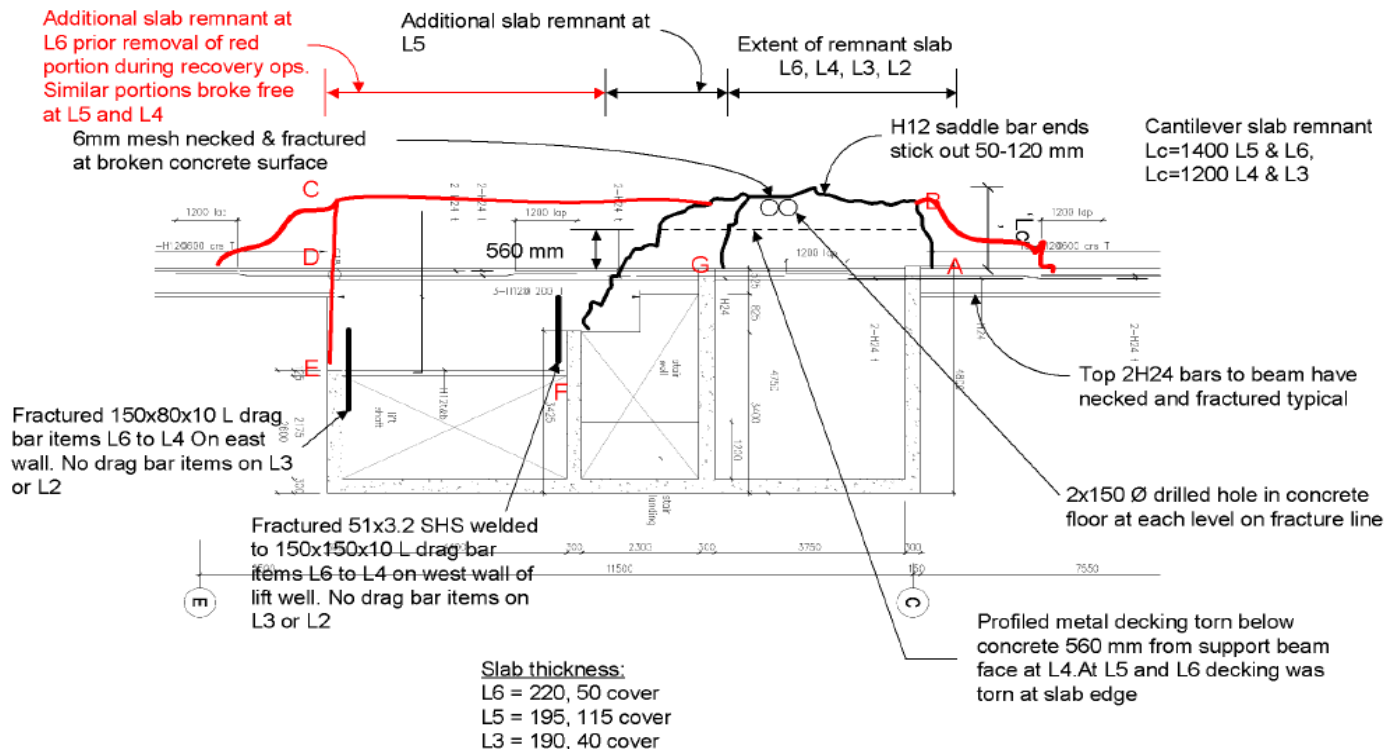
- I want to emphasize that the report discussion of the diaphragm tension failure planes shown below is strong: That is, on the upper floors, that the tension failure plane observed in the field is not the weakest and therefore not likely. However, this does not rule out partial disconnection.

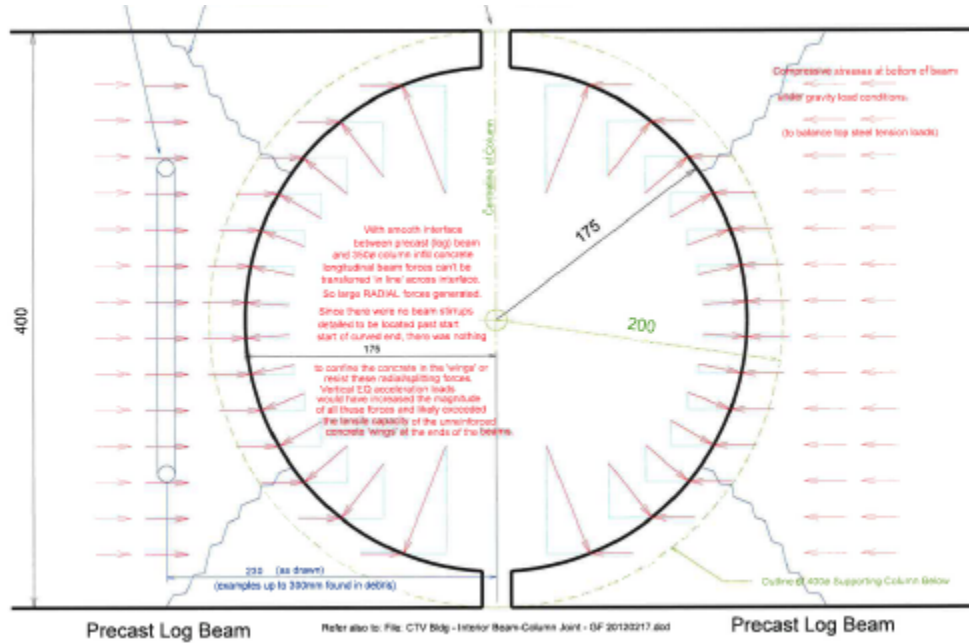
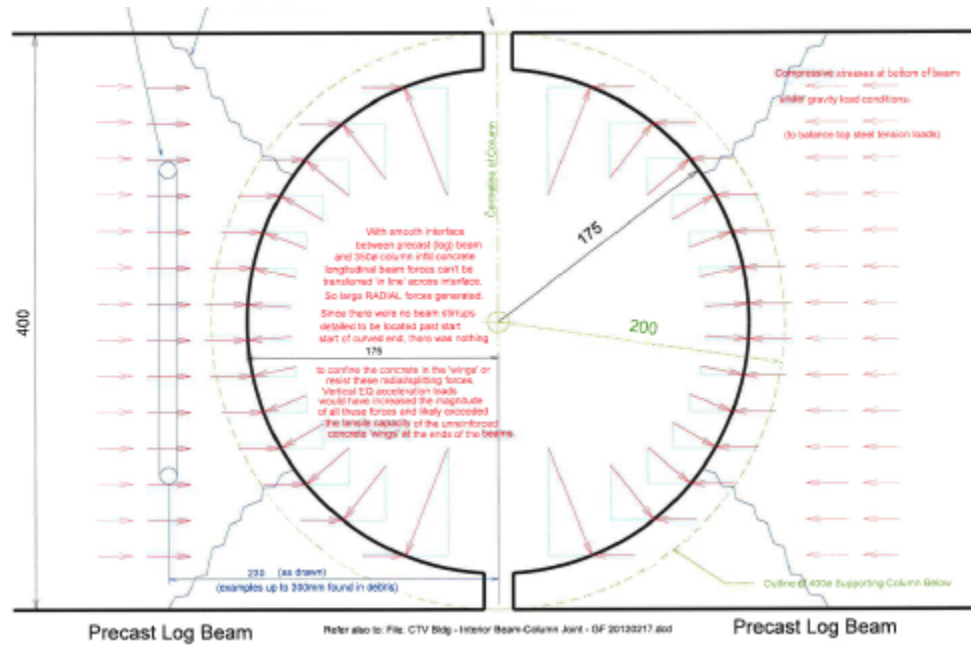
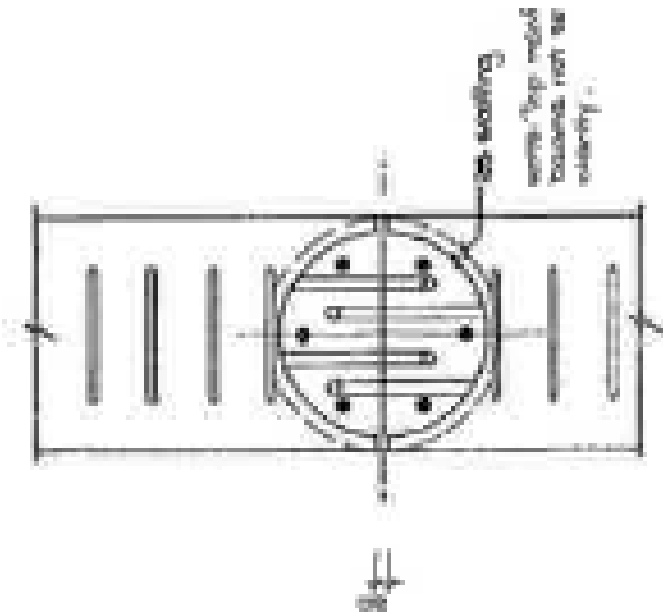
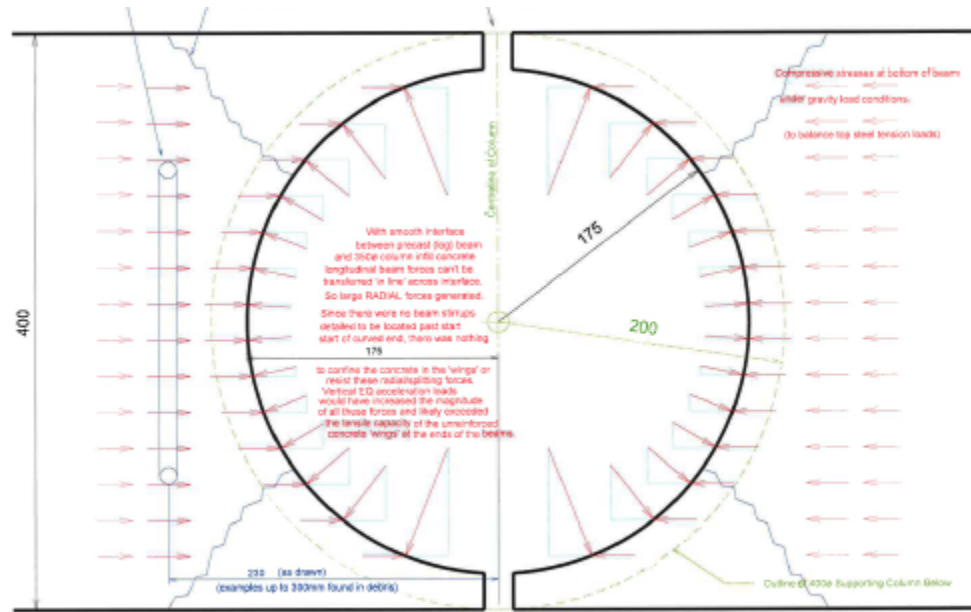
- I noted in my report Graham Frost's initial letter to DBH, but his testimony was far more detailed and convincing concerning:
 - The lack of intact joints observed
 - The smooth precast surfaces and lack of bond to the cast in place concrete
 - The potential failure plane of the precast wings under compression (either from vertical accel. or bending)
