~~SUBMISSION TO~~ THE ROYAL COMMISSION OF INQUIRY:

AN ALTERNATIVE COLLAPSE SCENARIO FOR THE CTV BUILDING

John B. Mander PhD, F.IPENZ

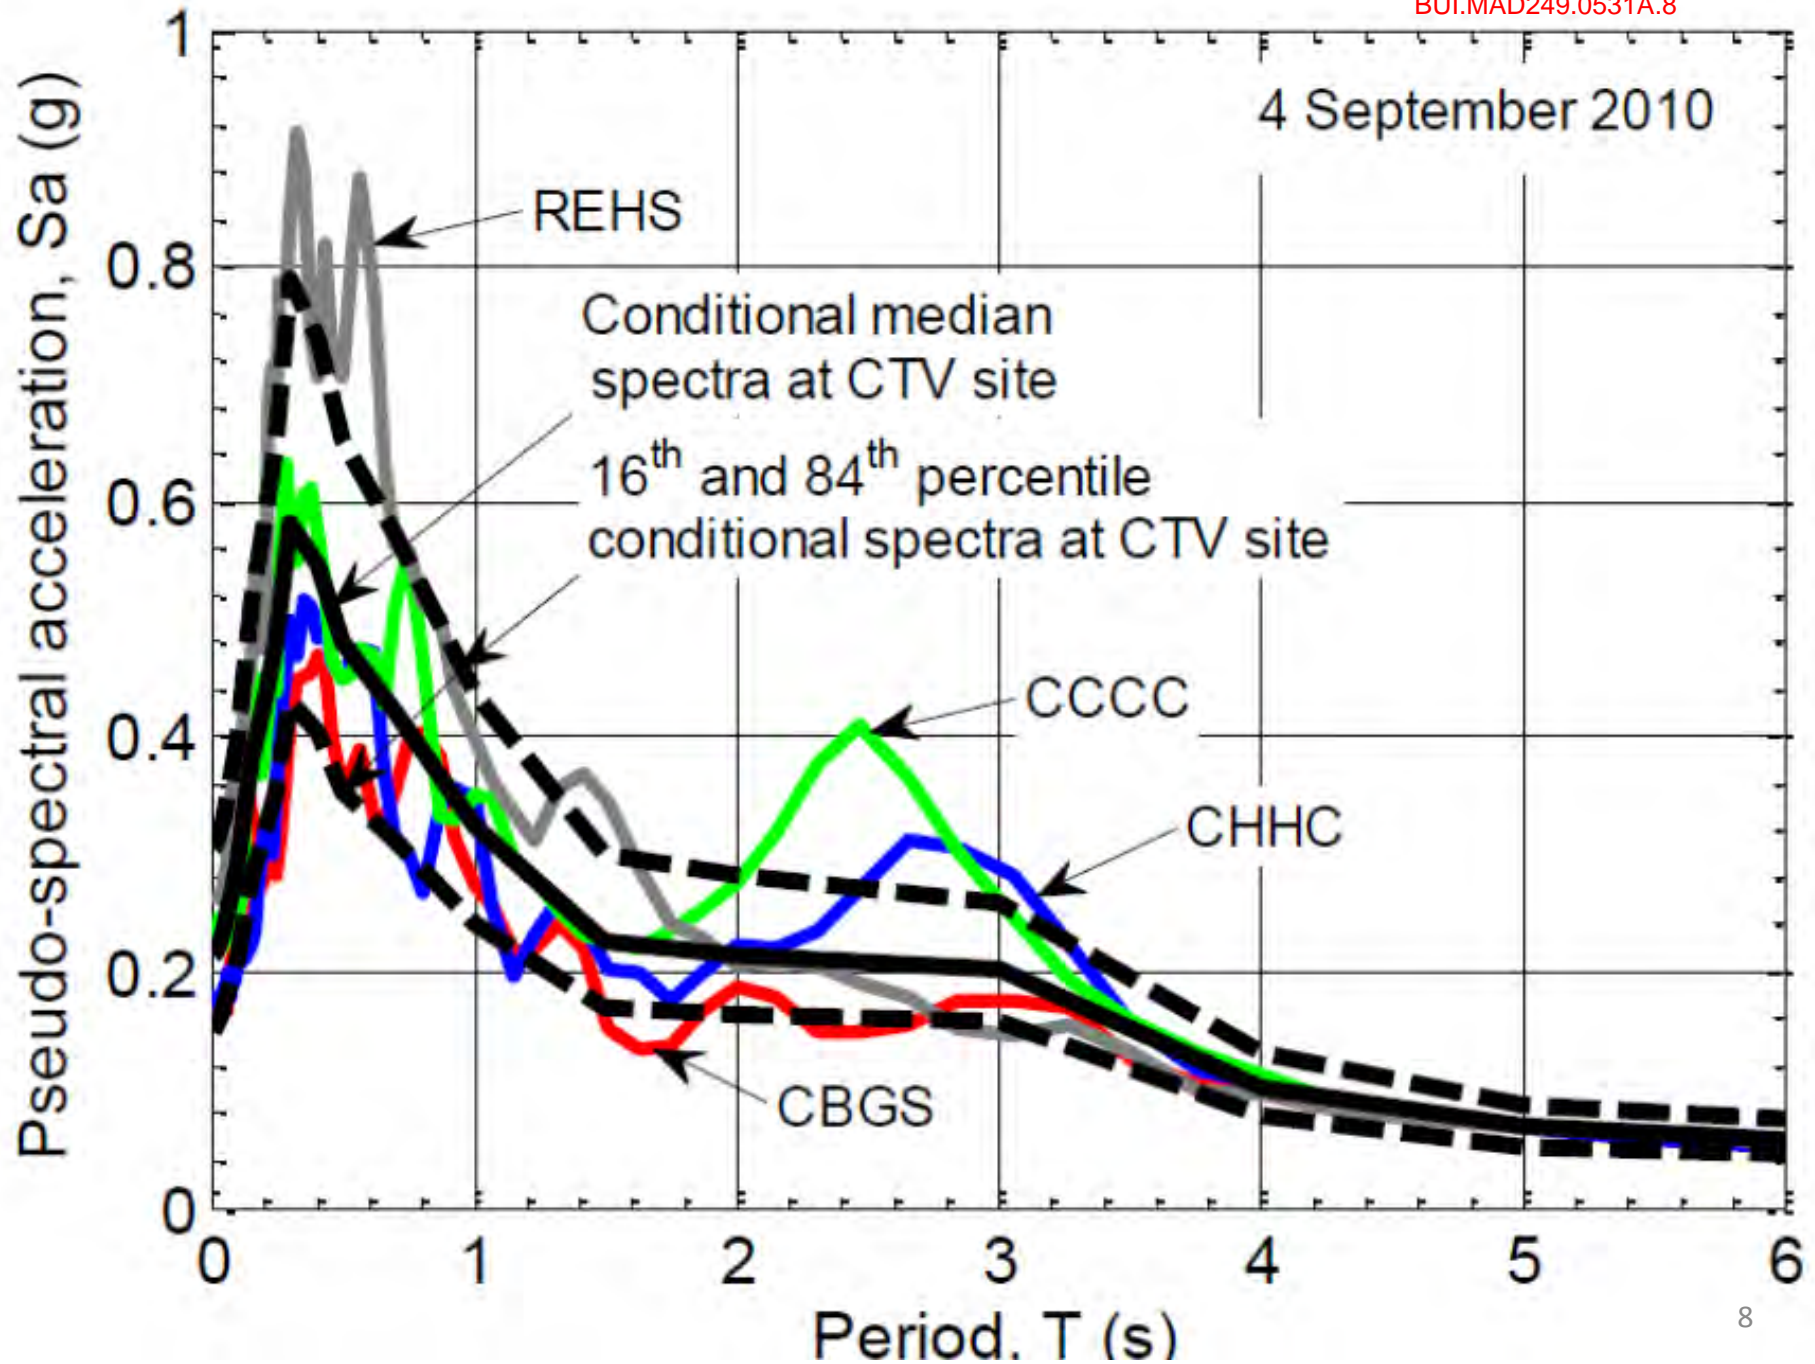
Fig 2.2. Acceleration response spectra comparison at the CTV Building site with the other Geonet recording stations within the Christchurch CBD (when actively recording).

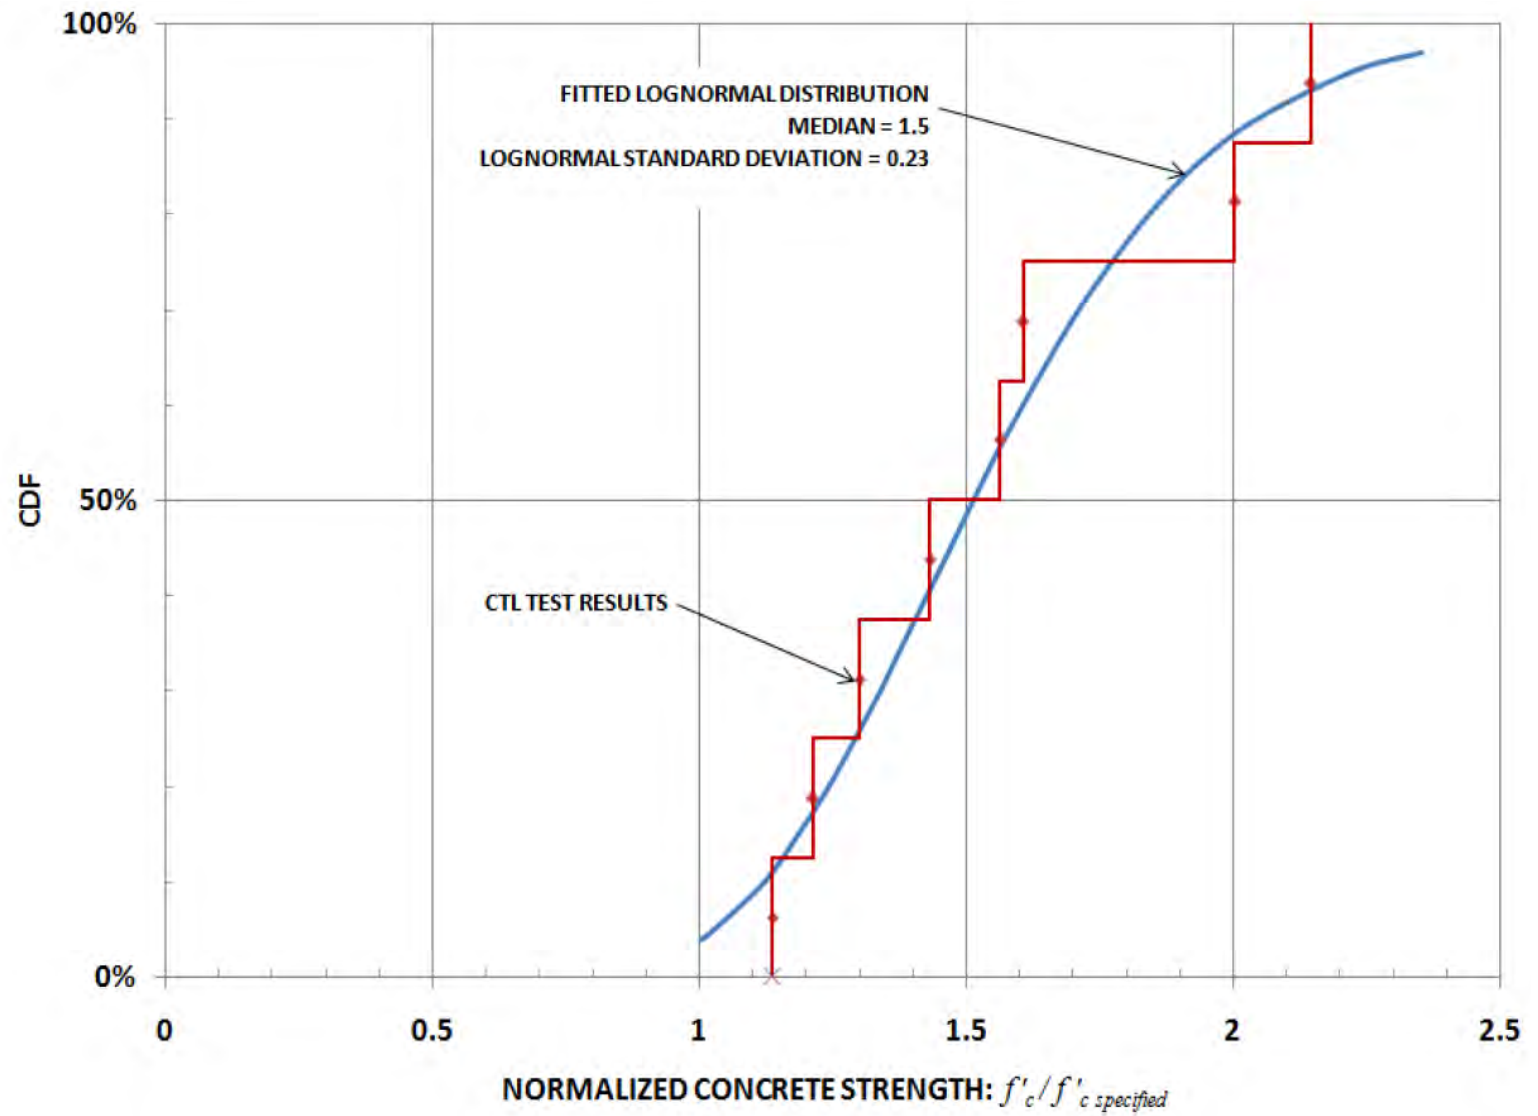
Fig. 2.3. Cumulative distribution plot of the normalized concrete strength from the CTL test results.

- When conducting an advanced analysis such as NLTHA, it is always prudent to perform a few “swing analyses” to examine the sensitivity of the overall outcomes to values adopted for certain key parameters. In the case of the CTV Building, the concrete strength is a very important parameter, largely because the columns are compression-critical. It is for this reason that the lower values previously used by Compusoft should be retained to model the extreme possibility of weaker concrete.
- The Compusoft analyses used concrete strengths amplified some 10% above the specified strength. With respect to the median concrete strength observed in the CTL tests, the Compusoft assumed concrete strengths fall approximately on the 10th percentile of the distribution (see the blue curve in previous Figure)

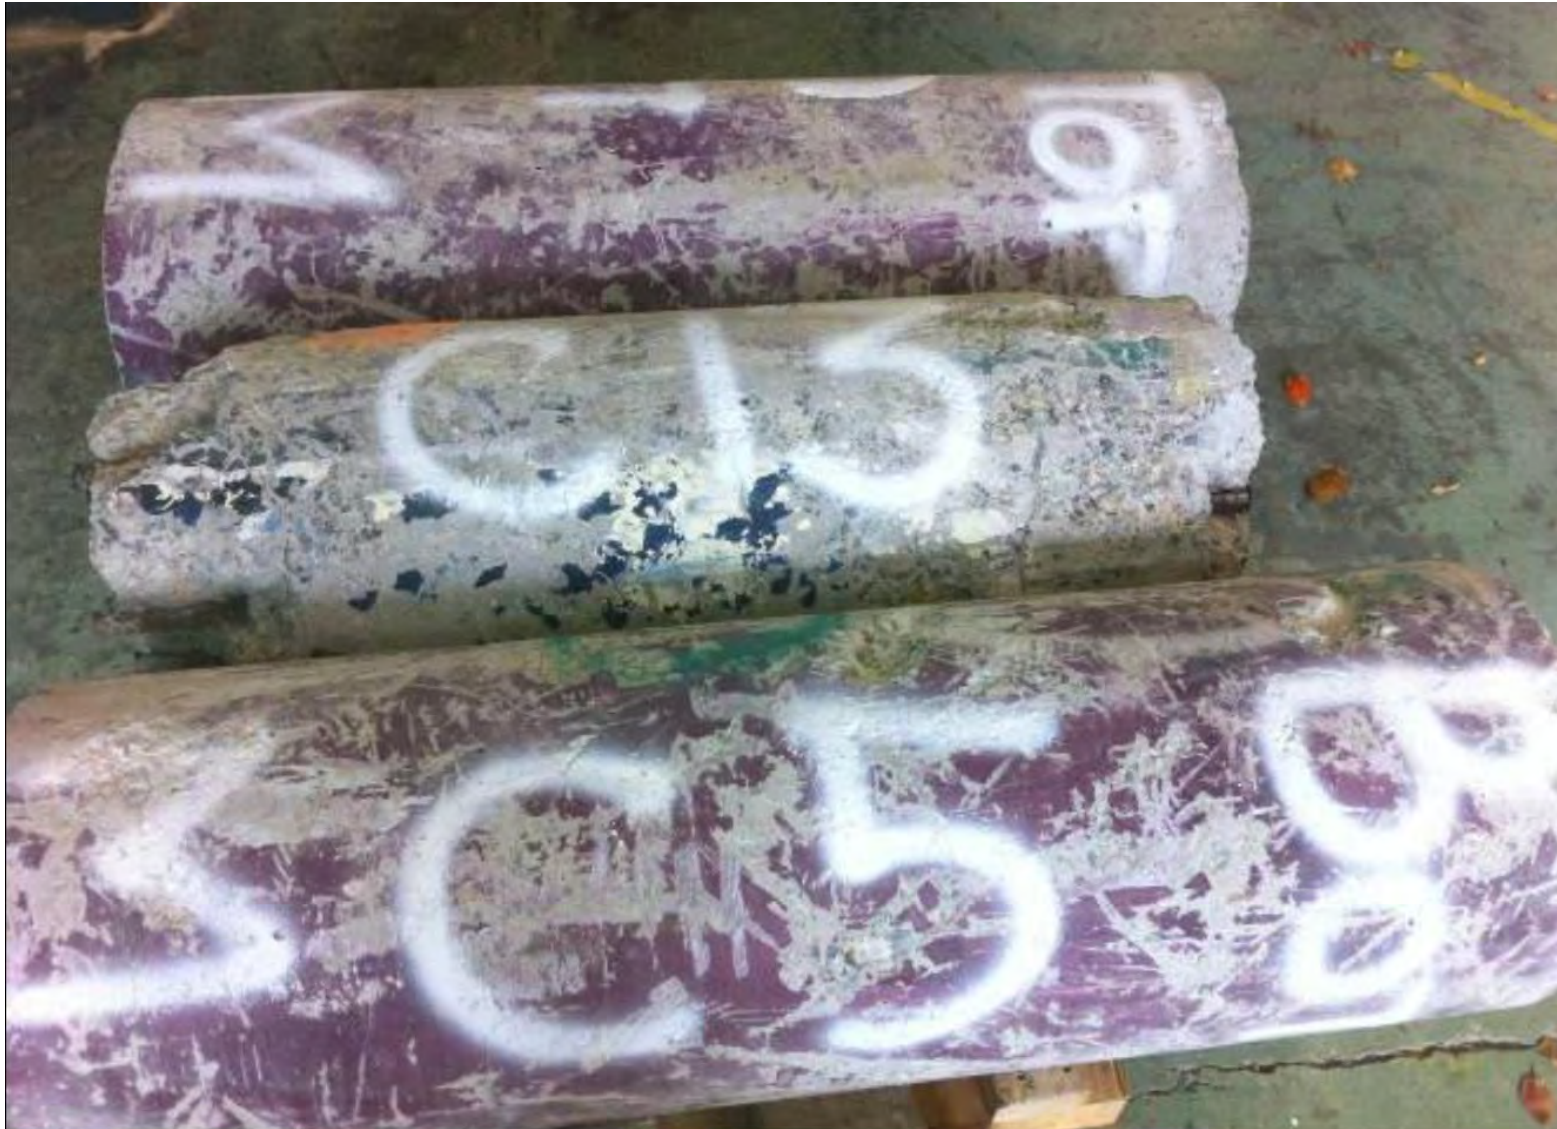
Fig. 2.4. The three column portions retrieved from the CTV Building used in the full-scale testing conducted at the University of Canterbury

Provisional Results

- The concrete strength is above the specified value of

$$f'_c = 25 \text{ MPa.}$$

- There is a size-effect present.
 - This may be in the order of $f'_{co} = 0.85 f'_c$,

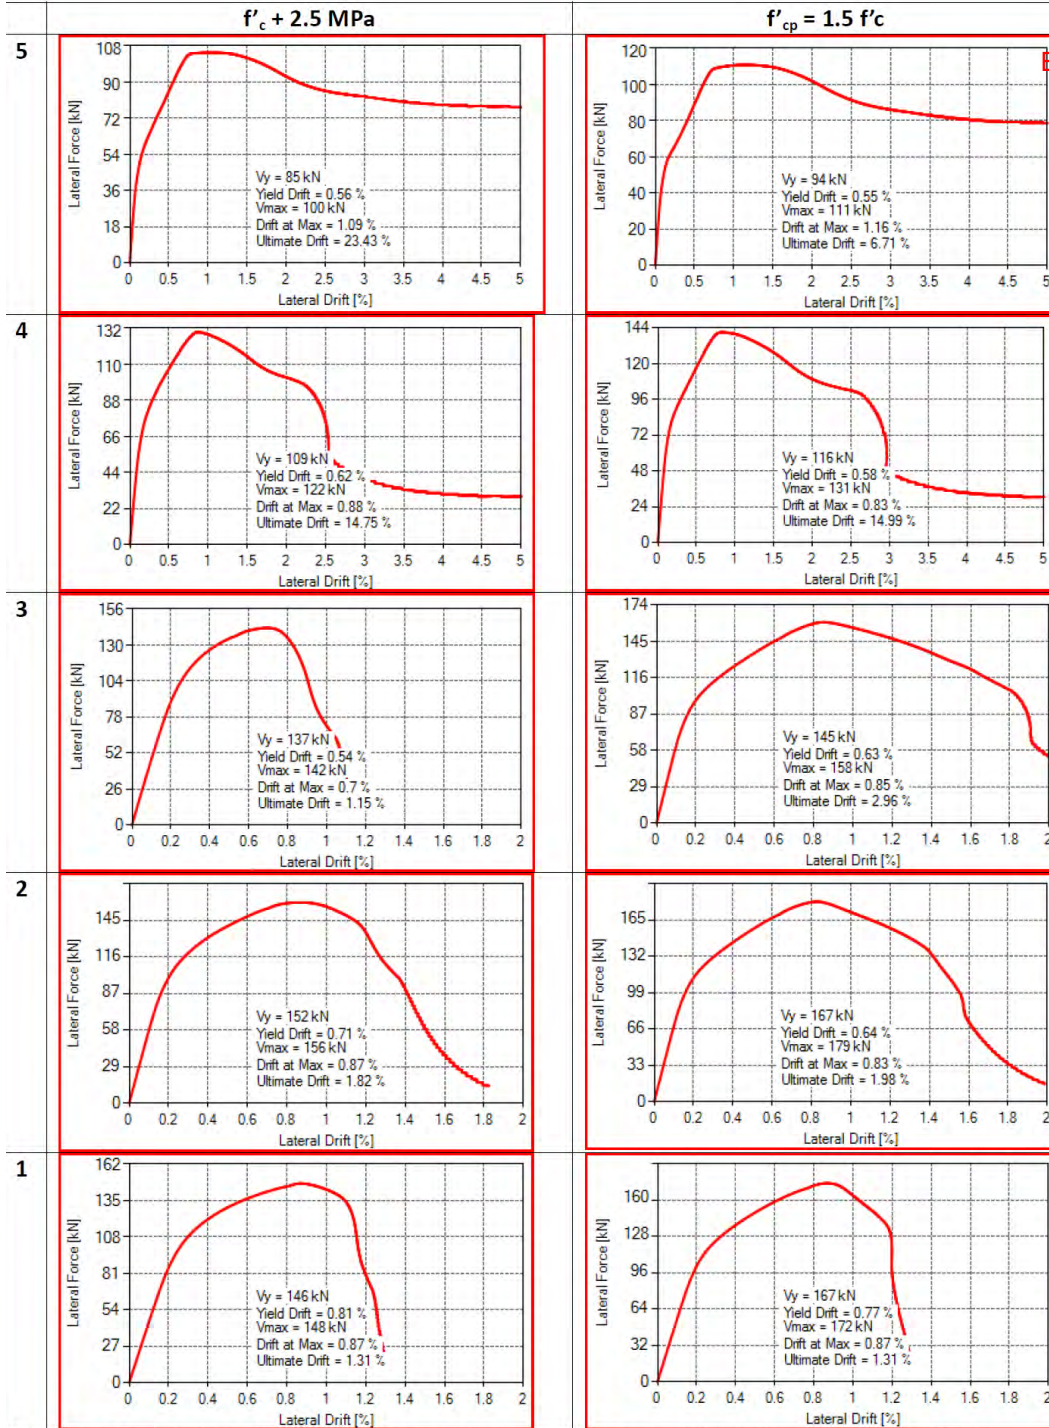
Normal gravity axial load effects

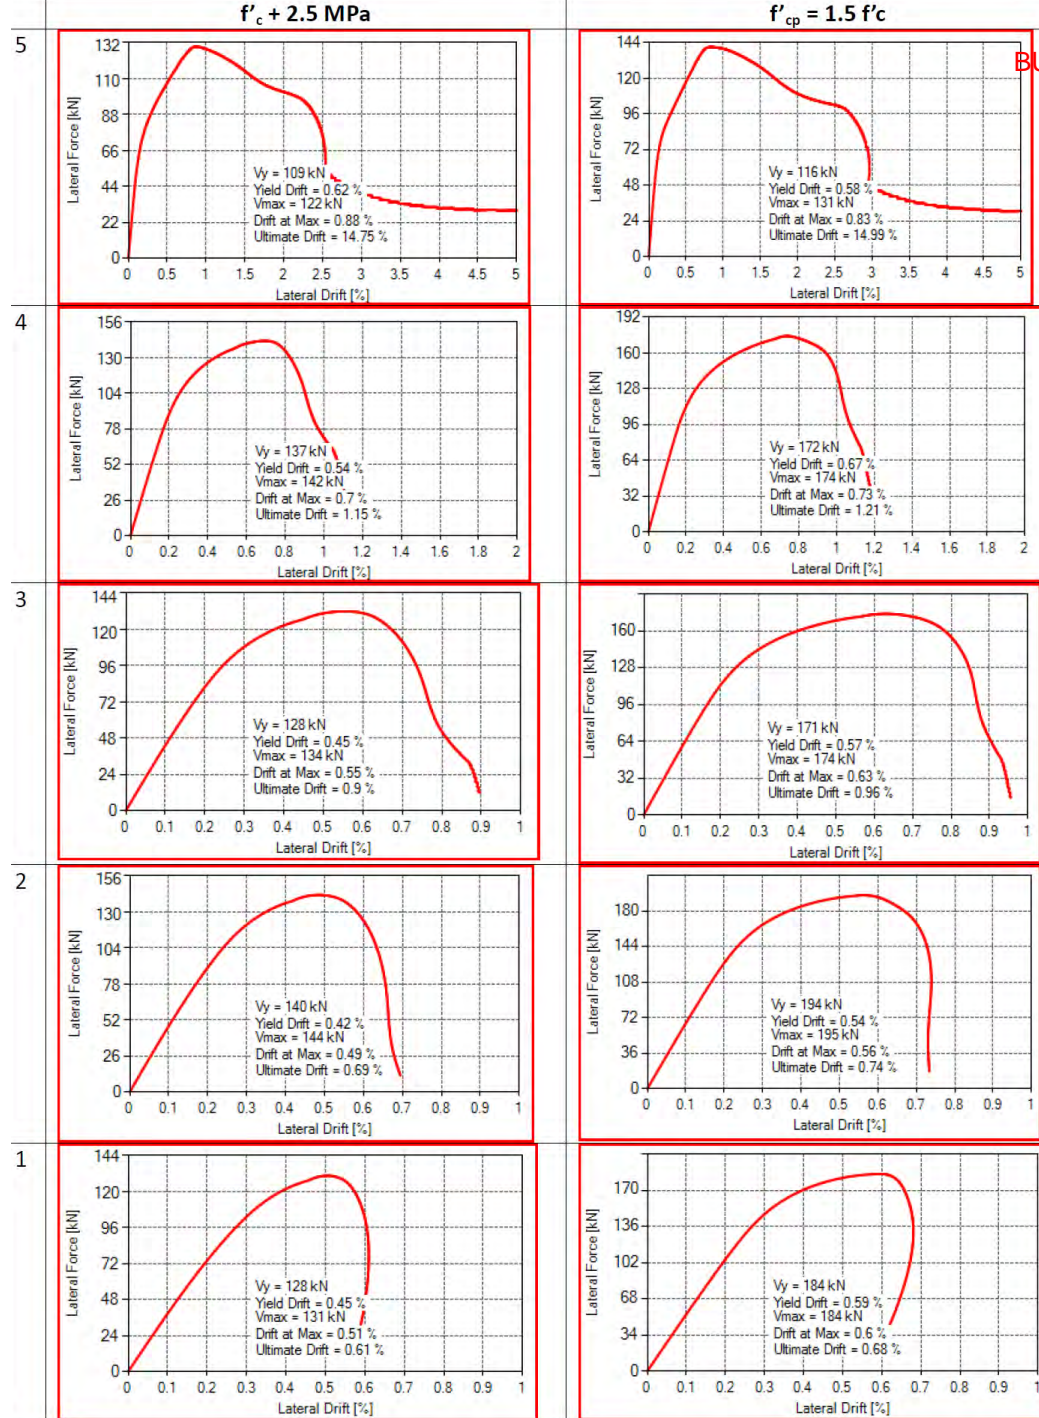
Gravity axial plus seismic axial load effects.

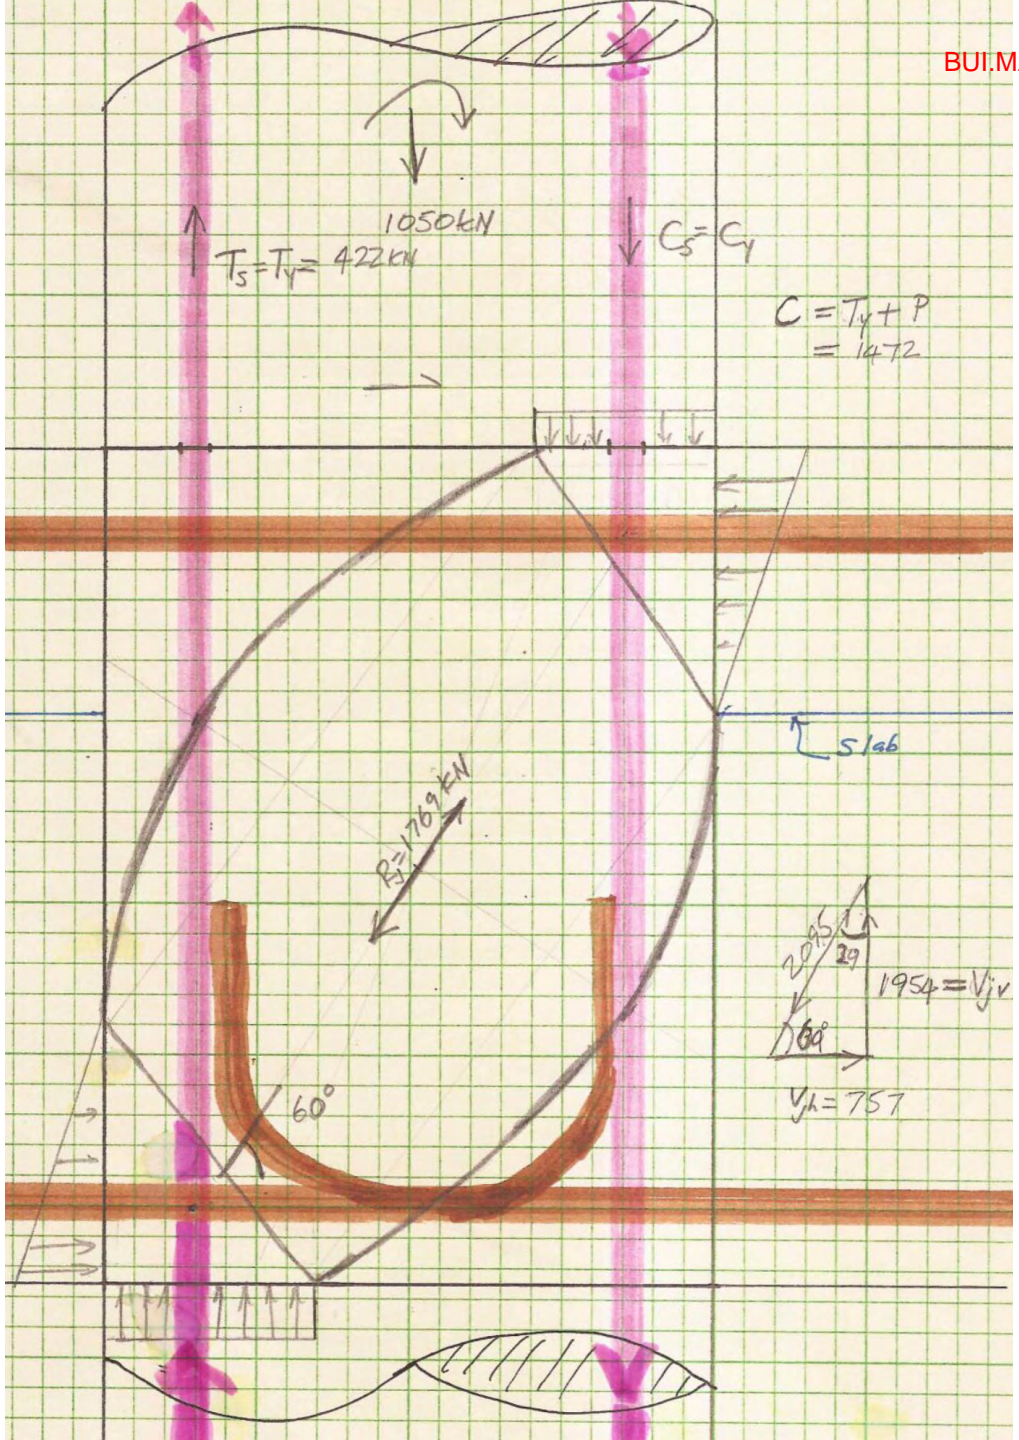
Fig 2.9. The beam column joint region

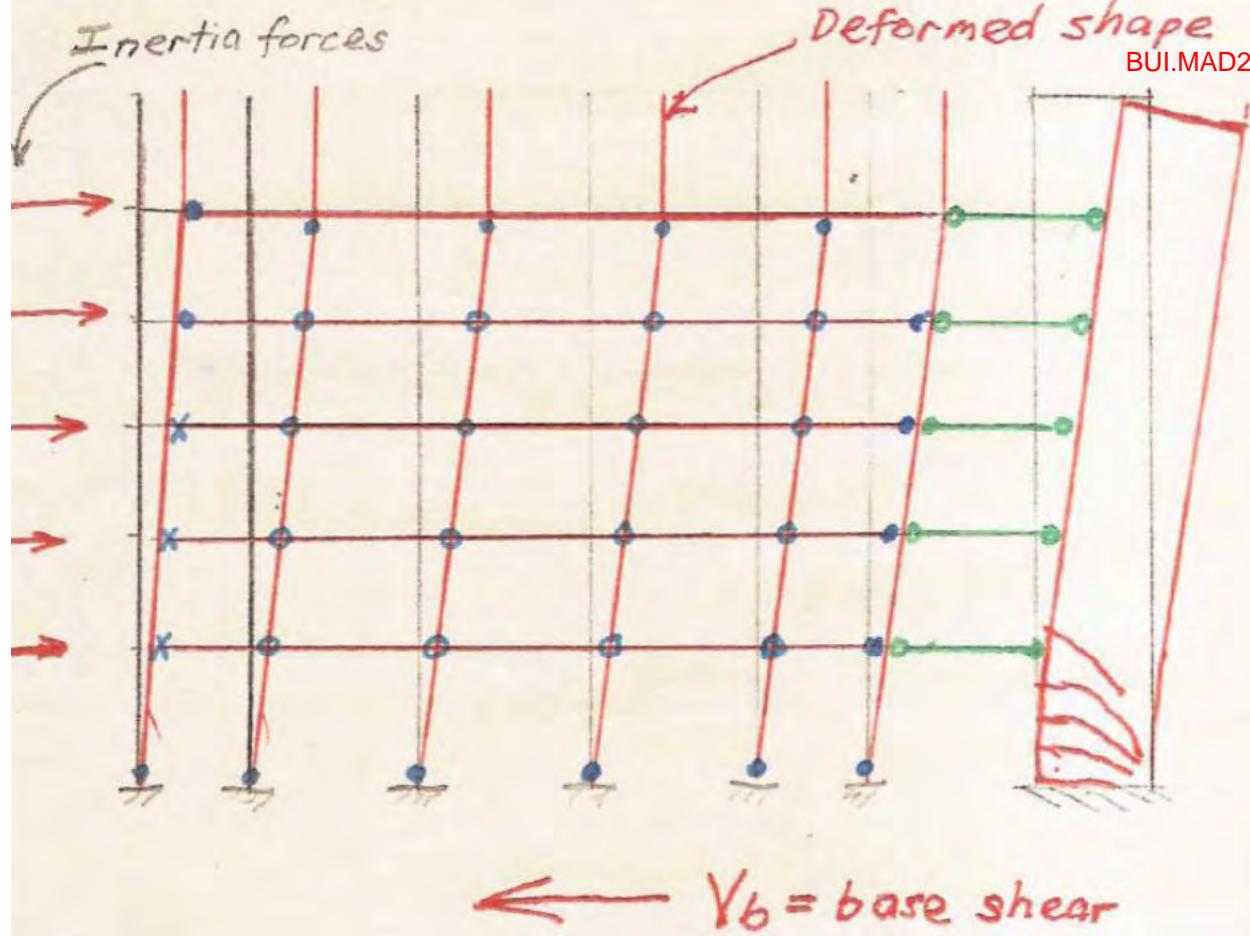
Fig 2.10. The modified sidesway mechanism arising from the presence of "weak" beam-column joint regions

- Plastic hinge zones at member ends
- X Failed plastic hinge zone through joint pull out
- Beam-column joint regions where the joints are weak in shear or failed in shear trying to resist high column and beam moment effects.
