Section 3

AN ALTERNATIVE GRAVITY-DOMINATED COLLAPSE SCENARIO

**John B Mander PhD, FIPENZ
Zachry Professor, Texas A&M University**

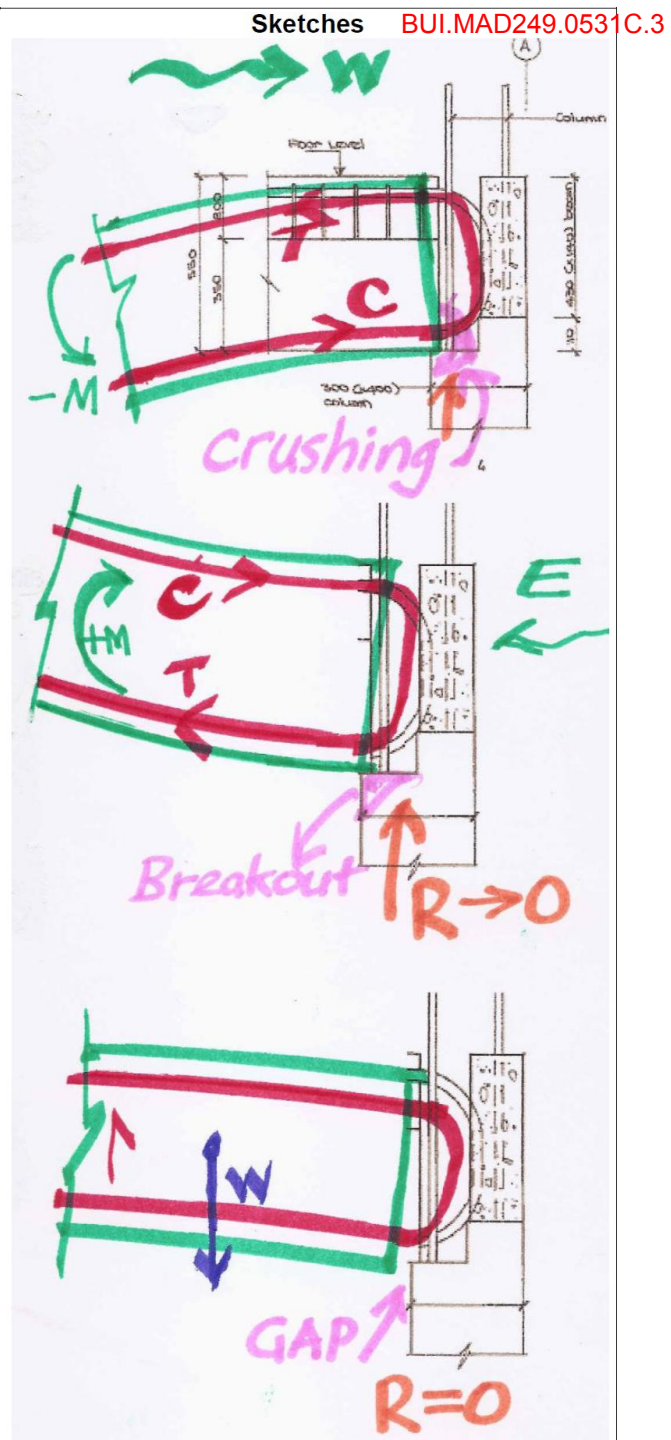
Figure 3.1. Beam-to-column connection failure sequence at the west wall; a trigger for the East-West Collapse Failure Mode

Sequence

Stage 1

The building sways to the west with a large velocity pulse. The E-W beams on column lines 2 and 3 at the West wall are required to form large negative moments that cause the joint core concrete and the beam-soffit cover concrete to crush.

Stage 2

During the next half-pulse the building lurches eastward. The beam along line 2 and 3 pull away from the west wall and their line A column seats to form the alternating positive moment. The crushed cover concrete from the previous reversal spalls off and the beam slumps down a little, with a partial or full loss of seating. Due to the loss of seating at the support line A there is a transfer of the previous gravity load from the tributary area of the beam onto the neighboring columns on line B. This action an axial force increase of up to 40% the columns along line B

Stage 3

As the building attempts to return to an upright condition by moving west, the unseated beams are inhibited from fully returning due to the presence of the west wall.

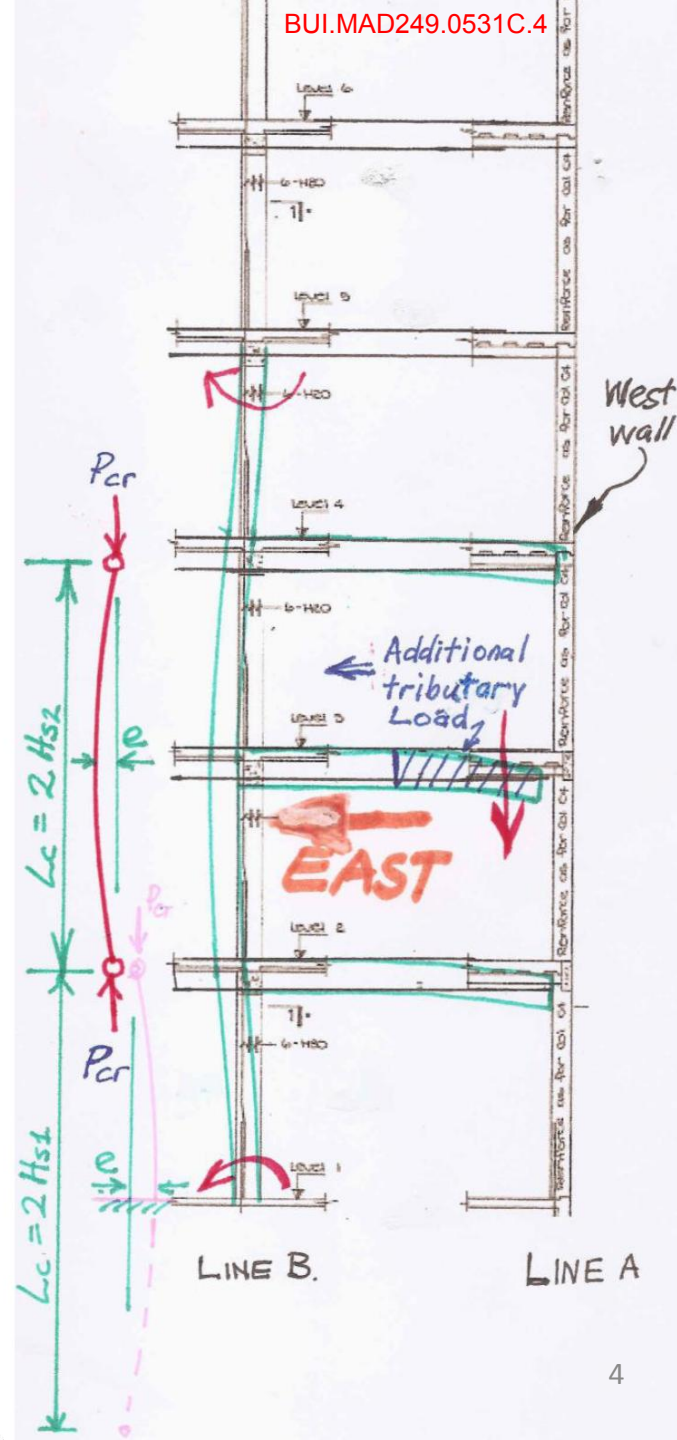
Figure 3.2. Four-story double bending buckling failure starting on column Line B leading to the East-West Collapse Failure Mode

Stage 4

Permanent differential deformations remain, that inhibit the columns along line be from remaining straight. This sets the columns up for a classic Euler buckling type failure, especially under further axial load derived from vertical accelerations and their consequent vibrations

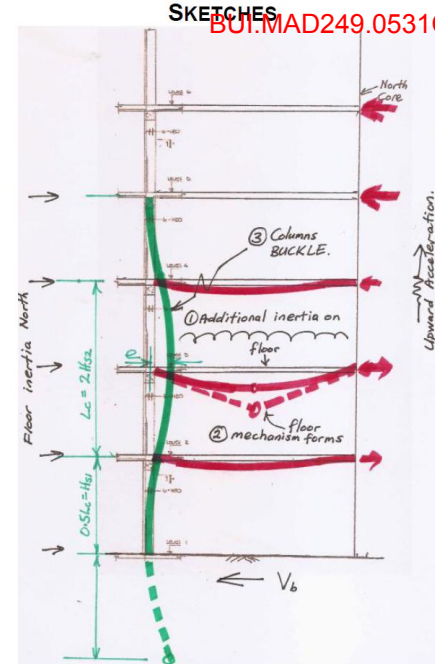
Figure 3.4. North-South Collapse Failure Modes

SEQUENCE

Step 1

Due to the lack of beams in the N-S direction and very high vertical motions, the in-plane stiffness is low. The slab buckles downward due to a combination of upward vertical acceleration, and N-S sideway of the frame.

Step 2

Because the slab buckles, and the columns lack lateral support in the N-S direction, a 4-storey, double bending column buckling mechanism forms.

Step 3

Column buckles and collapses.

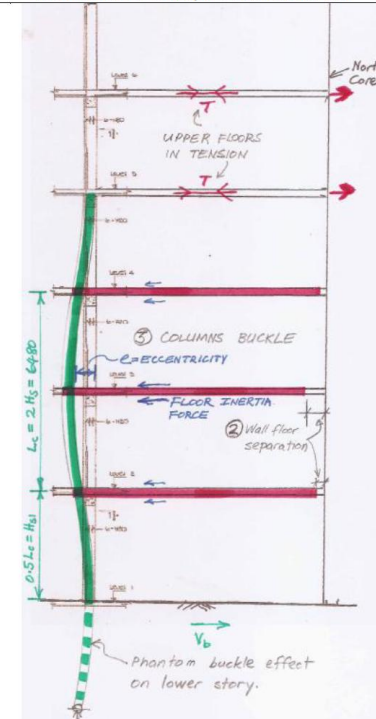
Northward Collapse Mechanism

Step 1

Due to the absence of drag bars in the lower stories, there is a large strain demand placed on the slab steel connecting with the North core. After one or two cycles the bars fracture due to low cycle fatigue.

Step 2

The columns on lines 2 and 3 lack lateral restraint from moving independently southward, therefore they move away from the north core. A double-bending column buckling mechanism forms in the lower four stories.

Step 3

Several columns buckle and the structure collapses downward.

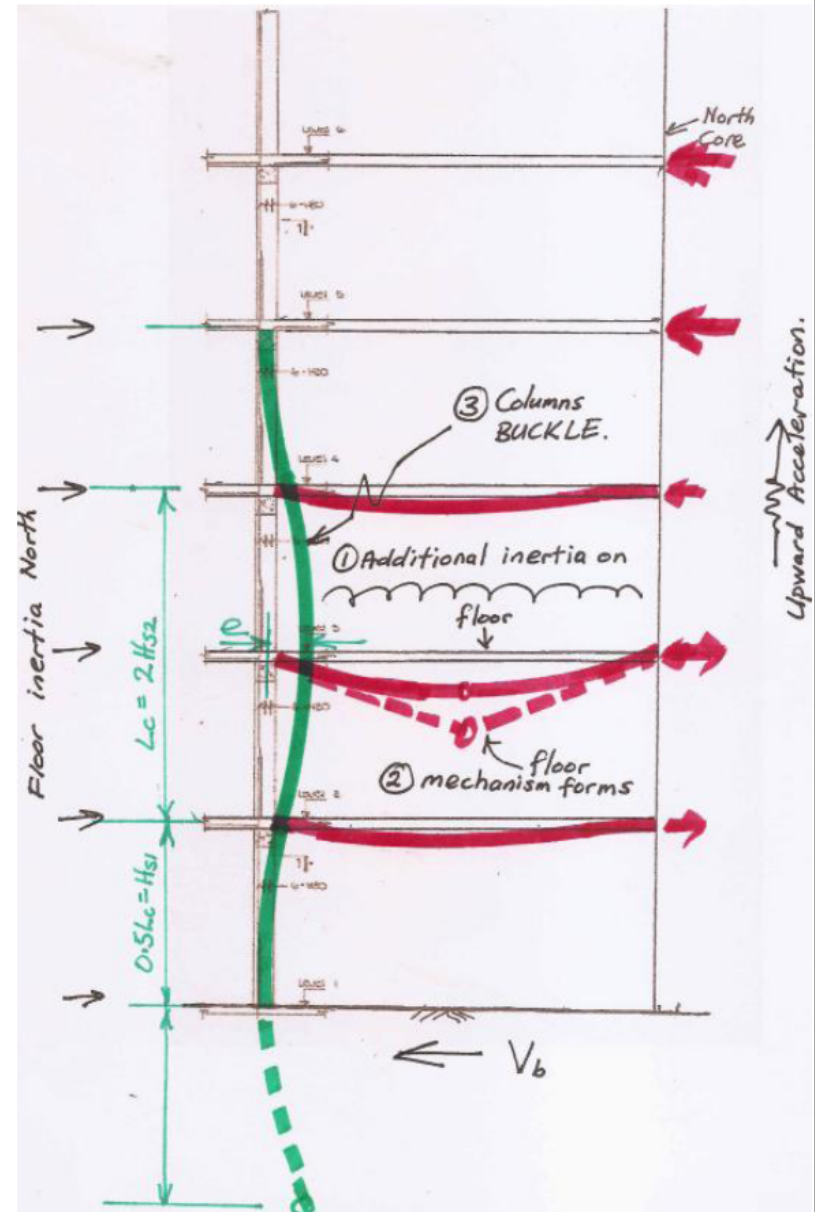
Southward Collapse Mechanism

SEQUENCE

Step 1

Due to the lack of beams in the N-S direction and very high vertical motions, the in-plane stiffness is low. The slab buckles downward due to a combination of upward vertical acceleration, and N-S sideway of the frame.

Step 2

Because the slab buckles, and the columns lack lateral support in the N-S direction, a 4-storey, double bending column buckling mechanism forms.

Step 3

Column buckles and collapses.

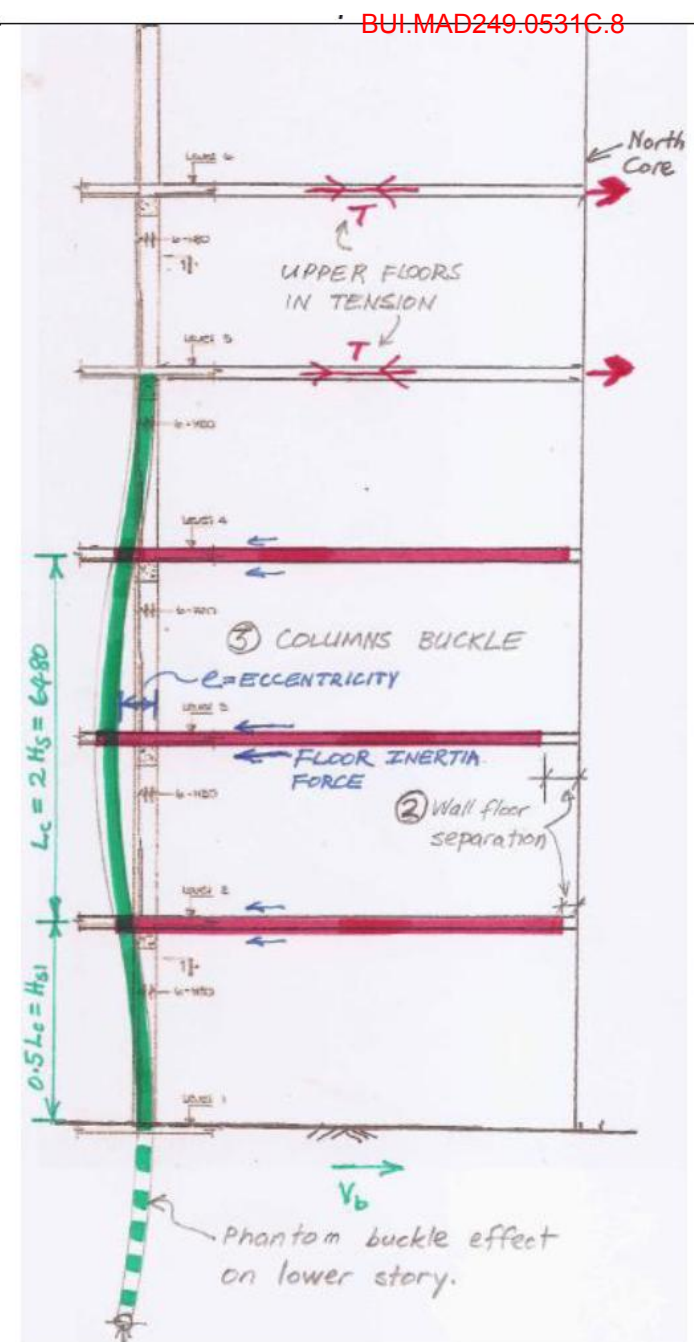
Northward Collapse Mechanism 7

Step 1

Due to the absence of drag bars in the lower stories, there is a large strain demand placed on the slab steel connecting with the North core. After one or two cycles the bars fracture due to low cycle fatigue.

Step 2

The columns on lines 2 and 3 lack lateral restraint from moving independently southward, therefore they move away from the north core. A double-bending column buckling mechanism forms in the lower four stories.

Step 3

Several columns buckle and the structure collapses downward.
