**ROYAL COMMISSION OF INQUIRY INTO  
BUILDING FAILURE CAUSED BY CANTERBURY  
EARTHQUAKES**

**THE CTV BUILDING COLLAPSE**

**SUBMISSIONS ON BEHALF OF BEREAVED FAMILIES AND THOSE INJURED**

**Dated: 4 September 2012**

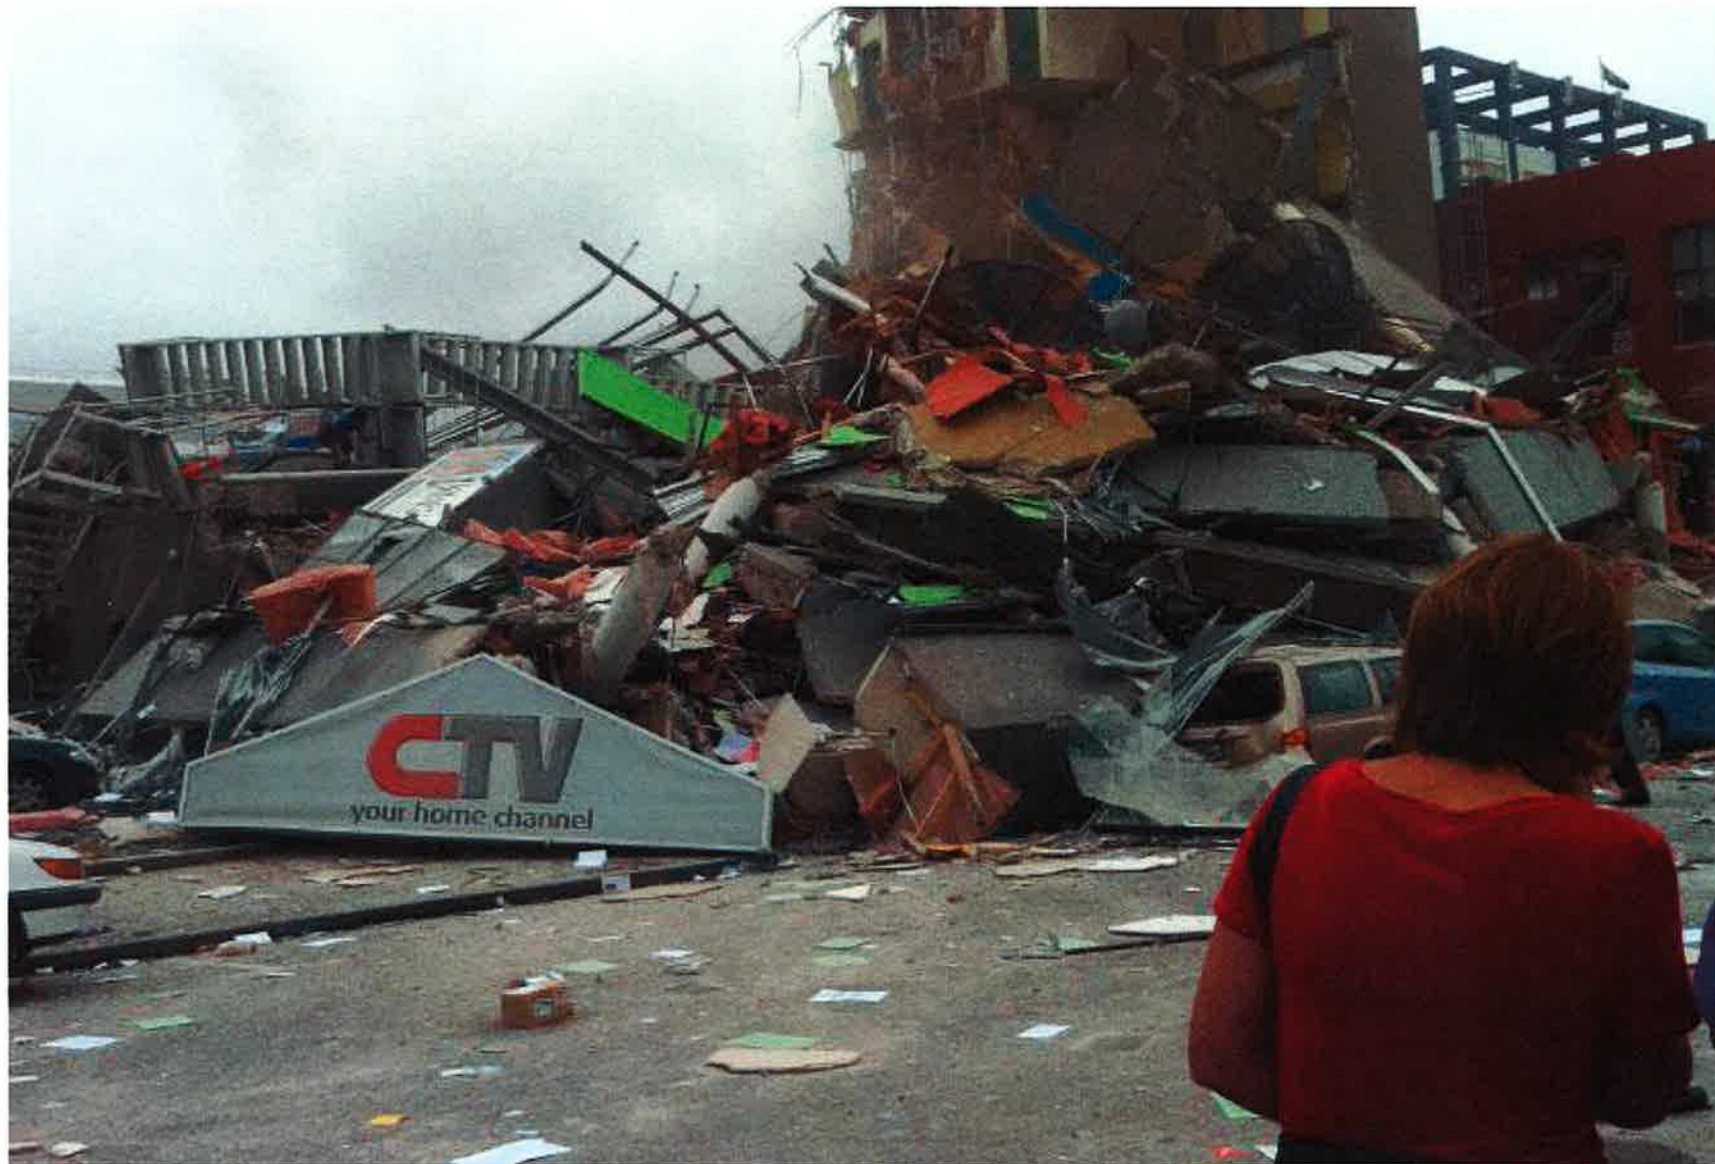
**Figure 17**

**View of the edges of the slabs near Line A looking towards the North Core from near the southwest corner of the Building (6:30 AM 24 February 2011).**

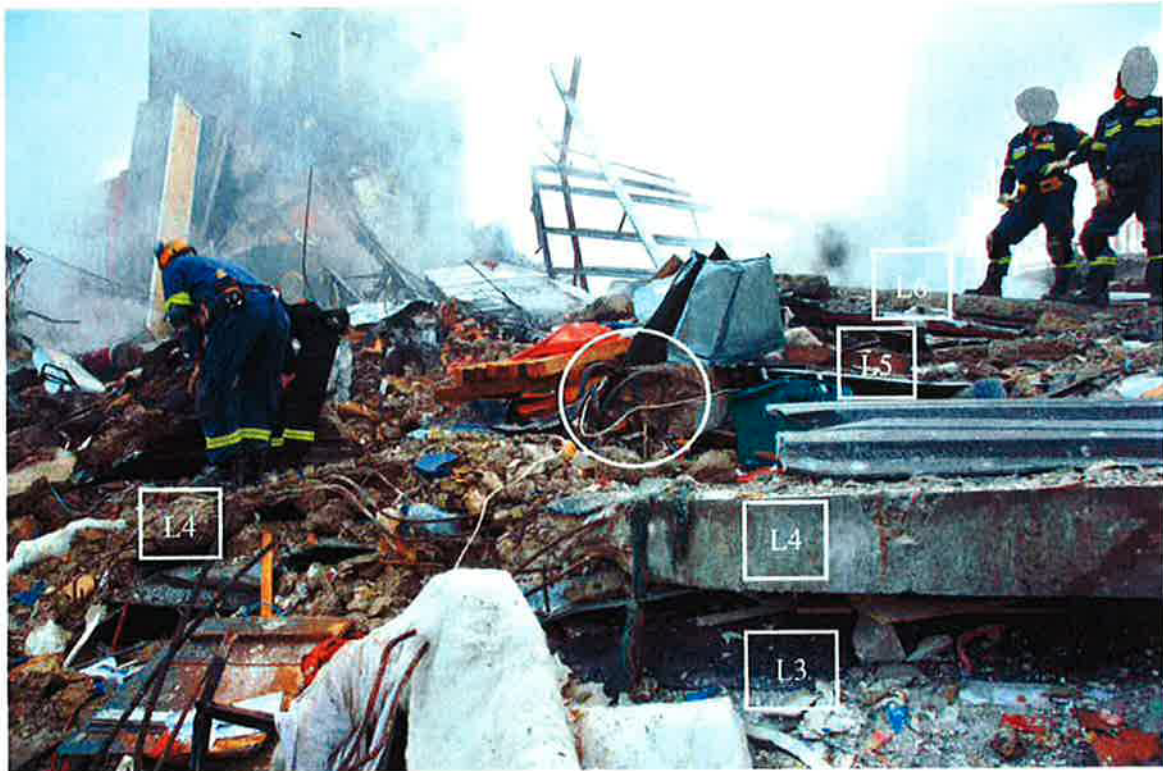
**Figure 15**

**Collapsed slabs lie on top of each along Line A. The ends of the Line 3 internal beam reinforcement have been circled and floor levels of the slabs labelled.**
