**BUILDING SAFETY EVALUATION AFTER THE
FEBRUARY 22, 2011 CHRISTCHURCH,
NEW ZEALAND EARTHQUAKE:
OBSERVATIONS BY THE ATC RECONNAISSANCE TEAM**

**Ronald Gallagher, SE
Bret Lizundia, SE, Team Leader
Jim C. Barnes, PE**

**APPLIED TECHNOLOGY COUNCIL
201 Redwood Shores, Parkway, Suite 240
Redwood City, California 94065
www.ATCouncil.org**

August 2012

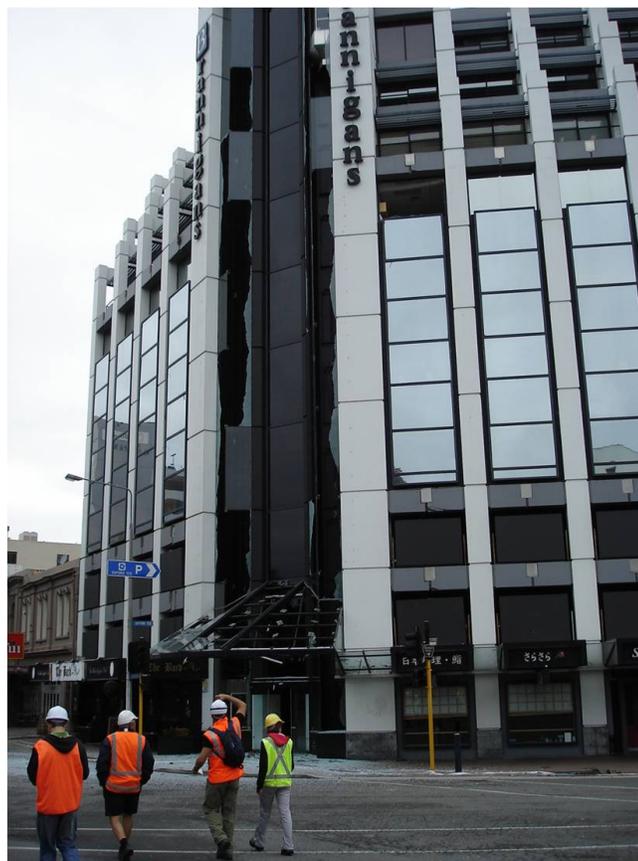
Figure 1-6 Safety assessment personnel in the Central Business District. Note the broken windows and canopy glazing. (Source: Ken Elwood)

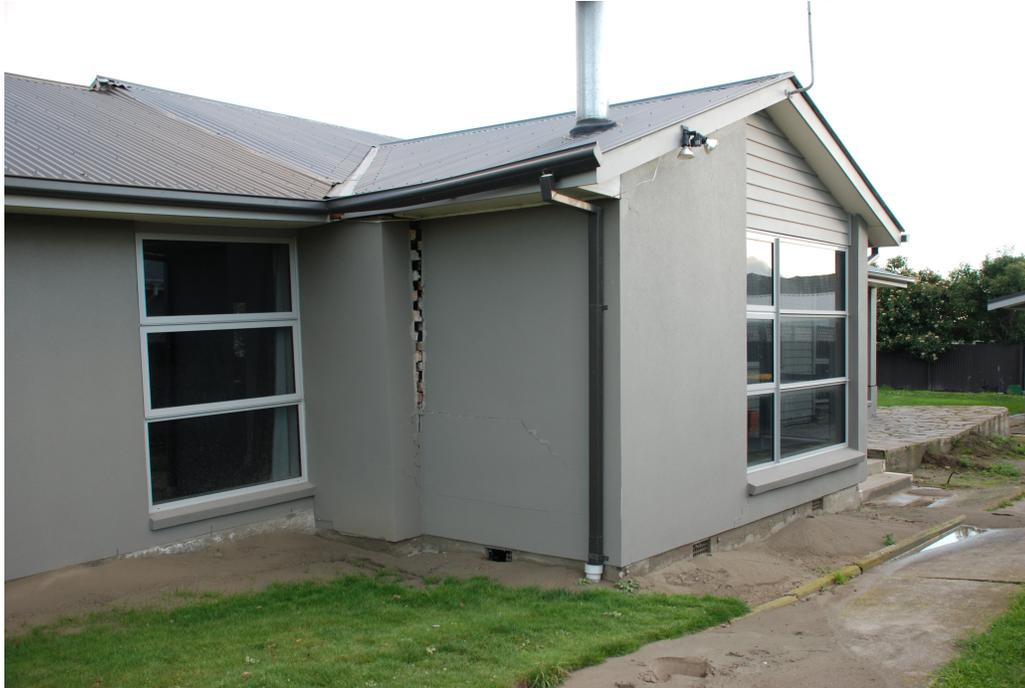
The soil liquefaction that took place in the city of Christchurch during the February event was on a scale that is considered unprecedented. Liquefaction first occurred in the September 4, 2010 earthquake; however, the February 22, 2011 event caused the most damaging liquefaction and lateral spreading (Cubrinoushi and McCahon, 2011). Approximately 20 to 30 percent of the city experienced some degree of liquefaction and soil consolidation. The resulting differential settlements and lateral spreading caused structural damage to homes, buildings and bridges (see Figures 2-1 and 2-2 for examples).

Figure 2-1 Home damaged by liquefaction. Note sand boil under window at right.

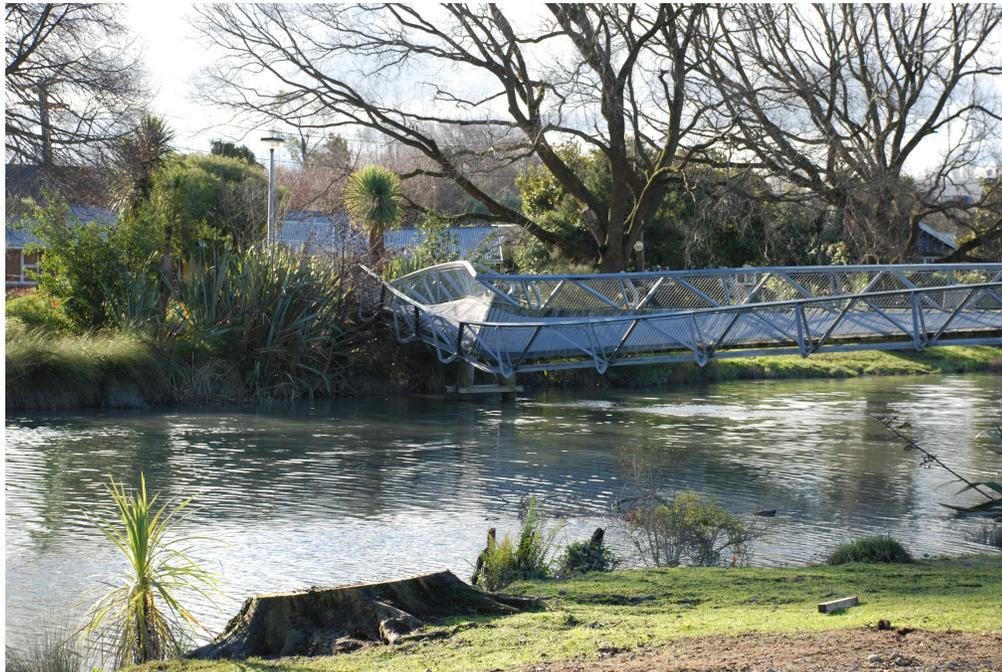
Figure 2-2 Pedestrian bridge damaged by liquefaction and subsequent lateral spreading. The bridge was initially damaged in the September 2010 Darfield earthquake, but experienced much more damage in the February 2011 event.

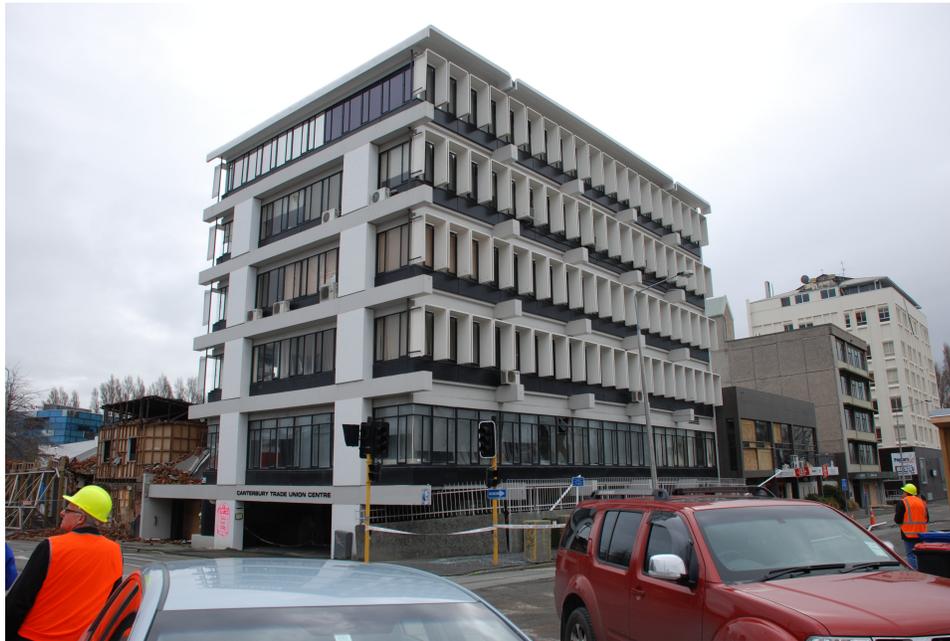
One example is the six-story concrete frame building shown in Figure 2-3. This building suffered some shaking damage, but much more damage was due to liquefaction-induced settlement of a row of columns (Figure 2-4).

Figure 2-3 The Trade Union building was damaged by both ground shaking and differential settlement caused by liquefaction. This building was later demolished.

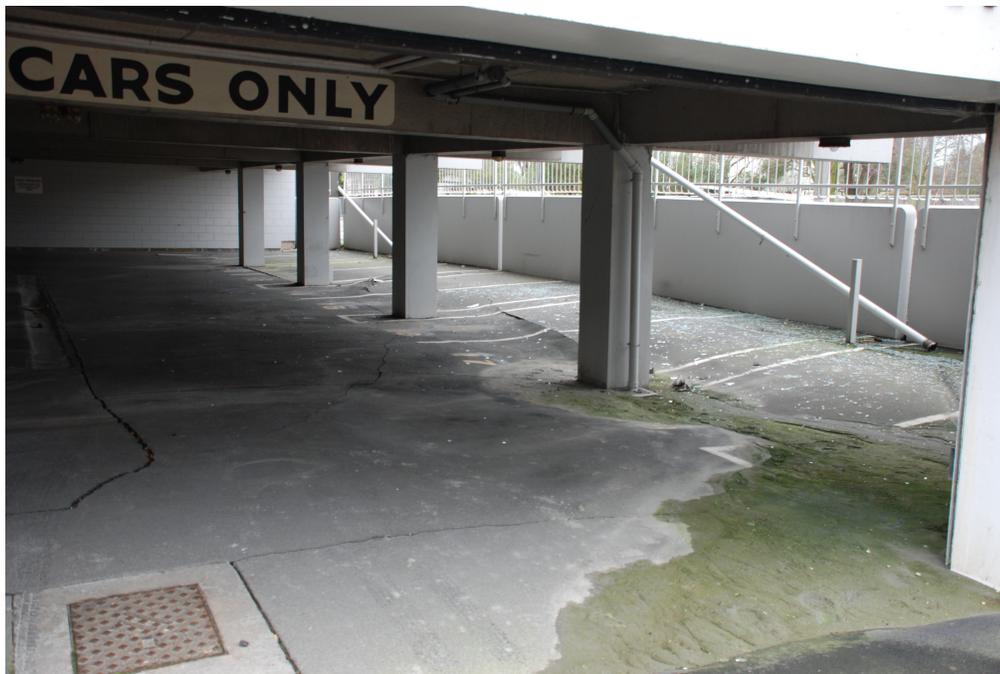
Figure 2-4 Trade Union building columns on right in the picture settled over 30 cm due to liquefaction induced settlement.

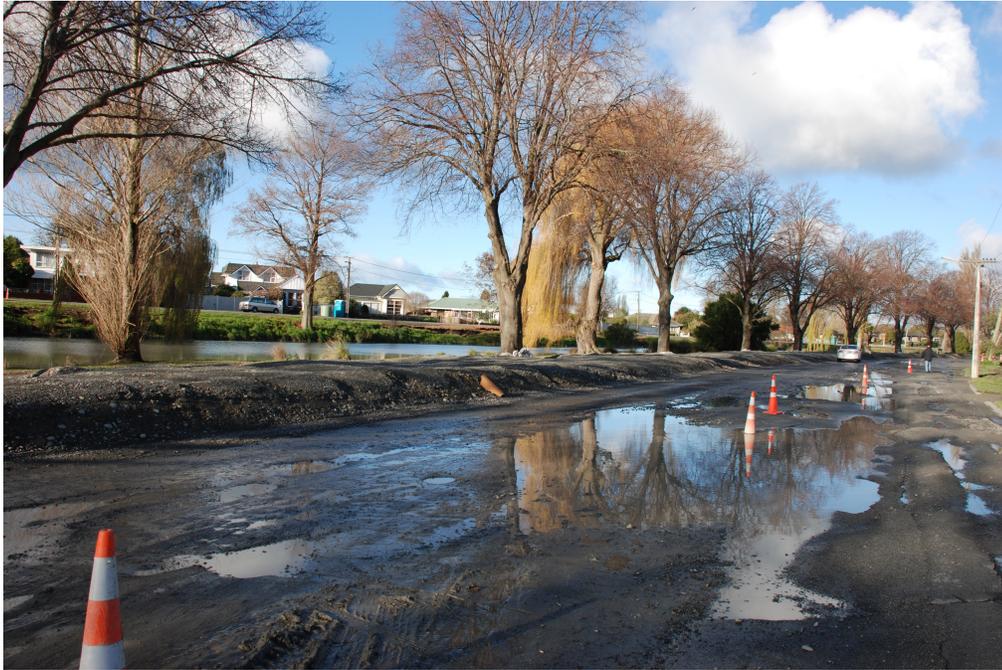
The Avon River flows through the northeast part of Christchurch. Many areas along the river experienced significant ground settlement due to subsidence caused by soil consolidation and liquefaction. After the February earthquake, authorities added about 30 cm to one meter to the height of the berms on both sides of the river to prevent future flooding of nearby homes. Figure 2-5 shows an example.

Figure 2-5 New built-up berm on the banks of the Avon River.

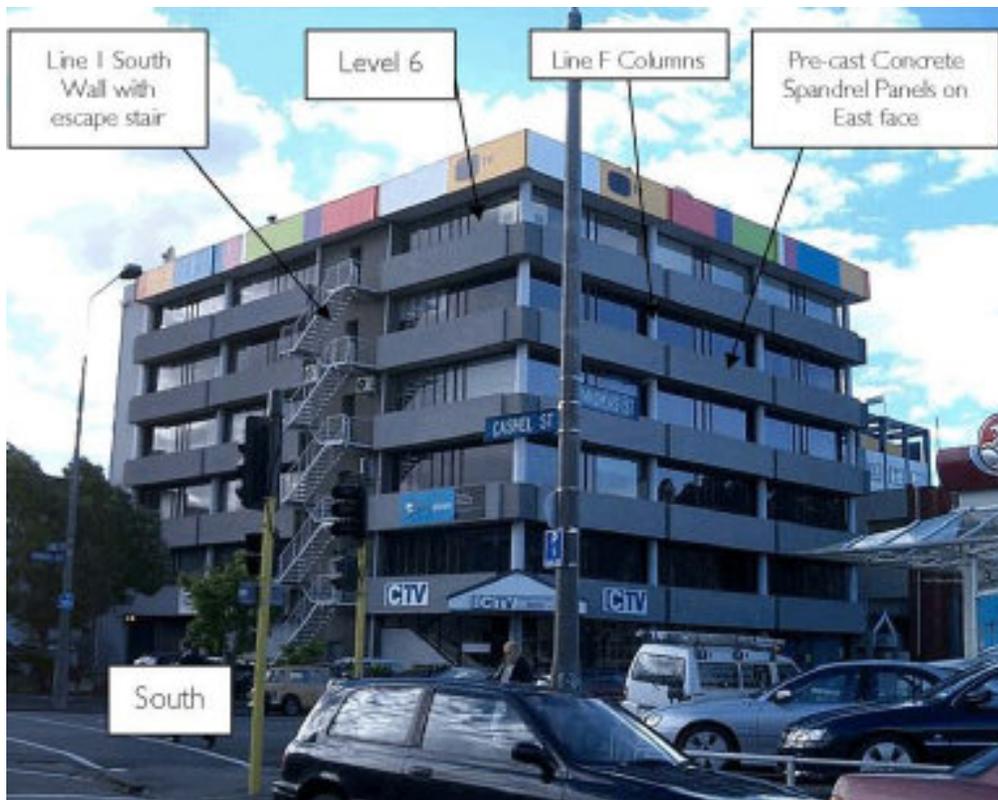
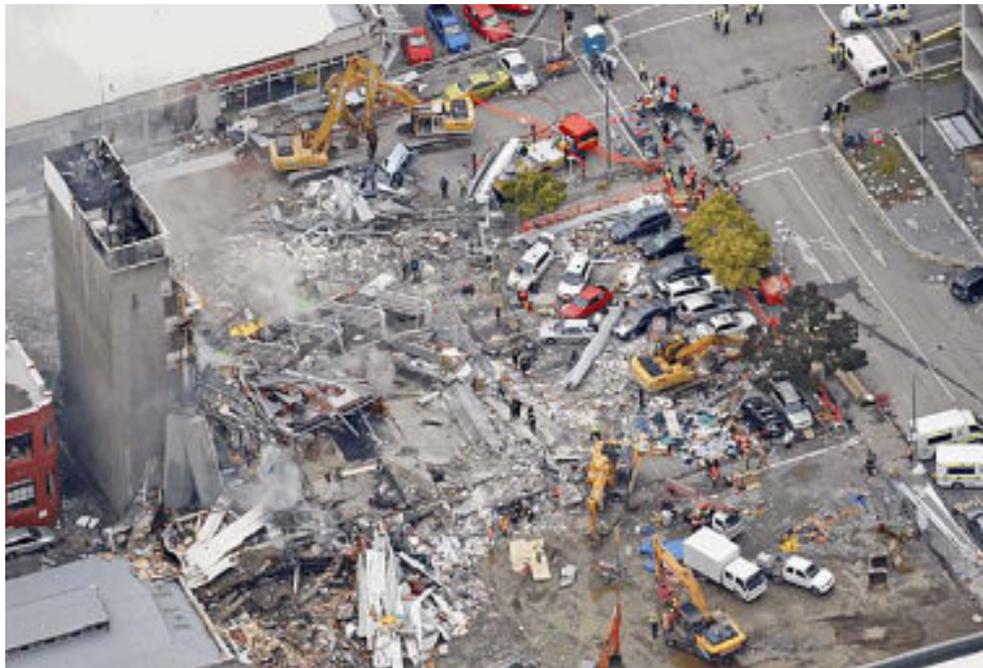
Figure 2-6 CTV building before and after collapse. One hundred and fifteen people were killed in this building. (Source: Hyland and Smith, 2011)

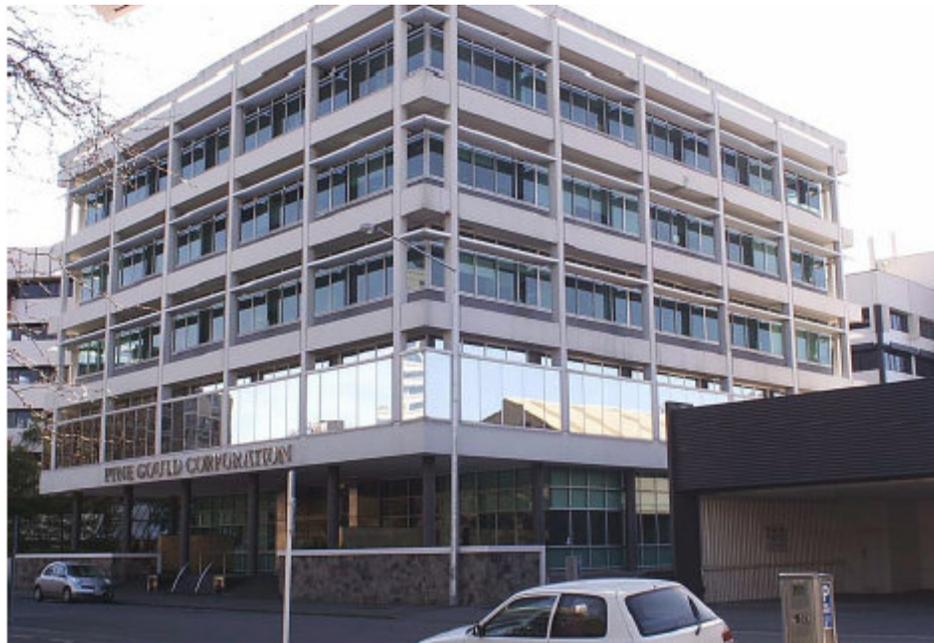
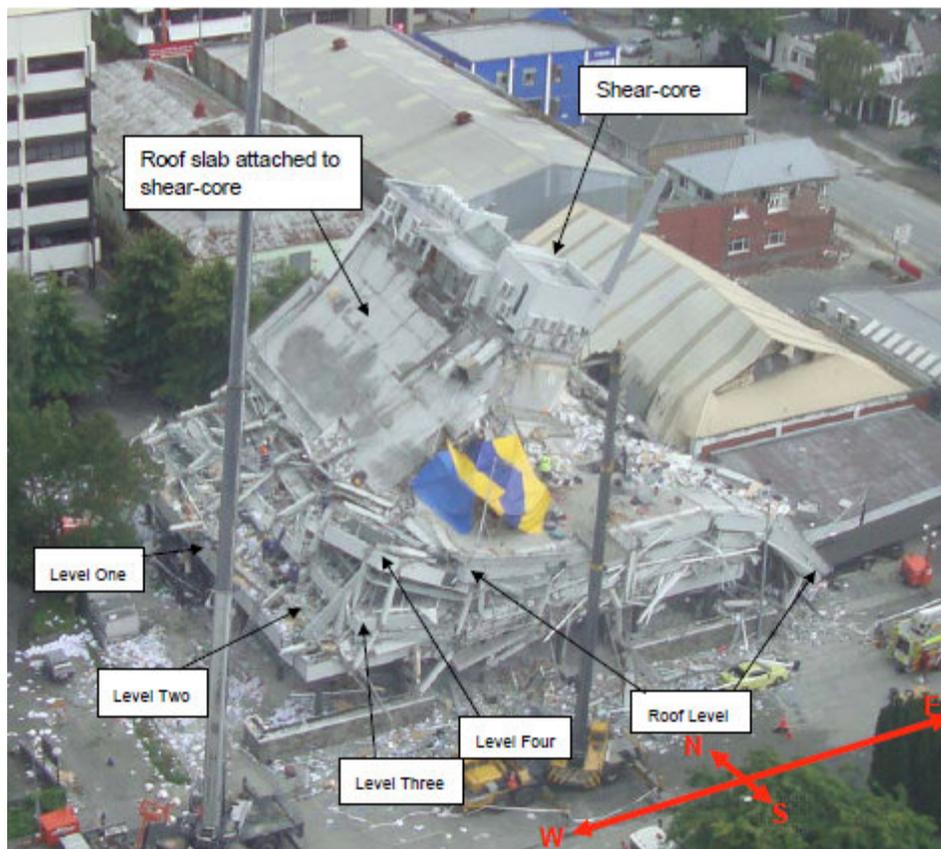
Figure 2-7 Pyne Gould Corporation building before and after collapse. (Source: BECA, 2011b)

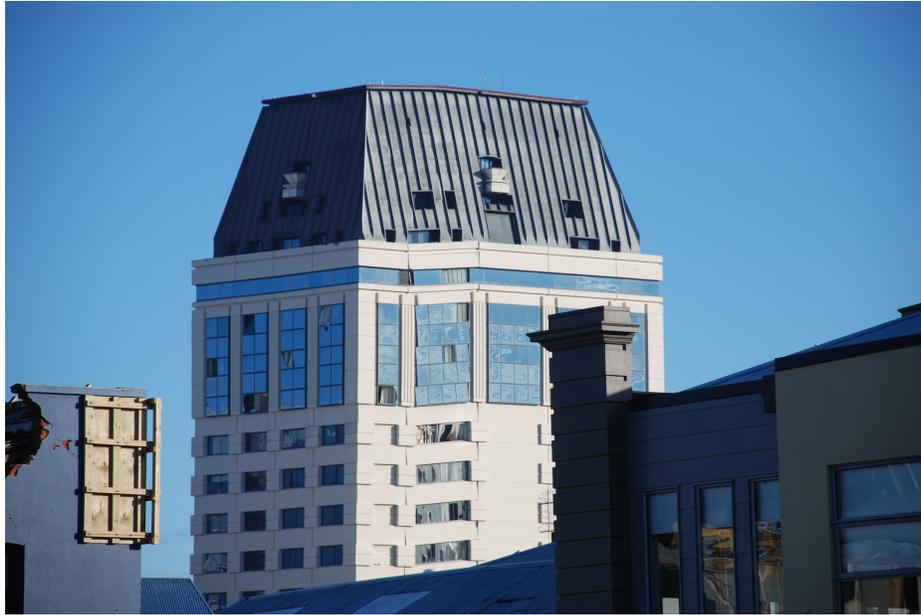
A number of relatively new buildings such as the Grand Chancellor Hotel (Figure 2-8) were so severely damaged that they will be demolished. To give a sense of the scale of the damage to mid-rise and high-rise buildings, a partial list of those to be demolished is given below.

Figure 2-8 The severely damaged Grand Chancellor Hotel in the CBD. This 22-story building was one of a number of high-rise buildings to be demolished.

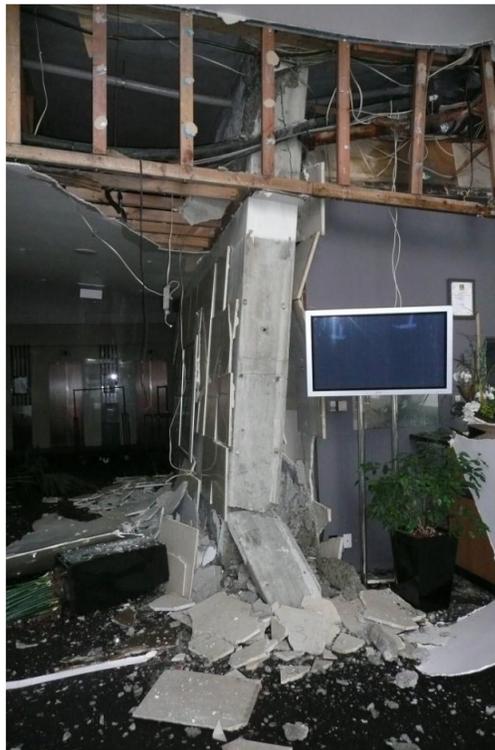
Figure 2-9 Shear wall failure in the Grand Chancellor. Failure of this wall caused the entire building to lean. (Source: Dunning Thornton, 2011)

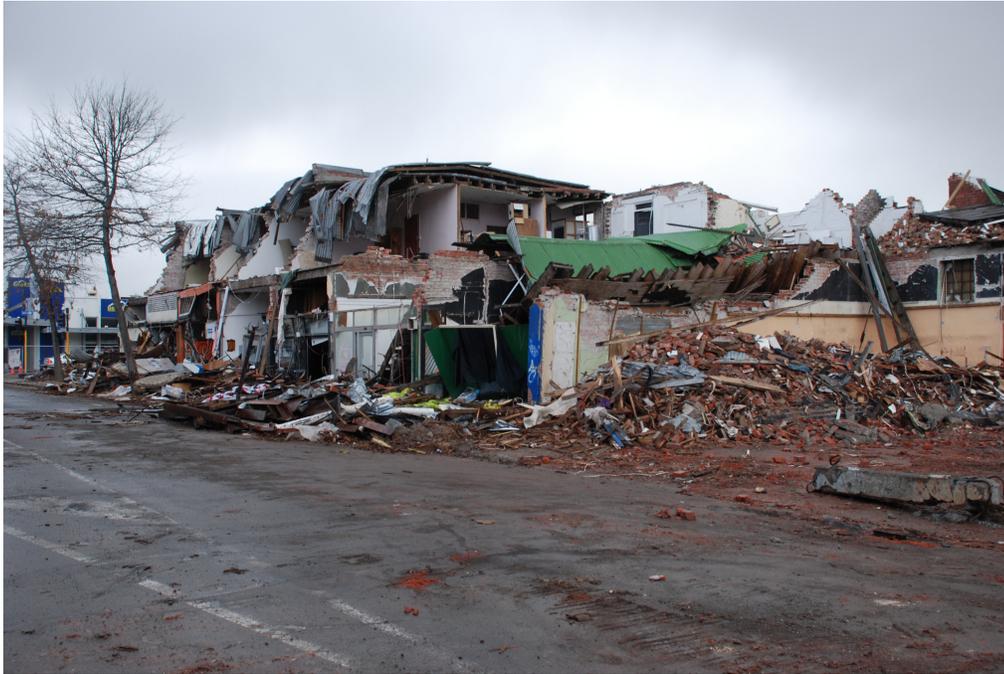
Figure 2-10 An example of the concentration of damaged URM buildings in the CBD.

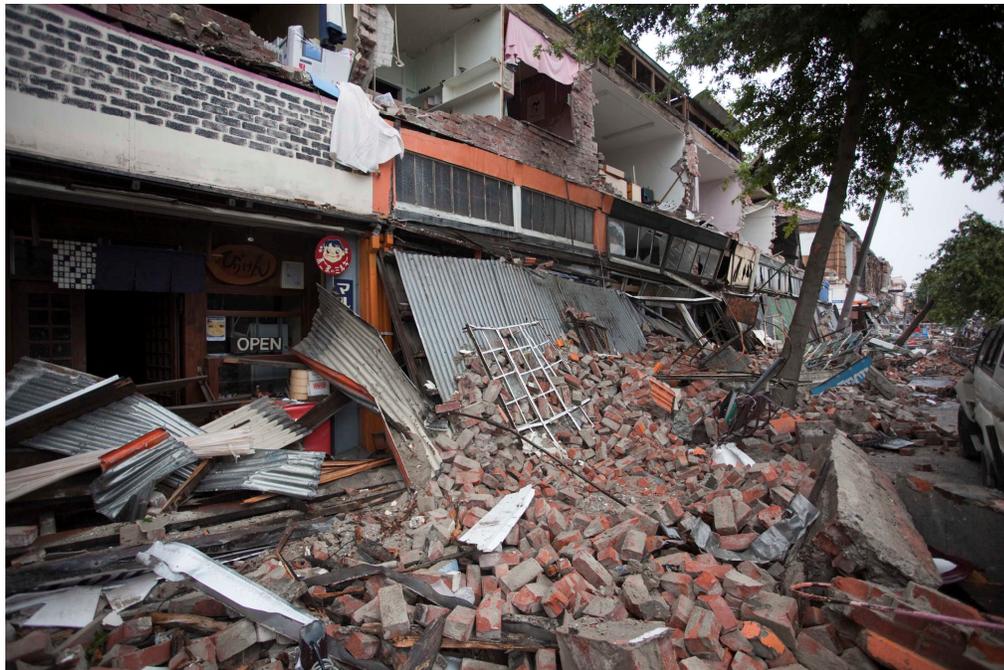
Damage was so severe and so pervasive (Figure 2-10) that officials cordoned off the entire 50 plus blocks of the CBD to control entry and keep the general public out of dangerous areas. Figure 2-11 shows typical CBD damage immediately after the earthquake with streets blocked by debris.

Figure 2-11 Damage in the Christchurch CBD immediately after the February 2011 earthquake. (Source: Christchurch City Council)

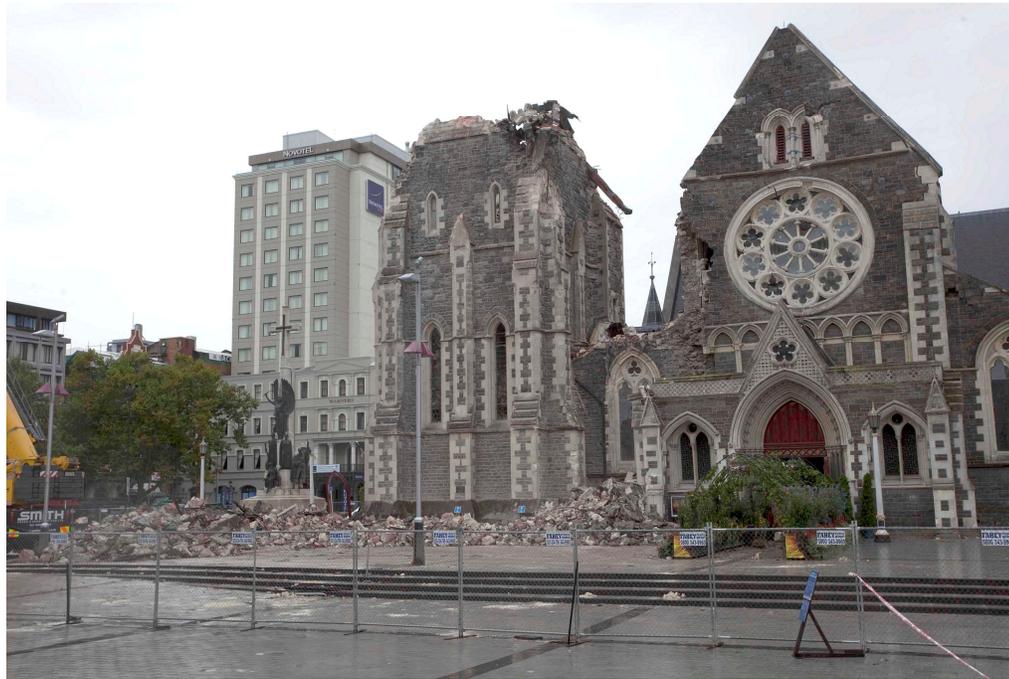
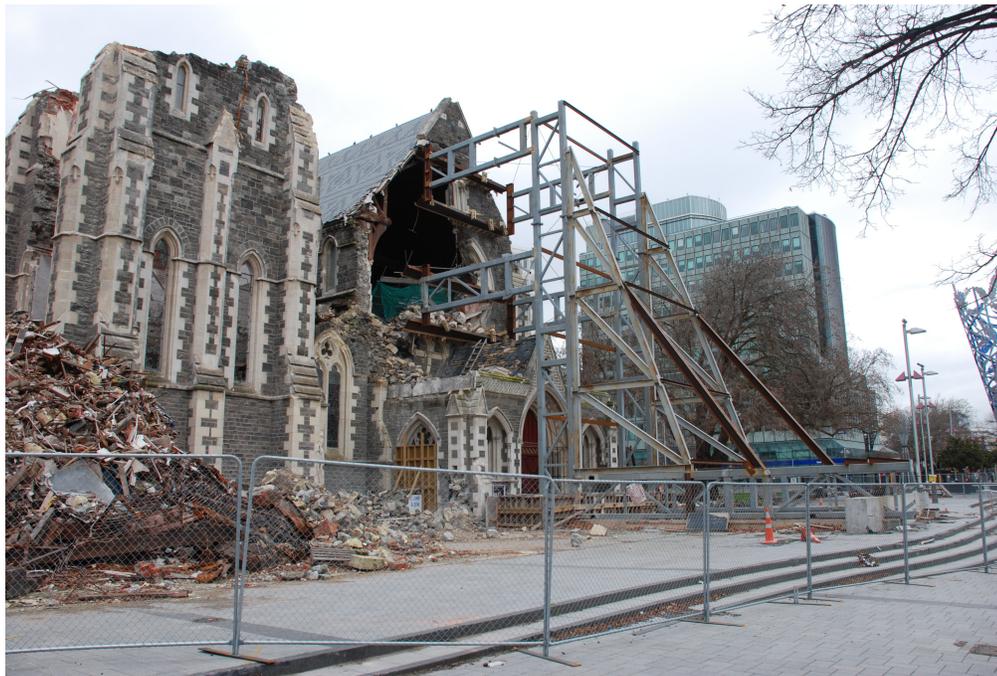
Figure 2-12 Failure of temporary wall shoring at the famous Christchurch Anglican Cathedral intended to allow removal of the Rose Window. The picture at top shows the wall and Rose Window after the February 22, 2011 earthquake, and the picture at the bottom shows the wall, and loss of the Rose Window, after the June 13, 2011 aftershock. (Source: Top picture, Christchurch City Council)

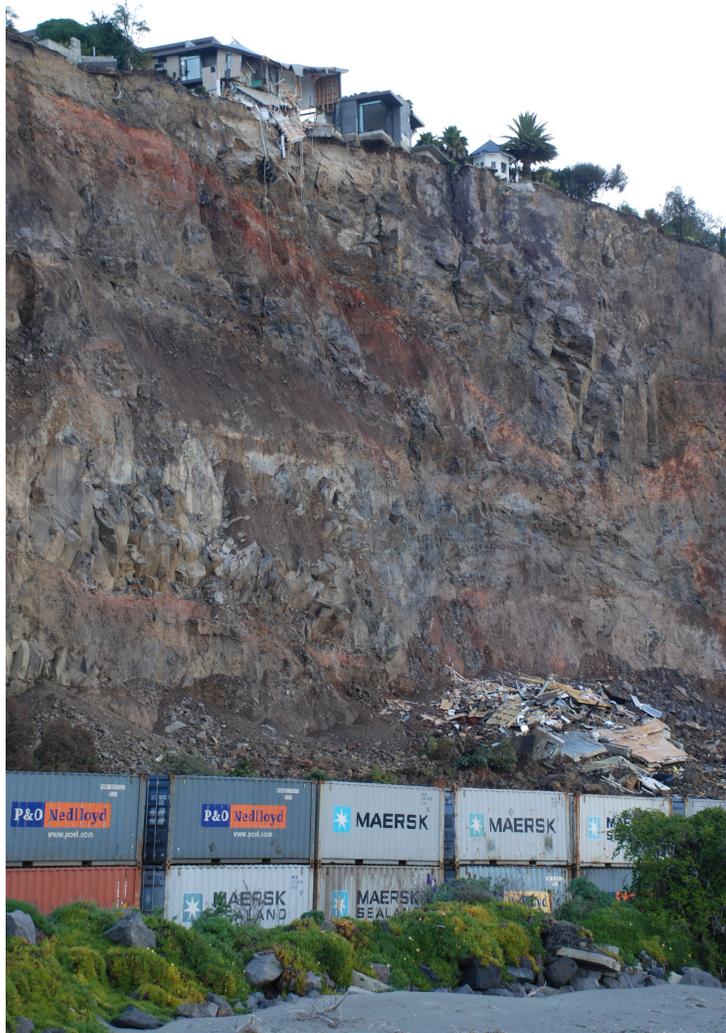
Figure 2-13 A home destroyed by slope failure in the Sumner area. Part of the home is at the top of the cliff and the other part at the bottom (just above the shipping containers on the right).

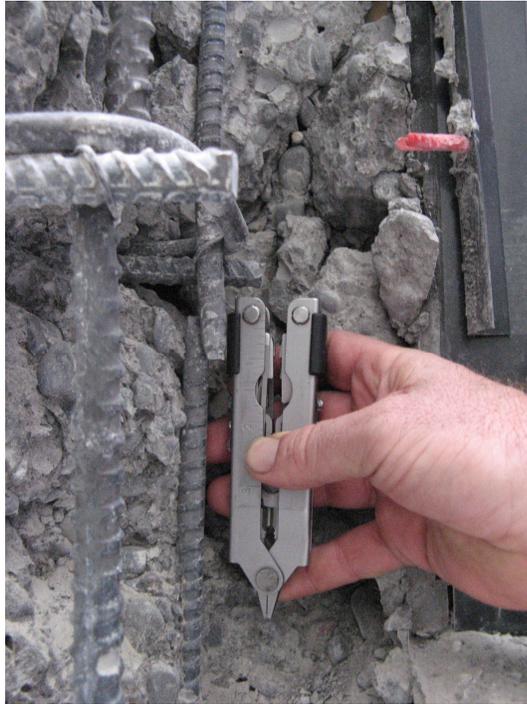
An unusual phenomenon was observed in some concrete shear wall buildings. Vertical reinforcement in shear walls was found to be fractured. It was reported for the first building where this was observed that when structural engineers initially inspected a wall, only a relatively small horizontal crack was found. However, when concrete covering the bar was removed, complete tensile fracture of the bar was found. Upon further exploration along the crack in the wall, other vertical bars were also found to be similarly fractured.

Figure 2-14 An example of a fractured vertical reinforcing bar in a concrete shear wall.
(Source: Des Bull)

A concern for future postearthquake inspections is that these cracks may close or leave only small crack widths that may be superficially repaired without consideration of the fractured, or possibly fractured, vertical reinforcing steel.

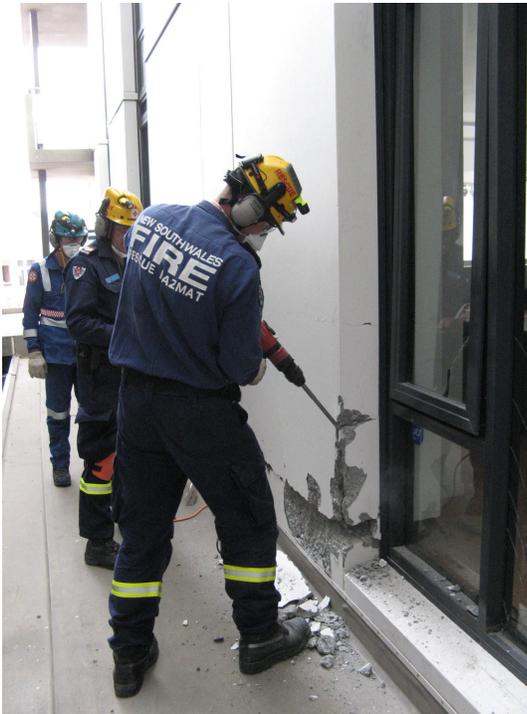
Figure 2-15 Exploration work in concrete shear wall for possible fractured bars.
(Source: Des Bull)

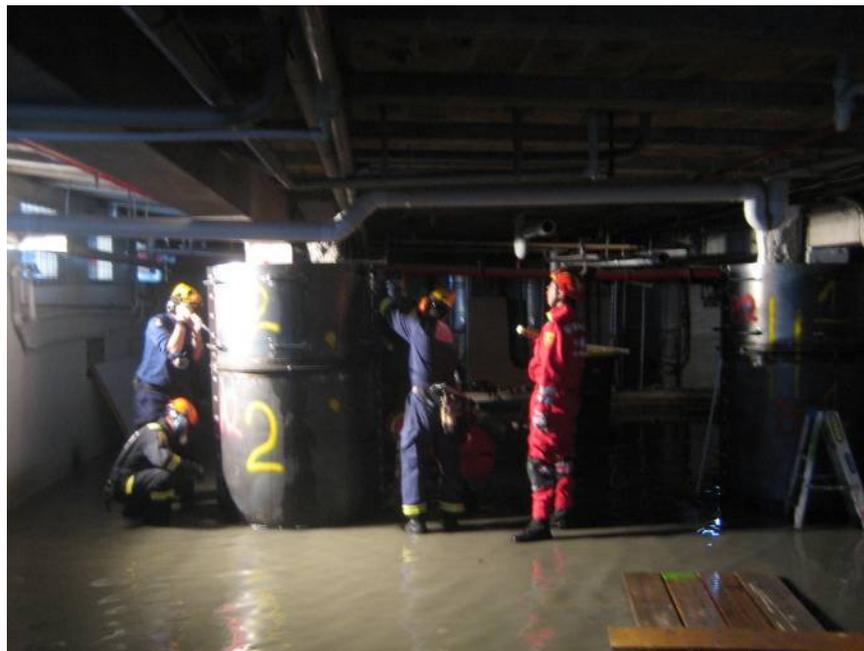
Figure 3-4 Emergency stabilization of columns. (Source: Holmes Consulting Group)

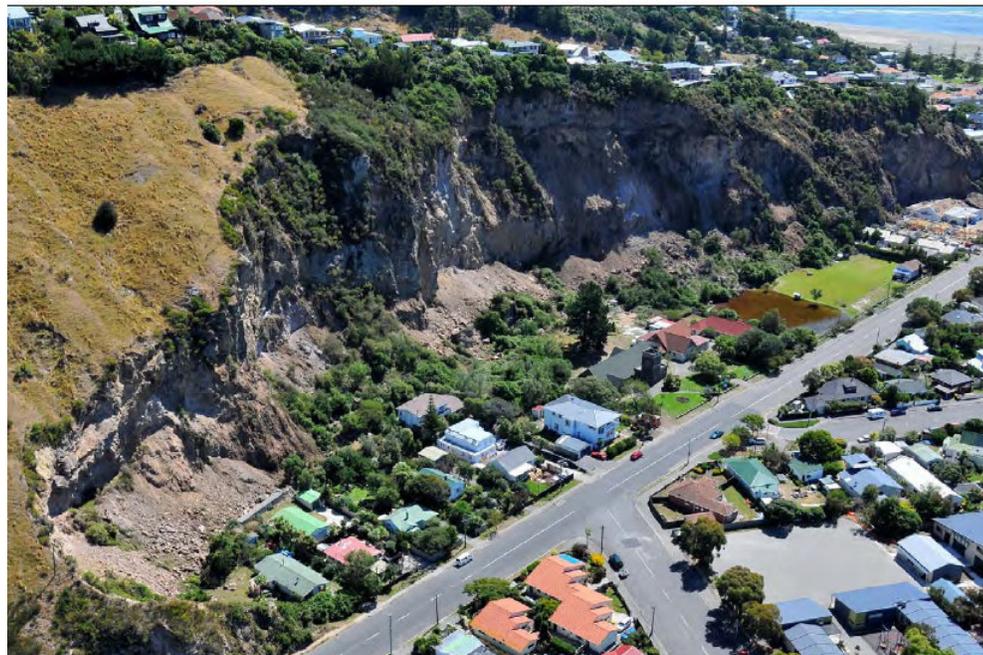
Figure 3-6 One of the cliffs in the Sumner District that experienced slides and rock falls. Note debris at bottom of cliff. (Source: GNS Science, 2011a)

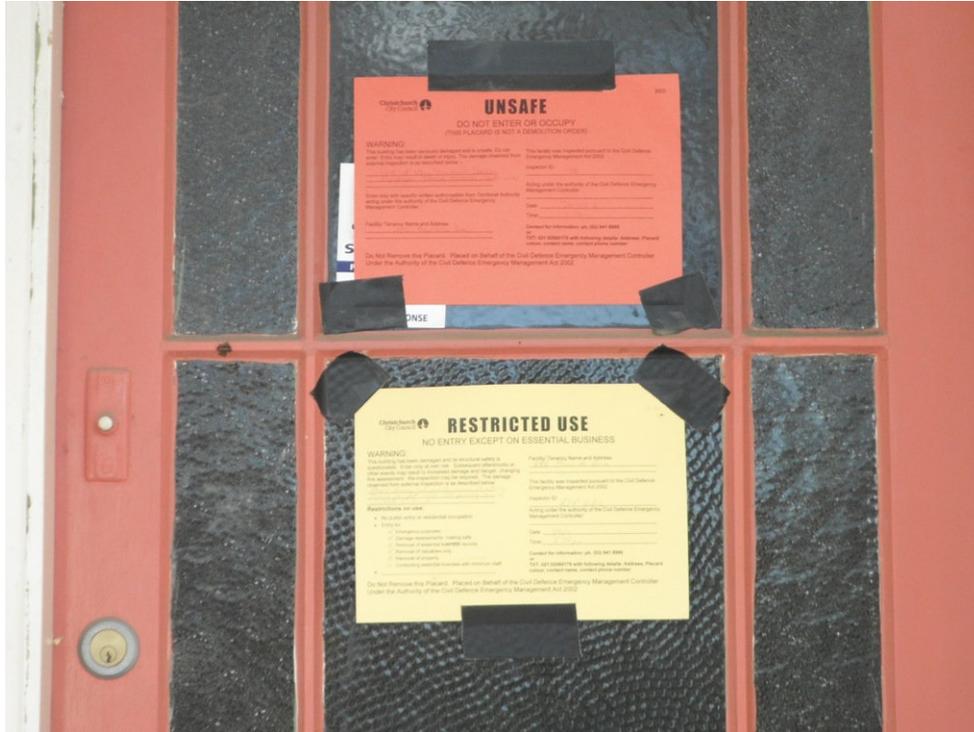
Figure 4-1 A building with two different placards. Often the older placard was not removed.

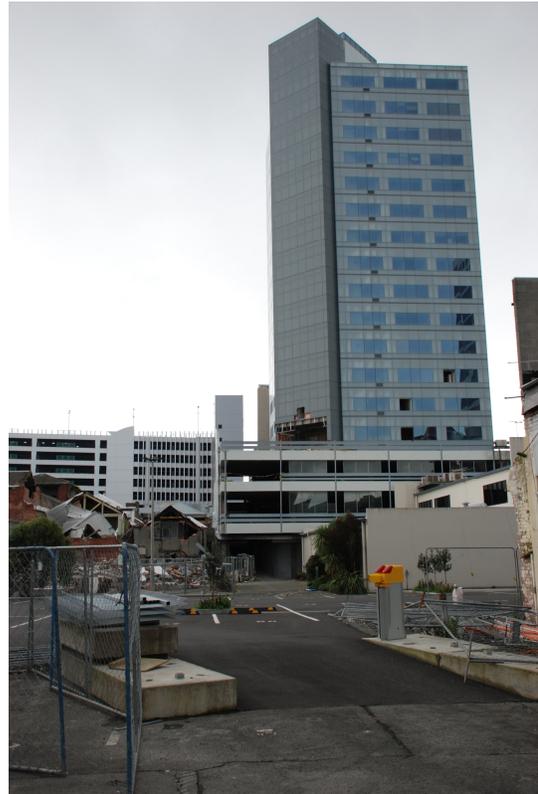
Figure 6-1 The 19-story Forsyth Barr building. Occupants were trapped in the upper floors when precast stairs collapsed.

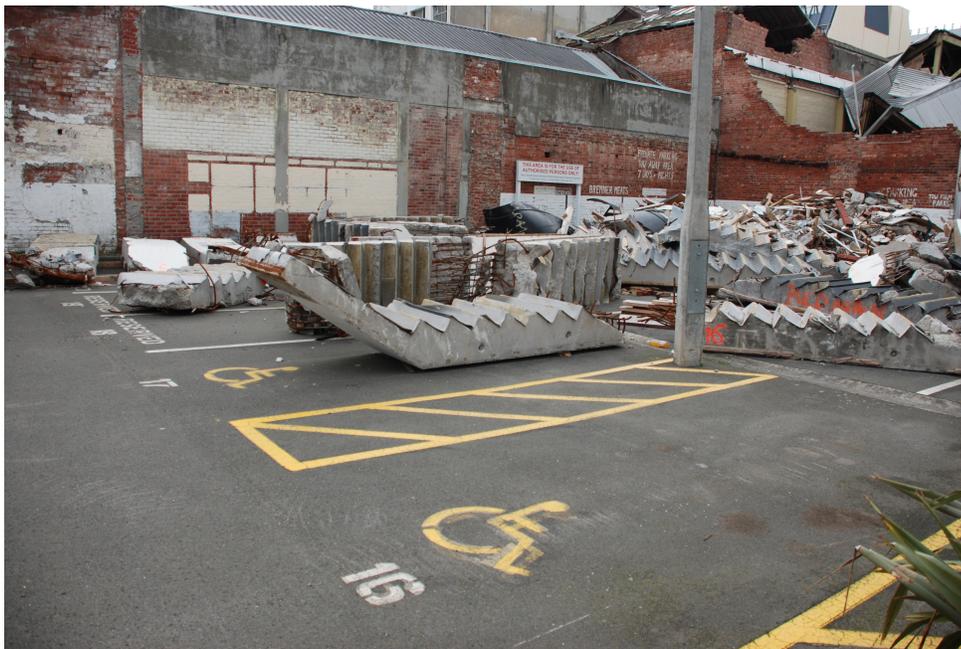
Figure 6-2 Failed precast concrete stairs from the 19-story Forsyth Barr building.
