| C1 TOWER |

This Detailed Engineering Evaluation Report (Report) has been prepared in connection with damage suffered by the building at the address shown on the front of this report (Building) resulting from the earthquakes that occurred in the Canterbury region on Saturday 4 September 2010, on Tuesday 22 February 2011, Monday 13 June 2011 and Friday 23 December 2011 (NZDT) and subsequent aftershocks up to the date of inspection by CPG.

The Pacific Tower Body Corporate via Fortis Construction Ltd engaged CPG to prepare this assessment of damage caused by the 2010/2011 earthquakes and prepare repair specifications as detailed in the CPG proposal dated 7 July 2011.

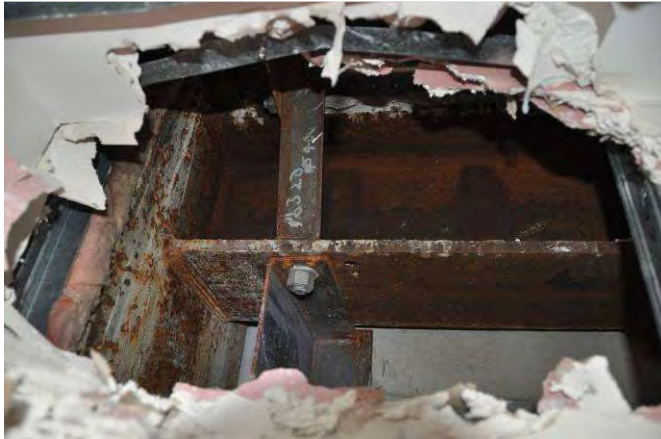
L6, Grid C2, active link

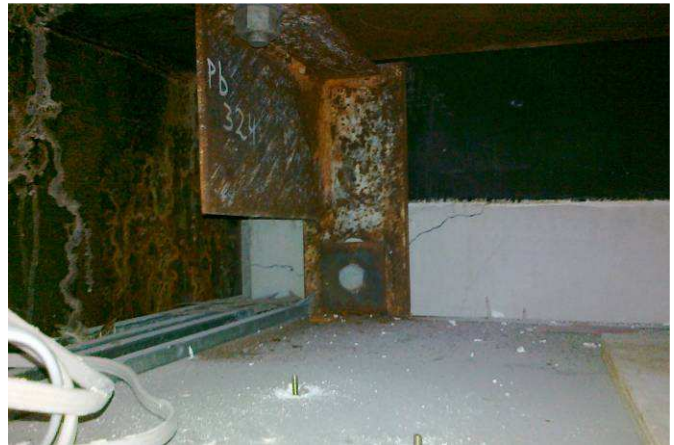
L11, Grid C2, damaged panel fixing

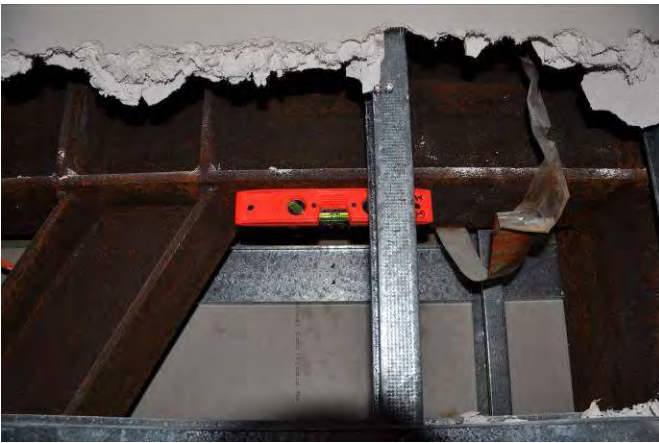
L11, Grid D4(east), active link

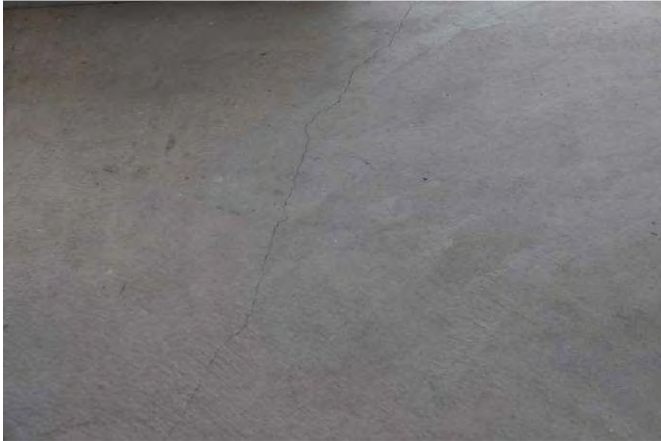
L22 crack to floor diaphragm (from stairwell to NE)

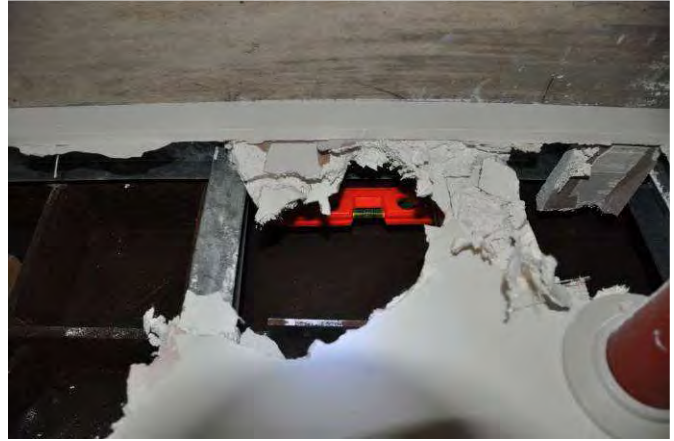
L22, Grid D4, active link.

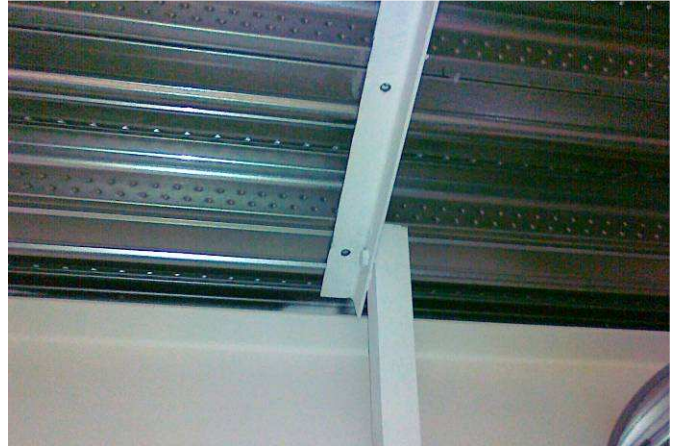
Missing floor anchors at L2 east wall at top of ramp

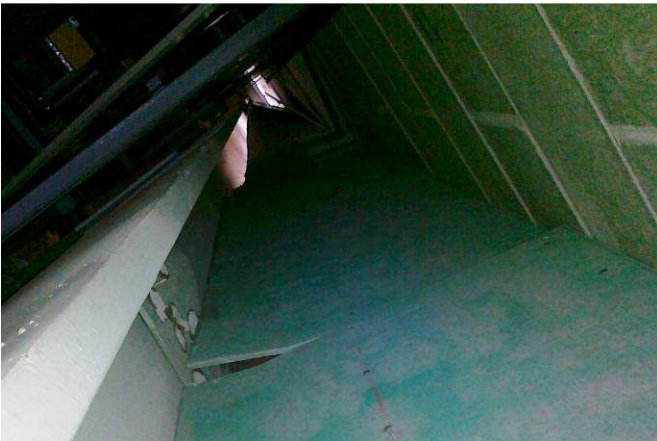
- The seismic flashings between the south reinforced masonry block area and the main tower have been crushed full height and will require replacement. There was also isolated roof damage. Flashings have been dislodged at the junction with the Sampan Noodle House to the east, and may have suffered damage at the corners of the building. These should be

Flashings between masonry block and tower

replaced as necessary. Consideration should be given to more permanent fire-rated flexible flashings. Refer [www.zonenz.net.nz](http://www.zonenz.net.nz)

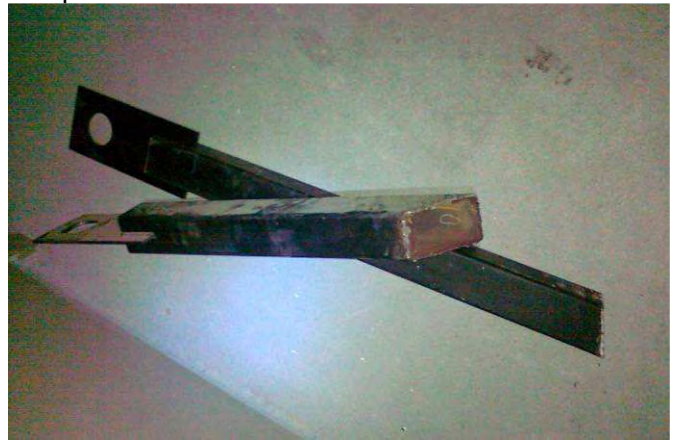
- The cross-bracing in many of the car stackers unhooked at midway along its length. These have been replaced with shackles as previously recommended. Inspection of the car-stacker restraints at the top of the car-stackers by Kiwi Sparky (electrical contractor) identified damaged restraints and some cleat connections pulled out. In addition, the building residual deformations resulted in the car-stacker columns not being vertical. The car-stacker columns have been re-levelled, straightened and are in the process of having the restraints reinstalled and strengthened as previously instructed.

Fractured carstacker top lateral restraints

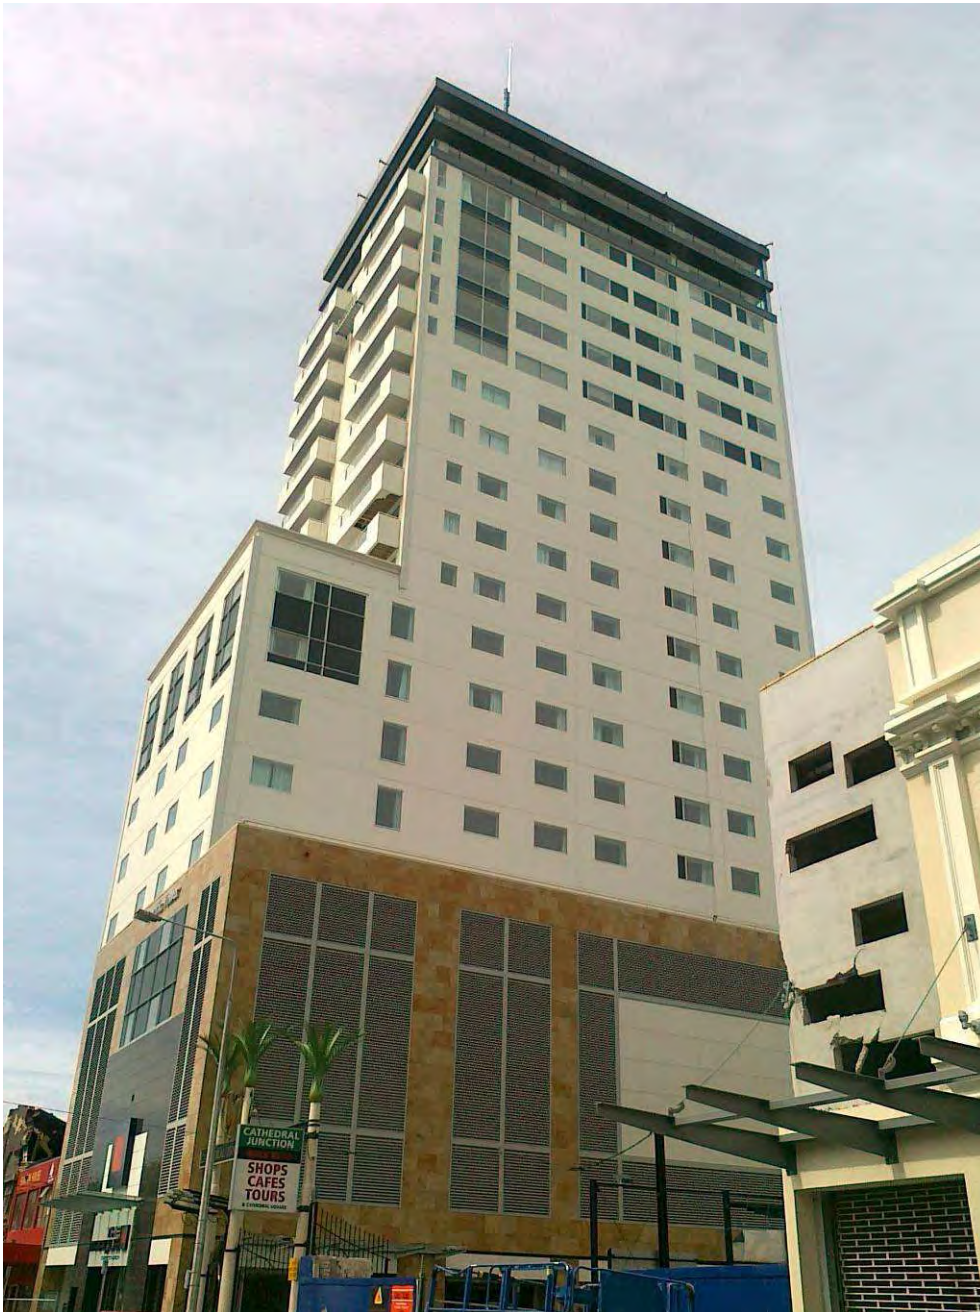
Pacific Tower 2 March 2011 (some damage to north balcony soffits visible).

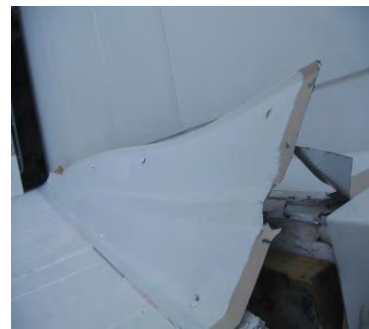
6th Floor Deck Flashing Cover Broken

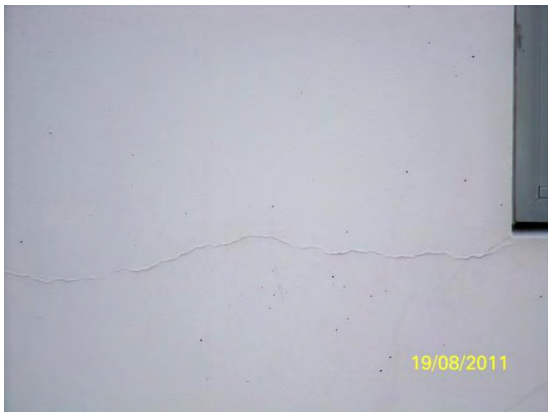
**Level 8 Right Panel**

After the June 13<sup>th</sup> Quake, we noted that these same cracks were much more pronounced. Notably, around the 8<sup>th</sup> & 9<sup>th</sup> floors, the severity of battering done by the North – South pounding of the horizontal beam to the External Concrete Panels appears to have pushed the Panels around even more.

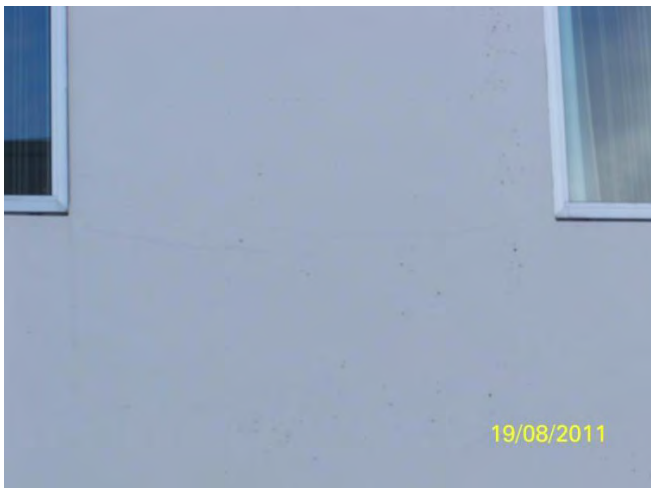
**This photo above is not brilliant, but there are several horizontal hairline cracks between the Right Panel Window on the Pacific Tower South Facade Concrete Panel. As well, this is common-place on the Eastern Side of this building.**

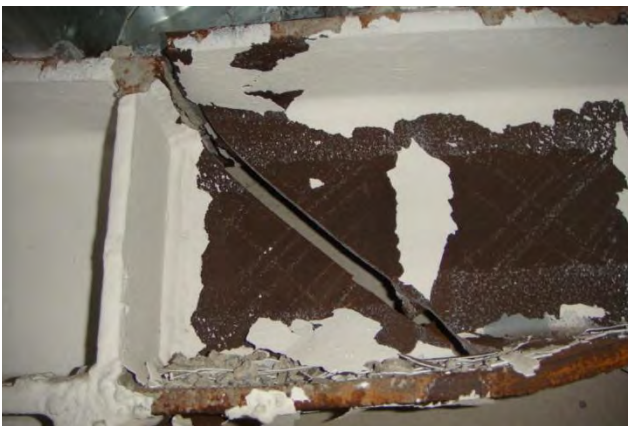
**Notably, the Car Stacker area on the PT Second Floor did have various issues posed by the February & June quakes. We are attaching photos herein of a 300 x 200 mm 'I' Beam that actually fractured/Ripped diagonally. This occurred at around Level 10 in the Northwest corner area. Further down that side, again within the Stacker, at Level 4, nuts actually broke off the bolts that connect the 'I' Beam. Photos are shown here below. The resulting beam displacement is shown here in the photo. It could be related to pile movements in the NW corner.**

Diagonal Beam Fracture in Car Stacker NW area at highest level, just beneath the roof at Level 10.

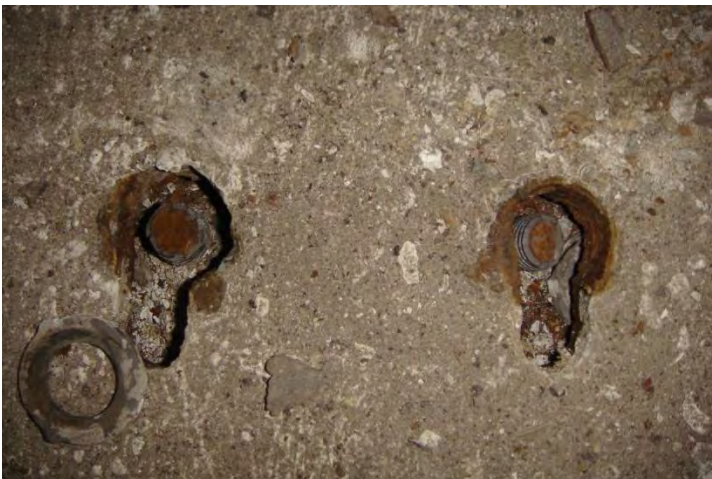
Note the nuts have actually broken off the connecting beam bolts. This is at Level 4 or so again in the same area as above (NW corner of Car Stacker).

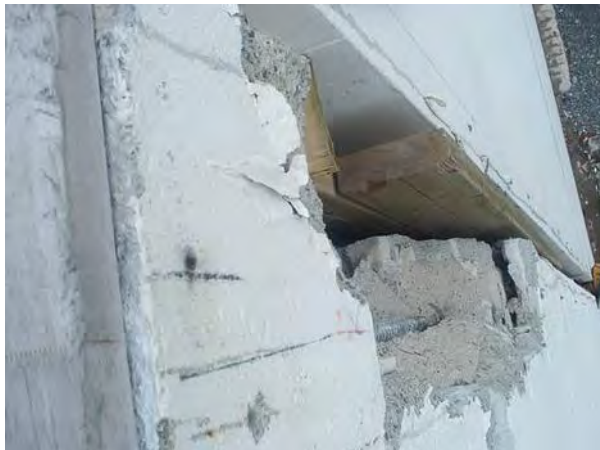
Southeast corner external wall

- The flashing from the deck to the building needs total removal and rebuilding.
- The structural supports underneath will need to be checked.
- The plywood deck may need to be replaced

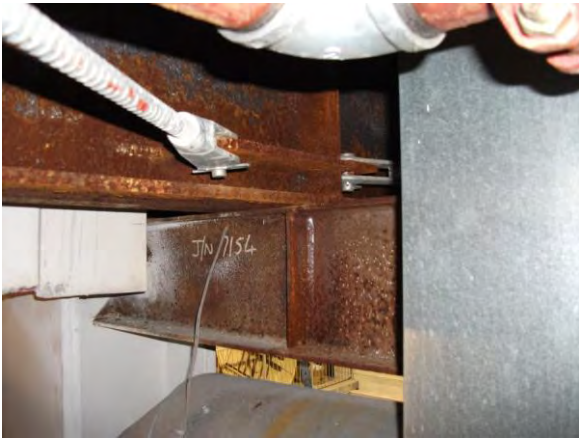
**South West Corner Attachment – no damage**

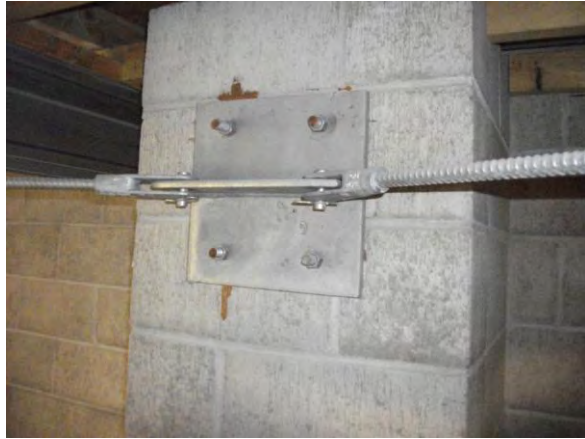
**Central South Side Plate Attachment – no damage**

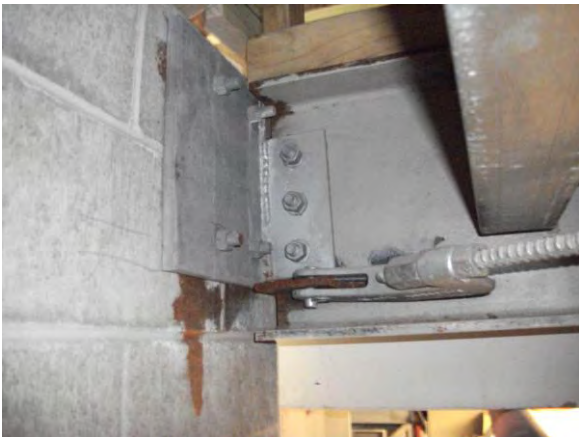
**South East Corner Attachment – no damage**

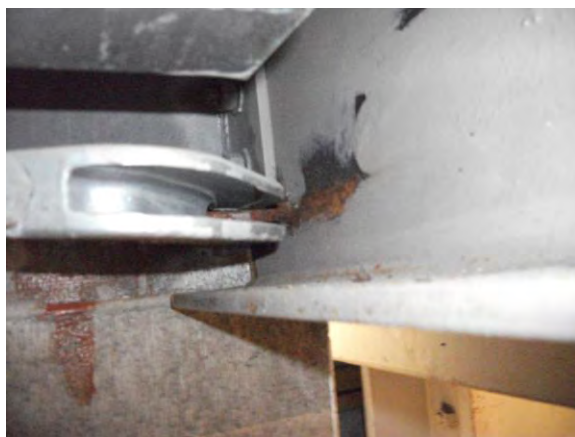
**North East Corner Attachment – no damage**

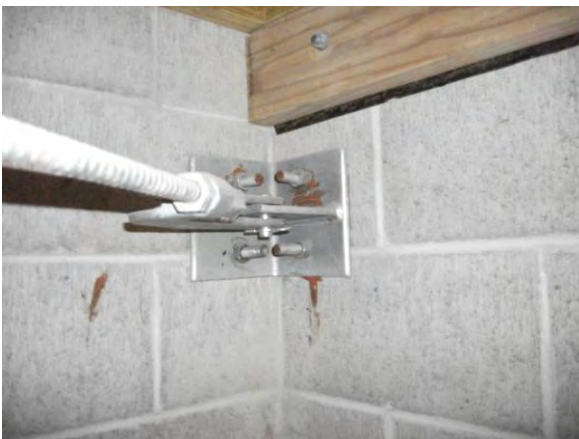
**South West Attachment – no damage**

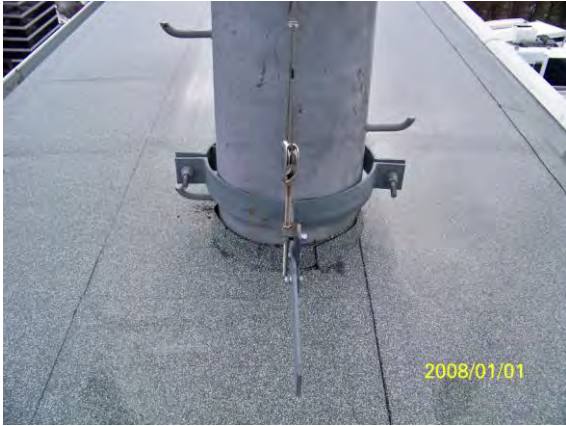
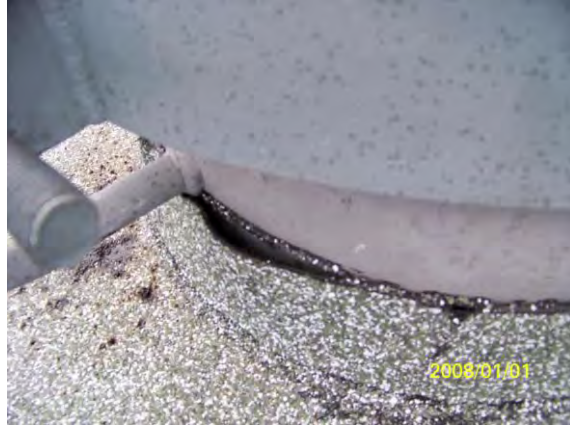
**Top Base Roof Ring Water Seal Broken**

- The wall at the base of the rooftop mast has suffered cracking around the wall anchor bolts. This section of wall should be rebuilt in concrete (reusing and supplementing the existing reinforcing steel), with larger anchor plates and bolts lower down the wall, as previously instructed.

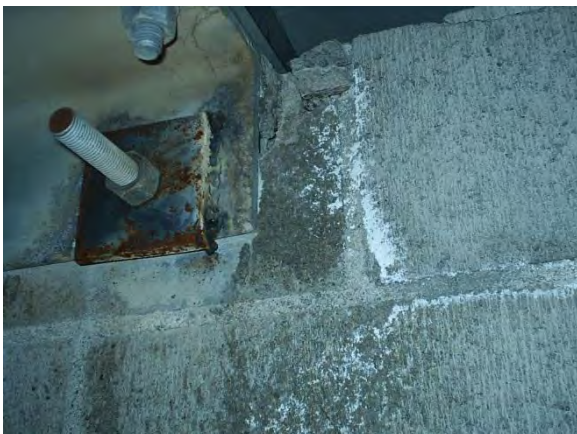
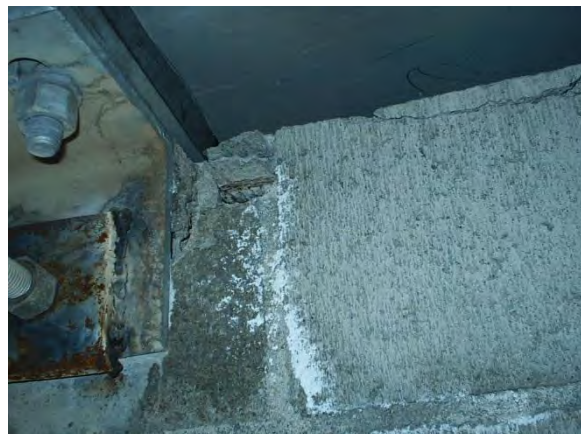
**Mostly Fractured Concrete Block & Base Mount Bolt Mounts below Roof**
