Section 1:

Introduction and background

The Performance of Unreinforced Masonry Buildings in the 2010/2011 Canterbury Earthquake Swarm

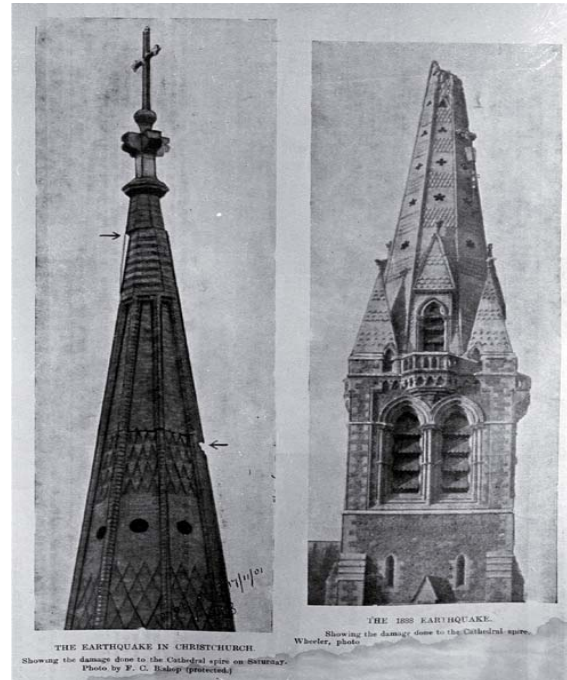
The large earthquake that struck the Amuri District of Canterbury (about 100 km north of Christchurch) in 1888 is thought to have originated on the Hope Fault, which is part of the Marlborough Fault Zone (Stirling, 2008). The earthquake's intensity reached MM 9 in the epicentre area, and caused severe damage to buildings made of cob and stone masonry located in the Amuri District (now part of the Hurunui Territorial Authority of Canterbury), as well as in Hokitika and Greymouth. This earthquake was felt in Christchurch city, and caused minor damage to buildings (PapersPast, 2010). A later earthquake in 1901 centred in Cheviot damaged the spire on the Cathedral for the third time in its short life and led to reconstruction of the spire in timber. Figure 1.3 shows the damage to the spire from the 1888 and the 1901 earthquakes.

Figure 1.3 Damage to the Cathedral Spire in the 1888 (left) and 1901 (right) earthquakes (Bishop & Wheeler, 1901).

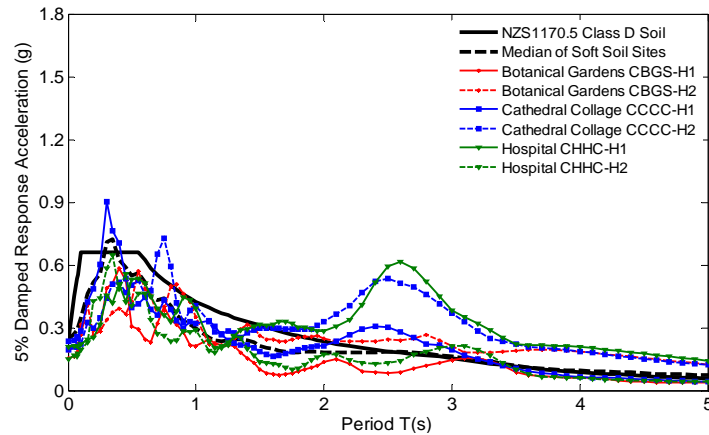
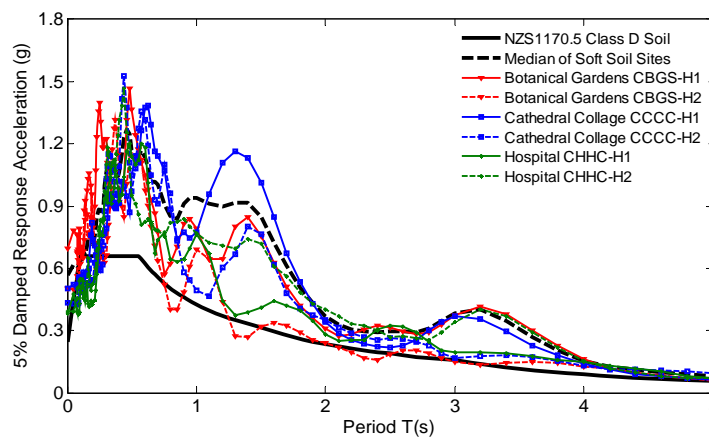
As detailed in section 2.5 (see Figure 2.10 and Table 2.5), the assessed seismic capacity of all unretrofitted unreinforced masonry buildings in the Canterbury province was expected to be less than 67% of the New Building Standard (NBS), and furthermore approximately 40% of the Canterbury URM building stock was estimated to have a strength of less than 33%NBS. Unreinforced masonry buildings are comparatively stiff structures, with a fundamental period typically in the range of 0.3-0.5 seconds. From Figure 1.6(a) it can be established that for this period range many URM buildings were subjected on 4 September 2010 to earthquake loads that were between 67-100% of NBS (ie the solid line in Figure 1.6(a) corresponding to NZS 1170.5) and that the same buildings were subjected on 22 February 2011 to earthquake loads that were between 150-200% of NBS (see Figure 1.6(b)). It is well established that URM buildings perform poorly in large earthquakes and consequently the level of earthquake damage observed in the Christchurch CBD is consistent with expectations for loading of this magnitude.

Figure 1.6 Earthquake spectral recording from the two principal earthquakes of the 2010/2100 earthquake swarm

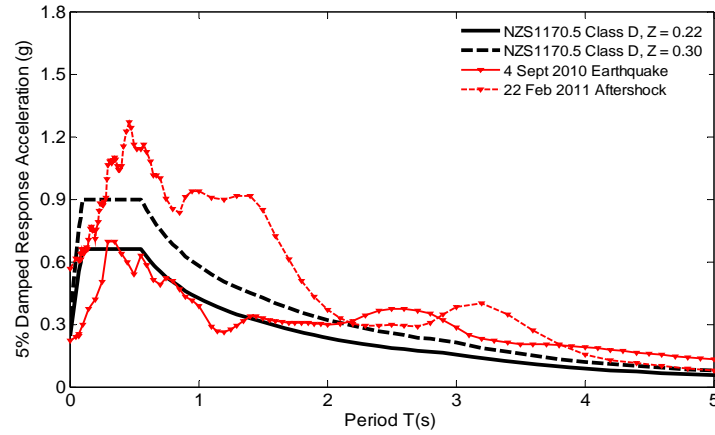
Figure 1.7 shows a comparison of the median response recorded in the 4 September 2010 and 22 February 2011 earthquakes, clearly identifying that the February earthquake was far more severe in terms of the load that it applied to unreinforced masonry buildings (and all other buildings having a period of less than 2 seconds). Following the February earthquake a decision was made to increase the seismic zone factor Z to 0.3, and the effect of this modification is also plotted on Figure 1.7. The effect of this increase in the seismic zone factor was to increase seismic design forces and displacements by 36%.

Figure 1.7 Comparison of earthquake spectra for the 4 September and 22 February earthquakes
