# Observed performance of unreinforced masonry buildings in the 2010/2011 Canterbury earthquake swarm

### 3.1 Damage to URM buildings from the 4 September 2010 earthquake

## The Performance of Unreinforced Masonry Buildings in the 2010/2011 Canterbury Earthquake Swarm

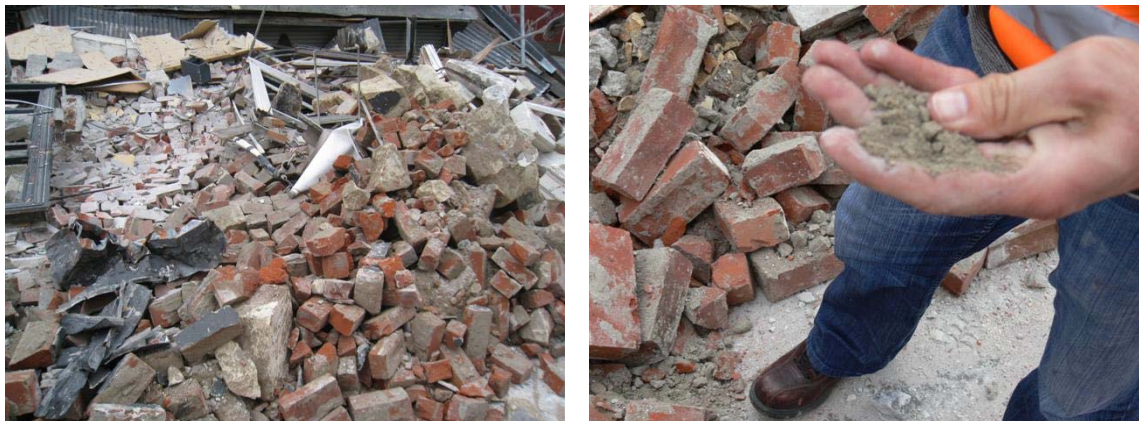
The general observation from the debris of collapsed URM walls was that the kiln fired clay bricks were generally of sound condition, but that the mortar was in poor condition. In most cases the fallen debris had collapsed into individual bricks, rather than as larger chunks of masonry debris (refer to Figure 3.3(a)). When rubbing the mortar that was adhered to bricks it was routinely found that the mortar readily crumbled when subjected to finger pressure (refer Figure 3.3(b)), suggesting that the mortar compression strength was very low. However, it appears that superior mortar was often used in the ornate parapet above the centre of the wall facing the street, as this segment of the collapsed parapet often remained intact as the parapet collapsed (refer Figure 3.4).

(a) Masonry rubble showing 'clean' bricks

(b) Weak mortar crumbles between fingers

**Figure 3.3 Masonry rubble from collapsed wall**

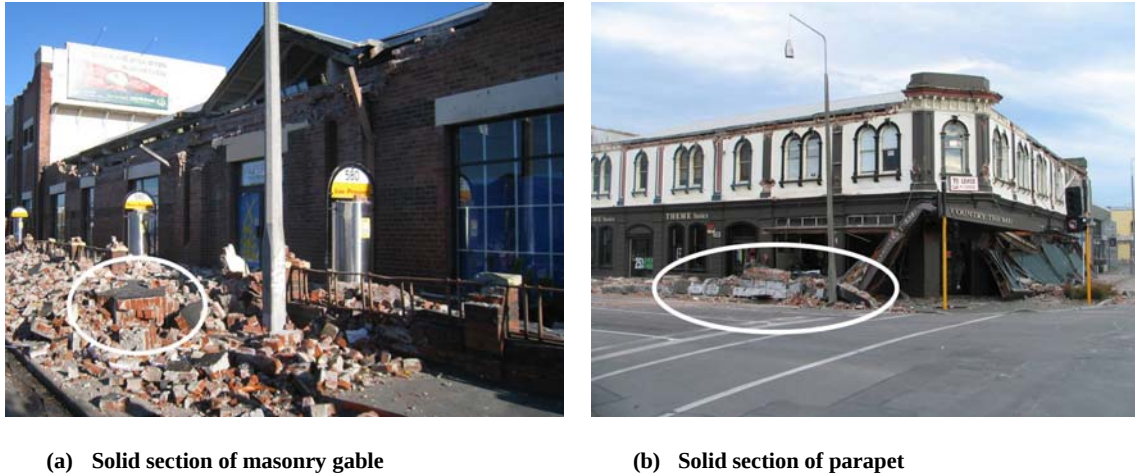
**Figure 3.4 Large sections of masonry intact after fall from buildings**

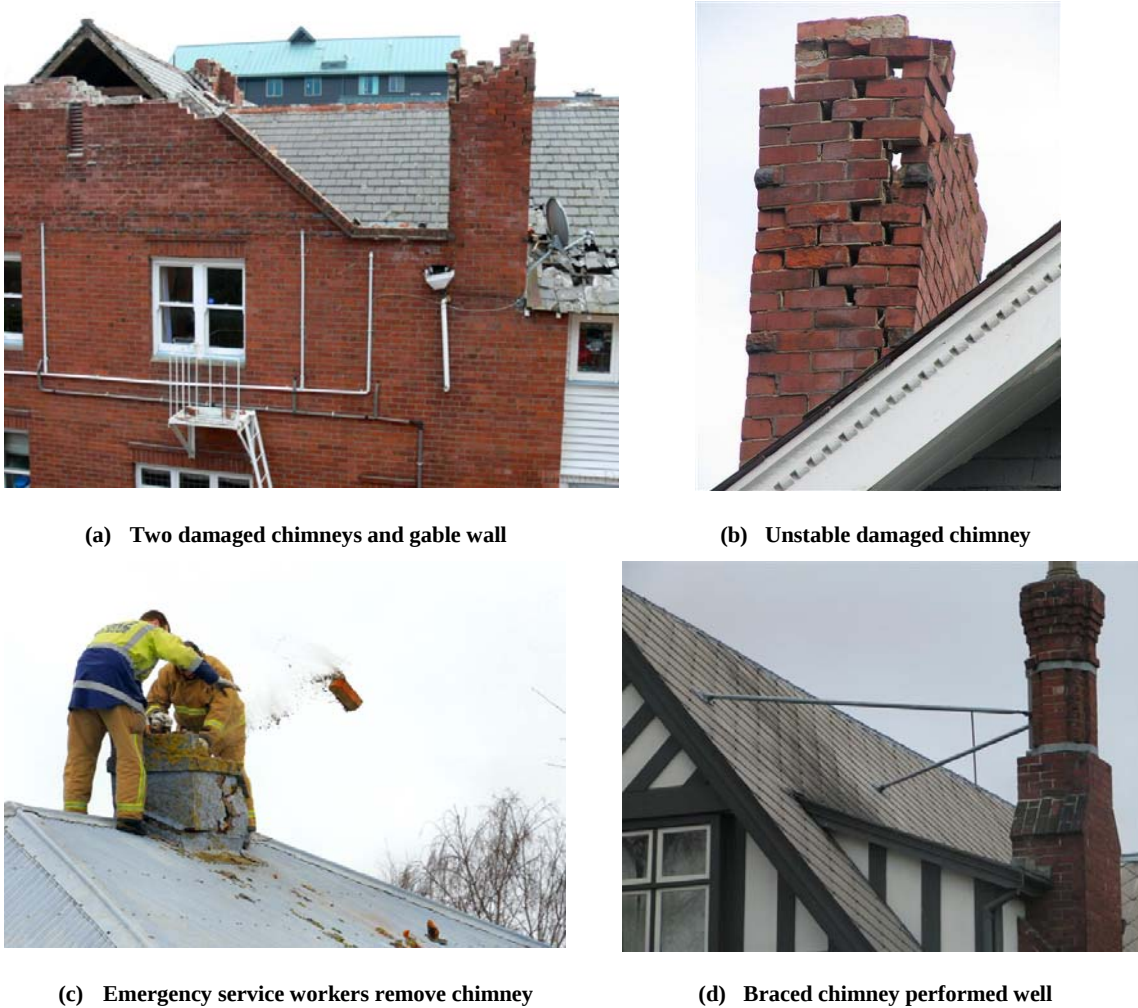
Unsupported or unreinforced brick chimneys performed poorly in the earthquake (Figure 3.6), with numerous chimney collapses occurring in domestic as well as small commercial buildings and some churches. Many examples of badly damaged chimneys that were precariously balanced on rooftops were also seen (Figure 3.6(b)) and it was reported that one week after the earthquake, 14,000 insurance claims involving chimney damage had been received, from a total of 50,000 claims (NewstalkZB, 2010). Emergency services personnel were in significant demand, being deployed to remove damaged chimneys in order to minimize further risk and eliminate these ‘falling hazards’ (Figure 3.6(c)). In contrast, Figure 3.6(d) shows an example of a braced chimney that performed well. Note that Figure 3.6(b) shows further evidence of the poor performance of mortar during the earthquake.

**Figure 3.6 Examples of chimney performance during the Darfield earthquake**

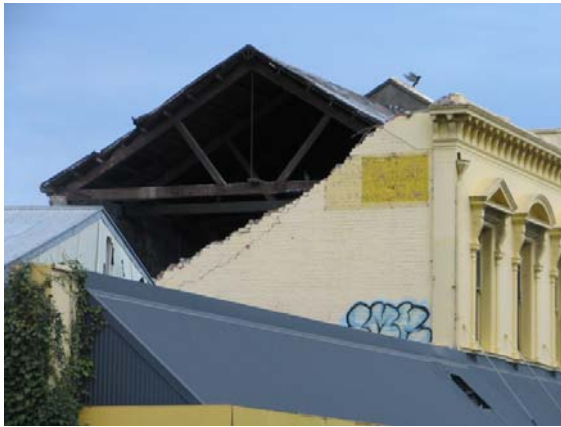
(a) 93 Manchester St

Many gable end wall failures were observed, often collapsing onto or through the roof of an adjacent building (refer to Figure 3.6(a) and Figure 3.7). However, there were also many gable ends that survived; many more than might have been expected, with the majority having some form of visible restraints that tied back to the roof structure. These examples are shown and discussed later (refer Figure 3.14 and Figure 3.15).

**Figure 3.7 Examples of gable end wall failures**

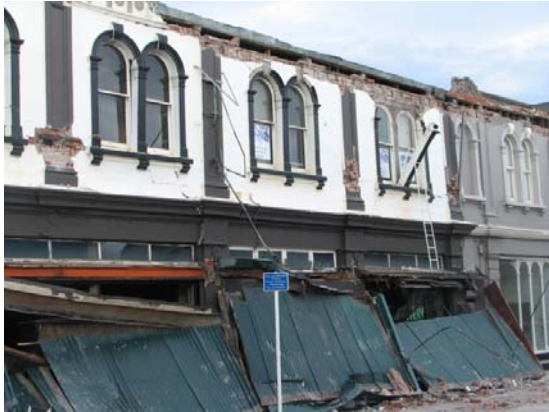
Numerous parapet failures were observed along both the building frontage and along their side walls. For several URM buildings located on the corners of intersections, the parapets collapsed on both perpendicular walls (refer Figure 3.8). Restraint of URM parapets against lateral loads has routinely been implemented since the 1940s, so whilst it is difficult to see these restraints unless roof access is available, it is believed that the majority of parapets that exhibited no damage in the earthquake were provided with suitable lateral restraint. In several cases, it appears that parapets were braced back to the perpendicular parapet, which proved unsuccessful.

(a) Multiple front wall parapet failures

**Figure 3.8 Examples of typical parapet failures**

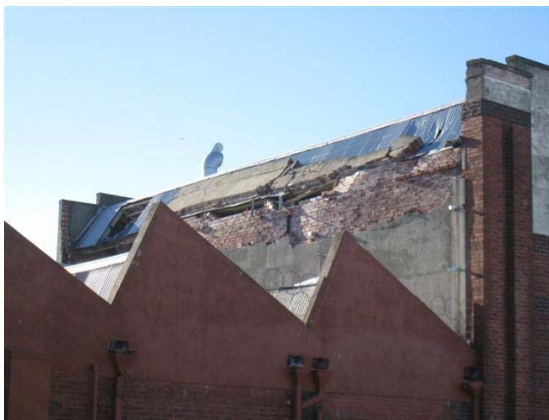
(c) Side wall parapet collapse onto roof.
