## The Performance of Unreinforced Masonry Buildings in the 2010/2011 Canterbury Earthquake Swarm

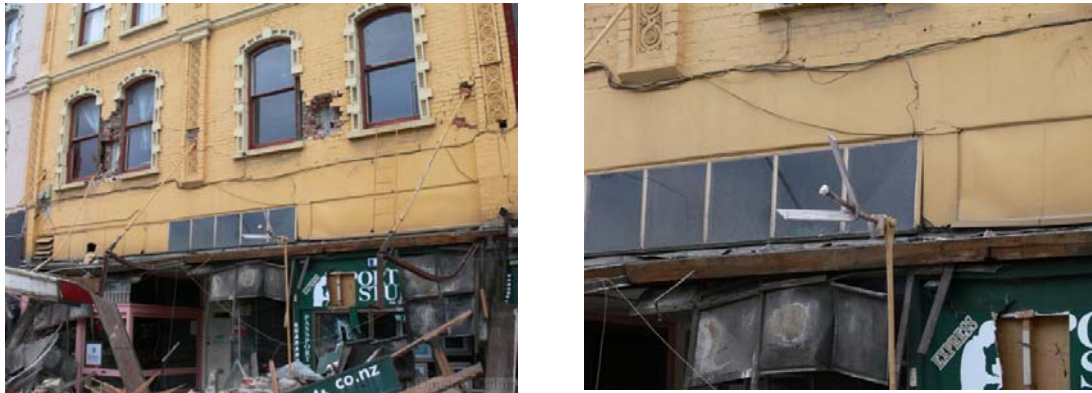
(a) Anchorage failure

(b) Close-up of failed anchorage detail

**Figure 3.9 Anchorage failure of awning brace due to parapet collapse**

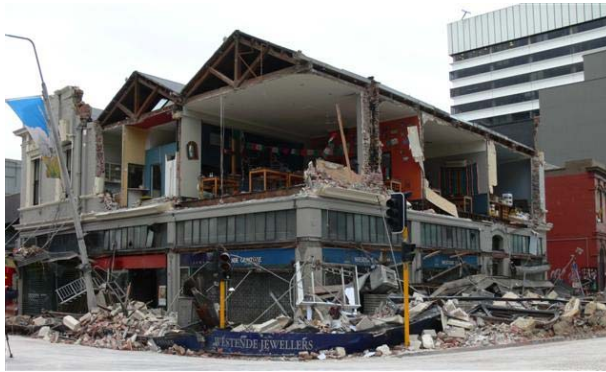
(a) Corner Worcester and Manchester streets

Out-of-plane wall failures were the first images to appear on television directly after the earthquake. Inspection of this damage typically indicated poor or no anchorage of the wall to its supporting timber diaphragm. Several examples of wall failure are shown below. Figure 3.10(a) shows a corner building that had walls fail in the out-of-plane direction in both perpendicular directions, on both sides of the corner. Figure 3.10(b) shows a 3-storey building where walls in the upper two stories suffered out-of-plane failures and Figure 3.10(c) shows similar damage for a 2-storey building. In all three of these instances, it appears that the walls were not carrying significant vertical gravity loads, other than their self weight, due to the fact that the remaining roof structures appeared to be mostly undamaged. In contrast, Figure 3.10(d) shows an out-of-plane failure of a side wall which was supporting the roof trusses prior to failure.

**Figure 3.10 Examples of out-of-plane failures in solid masonry walls**

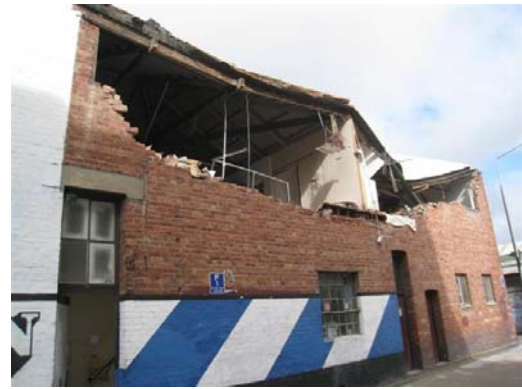
(d) Failure of long wall

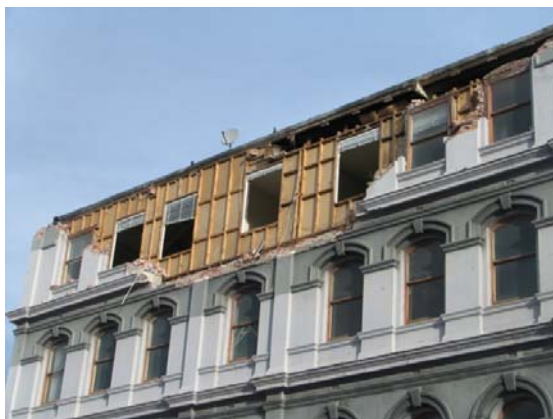
As shown in Figure 3.11, several examples of face load wall failure closely resembled observed damage in dry stack masonry experiments (Restrepo-Velez and Magenes, 2009), providing further support to the supposition that many of the wall failures were partly attributable to poor mortar strength.

(a) Wall damage at 140 Linchfield Street

**Figure 3.11 Failure mechanism comparisons – observed earthquake damage versus experimental simulation**

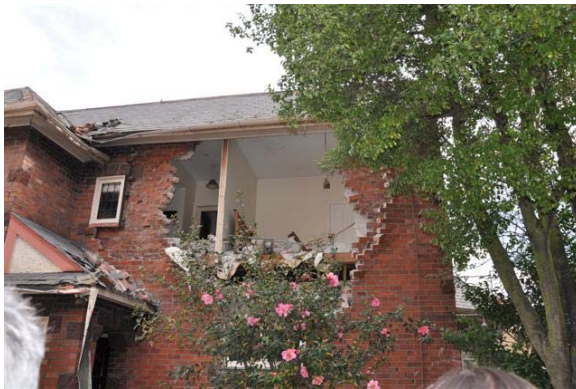
Cavity wall construction is generally believed to be much less common in New Zealand than is solid multi-leaf (or multi-wythe) construction. However, cavity wall construction can be extremely vulnerable to out-of-plane failure in earthquakes in situations where the cavity ties were poorly installed, or more commonly have corroded over time, as the wall is then comparatively slender and less stable than for solid construction. Figure 3.12(a) and (b) show examples of cavity wall buildings that suffered out-of-plane wall failures.

(a) Cavity wall failure in a residential building

**Figure 3.12 Examples of out-of-plane failures in cavity walls**

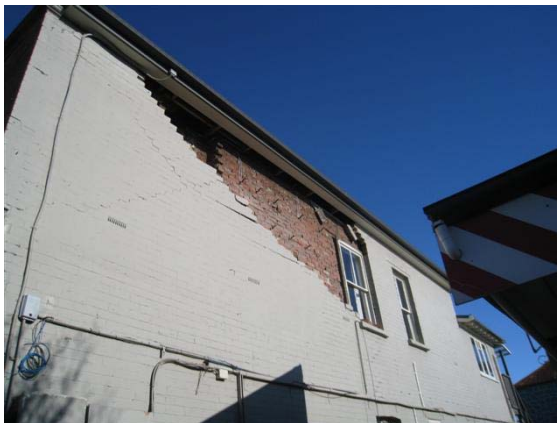
(c) Butterfly wall ties still intact

Figure 3.12(c) and (d) show that cavity ties were present but were insufficient to prevent the outer leaf from failing.

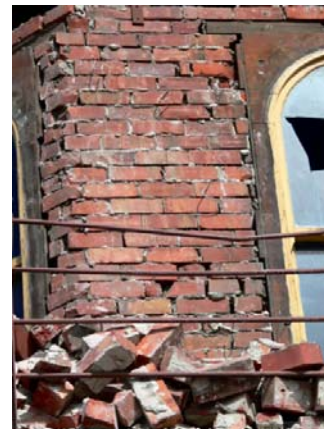
(d) Metal wall ties badly deformed.

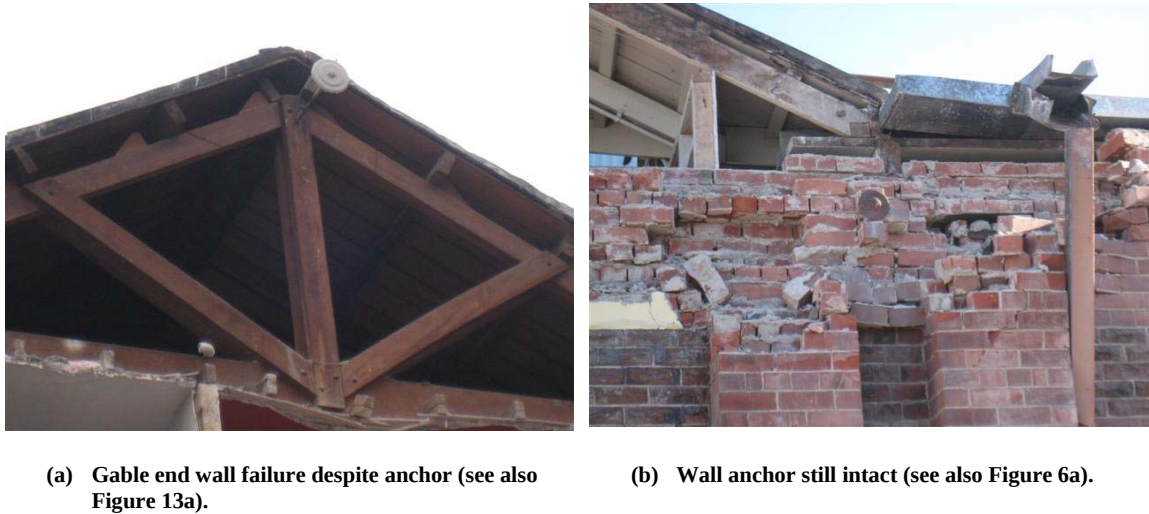
**Figure 3.13 Wall-to-diaphragm anchor details**

In some cases wall-diaphragm anchors remained visible in the diaphragm after the wall had failed, indicating that failure had occurred due to bed joint shear in the masonry (refer Figure 3.13(a)). Figure 3.13(b) shows a situation where a diaphragm anchor had been embedded within the wall. It can be seen that the anchor successfully prevented the restrained wall from failing, but was not able to prevent toppling of the parapet that was located above the anchor.

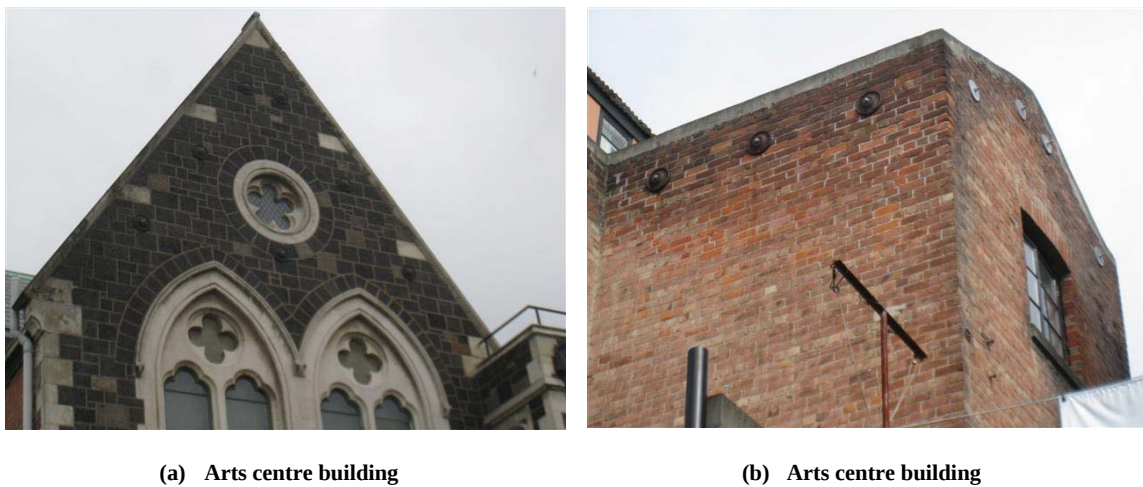
A significant feature of the earthquake was the number of occasions where anchored walls performed well during the earthquake. Photographs showing this are presented in Figure 3.14 and Figure 3.15. A typical wall-to-diaphragm (roof or floor) anchor typically consists of a long 20 mm bolt with a large circular disk of about 150-200 mm diameter between the wall exterior and nut that clamped the disk to the wall. This detail is shown quite clearly in Figure 3.13(a).

**Figure 3.14 Successful gable end wall and side wall anchorages**
