The Performance of Unreinforced Masonry Buildings in the 2010/2011 Canterbury Earthquake Swarm

### 3.1.10 Partial wall failures

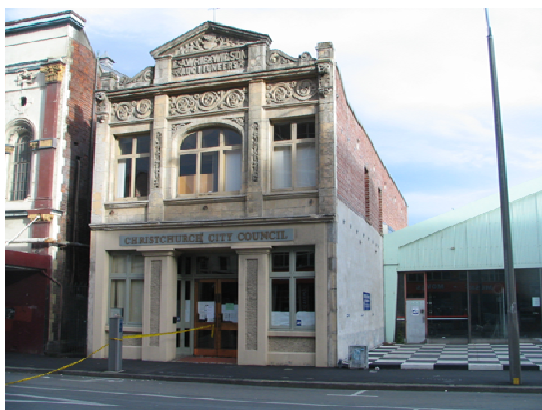
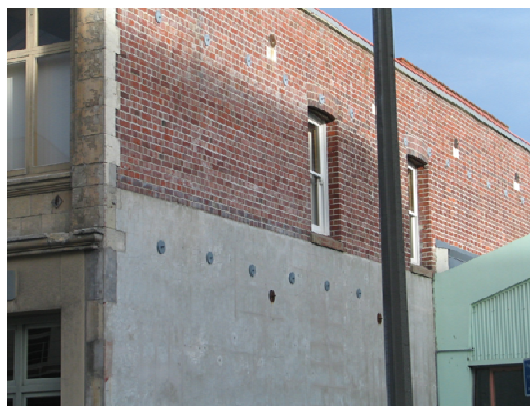
**Figure 3.15 Successful wall-floor and wall-roof diaphragm anchorages**

(a) Front elevation

(b) Side elevation

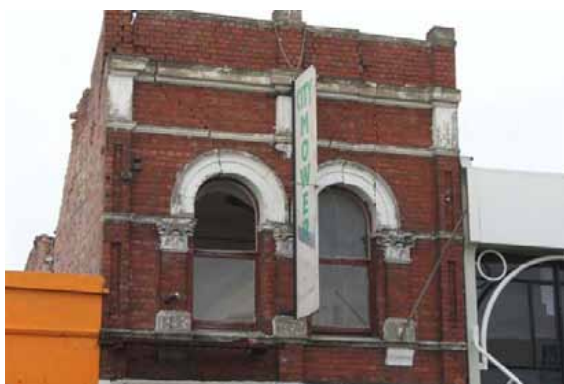
(a) Extensive vertical cracking above window openings

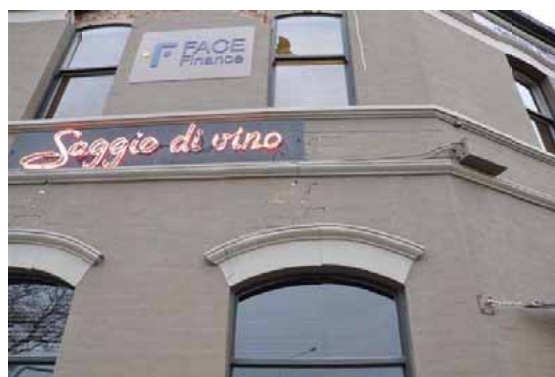
(b) Vertical crack above window opening

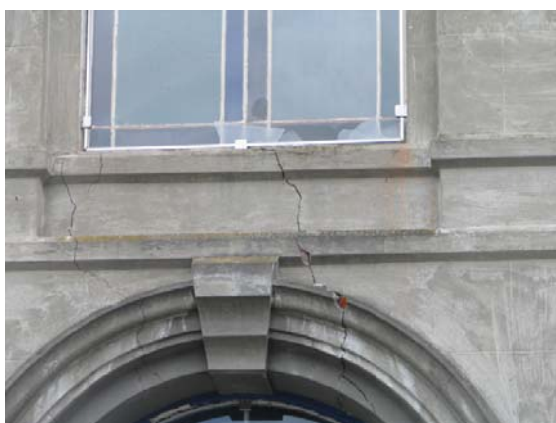
(c) Vertical crack through spandrel

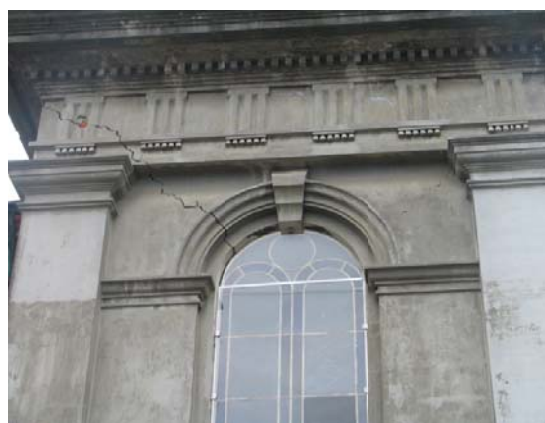
(d) Diagonal crack extending from window opening

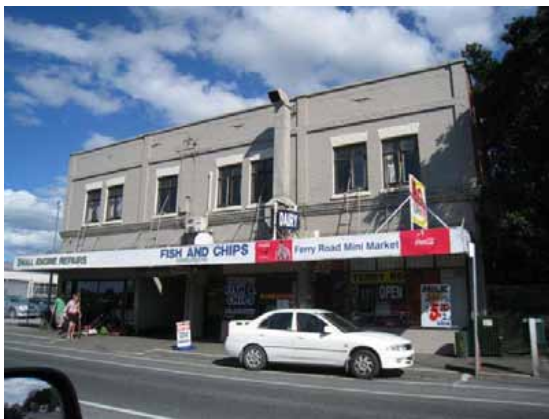
Another interesting feature of this earthquake is the observation of walls that only partly failed, allowing for identification of the specific failure mode at its onset. Several excellent examples are described below. The first of these is a 2-storey URM building on Ferry Road (see Figure 3.17) where the front, street facing, wall of the building had started to fail out-of-plane despite the presence of wall-roof diaphragm anchors. As is shown, the anchors were on the verge of pulling through the masonry wall. Internal inspection of the building revealed that the front wall had separated from the long side walls of the building and moved approximately 50 mm towards the road with respect to the ceiling/roof diaphragm (Figure 3.17(d)). It is believed that due to the nature of strength degradation of the brickwork at the onset of a punching shear failure, the anchorage has effectively failed and offers little residual resistance against further shaking. The only reason the wall did not completely collapse is probably due to the earthquake not imposing sufficient displacement on the wall after the anchorage failure.

(a) Building overview

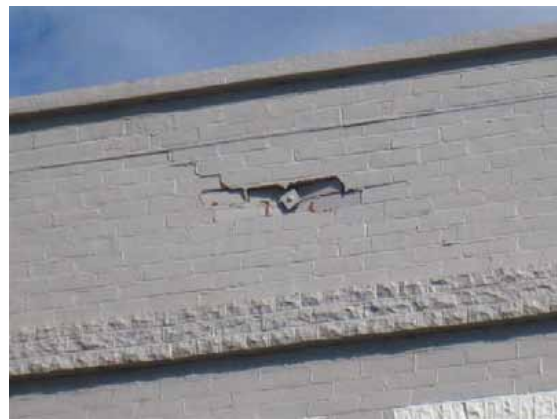
(b) Detail of partial anchorage failure

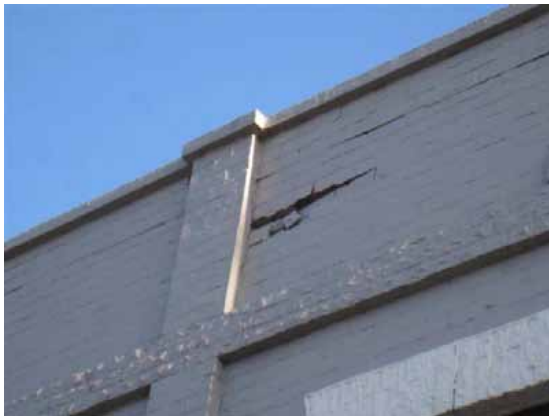
(c) Onset of anchorage failure

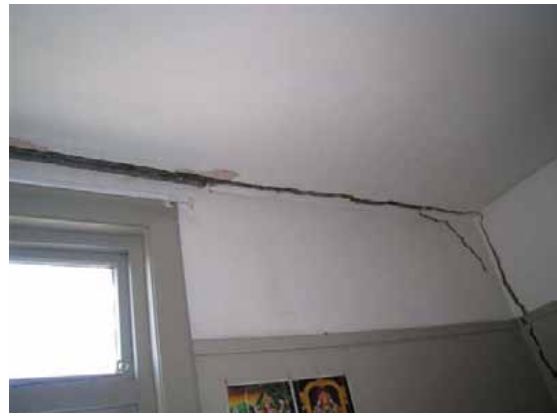
(d) Internal view showing wall separation
