## The Performance of Unreinforced Masonry Buildings in the 2010/2011 Canterbury Earthquake Swarm

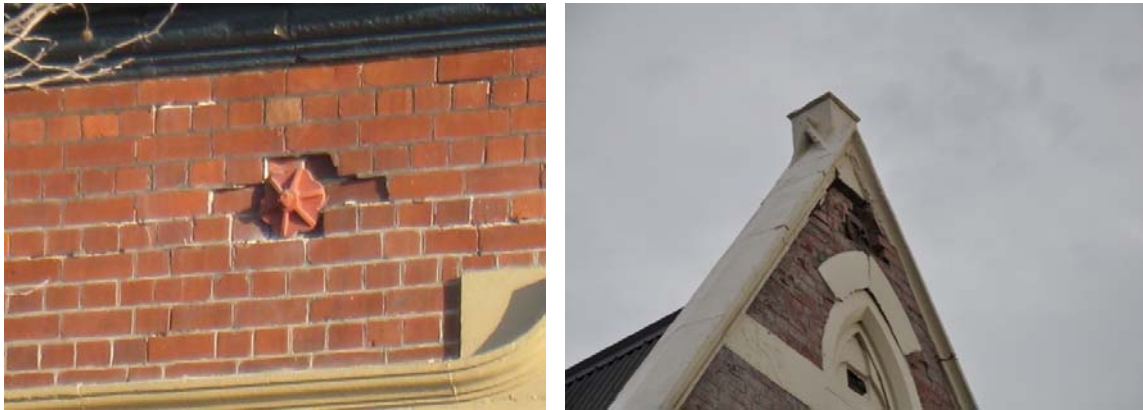
**Figure 3.18 Partial bed joint shear failure surrounding anchorage detail**

noted that the buildings were not in close proximity to each other. An example of a gable end partial failure is shown in Figure 3.18(b), which can be compared to the comparable anchorage detail shown in Figure 3.13(a) that resulted in complete failure.

(a) Wall-roof anchorage failure

(b) Gable end anchorage failure

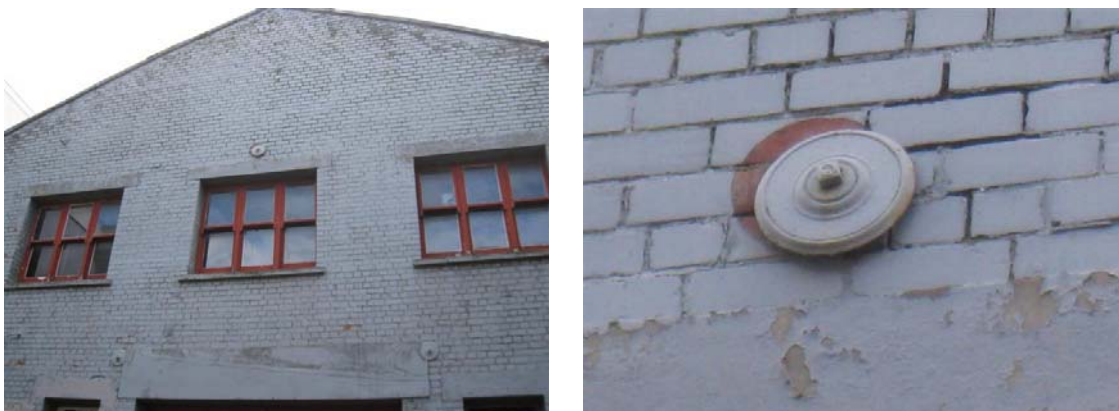
**Figure 3.19 Examples of yielded wall anchors**

There were frequent examples of wall-diaphragm anchors that had deformed plastically. In these photographs (Figure 3.19), the circular plate can be seen to be slack due to plastic stretching of the anchor rod.

(a) Overview of wall anchors

(b) Close-up view of yielded anchor

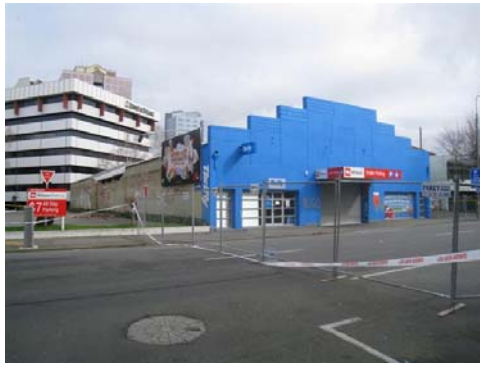
There was one instance where it was clear that diaphragm deformation, relative to the in-plane walls, contributed to partial failure of an out-of-plane wall. Figure 3.20 shows several views of a building which suffered out-of-plane parapet failure along its long, side walls. In Figure 3.20(b) it can be seen that the roof joists have tilted towards the front of the building. This suggested that the front wall of the building was driven forward at its top. Careful inspection of the front wall (Figure 3.20(c)) revealed a substantial outwards curvature which was most pronounced at the top.

(a) Overview of building

**Figure 3.20 Example of diaphragm deformation causing out-of-plane wall failure**

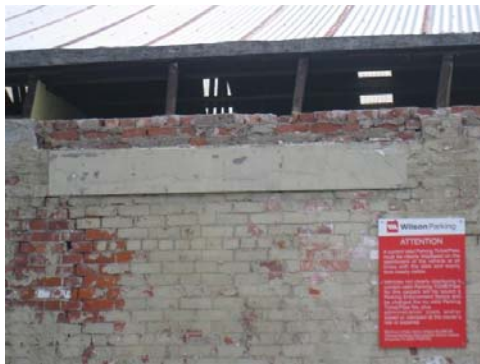
(b) Side-view of tilted joists

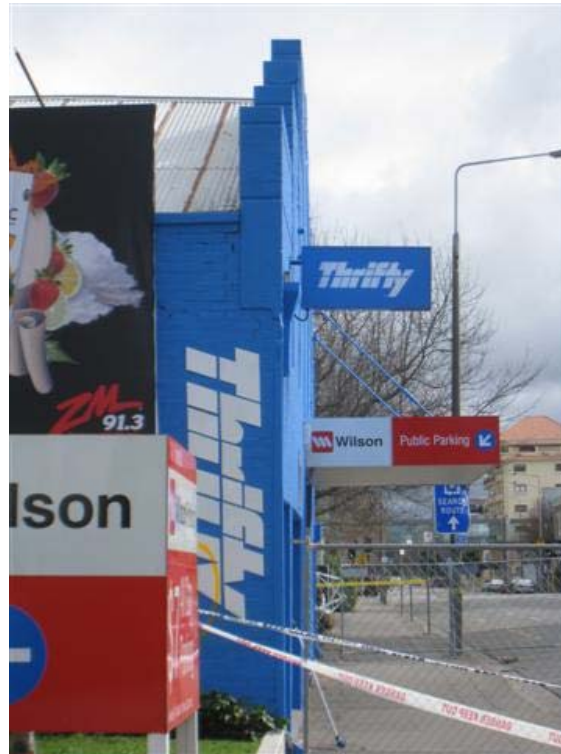
(c) Front wall curvature
