## The Performance of Unreinforced Masonry Buildings in the 2010/2011 Canterbury Earthquake Swarm

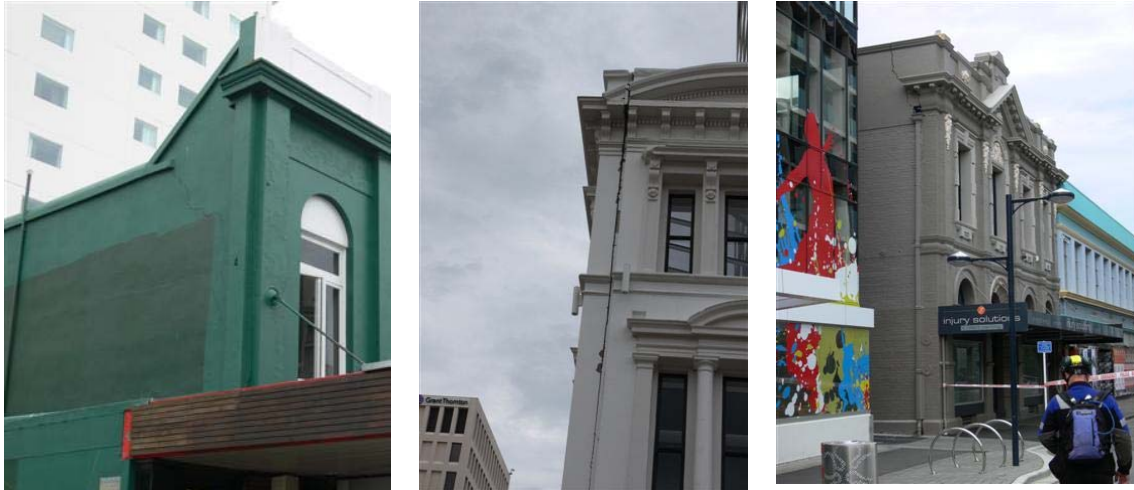
**Figure 3.21 Examples of wall separation at corners of buildings**

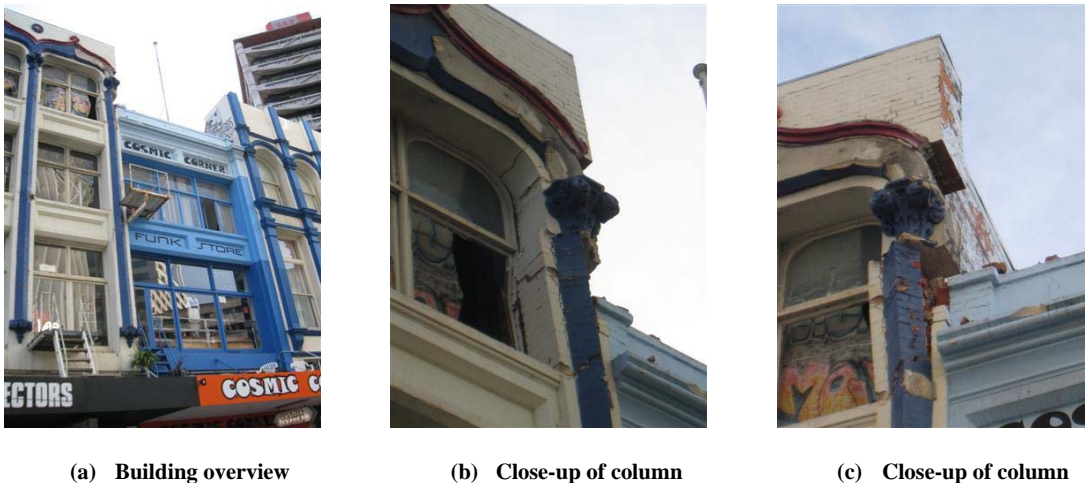
Several instances of damage due to buildings pounding against each other during the earthquake were observed. Figure 3.22 shows how the shorter building in the centre, which has different floor heights than the building to the left, damaged the column of the taller building at its top storey.

**Figure 3.22 Example of building pounding damage**

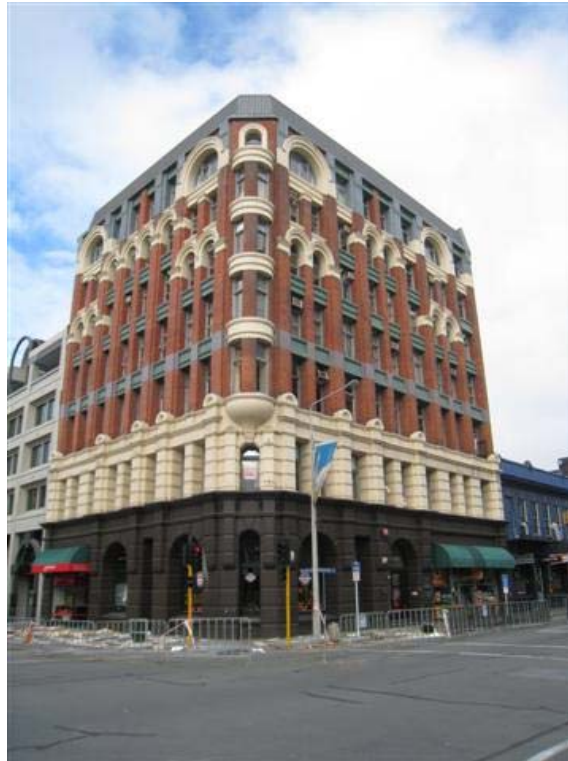
160 Manchester Street was a 7-storey office building that is reported to consist of load bearing masonry and was the most significant masonry building, at least in terms of height, in Christchurch (Figure 3.23). It is a registered heritage building and is a significant part of the fabric of the Christchurch city landscape. Unfortunately, the building suffered significant damage in the earthquake. The bottom two stories are reported to be reinforced concrete while the top five stories are reported to have load

**Figure 3.23 Manchester Courts building (view from NW)**

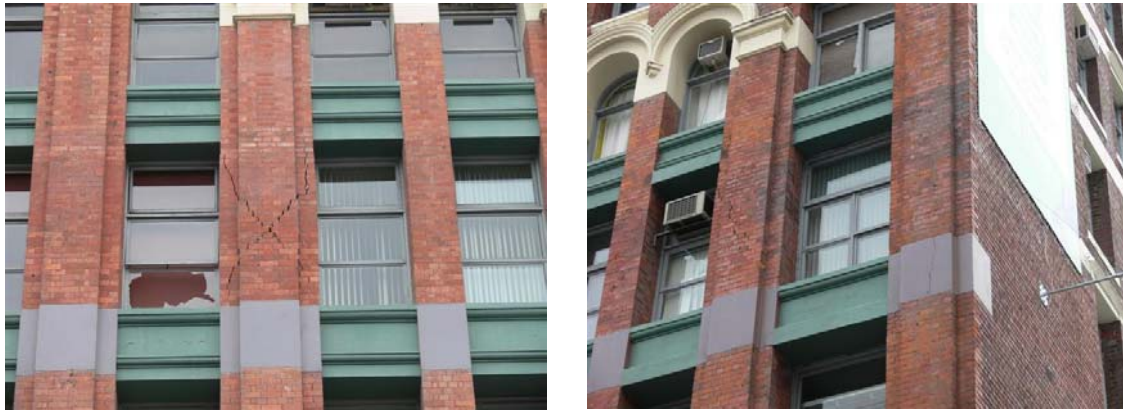
bearing unreinforced masonry piers around the exterior of the building and a steel frame internally (columns spaced roughly at 5 m) with timber floors throughout (New Zealand Historic Places Trust, 2010). The masonry piers, having dimensions of approximately 1200 x 900 mm, were badly cracked at levels 3 and 4 (Figure 3.24). This damage was most likely due to the transition from concrete to masonry at level 3 and the fact that the adjoining 2-storey building located along the southern wall side stopped providing lateral support at that level. It appears that the lift core had received some strengthening previously, as well as the roof, perhaps in the late 1980s as reported by the New Zealand Historic Places Trust (2010). Close up photographs of the masonry piers at levels 3 and 4 show the primary damage that concerned the assessment teams (Figure 3.24). Further inspection by the assessment team exposed the internal face of one pier on the western face of the building to reveal that the external cracking continued through the entire pier thickness.

(a) North wall piers, levels 3-4

(b) West wall piers, levels 4-5

**Figure 3.24 Damage to masonry piers of Manchester Courts building at levels 3-5**

Two days after the main earthquake, structural engineers met with Urban Search and Rescue Team leaders and city officials to determine a strategy for making the structure safe enough for building contractors and engineers to enter to determine more fully the extent of damage and the viability of repair. Four days after the main earthquake, the building had survived one M5.4 and three M5.1 aftershocks. After extensive deliberations the decision was taken to demolish the building.

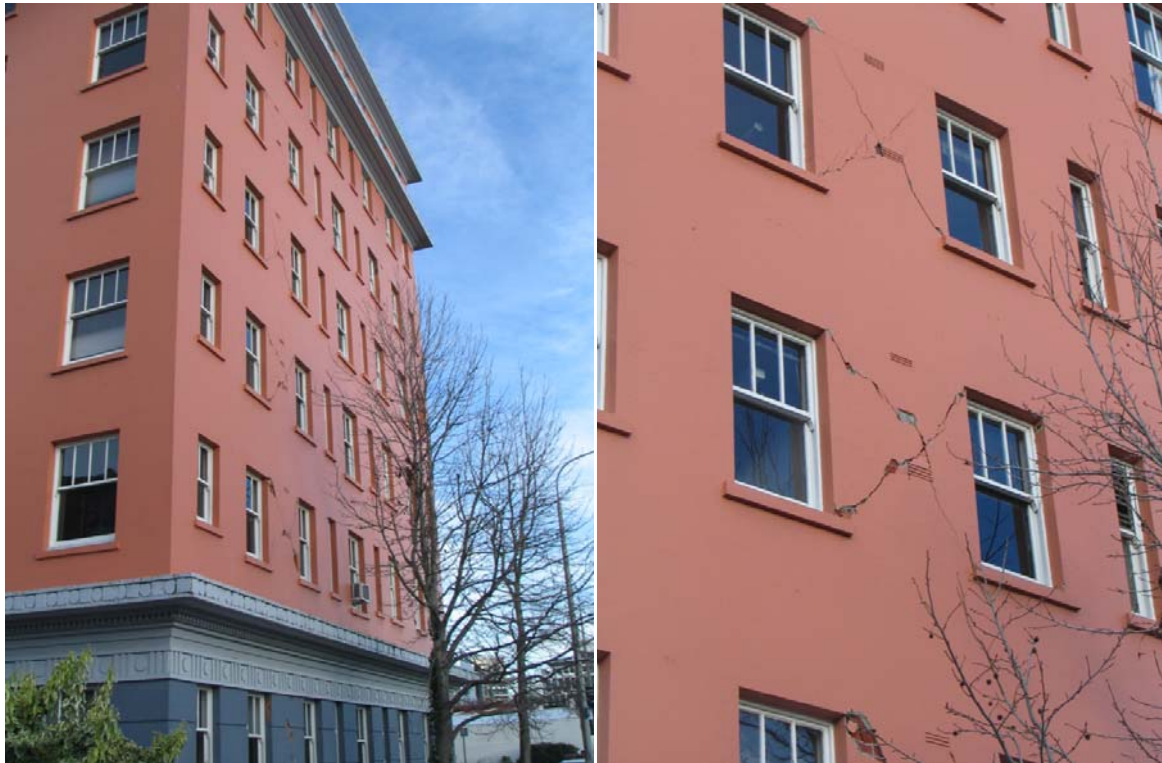
St Elmo Court was also a 7-storey building that was reported to be a reinforced concrete frame building with external clay brick masonry piers. Owing to the absence of control joints between the masonry and concrete frame, it appeared that the masonry piers attracted sufficient seismic in-plane forces to cause shear failure (refer Figure 3.25). However, once the masonry cracked the seismic loads were transferred to the concrete frame. Judging by the extent of cracking in the brickwork, it appeared that the storey drifts developed during the 4 September 2010 earthquake were less than 1%, implying that the concrete frame was not pushed to its maximum capacity (strength or drift). Following the 4 September 2010 earthquake the authors were not able to inspect the building from inside.

(a) Overview of building

(b) Close-up of damage to brickwork

**Figure 3.25 Views of St Elmo Court building, 47 Hereford Street**

The building was demolished after the 22 February 2011 earthquake.

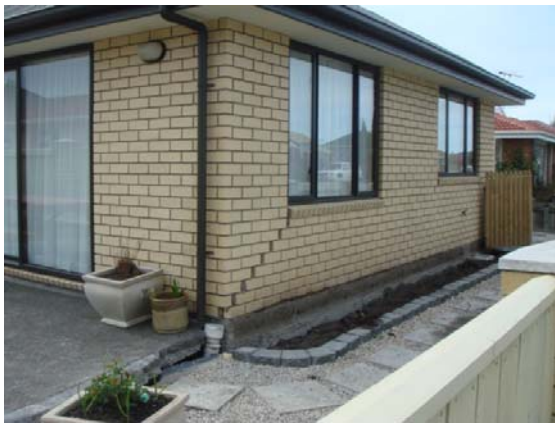
(c) Masonry veneer damage to recently built residence.

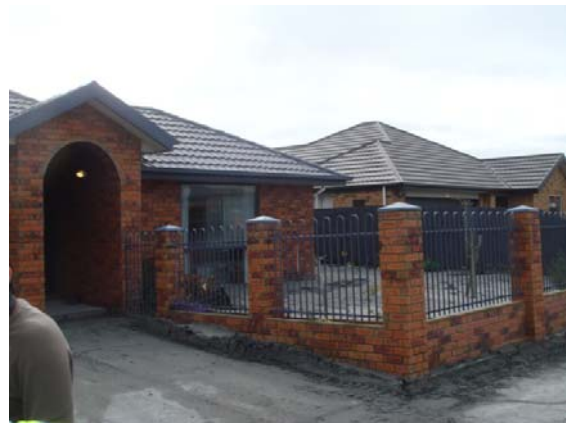
Perhaps the most striking aspect overall of the 2010/2011 Canterbury earthquake swarm was the extensive amount of liquefaction and ground deformation that occurred. These phenomena were not seen to a significant extent in the Christchurch CBD region containing the highest density of URM buildings, but did impact on a number of timber framed structures with masonry veneer. As shown in Figure 3.26, several cases of extreme ground deformation that affected URM buildings were observed outside of the CBD, and there were numerous cases where large crack widths formed in residential timber framed structures having a masonry veneer (Figure 3.26(c)). There were also cases where ground liquefaction had resulted in masonry structures having sunk into the ground (Figure 3.26(d)).

(d) Damage due to liquefaction
