3.2.2 Damage mechanisms in stone masonry buildings and churches

The Performance of Unreinforced Masonry Buildings in the 2010/2011 Canterbury
Earthquake Swarm

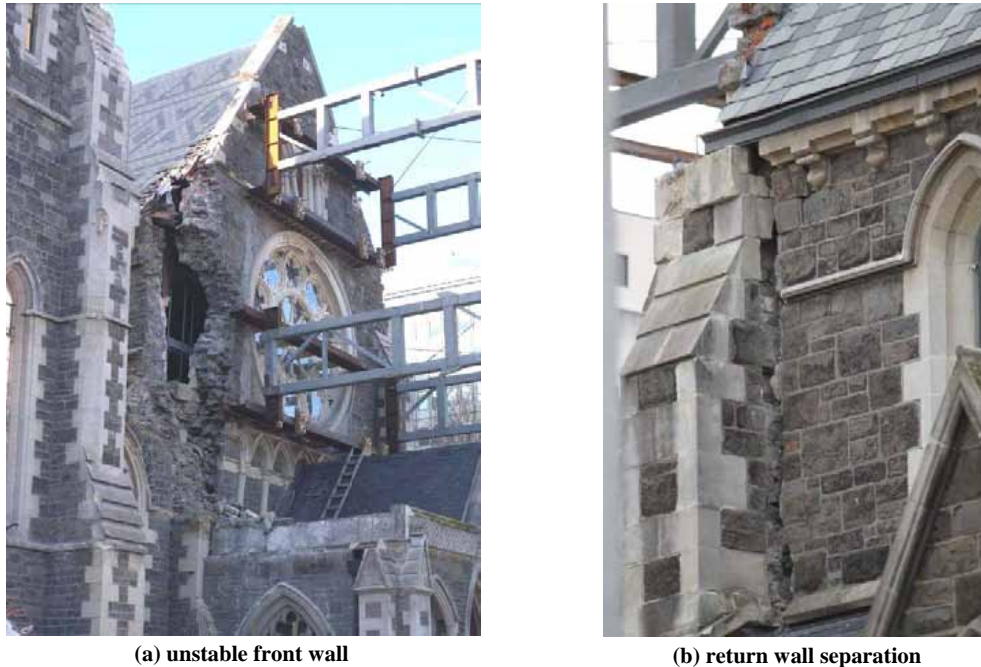
Figure 3.30 Christchurch Anglican Cathedral – front façade damage

Because the predominate direction of the 22 February 2011 earthquake was in the east-west direction, and because the buildings in the CBD are primarily oriented in the same direction, evidence of in-plane wall damage in the east-west running walls (see Figure 3.34 and Figure 3.35) was reported in conjunction with overturning of façades oriented in the orthogonal direction (see Figure 3.30).

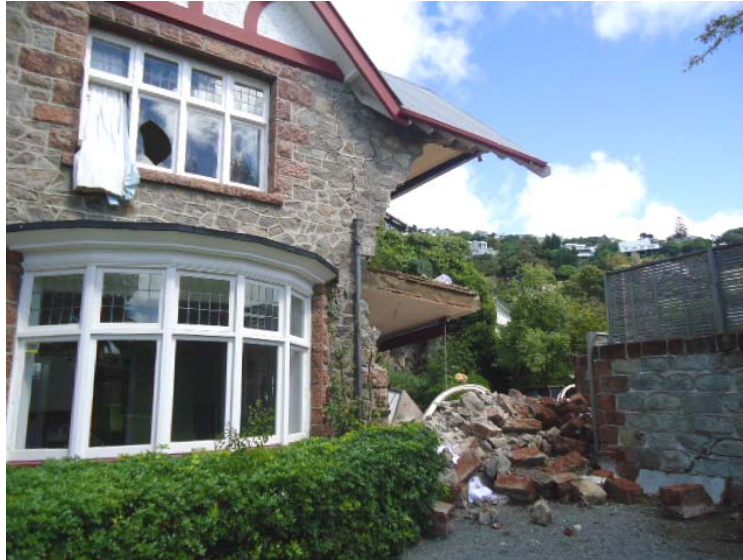
As expected for buildings having architectural features typical of the Gothic Revival style (long span façades, flexible floor diaphragms and weak connections between walls), partial or global overturning or instability of the façades was reported for most of the structures inspected, with damage ranging from moderate to severe and in some cases reaching collapse. Examples are shown in Figure 3.30 to Figure 3.32 relative to the main façade of the Anglican Cathedral (now partially collapsed after the June 2011 earthquake and aftershocks), the Rockvilla dwelling that experienced complete collapse of the north and east façades, and the former Old Boy's High building in which the north façade was propped to avoid collapse due to out-of-plane failure. All of these buildings appeared to have poor connections between the walls at their corners, leading to return wall separation and subsequent out-of-plane failure of entire walls as in the case of the Rockvilla house (Figure 3.31).

Figure 3.31 Rockvilla dwelling with complete collapse of the north and east façades

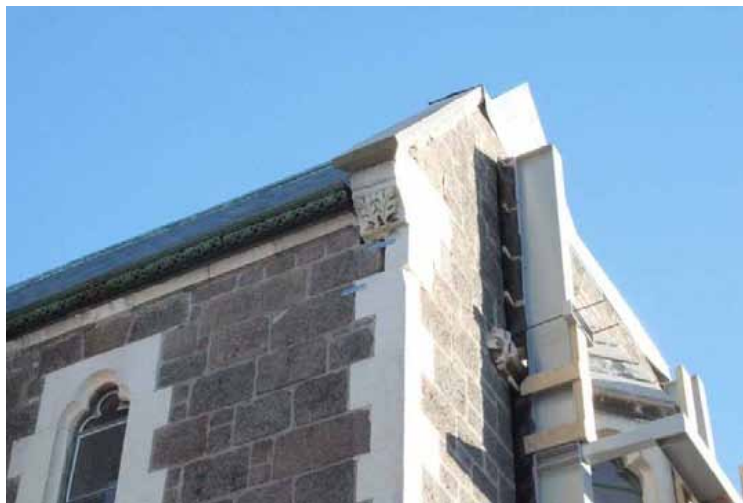
Figure 3.32 Christchurch Arts Centre (former Old Boy's High building), with severe damage due to instability of the façade at the second storey

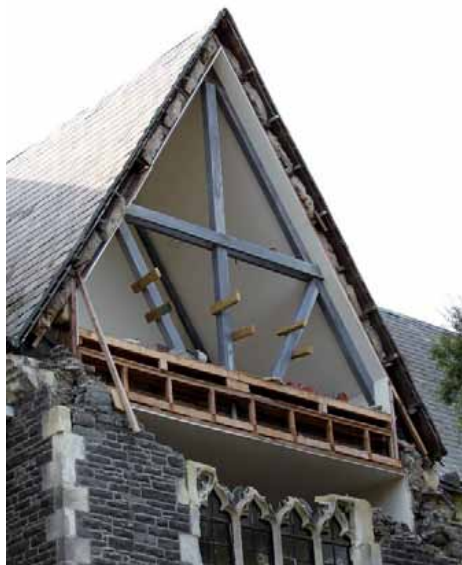
Many of the buildings that were constructed in the Gothic Revival style sustained partial damage to their gable ends, with many cases of complete collapse of the gable. The absence of significant gravity loads and inadequate connection between the gable and roof trusses are primary contributing factors to this failure mode, along with increased accelerations experienced at the top levels of the structure (Figure 3.33).

Figure 3.33 Cramner Court, showing complete collapse of a gable

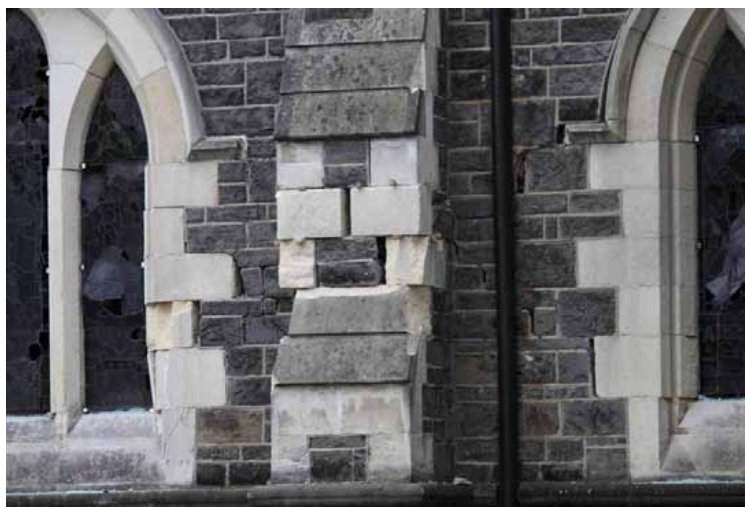
Figure 3.34 Christchurch Anglican Cathedral - diagonal cracks in the south façade piers

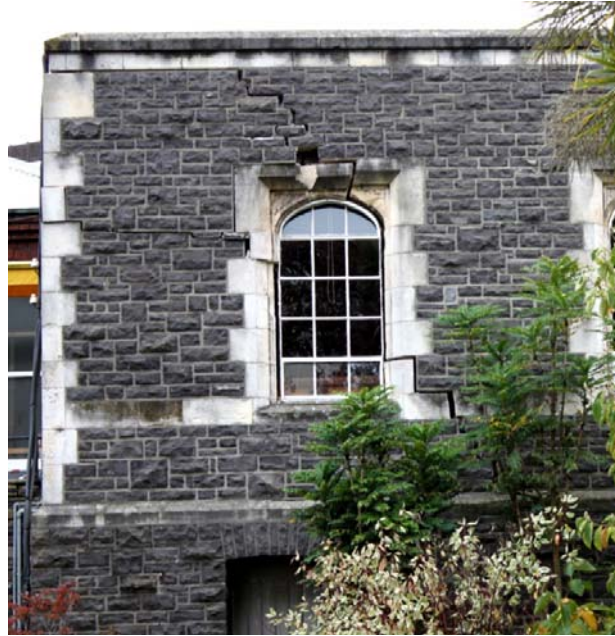
Figure 3.35 Canterbury Provincial Chambers - diagonal crack through entire south façade of the east annex

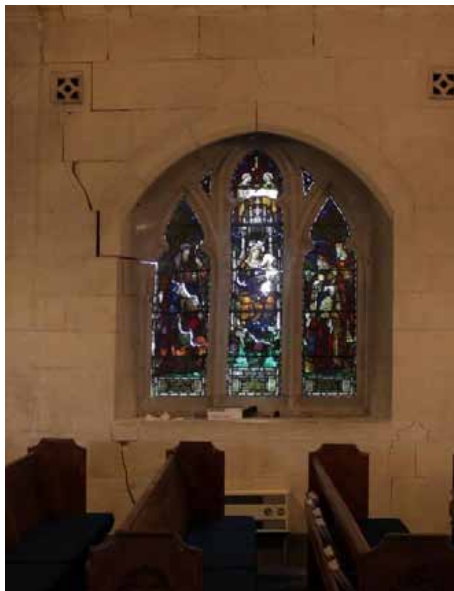
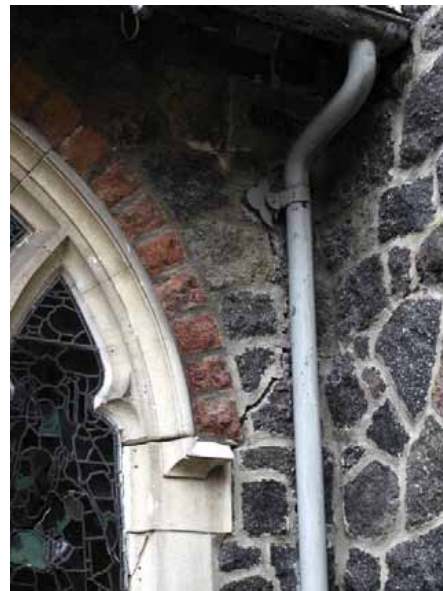
Damage that was attributable to plan irregularity was frequently observed, particularly for stone churches, due to interaction between adjacent structural elements at the intersections between walls. In most churches where the bell tower or low annexes are connected to the nave, damage developed at the intersection of the different structures (see Figure 3.36 and Figure 3.37).

Figure 3.36 St. Barnabas' Church, showing interaction between the nave and the bell tower

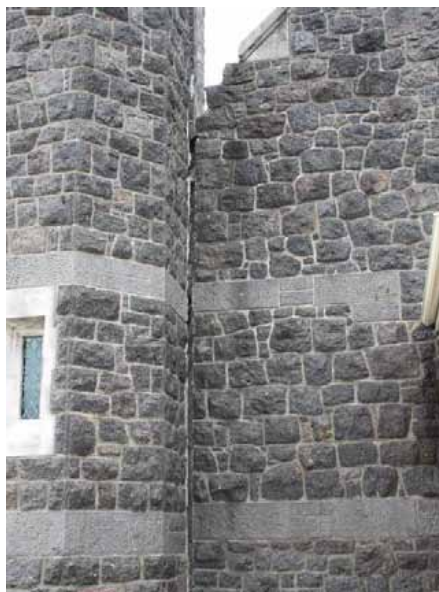
Figure 3.37 St. Mary's Anglican Church - detachment of the bell tower from the nave

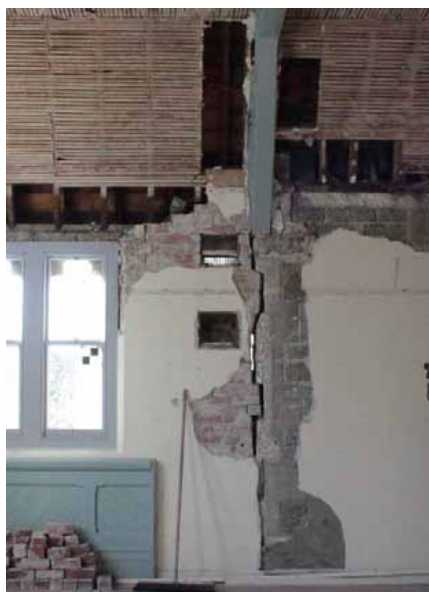
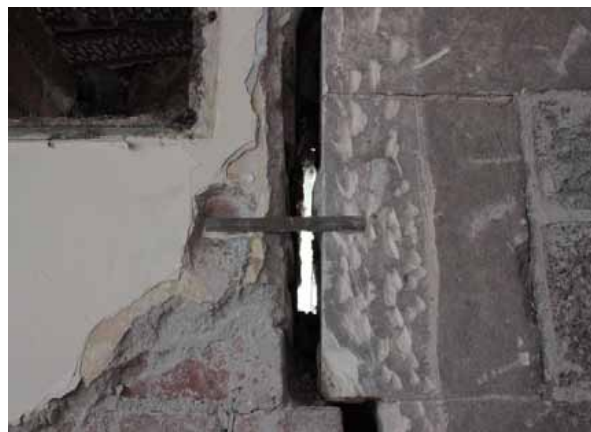
Another distinct example of damage due to plan irregularity in association with differential foundation settlement was observed at the former Old Boy's High building. Figure 3.38 shows the vertical crack that formed at the intersection between two buildings constructed in successive phases, attributable to the lack of connectivity between the structural walls and their separate foundations.

Figure 3.38 Interior views of Old Boy's High (part of the Arts Centre Complex, 2 Worcester St), showing interaction between adjacent buildings

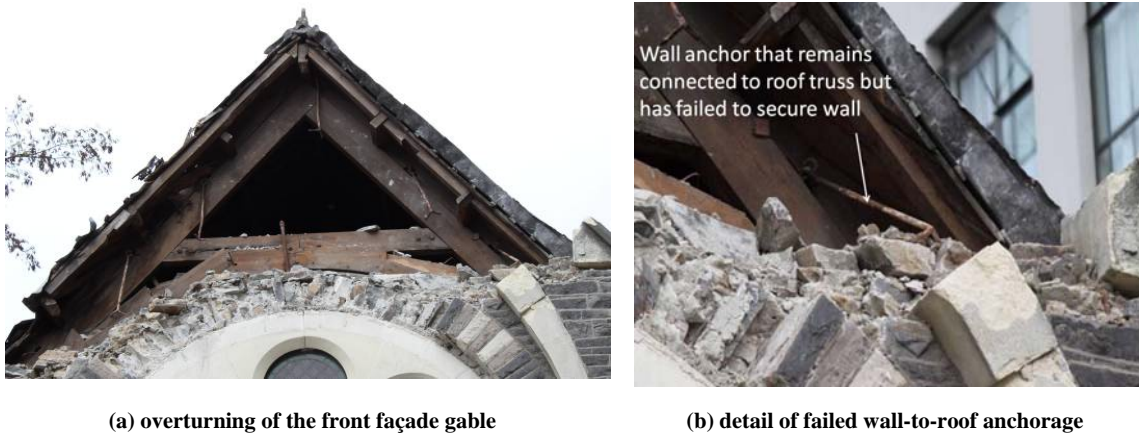
The influence of both inadequate and adequate securing of walls and diaphragms using wall-diaphragm anchors was observed. In some cases anchors were either absent or were spaced too far apart to prevent bed joint shear failure of the masonry at the location of the anchorage. In those cases where anchoring had been seismically designed, or sufficiently closely spaced to resist lateral loads, the overturning of gables and other portions of walls was prevented.

Figure 3.39 Former Trinity Church, showing details of gable ended out-of-plane wall failure

Two cases are presented to show the different behaviour induced by the presence and effectiveness of anchoring. Figure 3.39(a) shows the damage resulting from overturning of the gable of the main façade of the former Trinity Church in the Christchurch CBD while the detail in Figure 3.39(b) illustrates how the anchoring was insufficient in size and spacing to secure the wall in place. Figure 3.40 shows some examples of successful wall-to-roof anchoring in the Arts Centre building.

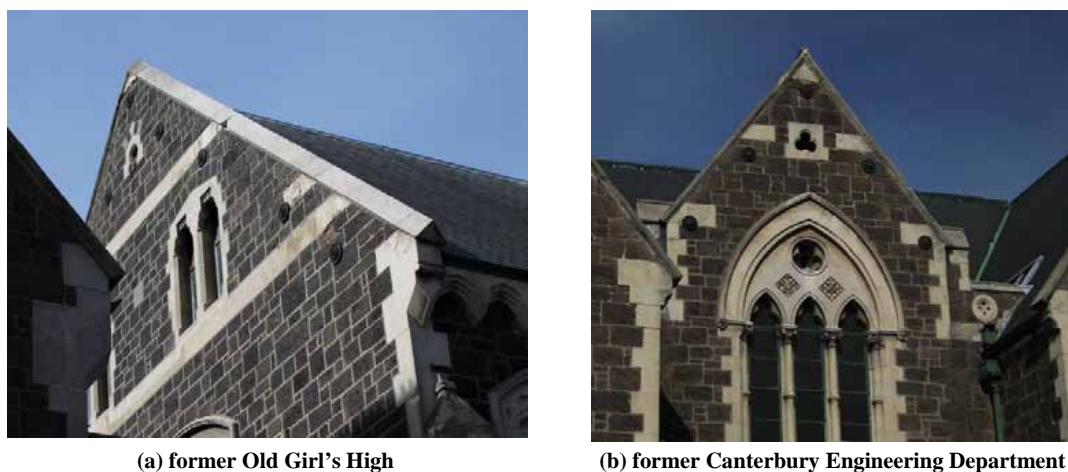
Figure 3.40 The Christchurch Arts Centre, showing successful use of wall-diaphragm anchorages

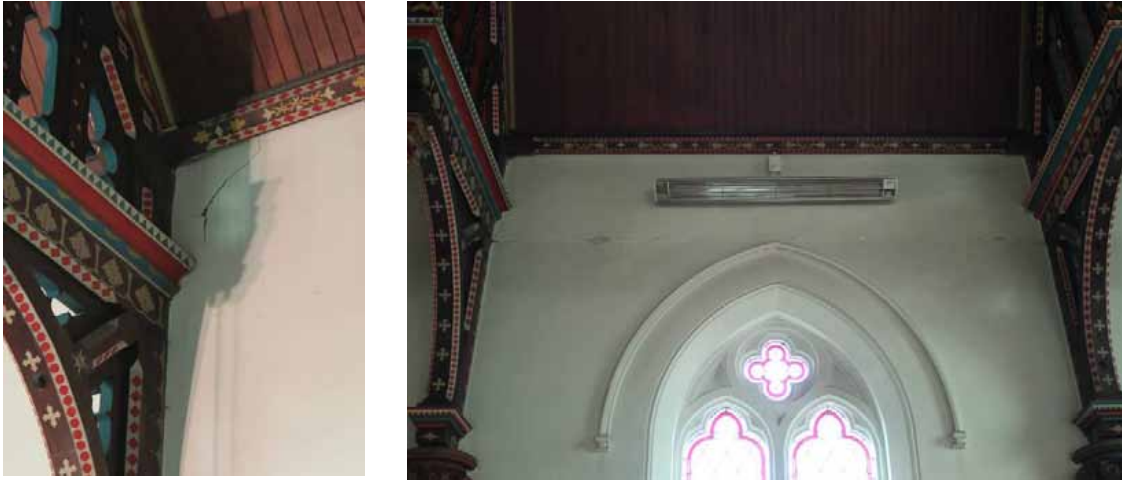
In the case of churches, hammering of roof trusses was reported as for the case of St. James' Church shown in Figure 3.41.

Figure 3.41 St James' Church, hammering of roofing elements on the walls of the nave

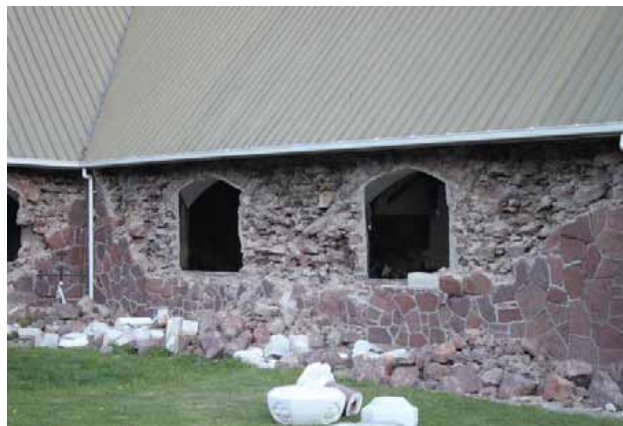
The quality of construction materials played a key role in the response of stone URM buildings. As previously described, one of the typical features of stone URM buildings in Christchurch is the different types of stone and mortar quality present in structures built with three-leaf walls. The use of soft limestone, such as Oamaru stone or the red tuff extracted in the Banks Peninsula, in conjunction with the use of low strength lime mortar, often lead to poor earthquake response. Examples of such behaviour include the Holy Trinity Church in Lyttelton, one of the oldest constructions in Canterbury, and St. John's the Baptist and the Time Ball station, as represented in Figure 3.42 to Figure 3.44.

Figure 3.42 Lyttelton Holy Trinity Church. Damage induced by hammering of the roof

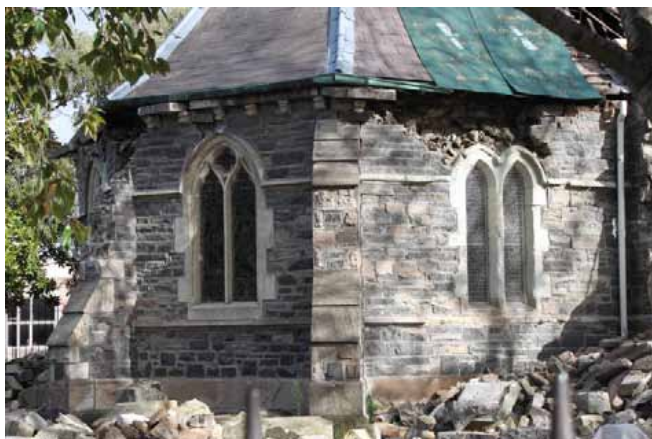
Figure 3.43 St. John's the Baptist Church. Local collapse of material

It has been reported that after the 13th June 2011 earthquakes, the remaining of these two buildings, and several others in Lyttelton that were in a similar state of damage, completely collapsed.

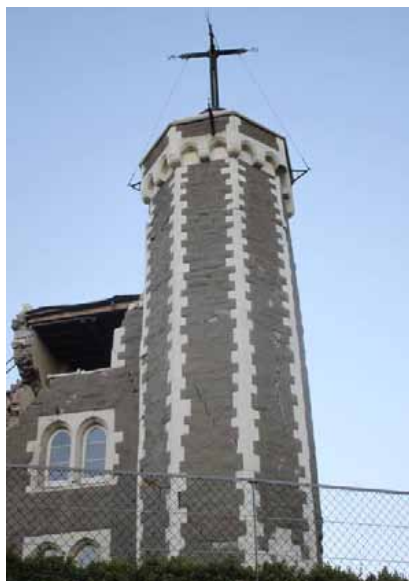
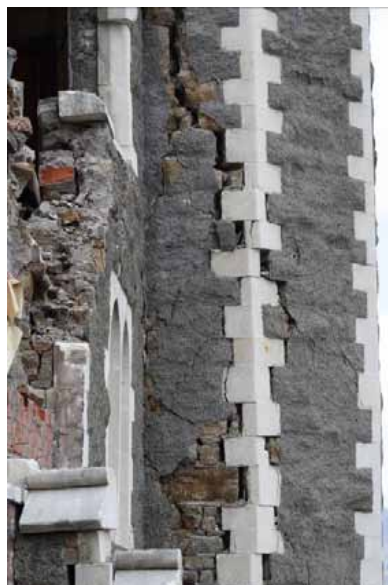
Figure 3.44 Time Ball Station. Damage in the Time Ball tower
