Section 5:

Set of representative buildings

The Performance of Unreinforced Masonry Buildings in the 2010/2011 Canterbury Earthquake Swarm

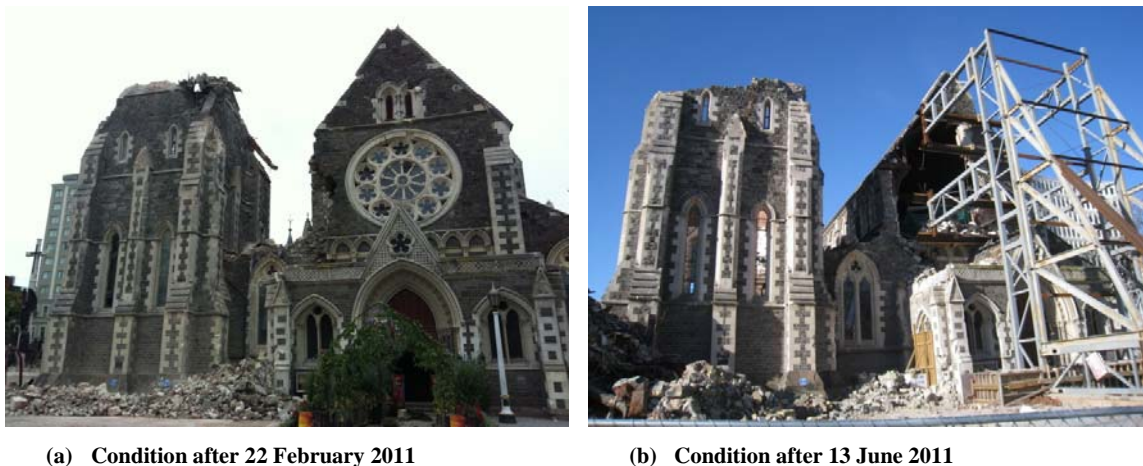
Christchurch Cathedral occupies a position of prominence at the centre of the Christchurch Square which is in the centre of the CBD. For many people the damage to the Cathedral has been a defining image of the events in Christchurch since 4 September 2010. The Cathedral's masonry construction is complex, with dressed outer stone and a clay brick interior. Anchor plates that were installed in the gable end wall above the rose window (see Figure 5.1(a)) helped to secure the wall during the 22 February 2011 earthquake, presumably enabling those within the Cathedral at the time to safely exit through the front door. Unfortunately the rose window sustained damage on 13 June 2011. The building is recommended for attention largely for its historic significance, but also because it is currently anticipated that the Cathedral will be rebuilt. Structural improvements to the Cathedral prior to 4 September 2010 appear to have been effective, but clearly have not prevented substantial damage to the building. See Figure 3.30 and Figure 3.34 for further images of the Cathedral.

Figure 5.1 Damage to Christchurch Cathedral

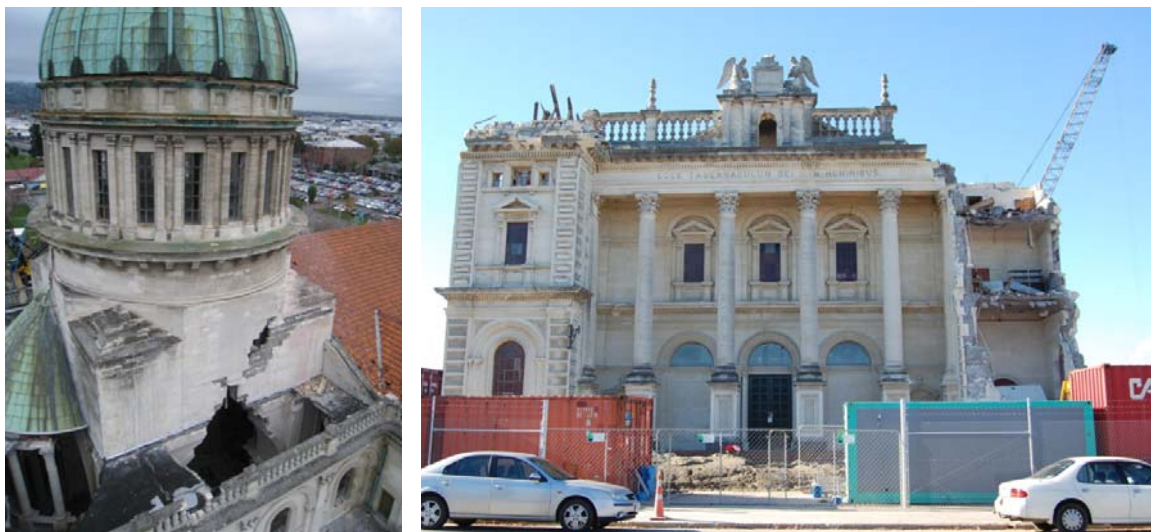
The Basilica is a complex structure exhibiting characteristics of both unreinforced masonry and early concrete construction (see Figure 3.27(b)). The primary reason for identifying this building for attention is because of its distinctive architectural character as it is not particularly representative of a larger stock of buildings in New Zealand. Currently the principal concern regarding the stability of the Basilica is to deconstruct the dome because of the falling hazard posed by the damaged drum at the dome base (see Figure 5.2(a)). Damage to the Basilica's clock towers (see Figure 5.2(b)) suggests parallels with the collapse to the spire of the Christchurch Cathedral as shown in Figure 5.1.

(a) Damage to drum at base of dome

(b) Damage to clock towers

Figure 5.2 Damage to the Christchurch Basilica (images taken post-February 2011)

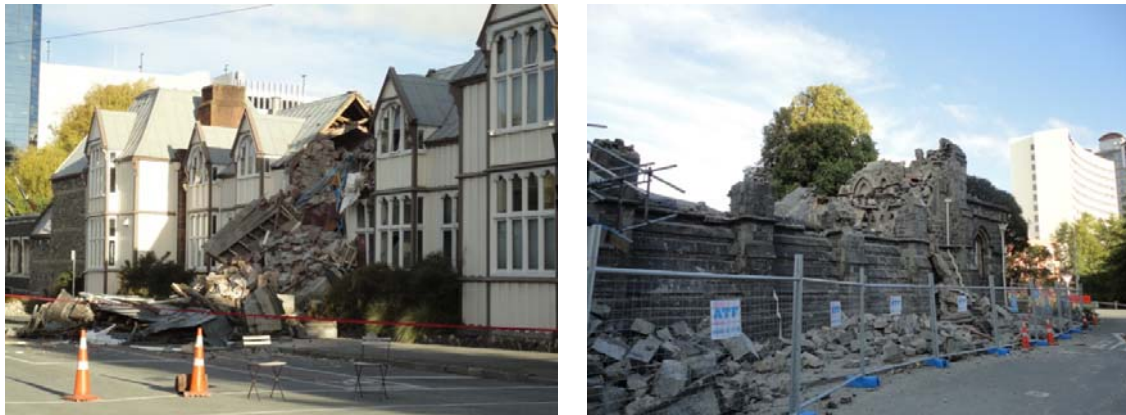
This set of buildings is recommended for further attention both because of the historic significance of the buildings and because the failure mode observed for the stone masonry construction (see Figure 5.3) is representative of failures observed in other stone masonry buildings, and in particular several stone masonry churches. See also Figure 3.35.

(a) Stone masonry collapse

(b) Collapse of the Stone Chamber

Figure 5.3 Earthquake damage to the Canterbury Provincial Council Building (images taken post-February 2011)

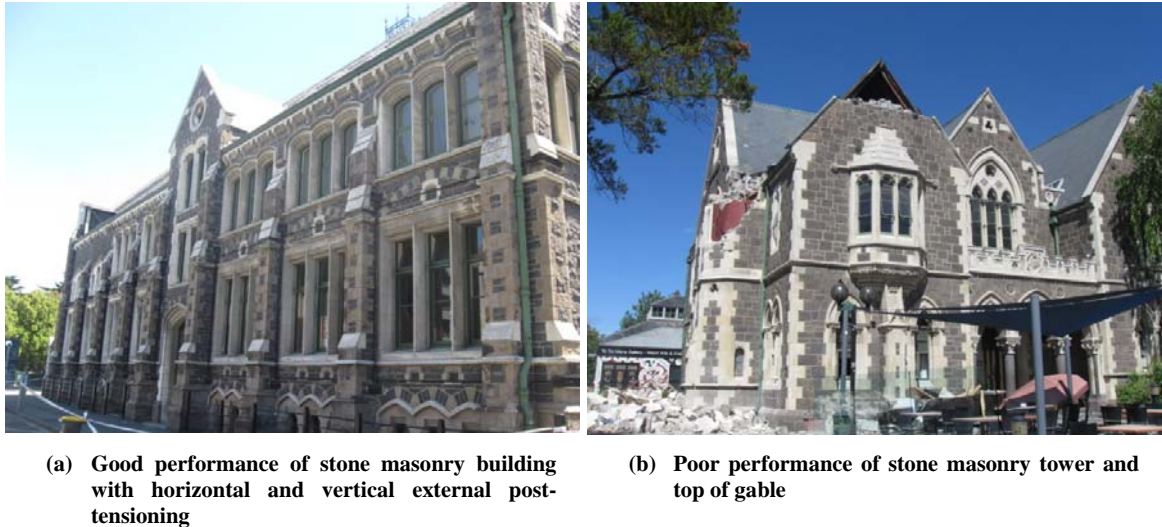
The Christchurch Arts Centre complex is composed of stone masonry buildings that merit investigation because of the number of seismic retrofit technologies that have been previously installed within the complex. Three technologies in particular merit attention, being the innovative use of horizontal and vertical unbonded post-tensioning that appears from the exterior to have been highly successful in preventing damage (see Figure 5.4(a)), the use of wall-diaphragm anchor plates that in most cases have

effectively restrained the major part of gable end walls although some damage at the top of gables has occurred (see Figure 5.4(b)), and the use of surface bonded fibre reinforced polymers to the interior of the building. Documenting the successful performance (or otherwise) of these technologies will be useful when considering appropriate seismic improvement techniques for other iconic stone masonry buildings. See also Figure 3.32, Figure 3.38 and Figure 3.40.

Figure 5.4 Mixed performance of the Christchurch Arts Centre (images taken post-February 2011)

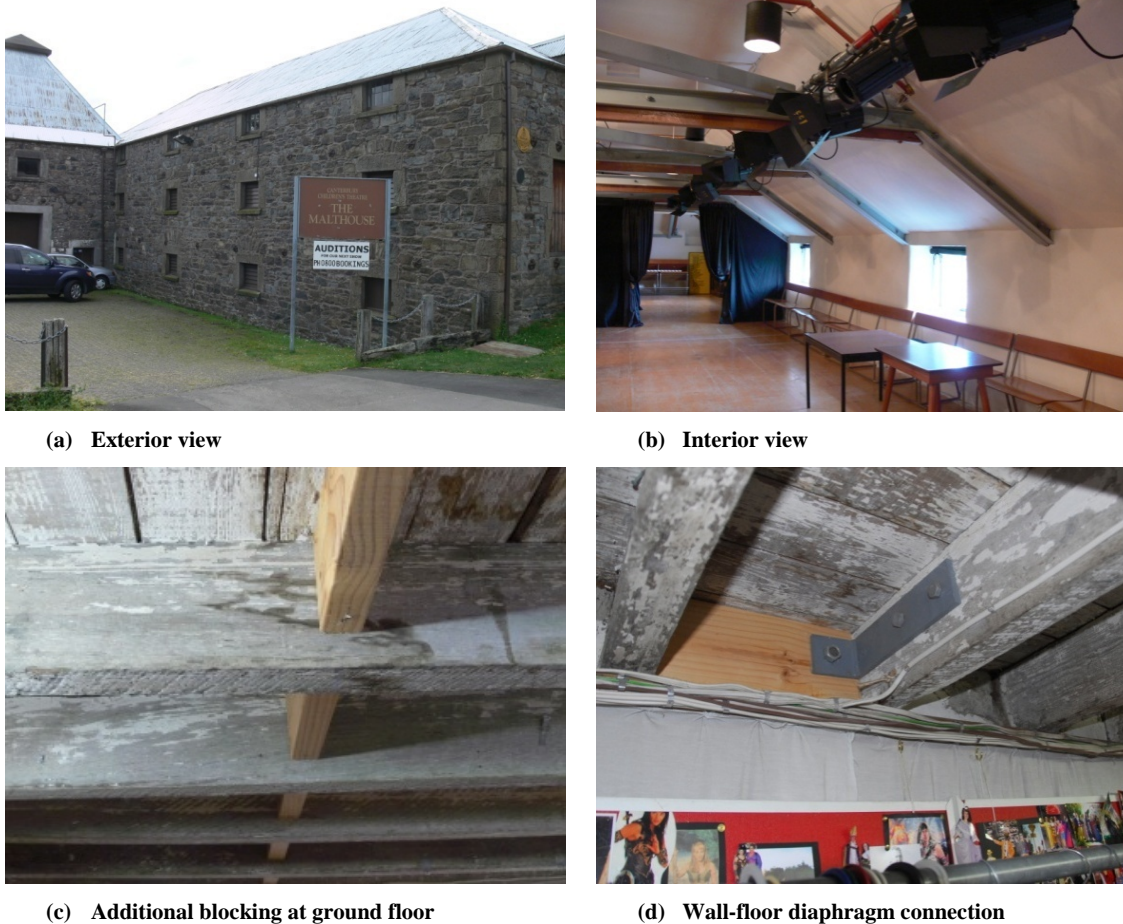
Figure 5.5 Former City Malthouse (images taken post-September 2010)

The Malthouse is a stone masonry building that was constructed in 1867-1872 (see Figure 5.5). The Malthouse is one of New Zealand's oldest buildings¹³ has three levels, with a half basement, timber floor and roof diaphragms and an irregular floor plan. The building was used as a Malthouse until 1955, when it was converted to the Canterbury Children's Theatre. Between 1972 and 1984 the Malthouse went through several architectural renovations that included seismic retrofit. The roof was raised in two stages: the first stage involved raising half of the roof in 1992 and the second stage involving raising the remainder of the roof in 2003. Seismic retrofit of the Malthouse in 2003 was found to be insufficient and consequently the building's lateral load resisting system was again updated in 2008. The seismic retrofit involved injecting grout into the rubble masonry walls, strengthening the roof by introducing new steel trusses (see Figure 5.5(b)), strengthening of the floor diaphragms by replacing the plywood and introducing additional timber blocking (see Figure 5.5(c)), and installing new wall-diaphragm anchors. It was established from discussions with the manager that the cost of retrofit was approximately \$NZ 750,000. The building appears to have performed well.

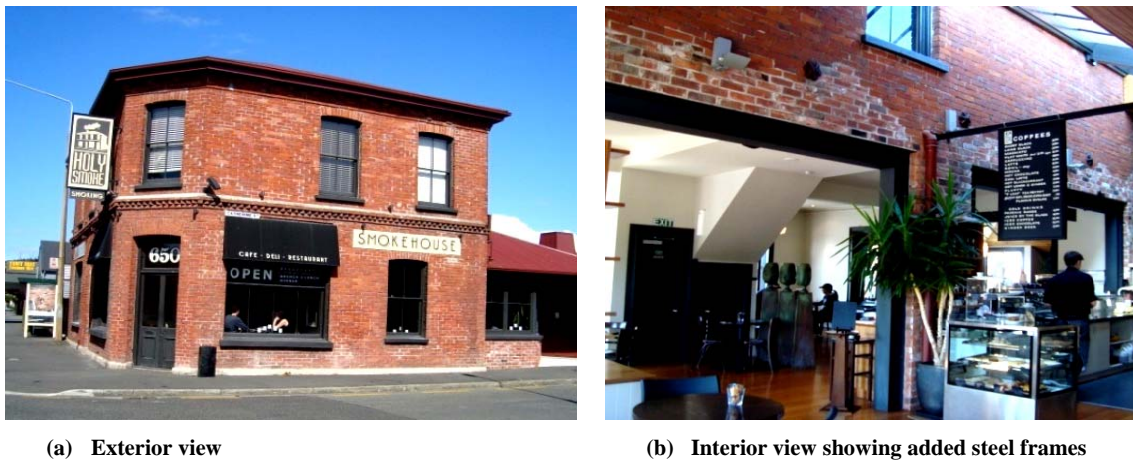
Figure 5.6 The Smokehouse, 650 Ferry Road (images taken post-September 2010)

The Smokehouse was seismically retrofitted in 2007 by introducing secondary moment resisting steel frames. This retrofit also included alterations to the internal layout, which involved partial removal of original external walls and replacement with moment resisting steel frames that created openings into the adjoining new section of the building (see Figure 5.6(b)), and also infilling one window at the second floor level. The retrofit design of the building won the New Zealand Architectural Award in 2008 for initiative in retention, restoration and extension of a significant building and its adaption to new uses¹⁴. The building appears to have performed well, with no significant signs of earthquake damage observed.

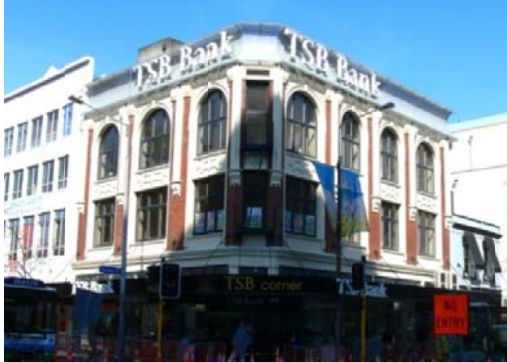
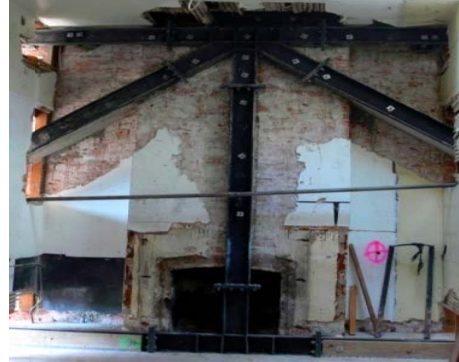
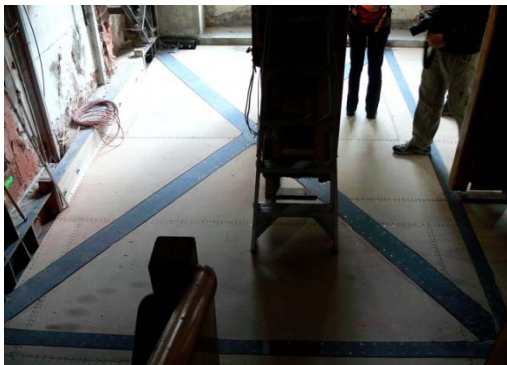
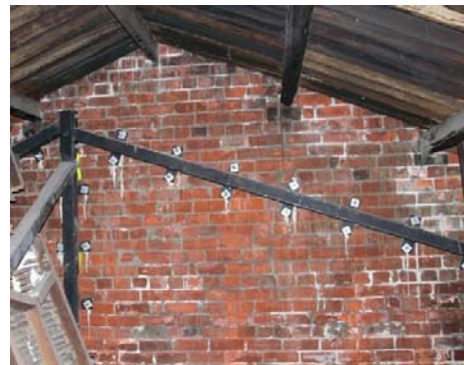
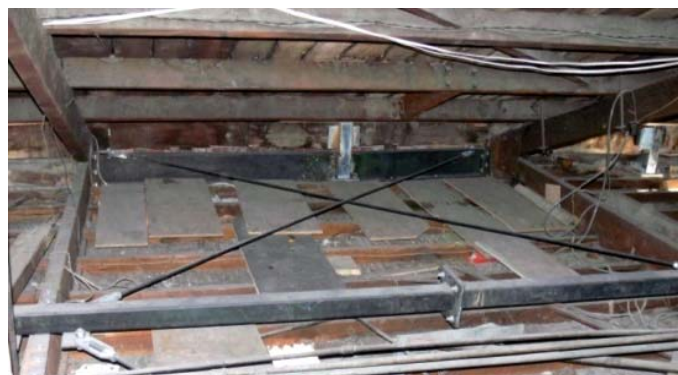
Figure 5.7 130 Hereford Street (images taken post-September 2010)

5.7(a). The estimated footprint area of the building was approximately 450 m². The ground floor has been re-furbished and is occupied by the TSB Bank, whereas the upper levels required refurbishment at the time of the 4 September 2010 earthquake and therefore the retrofit structure was exposed at the time of inspection. A weak lime mortar (scratched with a finger nail) was used in construction. The bricks used were bright red burnt clay bricks, laid in a common bond pattern. The building has flexible timber diaphragms that consist of plywood sheathing resting over timber joists that are supported on the load bearing URM walls.

The building was seismically retrofitted by the new owner (TSB Bank) in 2009, which involved the introduction of secondary frames. The facade is strengthened by concrete columns and beams at the floor levels (forming a concrete frame) and the side walls are strengthened using steel frames with diagonal braces that are anchored into the masonry as shown in Figure 5.8 and Figure 5.7(b). The floor diaphragms on levels 2 and 3 were stiffened with plywood sheets and 'X' pattern steel plates, with screw fixings spaced at approximately 20 mm to connect the plates to the timber diaphragm as shown in Figure 5.7(c). Figure 5.7(d) shows strengthening of the gable, consisting of steel frames secured with adhesive anchor bolts, and Figure 5.7(e) shows the roof diaphragm strengthening using steel tie rods. The walls are supported by newly added concrete beams at the basement level, further resting over old concrete basement walls.

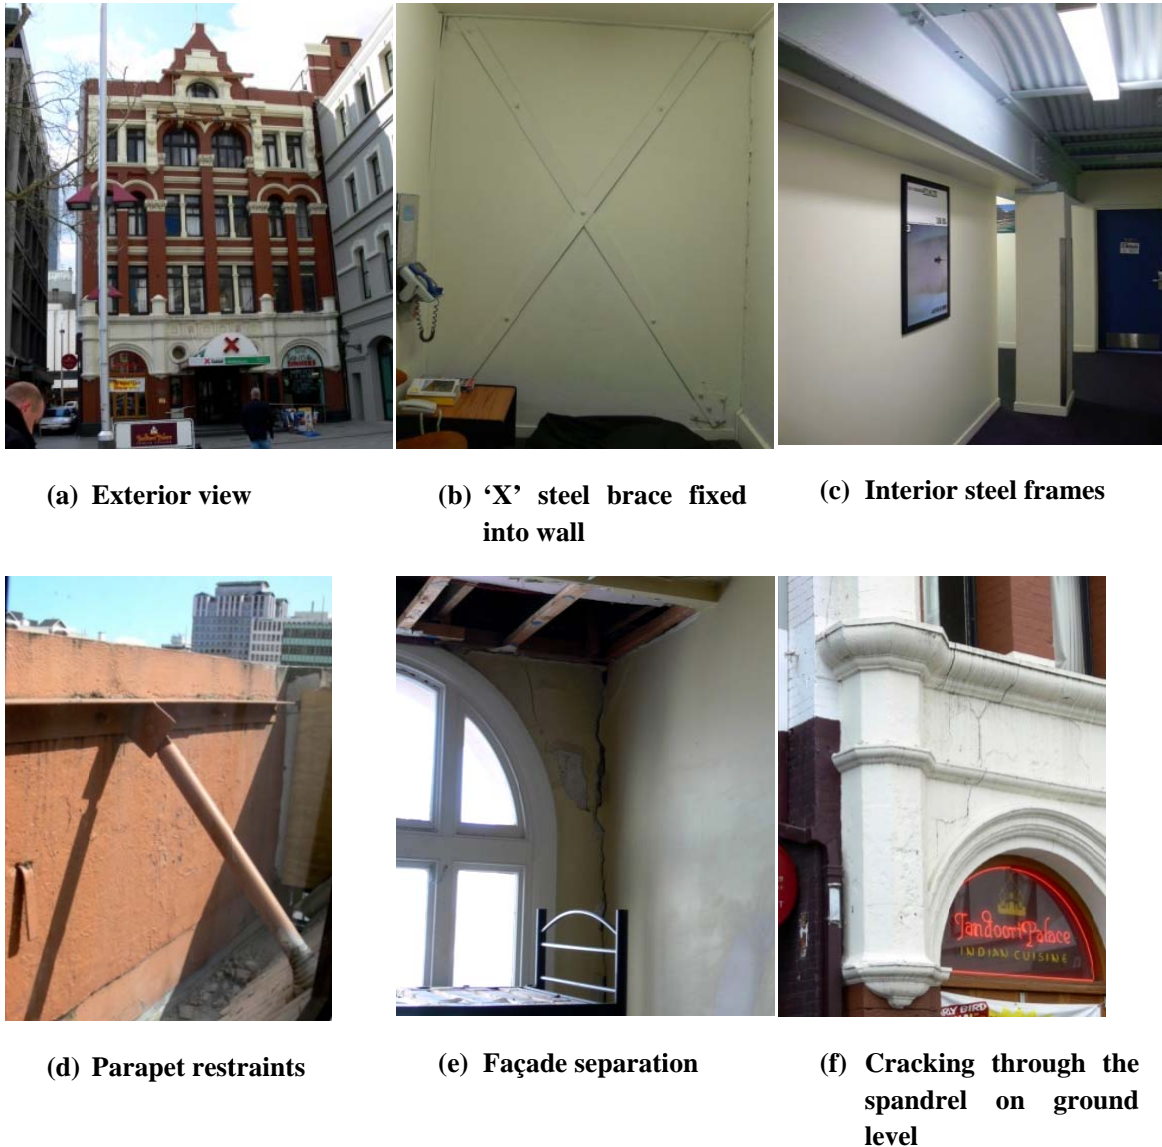
Figure 5.9 X Base Backpackers, 56 Cathedral Square (images taken post-September 2010)

The X Base Backpackers building was seismically retrofitted in 2001 using steel moment resisting frames. The moment frames, as seen from the fourth floor of the building, are shown in Figure 5.9(c). As part of the seismic retrofit scheme, the parapets were tied back to the roof structure using hollow steel circular sections (see Figure 5.9(d)). In a recent inspection of the building, steel straps anchored to the side walls in an X pattern were also observed (shown in Figure 5.9(b)) and were possibly part of an earlier retrofit scheme.

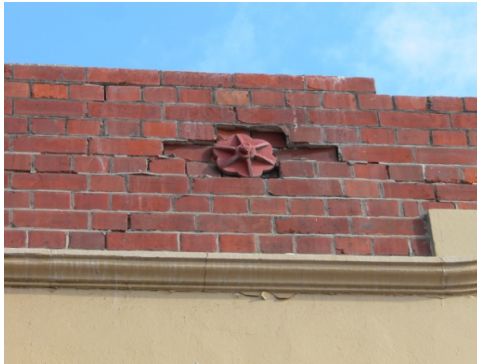
(a) wall-diaphragm anchor punching

During the 4 September 2010 earthquake the parapets collapsed out-of-plane and the wall-diaphragm anchors pulled out from the wall, with the anchors punching through the brickwork and creating localized wall damage (refer to Figure 5.10(a)). The building was cordoned off as falling hazards had been identified during post-earthquake evaluation but the internal retail area remained open.

Vast Furniture, 242 Moorhouse Ave	September: Partial punching shear of wall-diaphragm anchor, parapet collapse. See Figure 5.10.

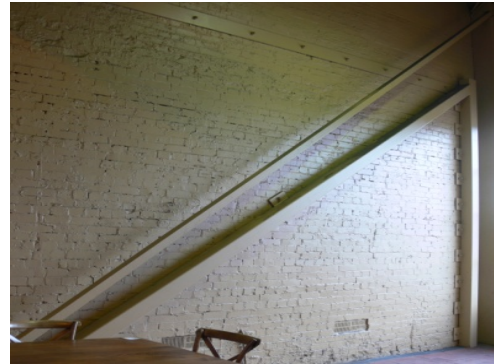
(b) wall strengthening using steel sections

The trusses are further supported on steel portal frames, but the frames had more modern welded joints than the old fashioned riveted joints used in trusses, which suggests that the portal frames were added later to the building as a seismic retrofit solution (see Figure 5.10(b) and (c)).

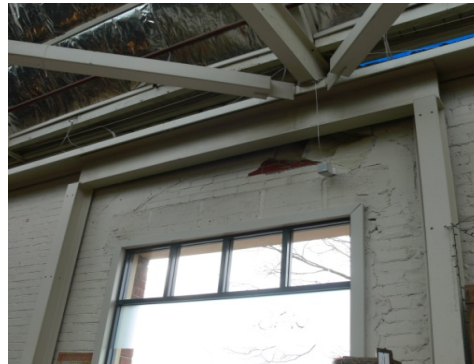
(c) interior of the building (location where anchor plate pull out occurred)

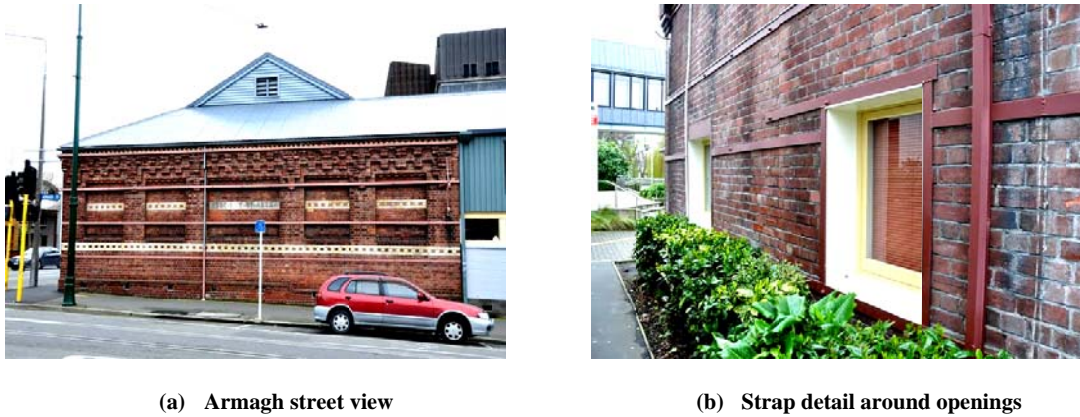
Figure 5.11 282-286 Durham Street North (images taken post-September 2010)

The building was seismically retrofitted in 1972 by the Justice Department. The seismic retrofitting scheme involved the addition of cross walls and strapping of the building with steel plates, as shown in Figure 5.11.

<p>December: Unknown.</p> <p>February: Wall-diaphragm anchors punched through further, but no collapse.</p> <p>June: No further significant damage externally visible.</p>
Environmental Court, 282-286 Durham Street North	<p>September: No apparent damage. See Figure 5.11.</p> <p>December: Unknown.</p> <p>February: Although the retrofit behaved well the building has suffered some damage, particularly around the entrance.</p> <p>June: No further damage.</p>
Shirley Community Centre, 10 Shirley Rd	<p>September: No visible damage. See Figure 5.12.</p> <p>December: Unknown.</p> <p>February: Differential movement between cavity wall layers causing veneer ties to become visible. Liquefaction and differential movement around the grounds. Some cracks extended from ground into the building. Movement of the roof diaphragm visible. In-plane cracking of external walls.</p> <p>June: Out-of-plane collapse of external veneer layer.</p>

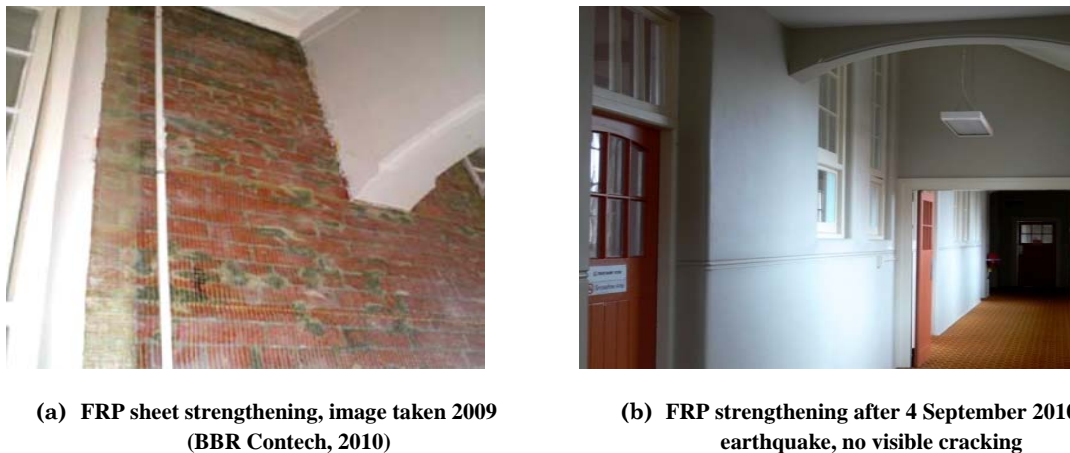
Figure 5.12 Shirley Community Centre

Seven individual wall areas were strengthened with surface bonded FRP sheets using Sikawrap 100G (the application of FRP retrofit is shown in Figure 5.12(a)) in the locations shown in Figure 5.13. FRP rod anchors were installed to bond the applied

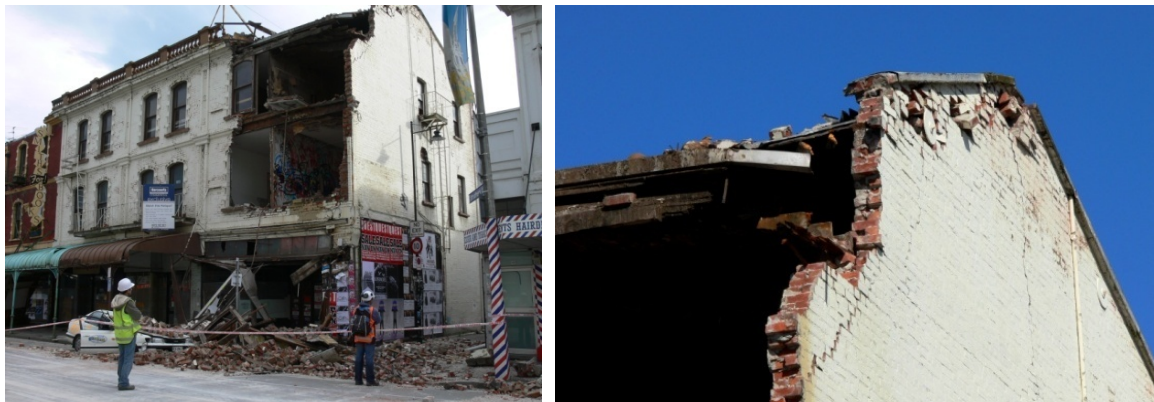
(a) 135-139 Manchester Street, out-of-plane facade collapse

(b) 139 Manchester Street, through steel anchors and rotten timber roof diaphragm

Figure 5.14 Damage to clay brick URM building at 135-139 Manchester Street (images taken post-September 2010)

The building sustained considerable damage during the 4 September 2010 earthquake, mainly concentrated at the end bay (139 Manchester Street) where the front facade entirely collapsed out-of-plane (see Figure 5.14). The entire building sustained damage from collapsed parapets, apart from two bays (135 and 137 Manchester Street) where the parapets remained on the building. From visual observations and physical assessment of the collapsed masonry the mortar was found to be in a moist condition and the mortar that was adhered to the bricks readily crumbled when subjected to finger pressure (see Figure 3.3), suggesting that the mortar compression strength was low (<2 MPa). The collapsed facade wall revealed extensive water damage to the timber structure, with rotten floor joists and roof rafters. Also, it was observed that there were large patches of moist masonry on the interior surface of the building, especially around the roof area (there was no precipitation during the period following the earthquake and prior to building inspection).

It appears that the through steel anchors at the gable did not provide sufficient restraint to the masonry, with the brickwork being pulled around the steel anchor plates. Furthermore, from images prior to the earthquake it is evident that there were significant cracks through the spandrel and the parapet over the top corner window of 139 Manchester Street. Falling parapets landed on the canopies, resulting in an overloading of the supporting tension braces that led to canopy collapse. The connections appeared to consist of a long, roughly 25 mm diameter rod, with a rectangular steel plate (approximately 5 mm thick) at the wall end that was approximately 50 mm wide x 450 mm long and fastened to the rod, and was anchored either on the interior surface or within the centre of the masonry pier or wall. The force on the rod exceeded the capacity of the masonry, causing a punching shear failure in the masonry wall (see Figure 5.15).
