## The Performance of Unreinforced Masonry Buildings in the 2010/2011 Canterbury Earthquake Swarm

### 5.4 Clay brick URM building that have been partially or fully demolished

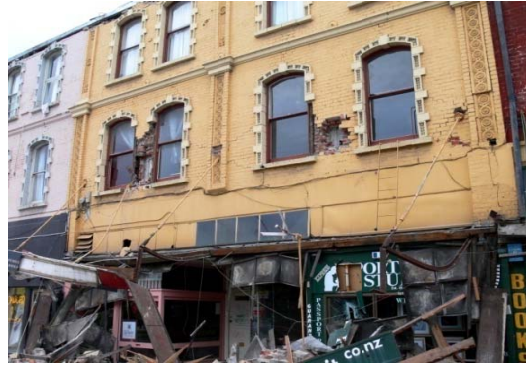
**Figure 5.15** 137 Manchester Street, pull out of the canopy supports

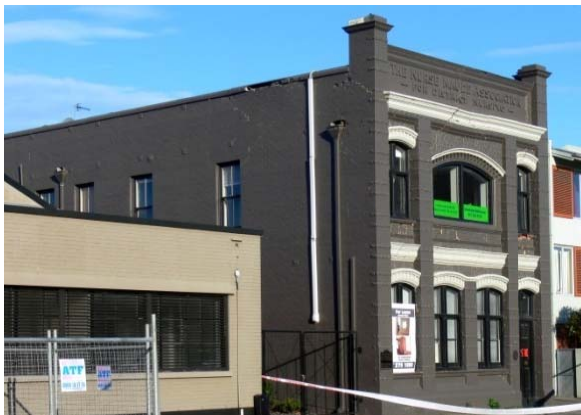
(a) cracking through top spandrel

Comprehensive damage was visible to the facade wall following the 4 September 2010 earthquake, with the spandrel panels at the first floor and roof level having extensive cracking, both vertically and diagonally. There appeared to be some movement of the facade at the diaphragm level in the horizontal direction perpendicular to the plane of the wall. The side walls suffered diagonal shear failures that were visible internally, extending into the stairway wells. The parapet remained attached, as it was supported to some extent by masonry columns that were an extension of the side walls. A diagonal crack extended from the intersection between the top east corner of the side wall and the masonry column diagonally down (see Figure 5.16(b)), indicating possible rocking of the parapet block out-of-plane.

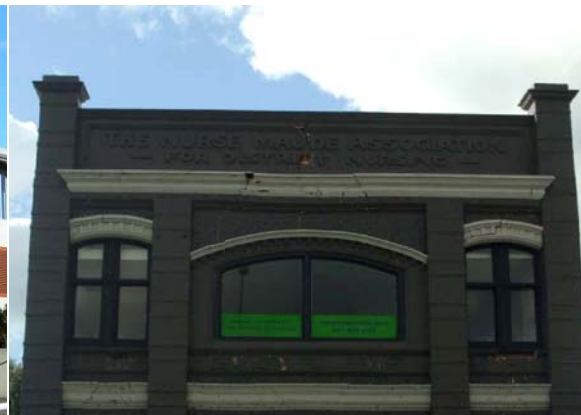
(b) in-plane diagonal cracking through top spandrel

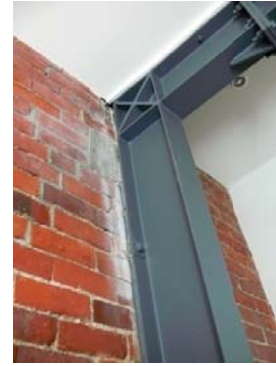
(b) Steel moment frame

The building was seismically retrofitted in 2004 using large steel portal frames oriented in the transverse direction of the building, spaced at approximately 4 m centres as shown in Figure 5.17(b). The building floor plan is shown in Figure 5.18. Diaphragm strengthening was not observed in the interior of the building.

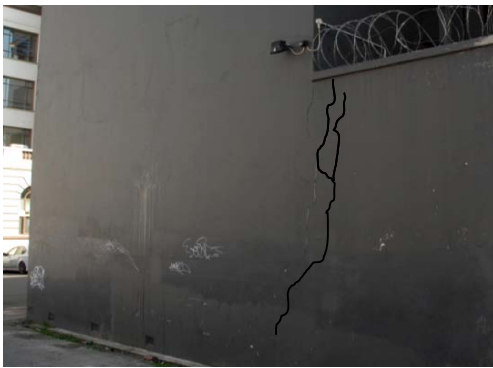
(c) Highlighted crack location at the rear of building

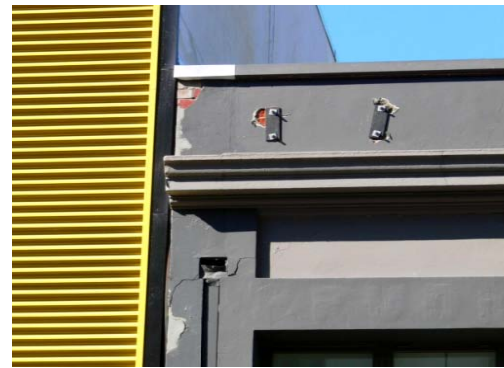
(d) Reduction of seismic gap

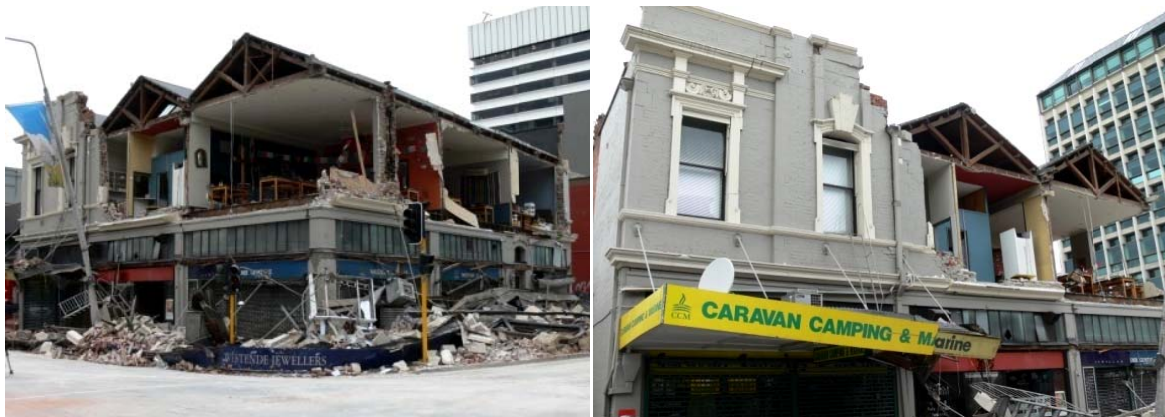
**Figure 5.20 Welstead House, 184-188 Manchester Street, after the 4 September 2010 earthquake**

(a) Corner view

(b) Side view, showing steel anchors

The building experienced a complete out-of-plane collapse of the street front corner facade walls (see Figure 5.20(a)). Anchors in the gables did not provide sufficient restraint, as they remained in the timber roof structure following the earthquake as shown in Figure 5.20(b). Steel anchor plates which were observed along the Worcester Street roof were positioned between the masonry leaves. These anchors remained in the timber roof structure, indicating that insufficient out-of-plane restraint was provided. Due to excessive damage and safety considerations the building was demolished following the 4 September 2010 earthquake.

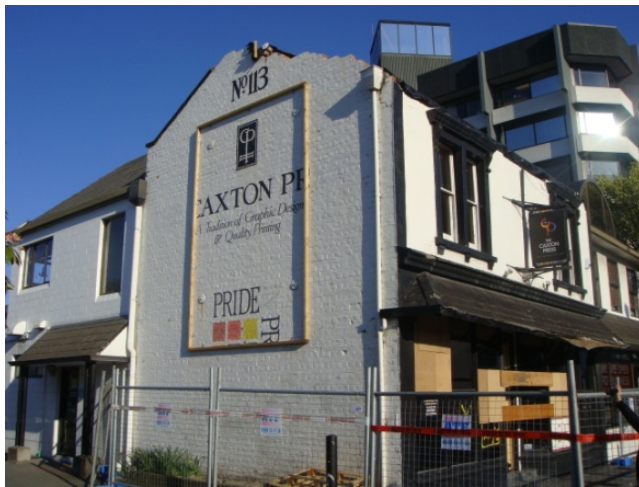
(a) Exterior view

The Caxton Press building was extensively damaged during the Darfield earthquake and the subsequent aftershocks. From external observation, the parapets on the facade wall had collapsed, the top of the gabled side walls had failed due to out-of-plane loading seen in Figure 5.21(a), the perforated facade wall had developed extensive shear cracks through the spandrel over the openings, and the facade wall had pulled away from the side walls due to insufficient anchorage, as shown in Figure 5.21(b). Furthermore, pounding was evident from cracking on the side walls adjacent to where the new concrete block building butted up to the URM building. On internal inspection, evidence of diaphragm movement was apparent as indicated by displacement of the floor boards and the 15 mm displacement of the bricks in the side walls.

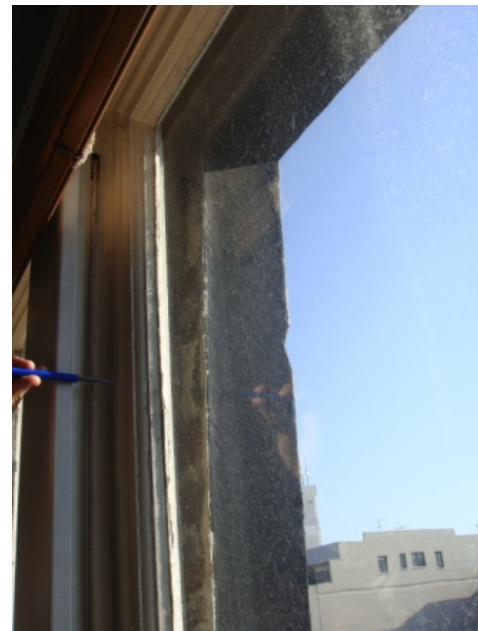
(b) facade wall pulled away from the side walls

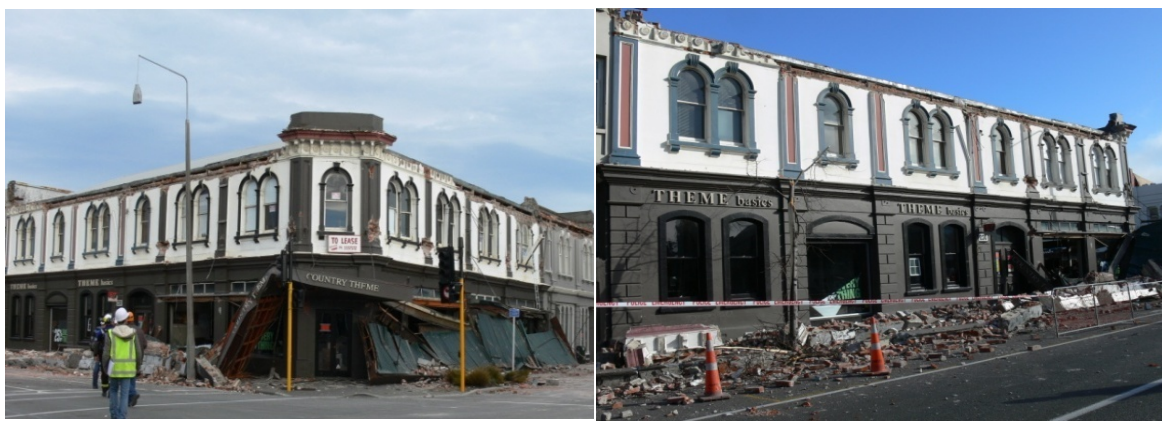
**Figure 5.22 Cecil House / Country Theme Building, 68-76 Manchester Street (images taken post-September 2010)**

(a) Corner view showing parapet collapse

(b) concrete beam on the ground

The most apparent earthquake damage was the toppled parapets around the street frontage as illustrated in Figure 5.22(b), with a lightly reinforced concrete beam on top of the parapet providing insufficient restraint. Falling parapets landed on the canopies below, overloading the supporting tension braces that caused a punching shear failure in the masonry wall and subsequent canopy collapse. The connections appeared to consist of a long, roughly 25 mm diameter rod, with a round steel plate (about 10 mm thick) at the wall end that was approximately 150 mm in diameter.
