FINAL REPORT

VOLUME 6  
CANTERBURY TELEVISION BUILDING (CTV)

The CTV building at 249 Madras Street collapsed during the earthquake at 12:51pm on 22 February 2011. One hundred and fifteen people lost their lives and others were injured.

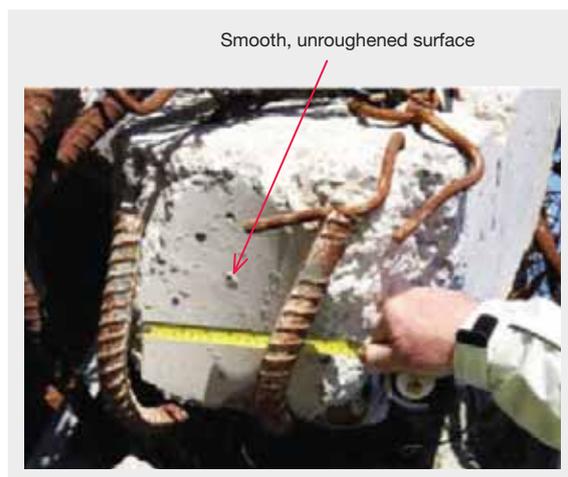
As we have noted, the lack of roughening to the precast beam surfaces was both a design issue and a construction issue. There was inconsistency and a lack of detail in the way this requirement was detailed by Mr Harding on the drawings and in the specifications. The structural drawings included notes directing the roughening of surfaces (as shown in Figure 19(a)). Roughening was required on the inside of most shell beams (Figure 19(b)) but was not shown at the critical region where the precast beams met the in situ concrete of the circular columns (Figure 19(c)).

Figure 20: Smooth end of precast beam where it connected to circular columns (source: Dr Robert Heywood)

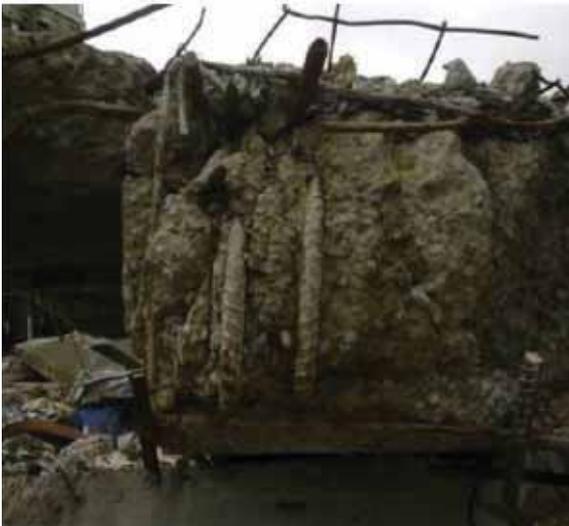
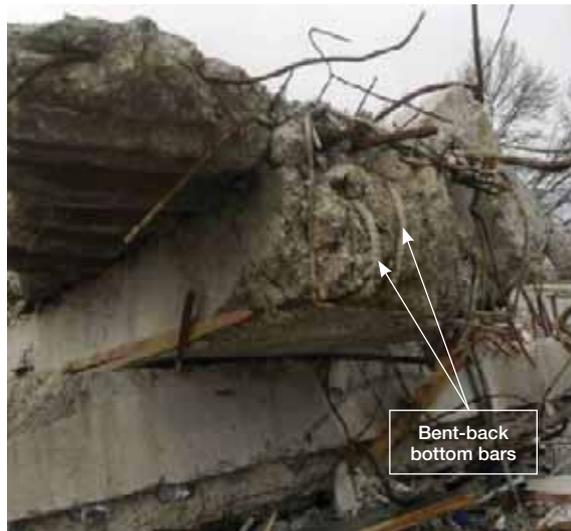
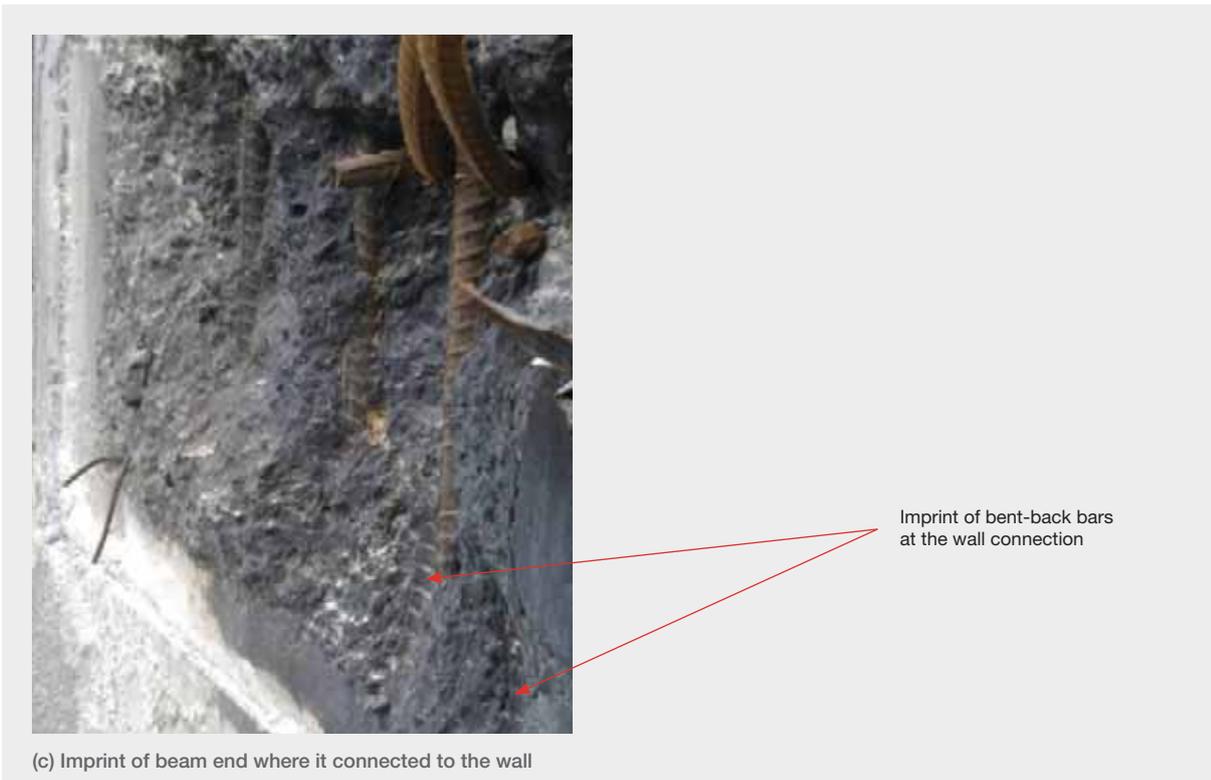
Figure 21: Bent-back bars from Hyland/Smith report

...the bottom reinforcing steel in the shell beams had not been developed fully into the Grid C core wall on Line 4 as specified, except at Level 2. The bars had been bent back into the concrete infill in the shell beam

An imprint from the bent-back bars can be seen where the beam would have been hard up against the wall in Figure 21(c). This was evidence that the bars were not embedded in the wall (as required by the drawings) when the concrete for the wall was cast.

(a) Two H24 bars bent back into shell beam

(b) End of beam with slab attached

(c) Imprint of beam end where it connected to the wall

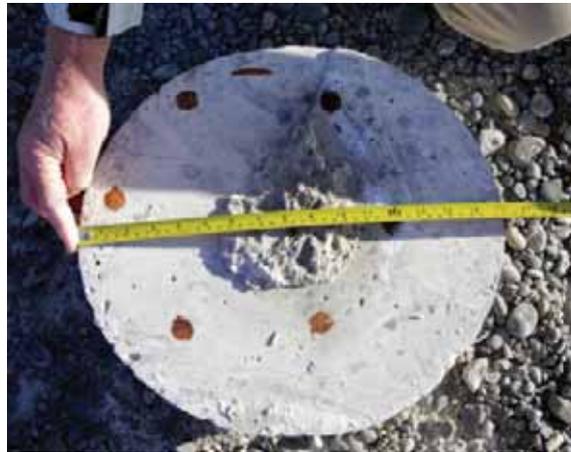
There was also an example of very poorly aligned vertical steel reinforcing in a column with a slightly oval shape. Mr Jones could not offer an explanation for the vertical reinforcement steel being so close to the outside of the columns in a photograph taken by Dr Heywood, as shown in Figure 23. The 6mm diameter spiral, specified by the designer, was described as being “quite light” by Mr Jones. It was stretched out on site to the 250mm pitch. This spiral alone would not adequately restrain the movement of column vertical bars within the formwork. This led to poor cover control with the bars skewed to one side of the column. This illustrates poor quality control; however, this construction defect is unlikely to have altered the behaviour of the columns.

Figure 23: Slightly oval cross-section with poor control of reinforcement cover (source: Dr Robert Heywood)

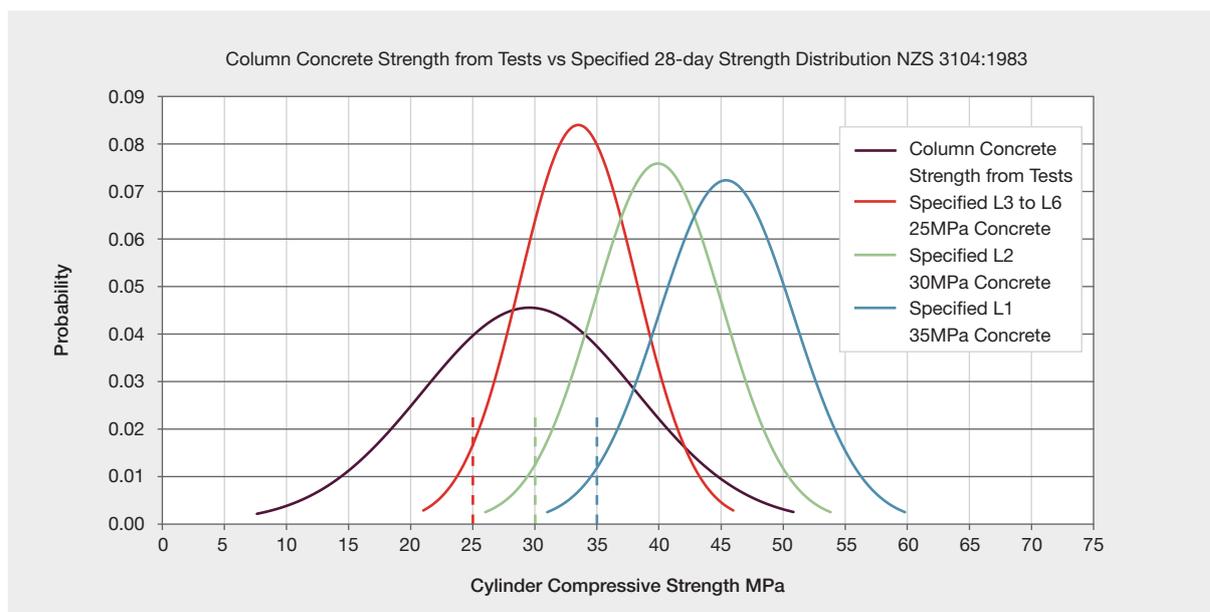
The Hyland/Smith report identified the concrete strength as a construction issue. Material testing of salvaged column samples carried out for the purposes of that report found that the concrete was “significantly weaker than expected”. Tests on 26 column samples from levels 1–6 had a mean concrete strength of 29.6MPa. The Hyland/Smith report illustrated this information as shown in Figure 24.

Figure 24: Hyland/Smith report column concrete test strengths compared to specified strength distributions

The Hyland/Smith report also stated an expectation that the actual strengths would be 25 per cent higher than the specified strengths shown in Figure 24. This expected increase was due to “the conservative approach to achieving specified strengths, and the expected strength gain with age”. Consequently, “low concrete strength in critical columns” was listed as a factor that contributed (or may have contributed) to the collapse.

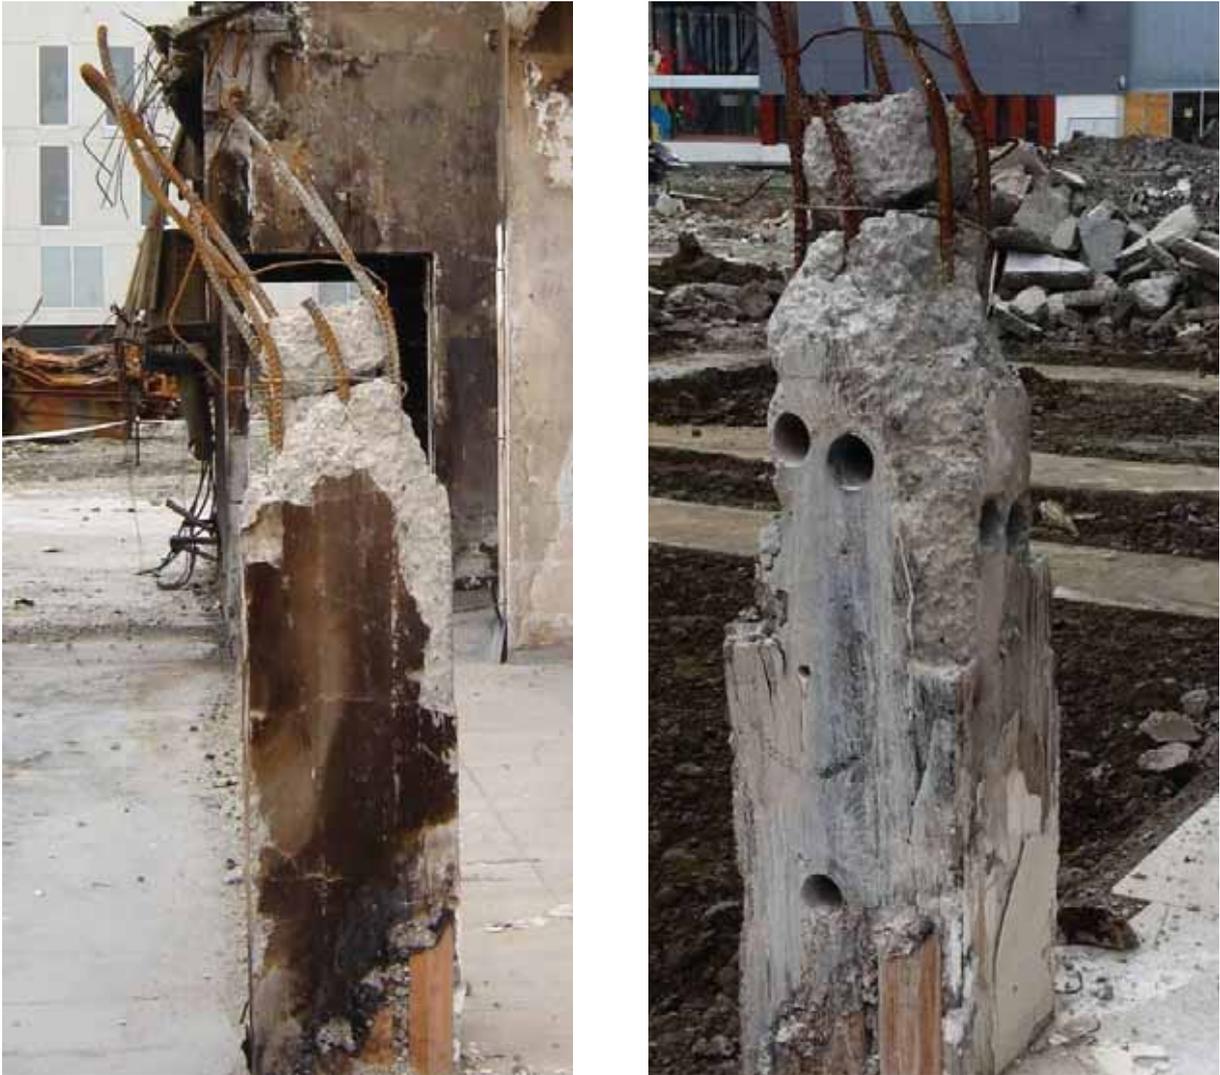
This column is visibly damaged with cracking and discoloration due to fire. This type of distress will reduce the compressive strength of the concrete. The six cores taken from this specimen had a “test core average” of 16MPa, which was regarded as an outlier by Mr Gaimster and Dr MacKechnie.

Figure 25: Concrete cores taken from column C18 on line 4, adjacent to wall D-E (source: Hyland/Smith report)

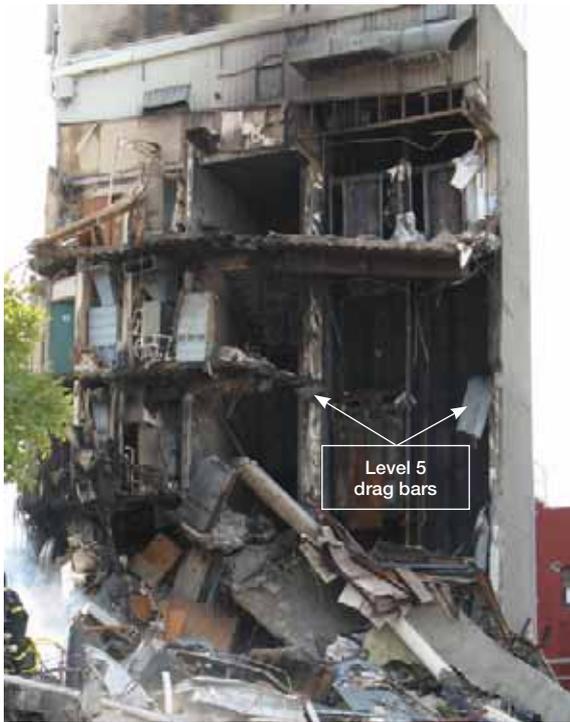
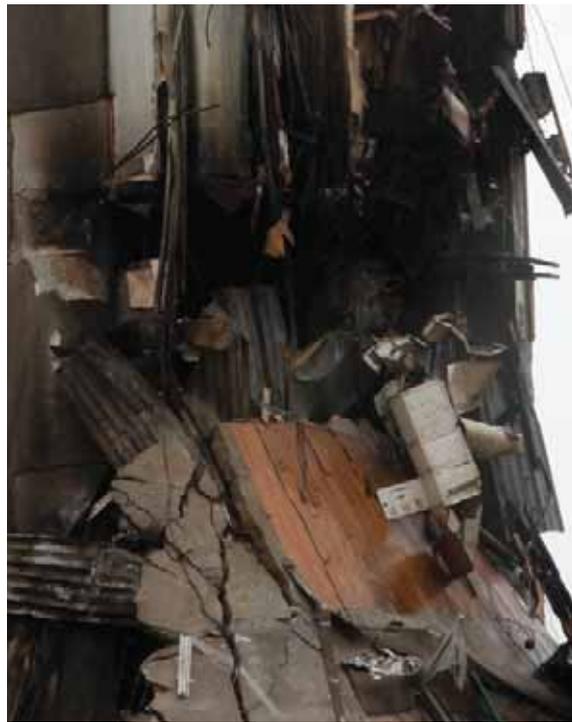
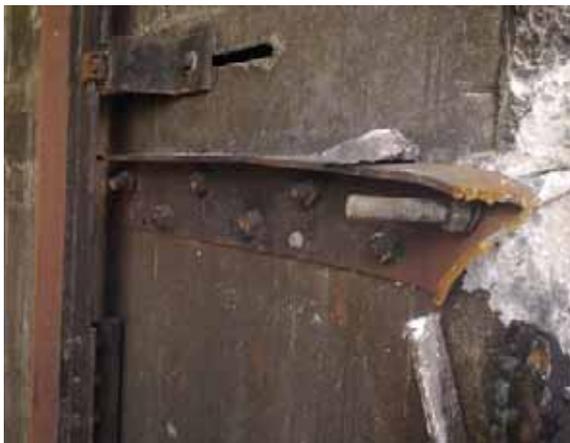
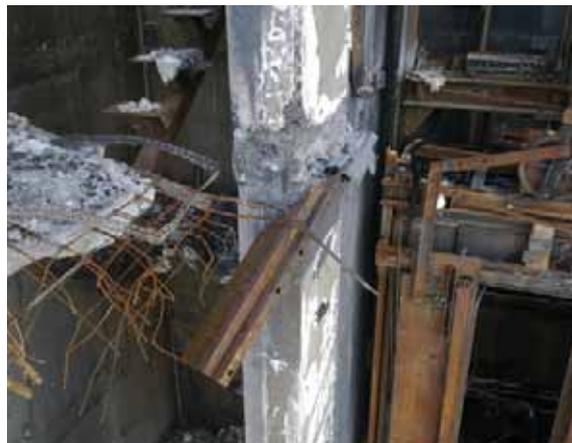
Figure 26: The locations of the drag bars and their state after the collapse of the building

(a) The north wall complex after the collapse

(b) Part of the north wall complex after the collapse

(c) A fractured drag bar on the wall on line D-E

(d) A bent drag bar on the wall on line D

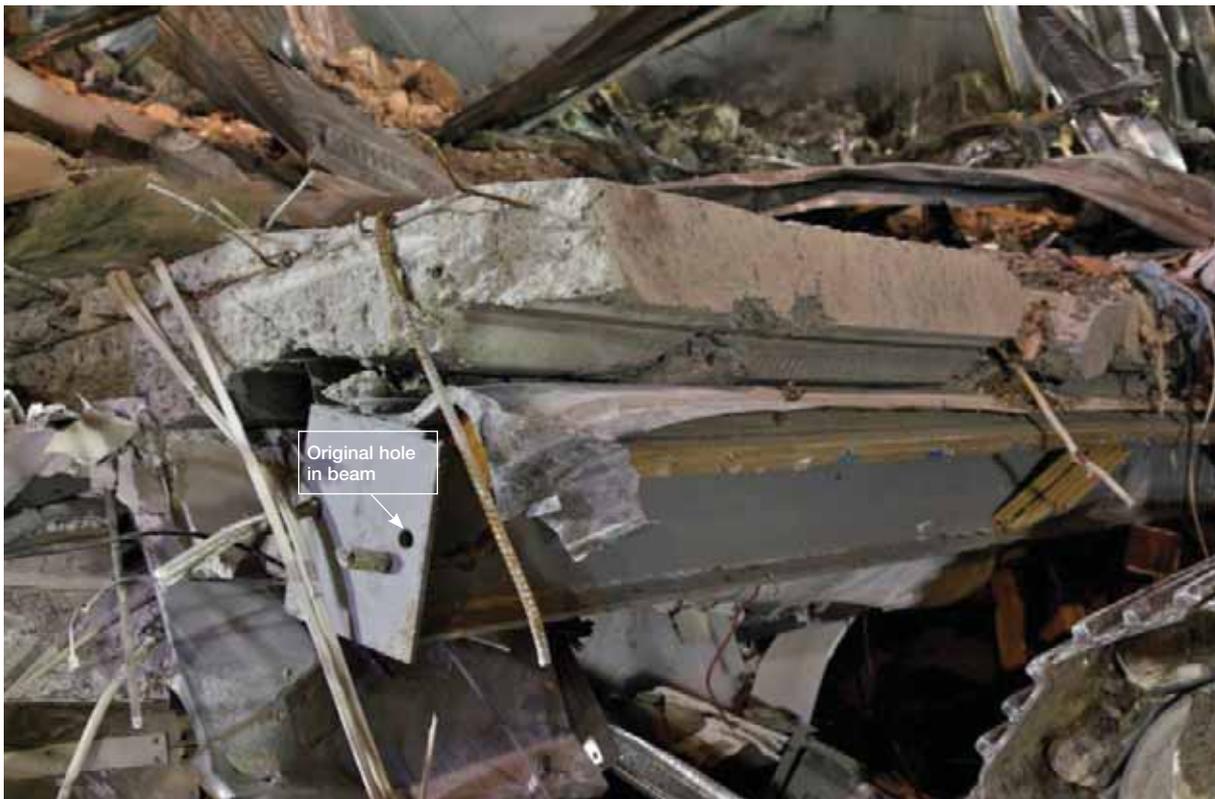
Figure 29: End of trimming beam

After the collapse of the building, Dr Heywood took a photograph of the end of the steel beam that attached to the south shear wall (Figure 29). It can be seen in this photo that an additional hole has been drilled in the beam. We consider that it is likely that the original hole conflicted with the location of reinforcing steel so was relocated; however there is no evidence to confirm this. Relocating the fixing bolt would be consistent with the construction worker hitting steel as it would be difficult for a masonry bit to drill through that steel.
