Section 3: From the September earthquake to the February earthquake

3.1 The Canterbury earthquakes

3.2 The September earthquake

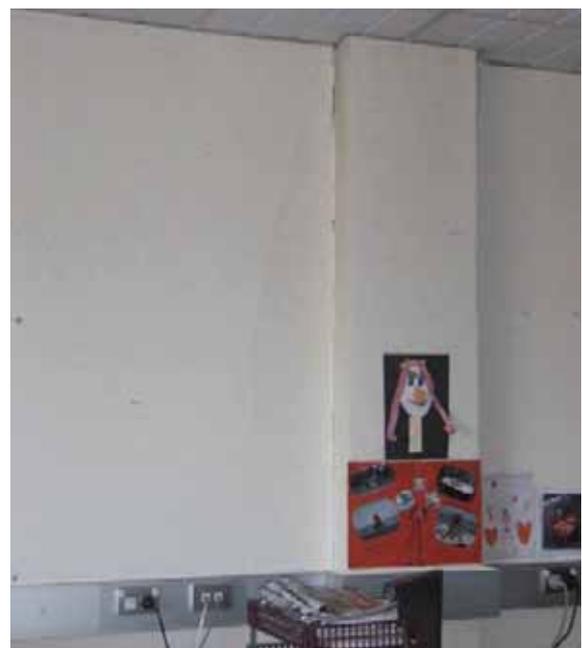
Mr Harris, Mr Thomas and Mr Brown all referred to damage along the western wall. Mr Harris said there were approximately 15 to 20 very noticeable cracks running roughly from floor to ceiling. He said daylight could be seen through some of them. Mr Thomas and Mr Brown both recalled two cracks in the western wall: one ran alongside a pillar, the other was in the south-western corner. Mr Brown confirmed the cracks were in the structural wall rather than plasterboard. Both cracks ran from close to the roof to around the middle of the wall and appeared to increase in size with each aftershock. Mr Brown said more and more daylight could be seen through the crack alongside the pillar. Mr Brown photographed this crack.

Figure 32: Vertical crack alongside pillar on western wall of level 2 (source: Peter Brown)

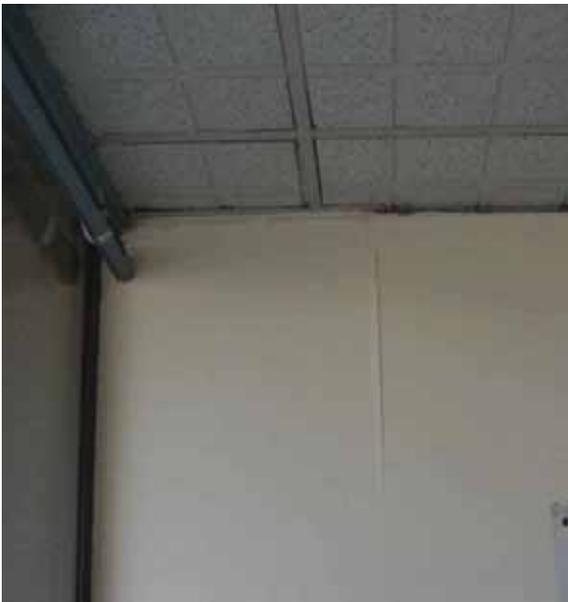
Mr Brown photographed two cracks in the north wall near the stair well. One ran vertically up the plasterboard under the ceiling and was about 600mm in length. The other ran vertically from the ceiling about a metre in length and joined the horizontal crack at the ceiling.

Figure 33: Two cracks in the north wall near the stair well on level 2 (source: Peter Brown)

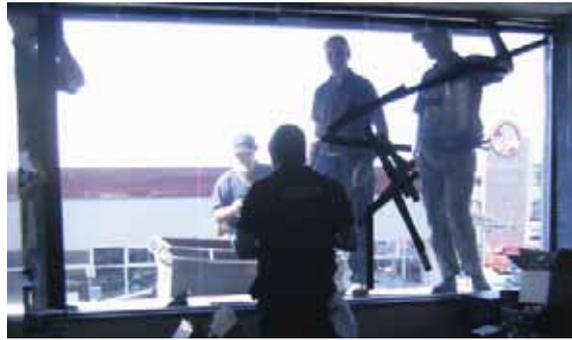
Mr Brown, Mr Thomas and Ms Spencer recalled areas of cracked glass along the eastern wall. The cracks deteriorated with each aftershock. Mr Brown put “gaffer” tape across them hoping that this would help keep the window pane together. The windows were eventually all replaced. Mr Brown photographed the replacement of one of them.

Figure 34: Replacement of a cracked window in the eastern wall on level 2 (source: Peter Brown)

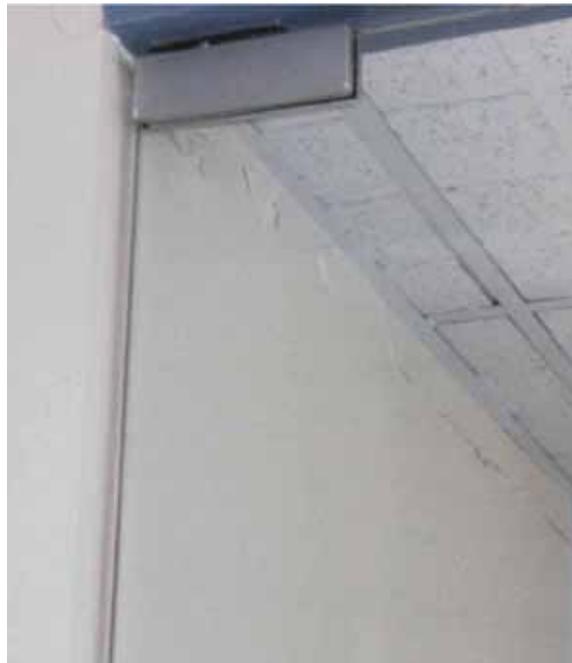
Mr Brown photographed a horizontal crack that appeared along the ceiling in the north-eastern end of the building. It was approximately 2m in length and 4mm wide. He said it appeared as though the ceiling had been forced down because it could be seen that the plaster board had compressed by about 4mm.

Figure 35: Horizontal crack along the ceiling at the north-eastern end of level 2 (source: Peter Brown)

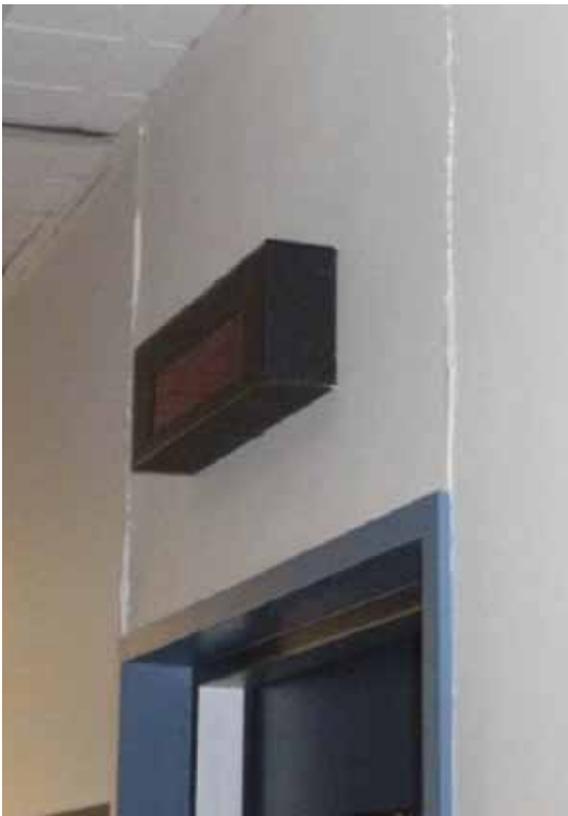
Mr Brown and Ms Spencer recalled two vertical cracks that appeared in an internal wall at the north-eastern end of the building. Mr Brown photographed the cracks.

Figure 36: Two vertical cracks in an internal wall in the north-eastern end of level (source: Peter Brown)

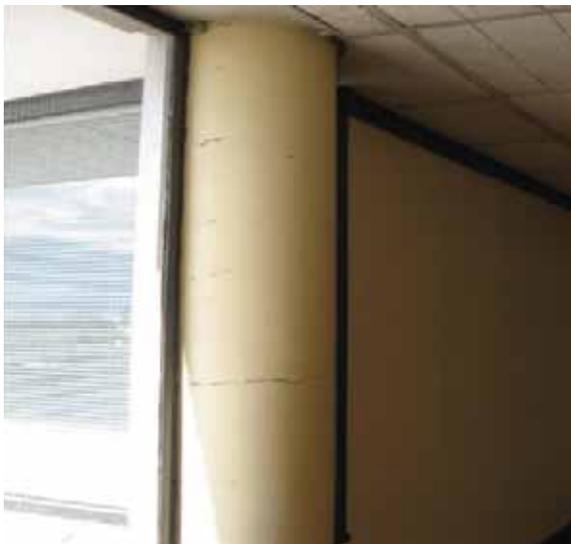
Several witnesses noticed that one of the columns outside the lifts was cracked. Mr Leonard Pagan photographed the damage as part of a walk through inspection with Mr Drew and Mr Coatsworth.

Figure 37: Cracked column C18 outside the lifts on level 6 (source: Leonard Pagan)

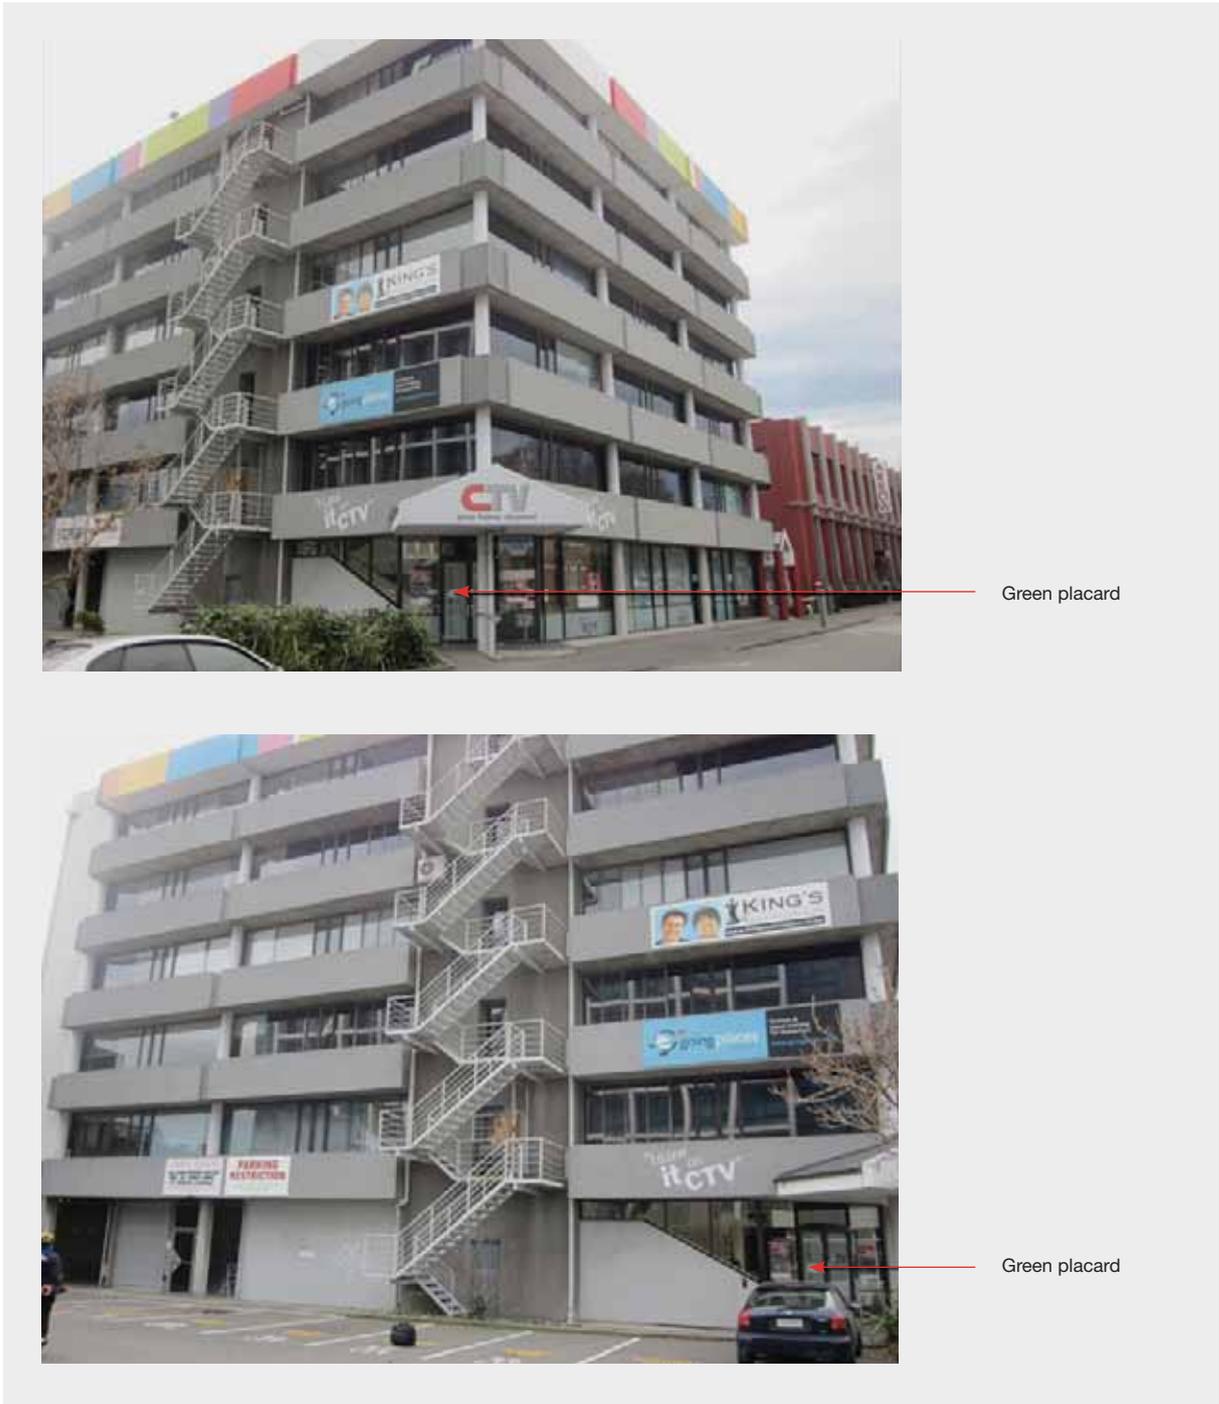
A Level 1 Rapid Assessment of the CTV building was conducted on the afternoon of 5 September. The inspection team comprised Mr Peter Van der Zee from the CCC, Mr Richard Sullivan who was a Chartered Professional Engineer, a USAR officer who has not been able to be identified and one other person, also unidentified. Mr Van der Zee is a CCC building consent officer who had three years' experience in that role at the time but no experience in building inspection. He completed a Level 1 Rapid Assessment form after consultation with the others in the team, recording that the estimated overall building damage was "None". They allocated a green placard and completed a form recording, "No restriction on use or occupancy". The form noted that the inspection was brief and that no apparent structural or other safety hazards had been found. However, the wording on the green placard encouraged the owner to "obtain a detailed structural engineering assessment of the building as soon as possible".

Figure 38: Photographs taken from respectively the south-east and the south of the CTV building by Richard Sullivan on 5 September 2010. The green placard can be seen on the main entrance door

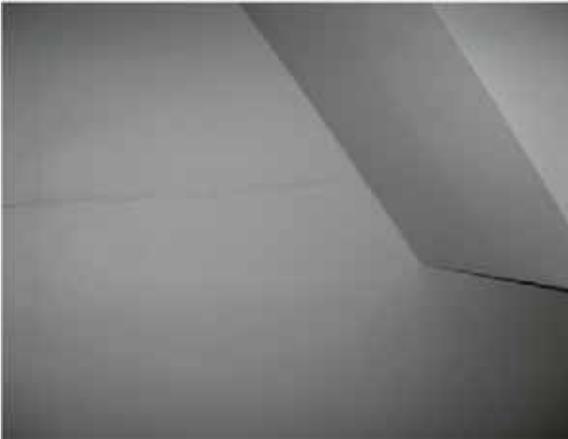
Mr Coatsworth observed cracking along construction joints in the walls and stairwells of the north wall complex at several floor levels. He said that these cracks generally measured less than 0.2mm in width with a few up to 0.35mm (see Figure 43). While this constituted minor structural damage, in his view it was not of an order that would signify yielding of the shear walls.

Figure 43: Cracking along construction connections in the north wall complex (source: David Coatsworth)

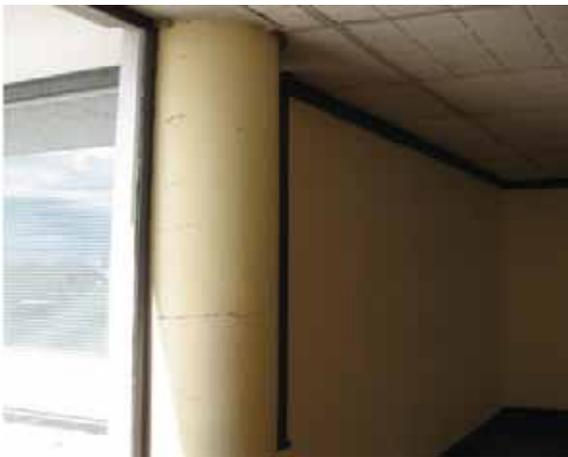
To assess the response of the columns and beams to the earthquake Mr Coatsworth looked for shear and/or flexural bending or cracking in the concrete at beam-column joints or in the columns and beams themselves. He said that the size of any cracking would indicate elastic or inelastic movement. He also looked for signs of compression failure in the columns as a result of vertical loading. He said he looked at every column on each floor. Although he observed some cracking to columns, he was of the view that none of it indicated structural damage. On level 6, the first column west of the north-east corner of the building exhibited some cracking, the appearance of which was accentuated because the paint had chipped off at the cracks. This column was referred to in the hearing as column C18 (see Figure 42). Mr Coatsworth's recollection was that the cracks were less than 0.2mm in width (see Figure 44).

Figure 44: Cracking in column C18 adjacent to lift lobby (source: David Coatsworth)

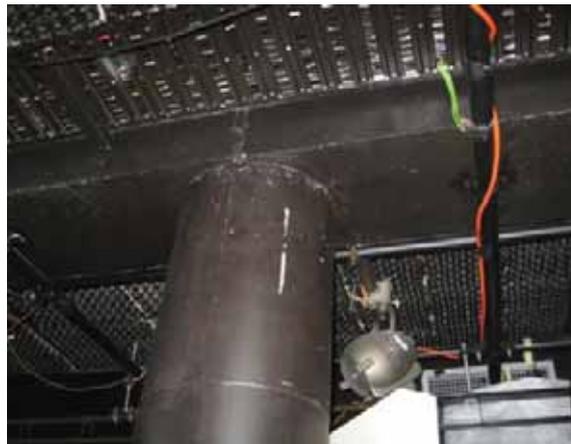
Figure 45: Internal beam-column connection under Level 2 with no evidence of damage (source: David Coatsworth)

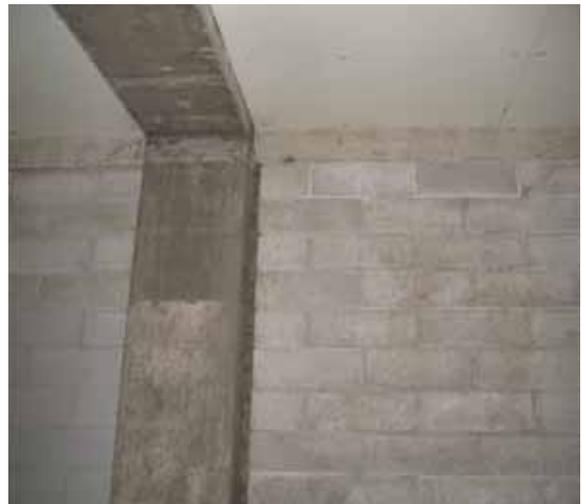
From his inspection of the non-load bearing concrete block wall on the western side of the building, Mr Coatsworth was able to confirm that the block wall was separated from the columns by a flexible sealant and did not appear to have sustained any damage (see Figure 46). He considered that if the block panels had impacted the columns to any extent there would be damage to the top corners of the block panels. He did not see any evidence of this. He did observe some separation between the block panel and the north-west corner column on level 2. There was a gap between the internal framing/lining and the column at this point through which it was possible to see daylight. From this it was evident to Mr Coatsworth that the flexible sealant between the block wall and the concrete column had fallen out. Although he saw no evidence of any impact between the block panel and the column, he recommended further investigation which would have entailed removing internal linings.

Figure 46: Western concrete block wall
(source: David Coatsworth)

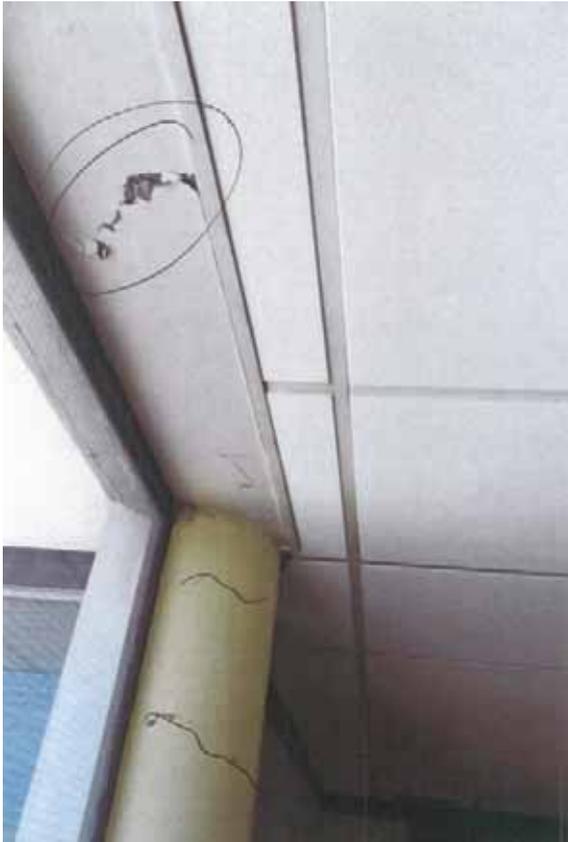
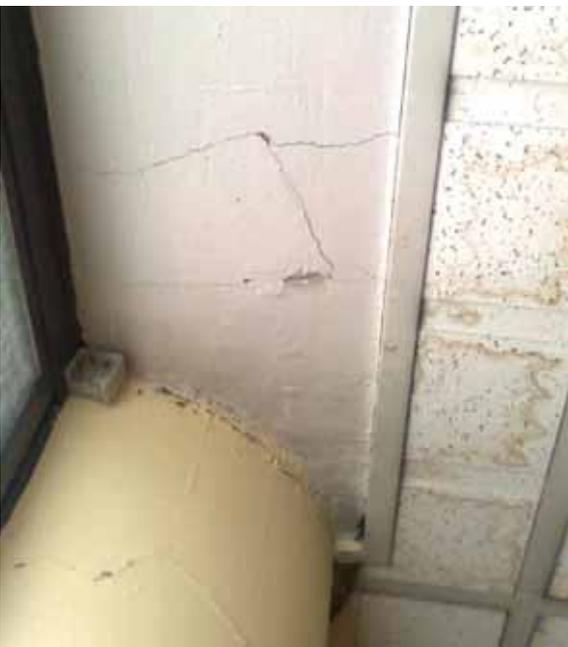
Mr Drew contacted Concrete Techniques early in 2011 and asked them to provide an estimate of costs to repair cracking in various elements in the building. Mr Peter Higgins, the southern regional manager, made two visits to the CTV building in February 2011. The first visit was on 8 February, and as he had not seen the Coatsworth report, he considered the visit preliminary. Mr Drew identified typical damage, including column C18 outside the lifts on level 6.

Mr Higgins visited the building again on 14 February after he had reviewed the Coatsworth report. The purpose of this visit was to quantify the scope of works and he did not form any view about the nature of the damage that he observed. He prepared a quote for Mr Drew dated 15 February 2011. A photograph produced by him shows that there had been potentially significant additional damage following the Boxing Day aftershock to the east finger wall of the north wall complex where it extended to column C18. The top of column C18 was photographed by Mr Pagan as a part of the assessment of the building on 29 September and it is notable that his photograph did not extend to show the damage that has been circled by Mr Higgins in photograph A in Figure 50. It is likely that if this damage had been there in September then it would have been noticed and photographed by Mr Pagan.

Figure 50: Photographs of column C18 on level 6 outside the lifts taken by Mr Higgins on 14 February 2011 and Mr Pagan on 29 September 2010

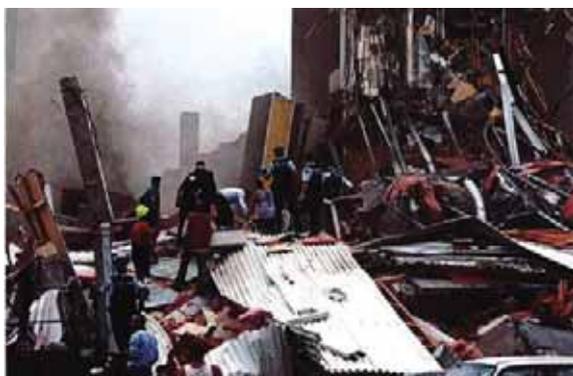
Figure 56: Photograph taken from the south-east corner of the CTV site approximately 30 minutes after the 22 February 2011 earthquake (source: Michael Williams)
