4 Observed Liquefaction and Response Spectra in CBD during the 2010 and 2011 Christchurch Earthquakes

4.1 Soil Liquefaction During the 22 February 2011 Earthquake

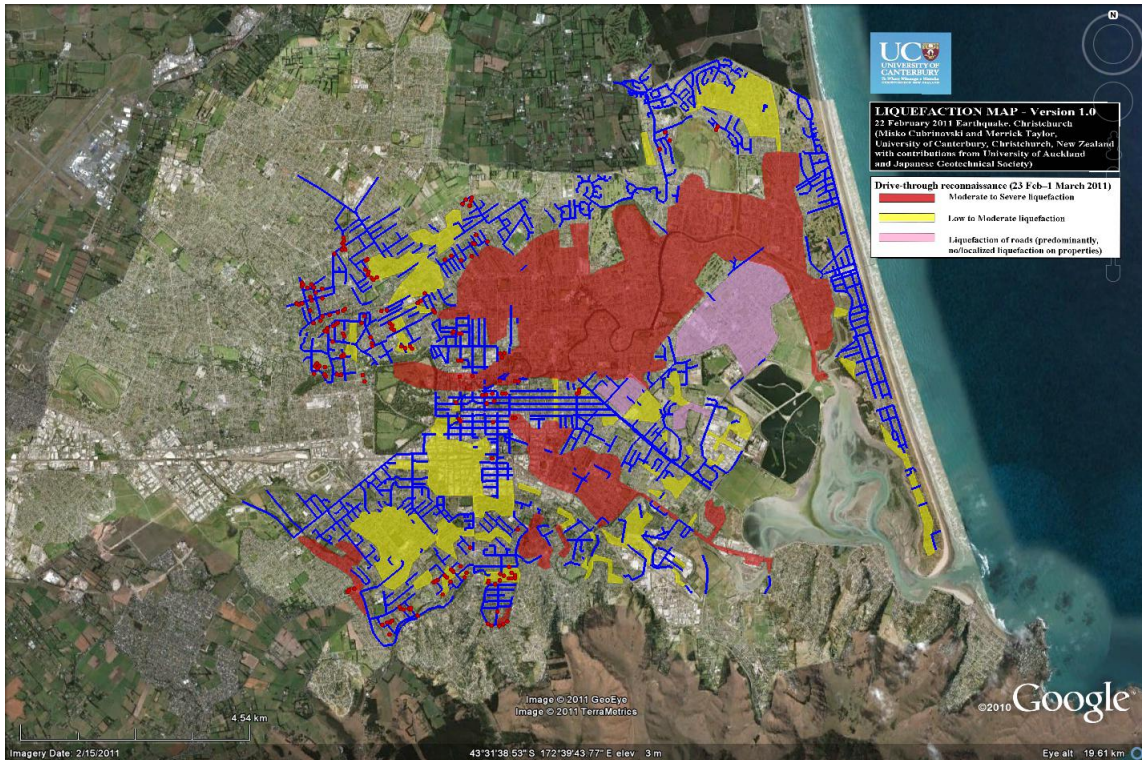
Figure 9 shows the extent of liquefaction caused by the 22 February 2011 earthquake in wider Christchurch documented through a drive-through reconnaissance that was conducted in the period from 23 February to 1 March by the University of Canterbury (Cubrinovski and Taylor, 2011). The drive-through survey aimed at capturing surface evidence of liquefaction as quickly as possible and quantifying its severity in a consistent and systematic manner. Four areas of different liquefaction severity are indicated in the map: (a) moderate to severe liquefaction (red zone, with very large areas covered by sand ejecta, mud and water, large distortion (undulations) of ground and pavement surfaces, large cracks and fissures in the ground, and significant liquefaction-induced impacts on buildings), (b) low to moderate liquefaction (yellow zone, with generally similar features as for the severe liquefaction, but of lesser intensity and extent), (c) liquefaction predominantly on roads with some on properties (magenta zone, where heavy effects of liquefaction were seen predominantly on roads, with large sinkholes and ‘vents’ for pore pressure dissipation, and limited damage to properties/houses), and (d) traces of liquefaction (red circular symbols, with clear signs of liquefaction, but limited in extent and deemed not too damaging for structures). The suburbs to the east of CBD along Avon River (Avonside, Dallington, Avondale, Burwood and Bexley) were most severely affected by liquefaction, which coincides with the area where about 5000 residential properties will be abandoned (New Zealand Government, 2011).

Figure 9. Preliminary liquefaction map of Christchurch from drive-through reconnaissance (Cubrinovski and Taylor, 2011); the map is not complete and shows only general overlay of areas (it cannot be used on property basis)

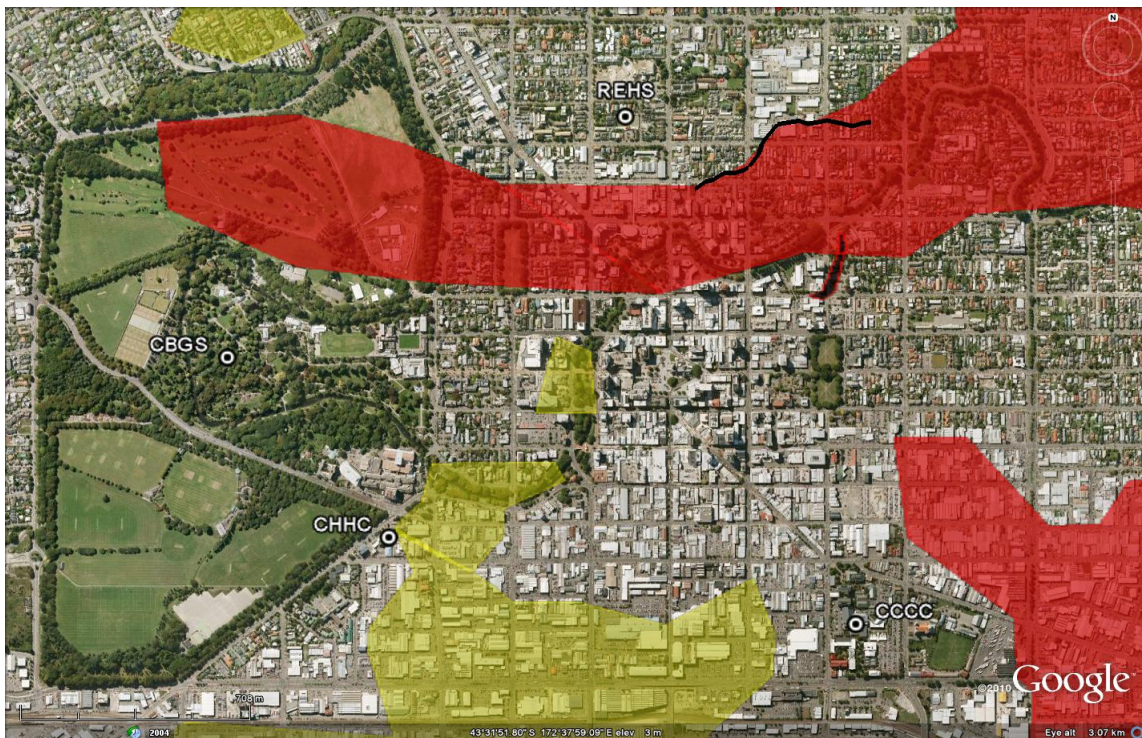
Ten days after the earthquake, after the urban search and rescue efforts had largely finished, a comprehensive ground survey within the CBD was initiated to document liquefaction effects in this area. Figure 10 shows the resulting liquefaction documentation map for the CBD. The principal zone of liquefaction stretches west to east through the CBD, from Hagley Park to the west, along the Avon River to the northeast boundary of the CBD at the Fitzgerald Bridge. This zone is of particular interest because many high-rise buildings on shallow foundations and deep foundations were affected by the liquefaction in different ways. Note that this zone consists mostly of sandy soils and it largely coincides with the path of the Avon River and the network of old streams shown in the 1850s survey maps (Figure 4). Another zone of moderate to severe liquefaction was found in the south-east part of the CBD, though its effects were less significant in relative terms.

Even though the map shown in Figure 10 distinguishes the zone along Avon River as the most significantly affected by liquefaction, the severity of liquefaction within this zone was not uniform. In this zone, the manifestation of liquefaction was primarily of moderate intensity with relatively extensive areas and volumes of sand/silt ejecta. There were also areas of low manifestation or only traces of liquefaction, but also pockets of

Figure 10. Preliminary liquefaction map indicating areas within the CBD affected by liquefaction in the 22 February earthquake

The north extent of the zone, which is shown by the thick black line in Figure 10, is a clearly defined geomorphic boundary (easily detectable change in the ground surface due to features of underlying soils) running east to west. This feature was marked by a slight change in elevation of about 1 m to 1.5 m over approximately 2 m to 10 m wide zone, and was characterized by ground fissures and distortion associated with gentle slumping of the ground surface and localized spreading towards the down-slope side. Ground cracks, fissures and a distorted pavement surface marked this feature, which runs continuously through properties and affected a number of buildings causing cracks in both the foundations and their structures. Liquefaction and associated ground deformation were pronounced and extensive on the down-slope side between the identified geomorphic feature and the Avon River, but noticeably absent on the slightly higher elevation to the north (upslope side away from the river). This feature is thought to delineate the extent of a geologically recent river meander loop characterized by deposition of loose sand deposits under low velocity conditions. A similar geomorphic feature was observed delineating the boundary between liquefaction damage and unaffected ground within a current meander loop of the river to the east of this area (Oxford Terrace between Barbados Street and Fitzgerald Avenue).

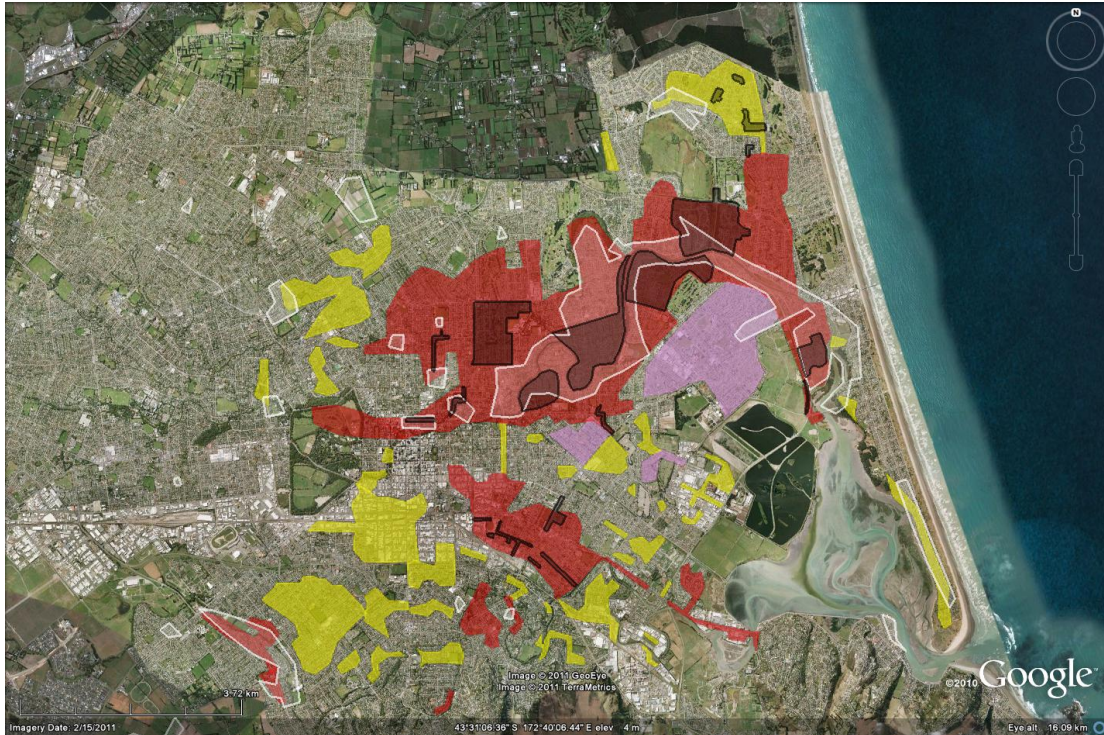
Soil liquefaction repeatedly occurred at the same sites during the earthquakes producing strong ground shaking in Christchurch, and in particular during the 4 September 2010, 22 February 2011, and 13 June 2011 earthquakes. Figure 11 comparatively shows liquefied areas of Christchurch in these three events, as documented by field inspections. Note that only parts of Christchurch have been surveyed (coloured areas) and that the aim of the surveys was to capture general features and areas affected by liquefaction as observed from the roads, hence, the zoning is not applicable to specific properties.

Figure 11. Preliminary liquefaction maps documenting areas of observed liquefaction in the 4 September 2010 (white contours), 22 February 2011 (red, yellow, magenta areas), and 13 June 2011 (black contours) earthquakes; note that only parts of Christchurch were surveyed (coloured areas), and that the aim of the surveys was to capture general features and areas affected by liquefaction as observed from the roads, hence, the zoning is not applicable to specific properties
