P.G.C Inspection Photos and Locations 16 Sept 2010

PGC BUILDING – 233 CAMBRIDGE TCE – CHRISTCHURCH

Photographic Summary of Primary Damage Observed – 16 Sept 2010

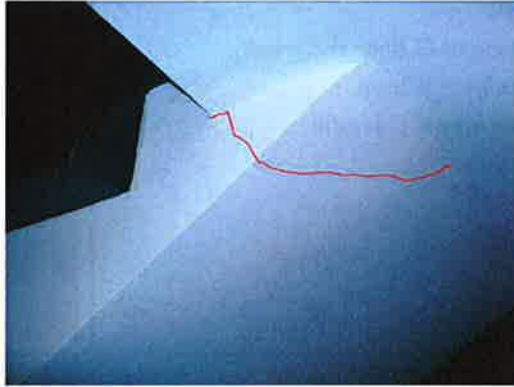
Damaged Item	Example
<p>Photo 001</p> <p>Minor cracking to underside stairs to L1 Typically $\leq 0.2\text{mm}$</p>

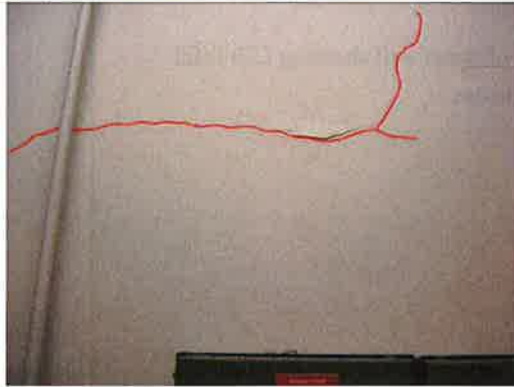
<p>Photo 002</p> <p>Cracking to G floor shear wall Typically $\leq 0.2\text{mm}$</p>

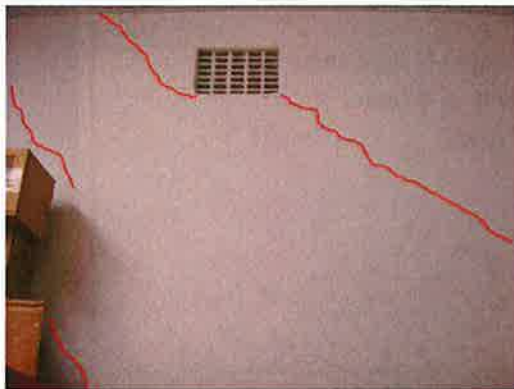
<p>Photo 003</p> <p>Cracking to G floor shear wall Typically $\leq 0.2\text{mm}$</p>

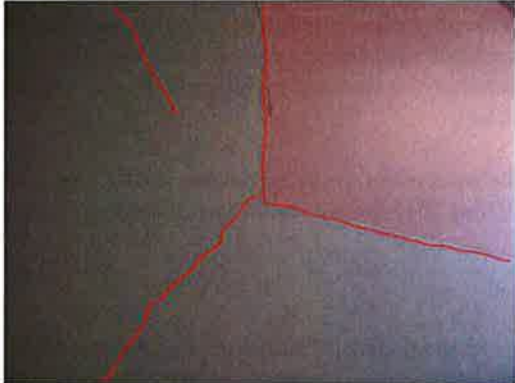
Damaged Item	Example
<p>Photo 004</p> <p>Cracking to G floor shear wall Typically $\leq 0.2\text{mm}$ Shaded area is Gib infill</p>

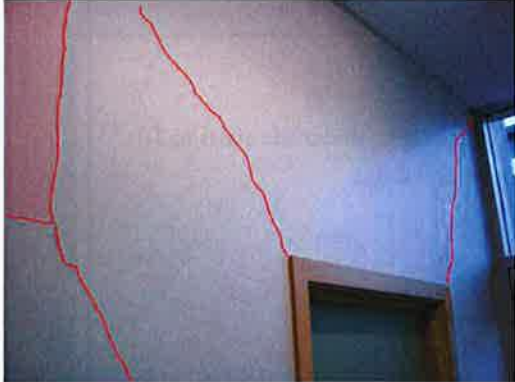
A close-up photograph of a wall with a red crack. A red shaded area is visible, indicating Gib infill. The crack runs diagonally across the wall.
<p>Photo 005</p> <p>Cracking to G floor shear wall Typically $\leq 0.2\text{mm}$ Shaded area is Gib infill</p>

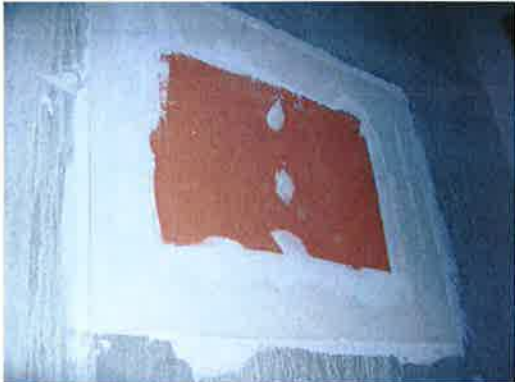
A photograph of a wall with a red crack. A red shaded area is visible, indicating Gib infill. A doorway is visible in the background.
<p>Photo 006</p> <p>Rear of shear wall showing Gib infill Plantroom</p>

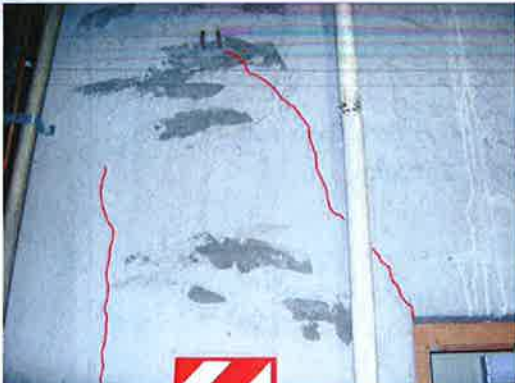
A photograph showing the rear of a shear wall in a plantroom. The wall is covered in white Gib infill. A red shaded area is visible, indicating Gib infill.
<p>Photo 007</p> <p>Cracking to G floor shear wall Typically $\leq 0.2\text{mm}$ Plant room</p>

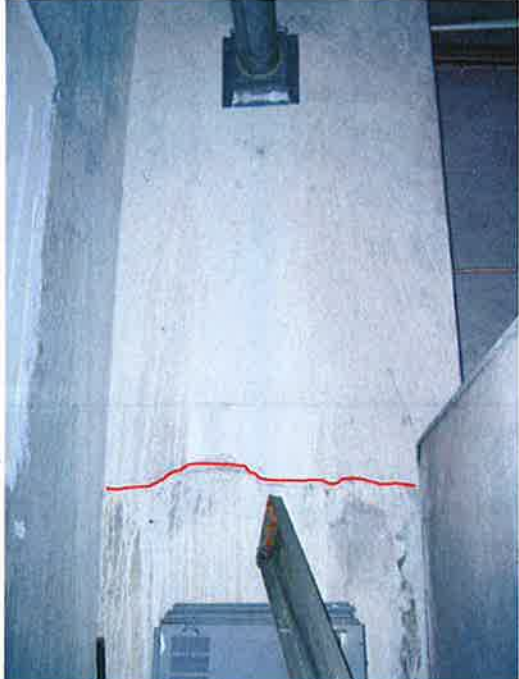
Damaged Item	Example
<p>Photo 008</p> <p>Horizontal cracking to G floor shear wall Typically $\leq 0.3\text{mm}$ Plant room</p>

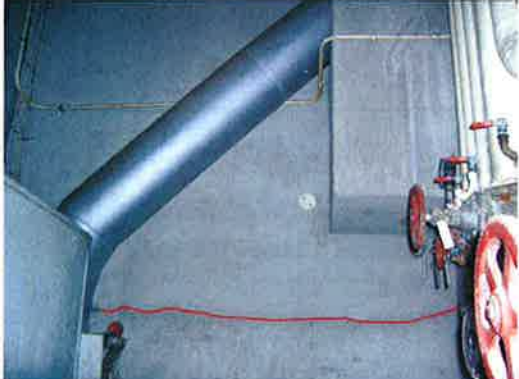
A photograph of a white wall in a plant room. A horizontal crack is visible, highlighted with a red line. The crack is slightly irregular and runs across the width of the wall. A metal pipe is visible at the top of the wall, and a piece of equipment is at the bottom.
<p>Photo 009</p> <p>Horizontal cracking to G floor shear wall Typically $\leq 0.3\text{mm}$ Plant room</p>

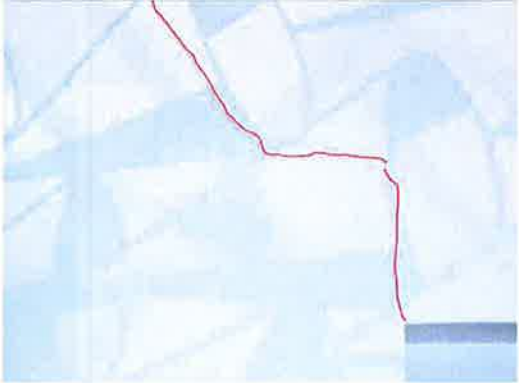
A photograph of a white wall in a plant room. A horizontal crack is visible, highlighted with a red line. The crack is located near a large, dark-colored pipe that runs diagonally across the wall. In the background, there are red fire extinguishers and other equipment.
<p>Photo 010</p> <p>Shear crack to G floor shear wall Typically $\leq 0.2\text{mm}$</p>

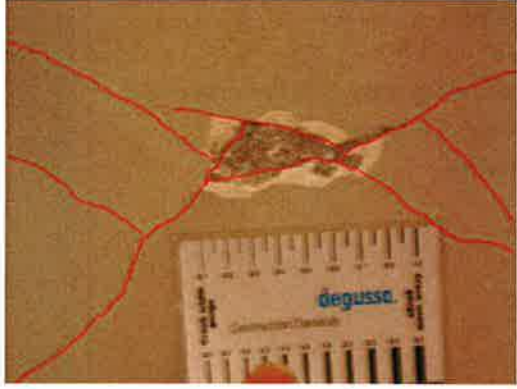
Damaged Item	Example
<p>Photo 011</p> <p>Cracking to L1 shear wall Typically $\leq 0.2\text{mm}$</p>

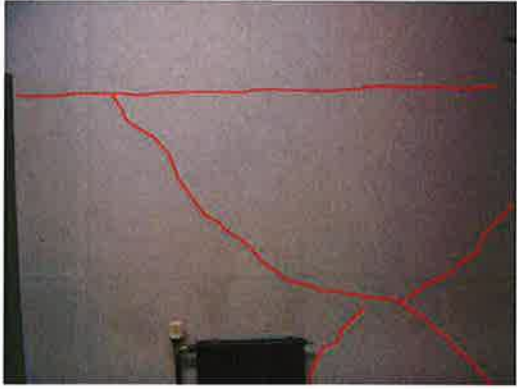
<p>Photo 012</p> <p>Cracking to L1 shear wall Typically $\leq 0.2\text{mm}$</p>

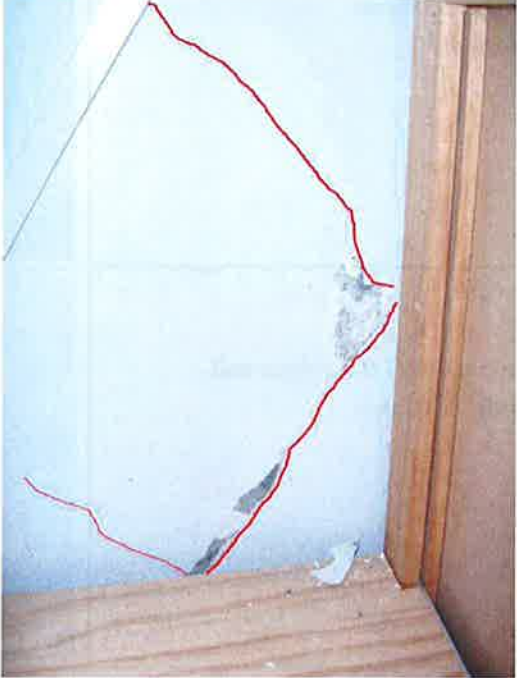
<p>Photo 013</p> <p>Cracking to L1 shear wall in storeroom Crackwidths between 0.2mm – 0.6mm At Lift Core Wall</p>

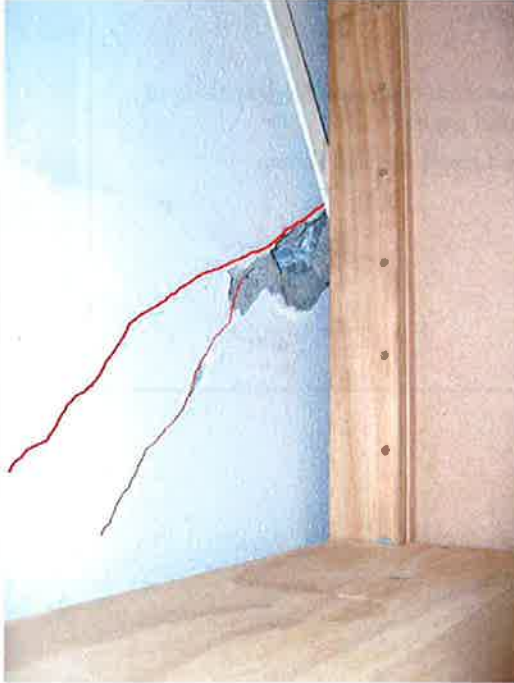
Damaged Item	Example
<p>Photo 014</p> <p>Cracking to L1 shear wall in storeroom Crackwidths between 0.2mm – 0.6mm At Lift Core Wall</p>

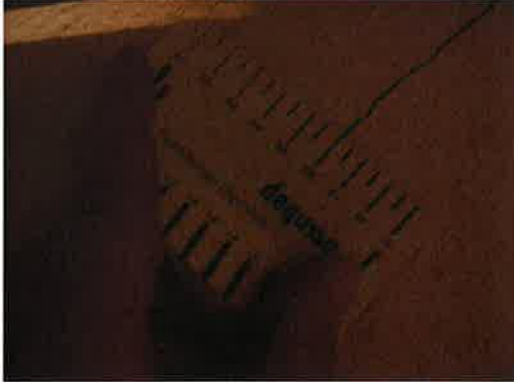
<p>Photo 015</p> <p>Cracking to L1 shear wall in storeroom Crackwidths between 0.2mm – 0.6mm At Lift Core Wall</p>

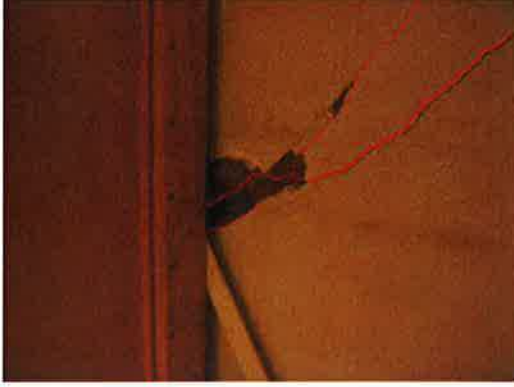
<p>Photo 016</p> <p>Cracking to L1 shear wall in storeroom Crackwidths between 0.2mm – 0.6mm At Lift Core Wall</p>

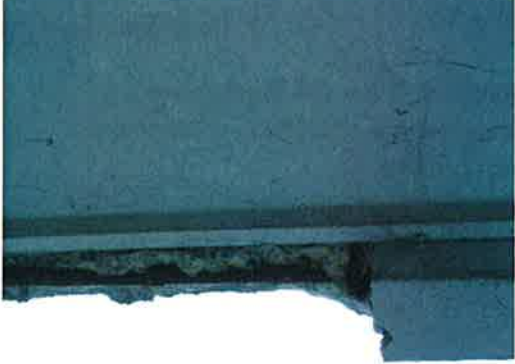
Damaged Item	Example
<p data-bbox="276 327 391 353">Photo 017</p> <p data-bbox="276 405 703 506">Corrosion induced cracking/spalling of spandrel panels Typical panel damage shown</p>
