Building Evaluation Transition Team

Processes Used and Lessons Learnt following the Darfield Earthquake of 4 September 2010

Building Evaluation Transition Team (BET TEAM)

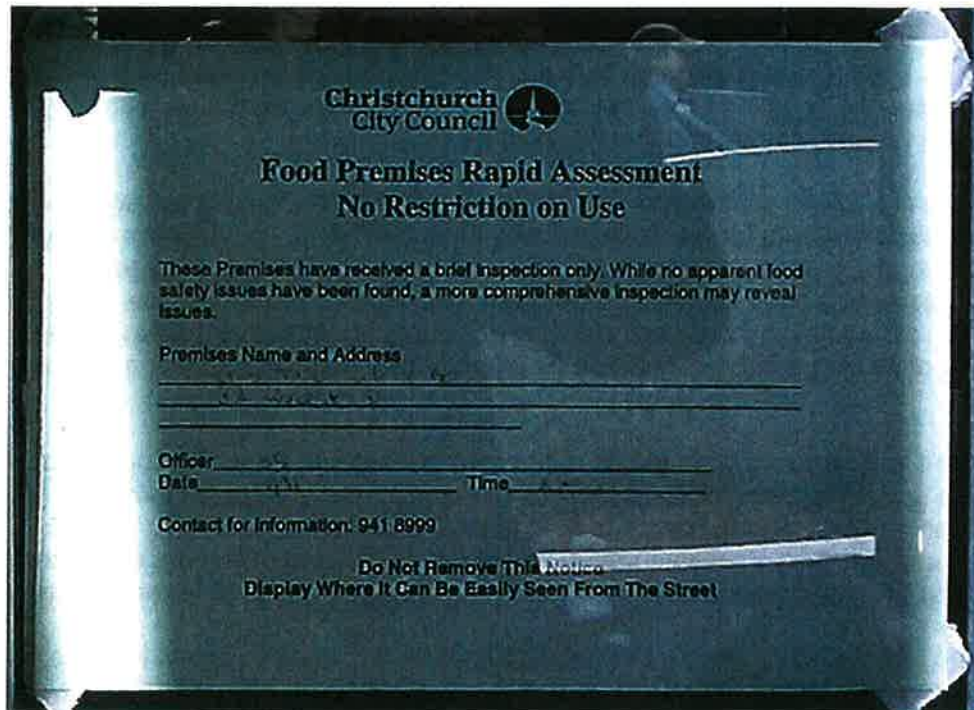
Figure 1 Modified Rapid Assessment Placard (Green) Affixed to Food Premises on Worcester Street

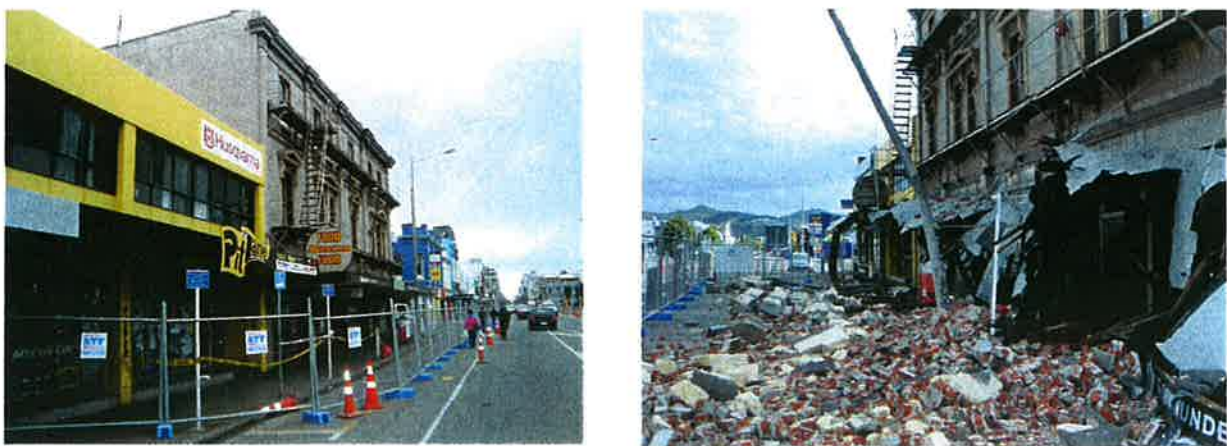
Figure 1: 73 Manchester Street (South view) 21.09.10 & **Figure 4:** (North view) on 31.10.10

Buildings inspected in the initial response following the aftershock (26-27 December) were found to have sustained rotational movement in the opposite direction of the main shock. Temporary remedial works completed (to allow access to buildings damaged during the main shock) withstood the impact of the aftershock. However, as can be seen in Figure 4 and 5, the temporary bracing work may not have withstood an aftershock of greater shaking intensity or longer duration.

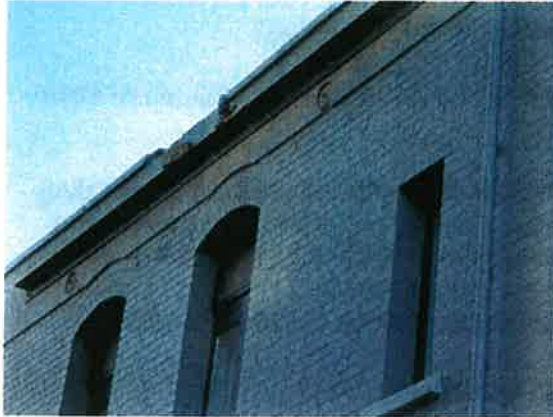
Figure 4 Cashel St property with debris from parapet balancing on temporary steel strengthening work.

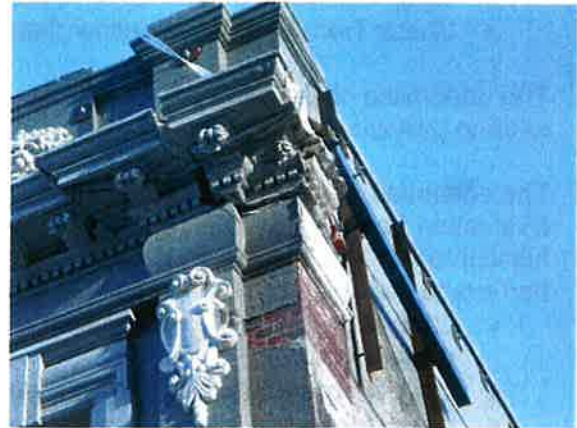
Figure 5: Steel strengthening in place following main shock reinforced by cross beam and straps following Boxing Day aftershock.

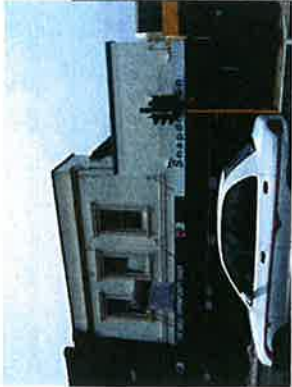
442 / 444 / 446 – SNAPDRAGON, GREAT OPPORTUNITY

Progress
Luke Dirkzwager, 021 386067. Couple of issues to sort out with adjoining buildings before demolition can start.

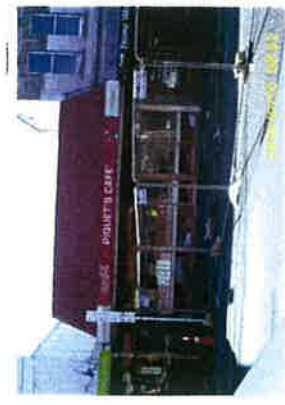
458 – PIQUET

John Kuipers 3327 926. Minor damage, problem with adjoining building.

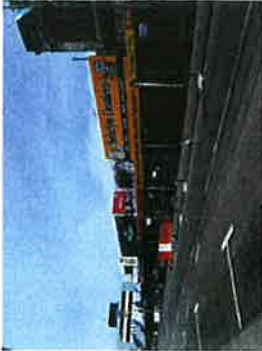
429 – SELWYN DEALERS

Robin Milligan, 332 1497. Red placard because of 431 which is to be demolished. Owner and tenant increasingly frustrated,.

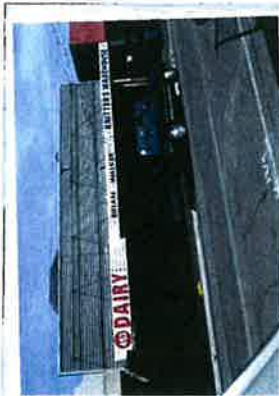
455 – KNITTERS WAREHOUSE

Progress
Bob Marchand, 329 0834. Owns 455,457,459, 461 – 469
This building OK, waiting for demolition of 461 - 469.

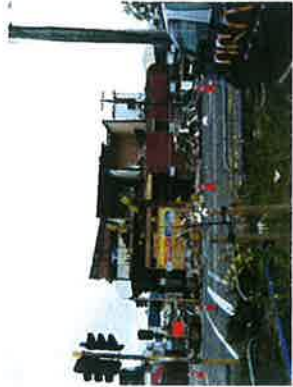
461 – 469 ANGUS DONALDSON

Progress
Bob Marchand, 329 0834. Demolition commenced 5/11.
