Landmark Tower
Robert Jones House
Selected Drawings

Forsyth Barr House - Level 2 Seismic Assessment

FORSYTH BARR TOWER POST-EARTHQUAKE ASSESSMENT AND REPAIR REPORT

Investigation into the Collapse of the Forsyth Barr Building Stairs on 22nd February 2011

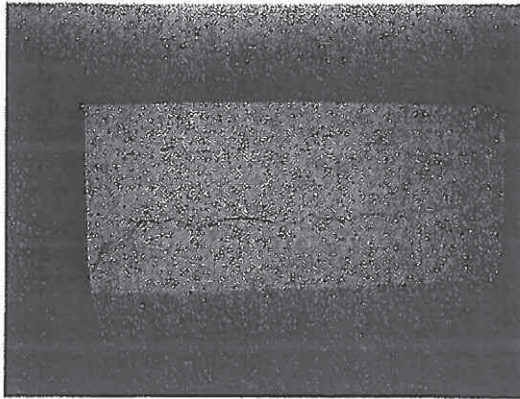
- Beam and connections supporting the base of the stair (~380-PFC) appeared to be in good condition.
- Fire proofing material was intact.
- Flexural cracking in the base of the lower knee of the scissor flight has resulted in residual deformation of the stair, with the stair settled by ~40mm at that location.

Photo 1. Flexural cracking in base of stair

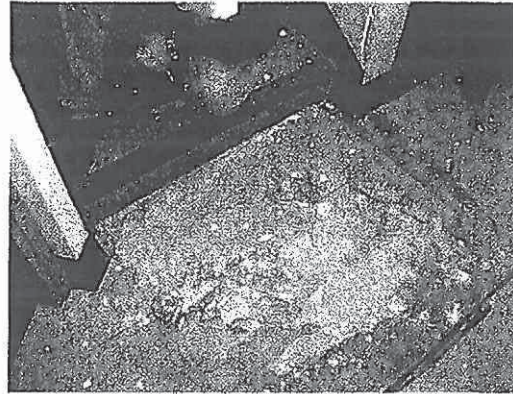
Photo 2. Spalling of concrete at stair knee.

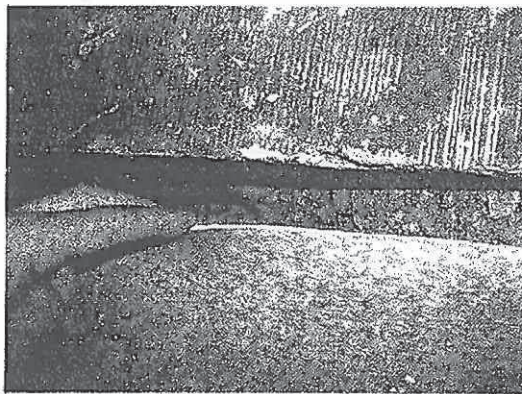
Photo 3. Debris in Seismic separation

- Cleaning of loose debris from the seismic separations at the base of all stairs.
- Propping of Car ramp beam to level 2 slab below, and a further prop from that slab to the level 1 slab below that.
- The scissor stairs are available for normal use after health and safety issues have been addressed.
- The loose debris should be cleared from the seismic separated gaps at the end of each stair flight to allow movement as originally intended.
- The current temporary propping to the car park ramp beam at level 2 will allow pedestrian access but not vehicle access to the supported ramp.

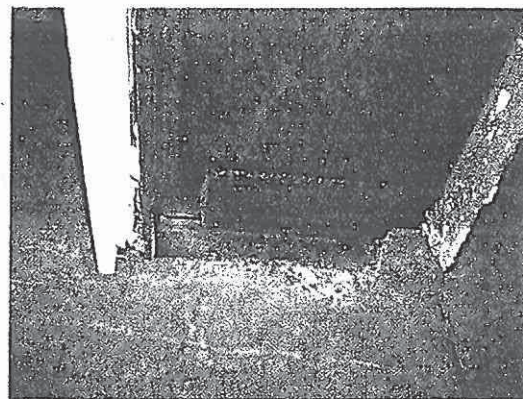
As noted in the Level 2 assessment, a failed weld in the beam supporting the car ramp on Level 2 has failed resulting in ~40mm of settlement. Propping will be required from the beam down to the level 2 slab, then also down from level 2 to level 1 slab.

Photo 4. Broken Weld

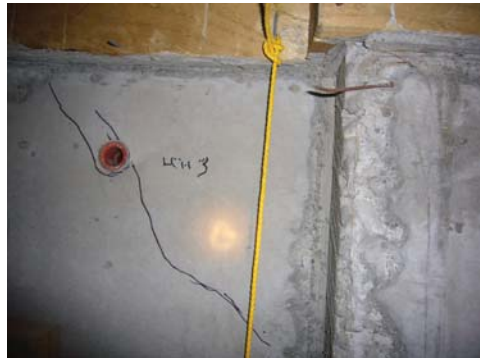
Damaged Item	Example
<p>1. Minor flexural cracking was observed in the concrete beams at the beam-column joints on all floors inspected (cracking shown in example photograph highlighted by permanent marker). All cracks measured were less than 0.2mm.</p>

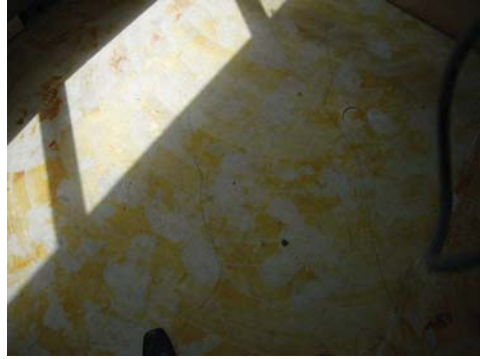
<p>2. Cracking to slab adjacent to concrete frames for levels 9 and 13 (cracking shown in example photograph highlighted by permanent marker). Cracks measured were less than 0.2mm and required no repair.</p>

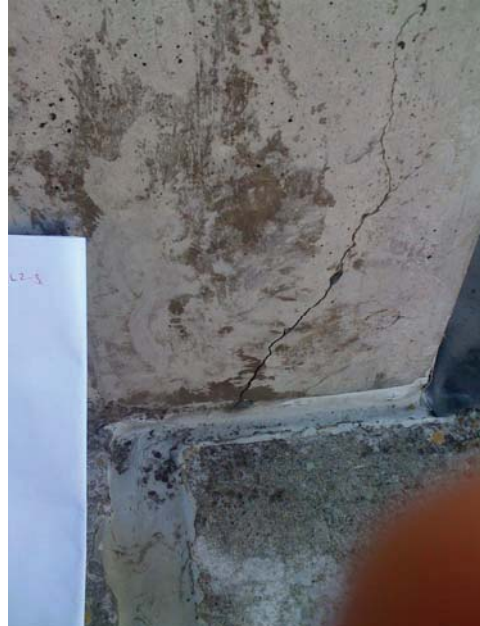
<p>3. Cracking to columns within car park levels</p>	
<p>3.1. Column on grid K between grids 13 and 14 had cracks measuring up to 0.5mm at the base of the column at the location of the seismic joint.</p>

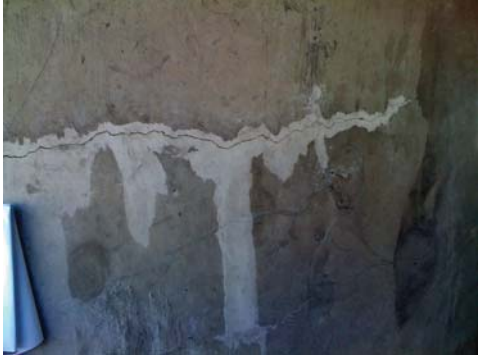
Damaged Item	Example
<p>3.2. Column on grid M between grid 13 and 14 had cracks measuring up to 0.8mm.</p>

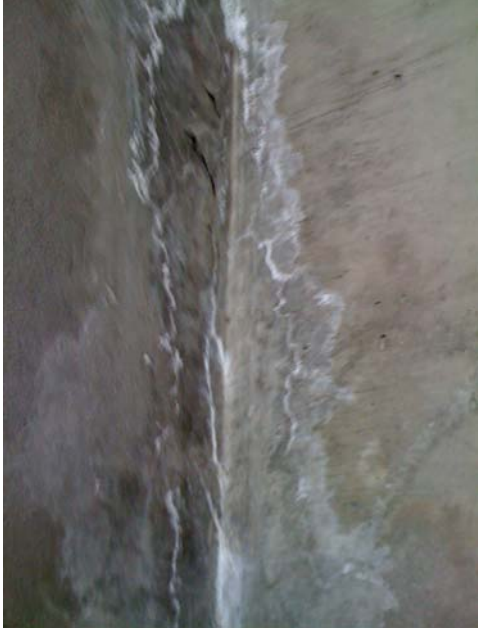
<p>4. Other items specific to car park levels (Levels 1-3)</p>	
<p>4.1. Minor cracking and spalling was observed at the beam to beam joint on grid M/13. Staining due to water leaching through the joint was observed.</p>

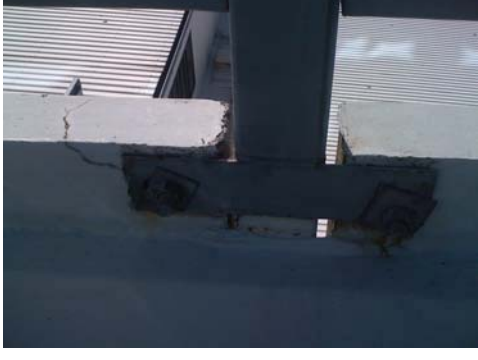
<p>4.2. Cracking in the curb at the location of the balustrade fixing to the car park level slabs was observed. Some rust staining to the bolts and cleat plate was observed, both above the slab as shown in the example photograph and also to the cleats and bolts fixing the balustrade to the underside of the slab.</p>

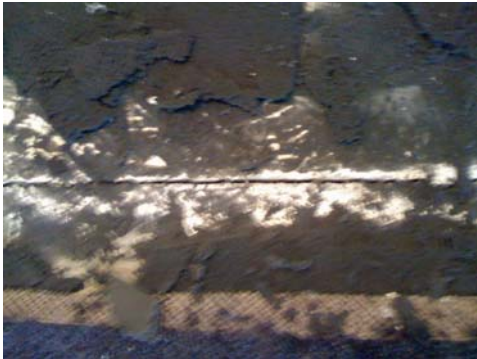
Damaged Item	Example
5. Inspection of Level 7 and 9 floors as requested	
5.1. The infill slab over the previous stair void sustained only minor cracking in one corner of the infill slab. The cracks measured were less than 0.2mm in width. The example photograph shows the joint between the infill and main level 7 slab.

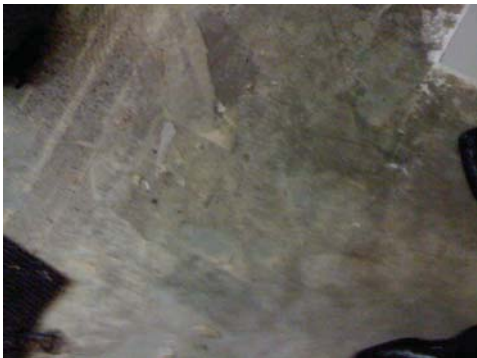
5.2. The floor topping over the main floor slab causing the uneven floor at level 9 showed no signs of damage.

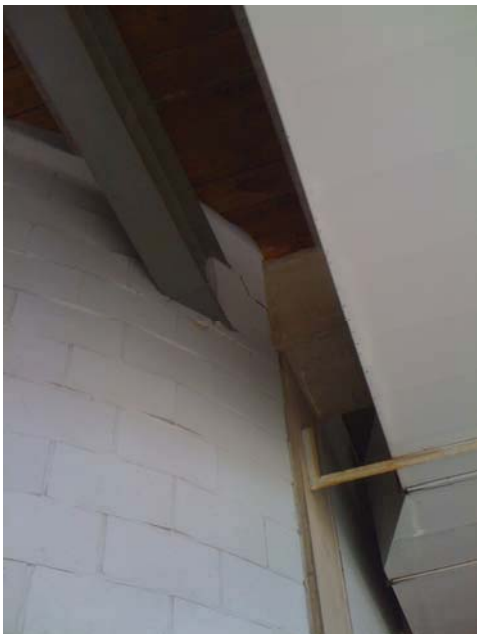
6. Cracking had occurred to the masonry wall at the entry to the car park. The steel beam shown supports the ramp between levels 1 and 2. At the time of the inspection, it was unable to be determined if the wall was load bearing or if the beam was fixed to the concrete beam or column shown in the photograph.

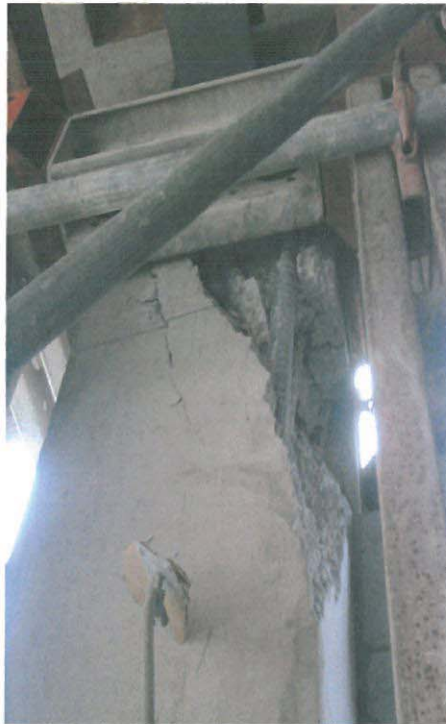
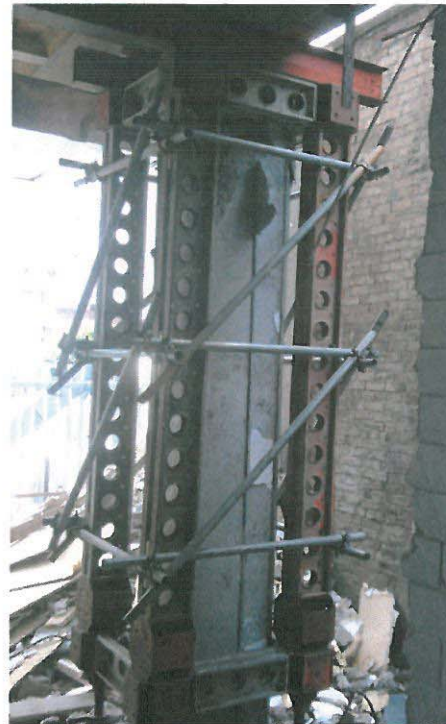
The damage to the east elevation consists of cladding removed by USAR to remove the collapsed stairs, car-park barrier on the top car-park level section removed by USAR for stair

removal, South east ground floor car-park column has failed at the underside of the cantilever. Propping for the failed has been installed by USAR.

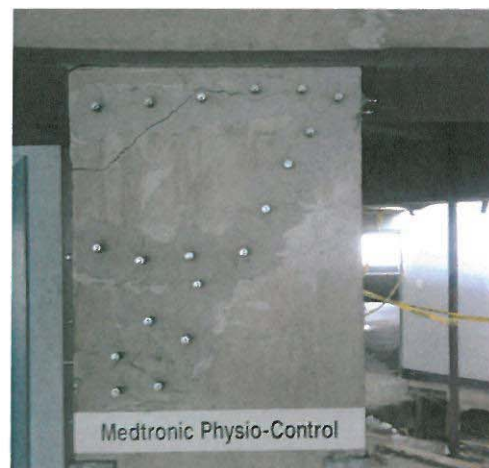
The car-park columns have cracked in general in similar locations to the September 4th earthquake. The injection repairs for these were being carried out around the time of the February 22nd earthquake.

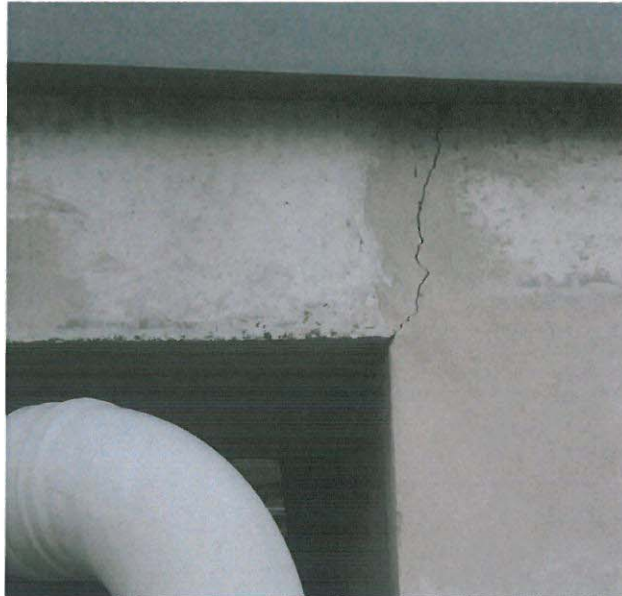
Only the lower half and underside of the forth floor tower beams is visible from the third floor car-park deck. Limited cracks less than 1mm are visible at the beam column interface.

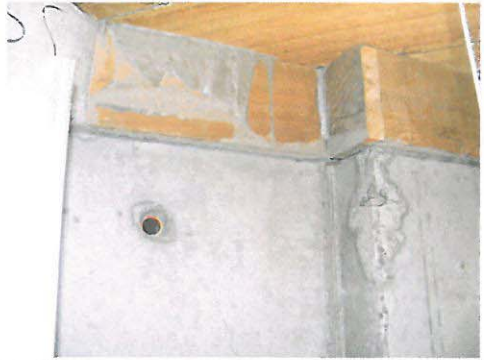
Damaged Item	Example
Up to 0.5mm cracks to moment resisting frames

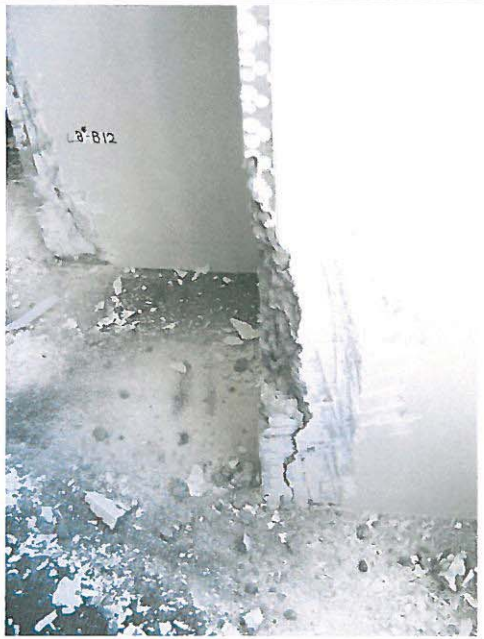
Spalling of concrete to base of corner columns

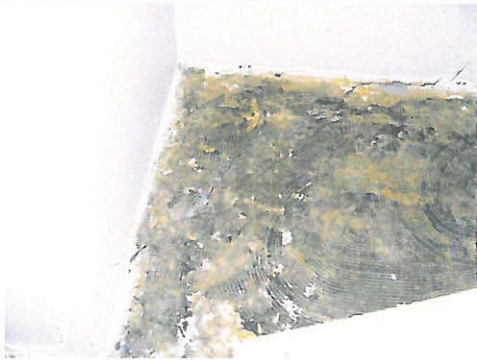
Damaged Item	Example
Up to 4.0mm cracks to floors around corner columns

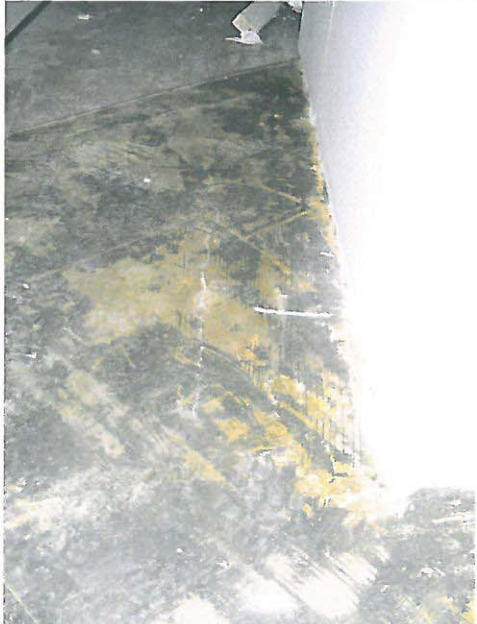
Up to 2.0mm cracks around other columns

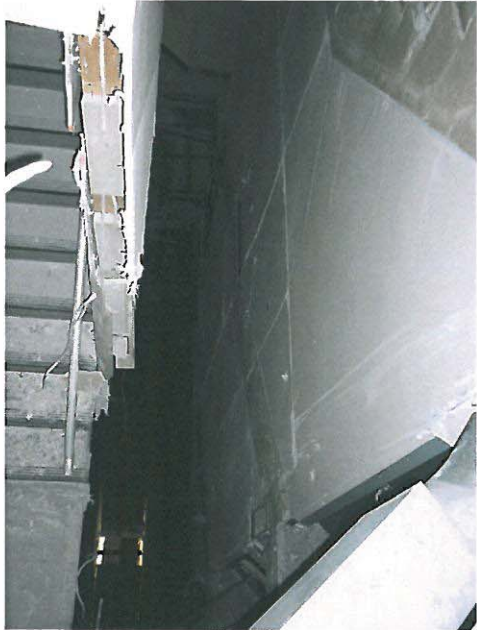
Damaged Item	Example
Collapsed stairs

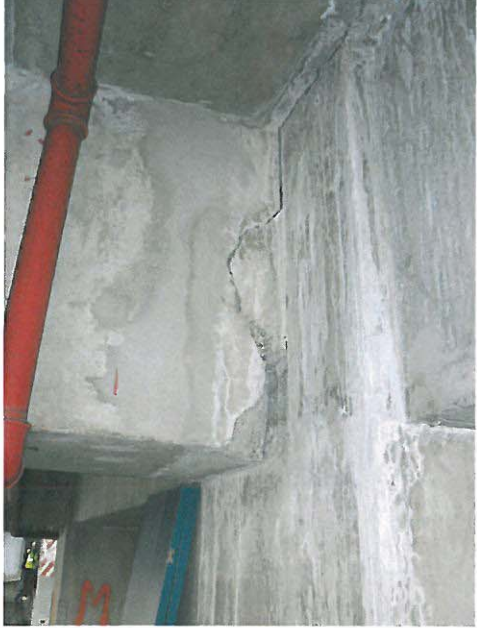
A photograph showing a section of a staircase that has collapsed. The concrete steps and supporting structure are broken and displaced, with debris visible. The remaining structure is dark and appears to be made of metal or concrete.
Damage to tie between podium and main structure

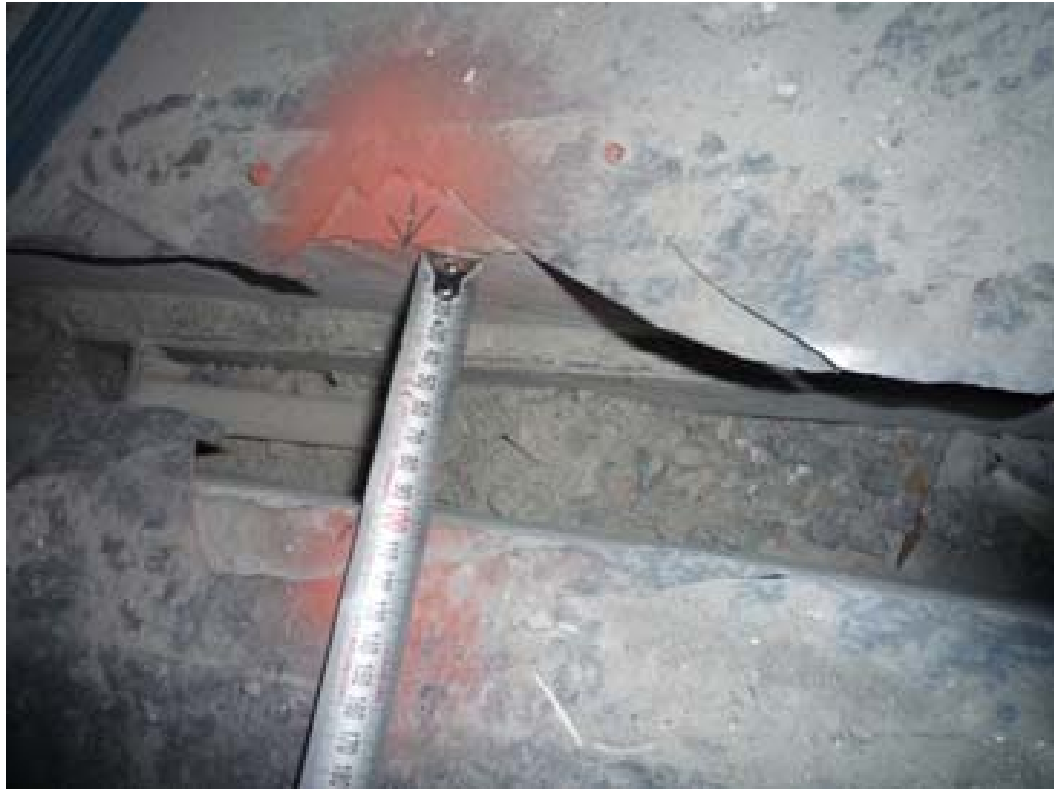
Figure A2.6.1: Level 15 North-West Unit, South-West Landing, Gap with 23 mm Removed off Unit

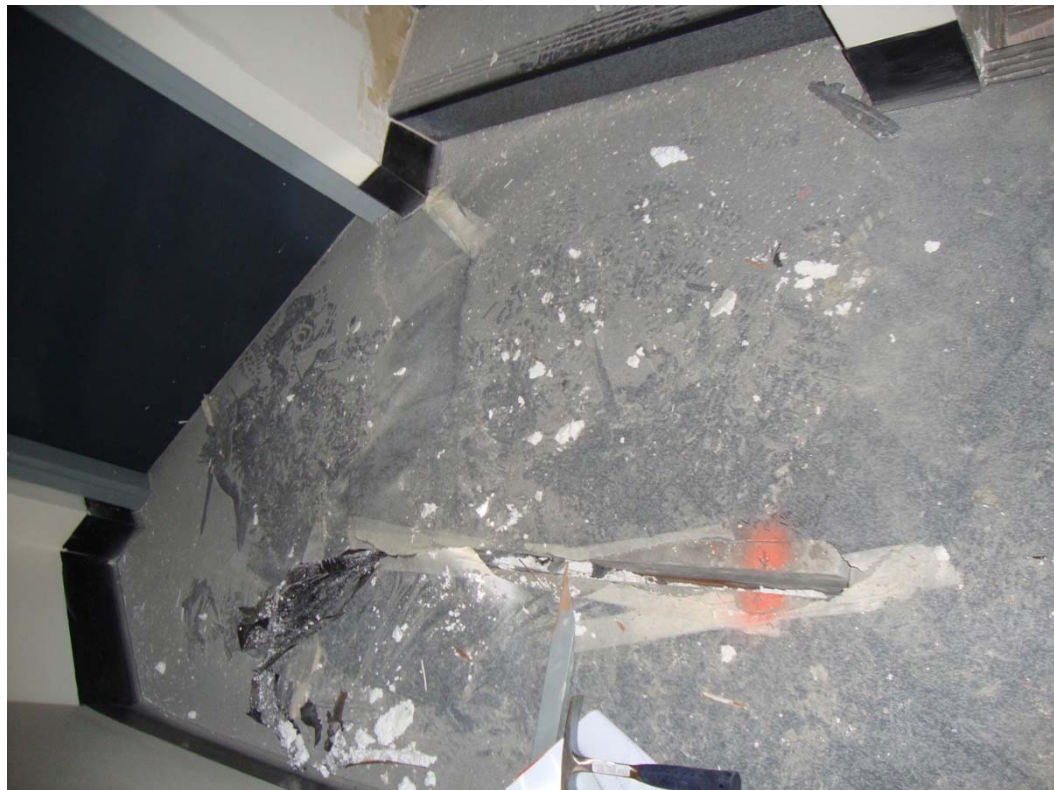
Figure A2.6.2: Level 16, North-East Landing, South-East Unit, Seismic Gap with 20 mm Polystyrene Sheet Infill

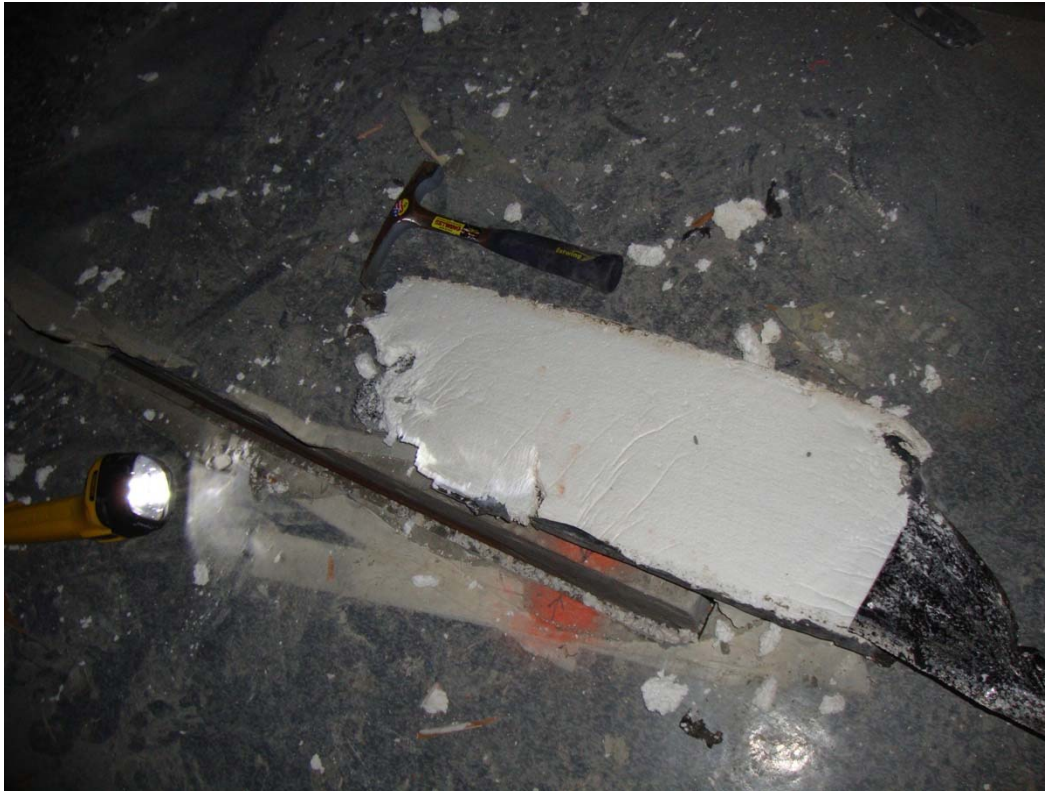
Figure A2.6.3: Level 16, North-East Landing, South-East Unit, Seismic Gap with 20 mm Polystyrene Sheet Infill Removed

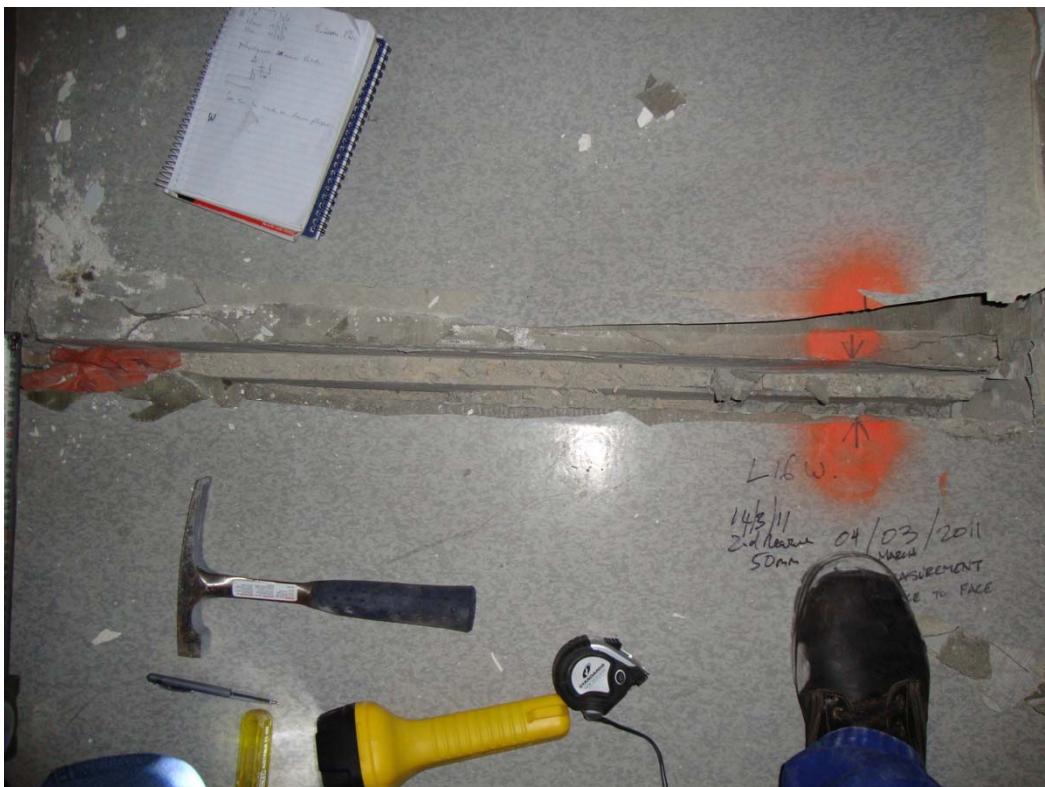
Figure A2.6.4: Level 16, South-West Lobby, North-West Unit, Seismic Gap with Stepped Landing

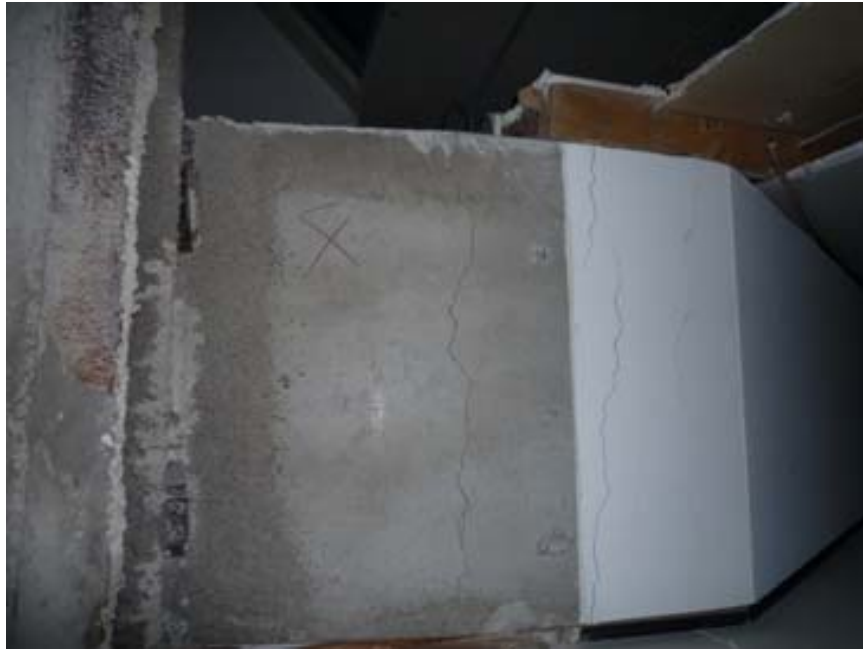
Figure A2.6.7: Level 16, South West Lobby, Looking up at Underside of North-West Unit Showing Cracking
