2 May 2011

**Christchurch Earthquake:
Education Review Office in Pyne Gould Corporation Building**

SITE REPORT

PGC BUILDING. REINSPECTION, GROUND FLOOR WINDOW FRAME GAP, 2nd FLOOR PARTITION CRACK.

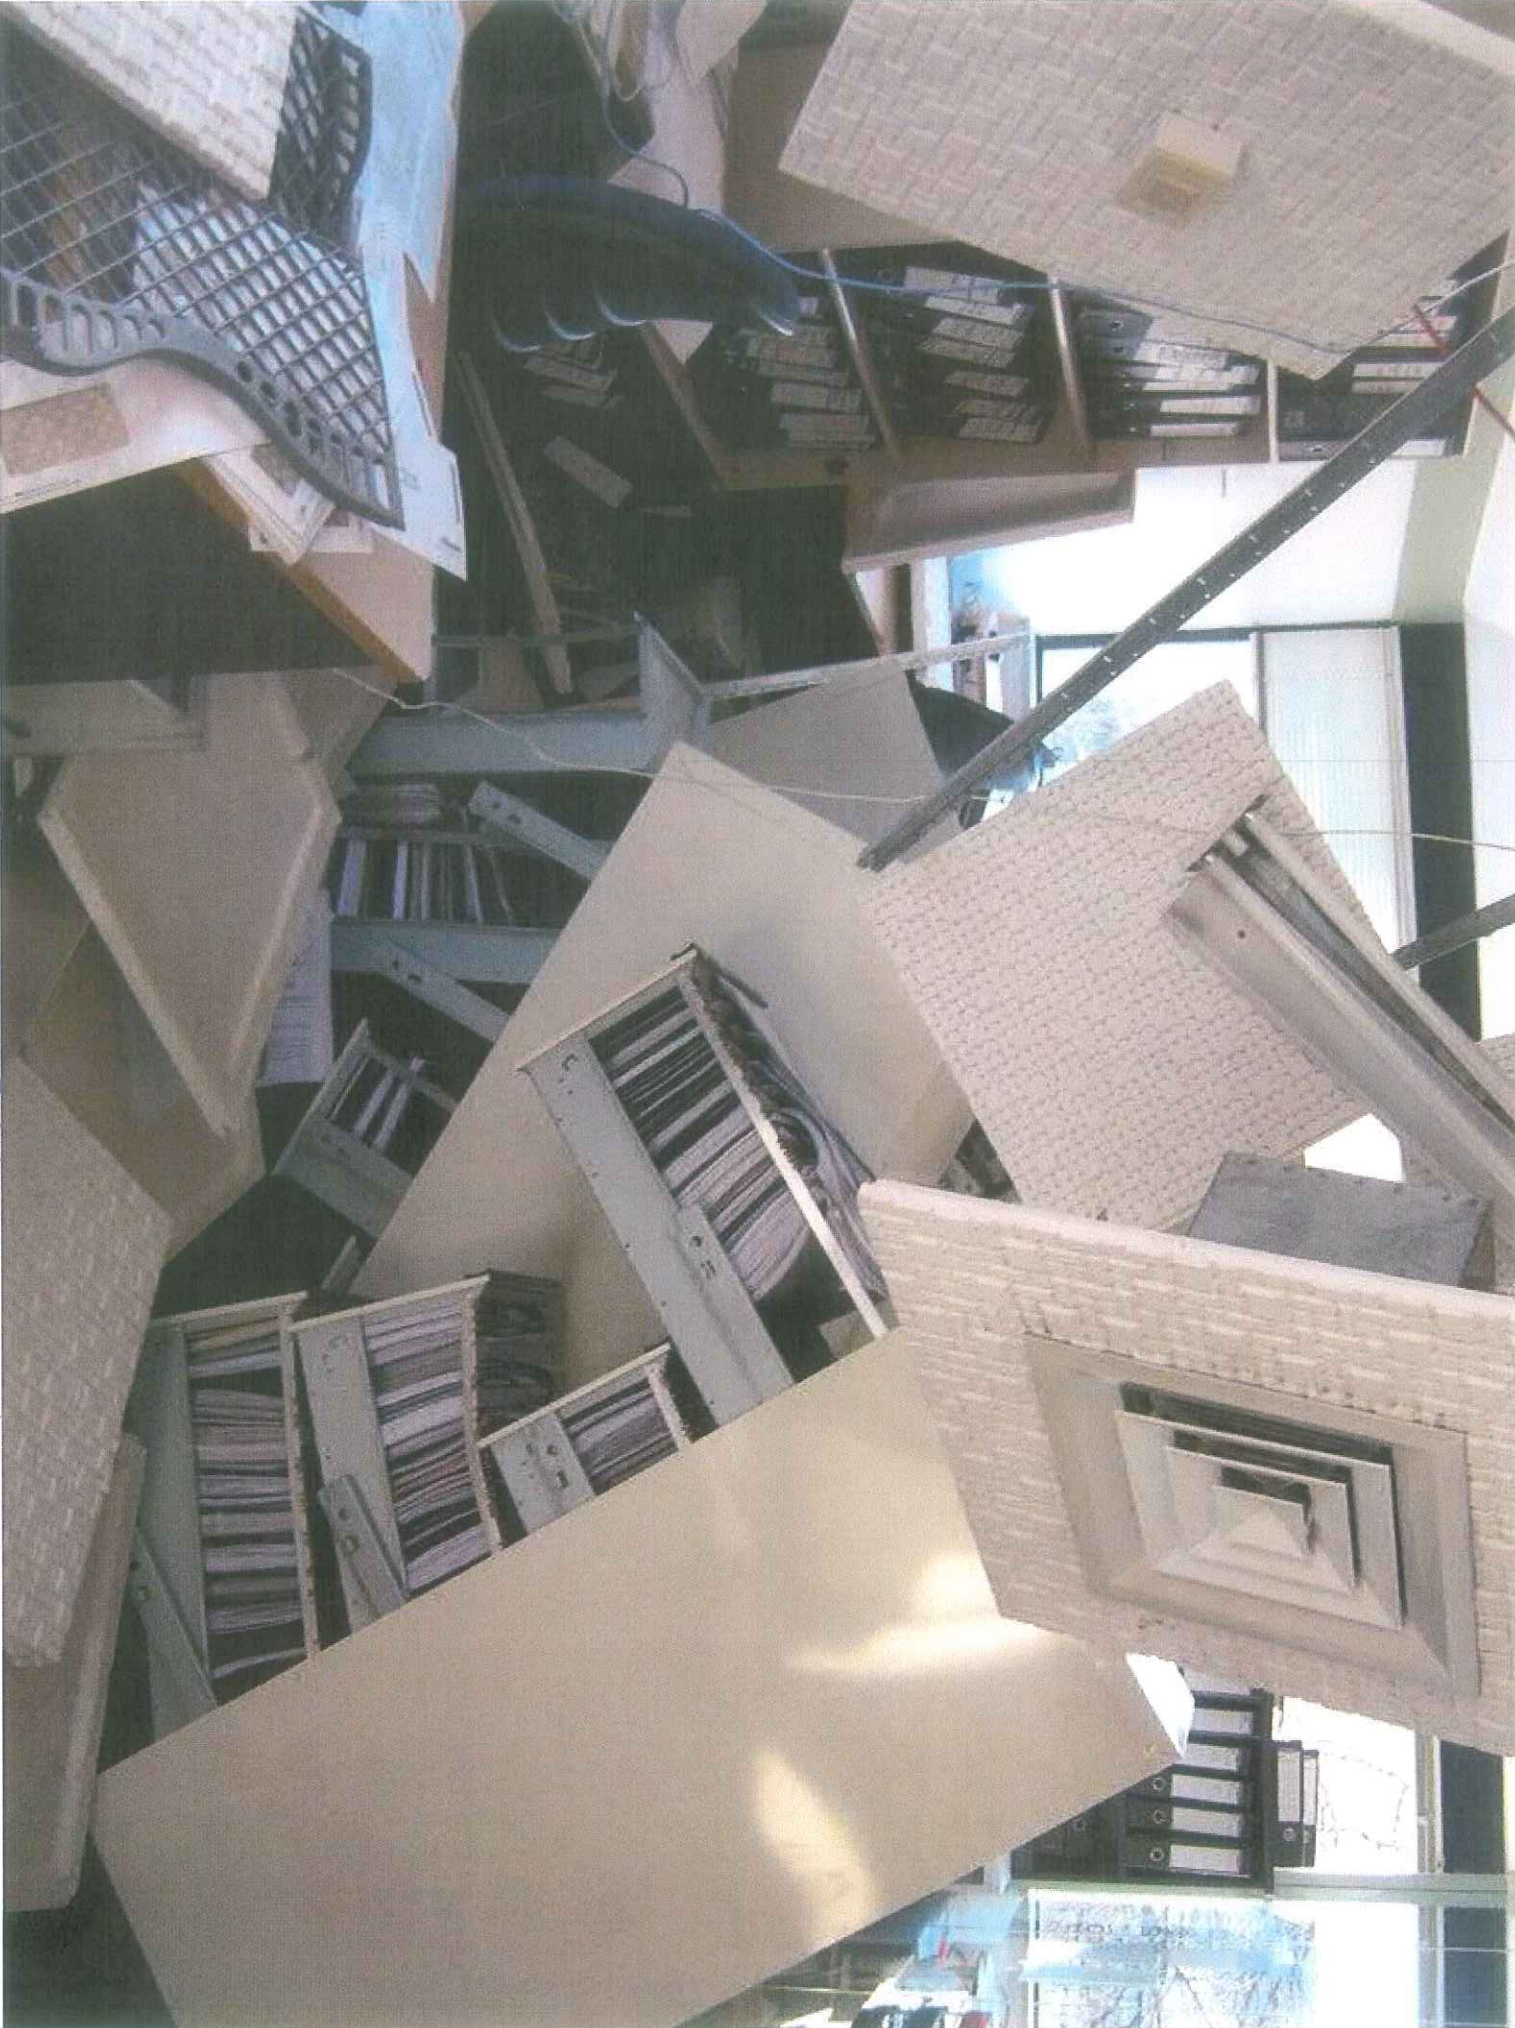
EAO Office Bldg 9 Sept 2010

The major damage to our office from the September 2010 earthquake was falling ceiling tiles. Following that earthquake ERO arranged for the building's management to replace the heavy plaster ceiling tiles with much lighter versions. We enclose photos of our office in September 2010 showing the damage and the replacement work.
