# FORSYTH BARR

FORSYTH BARR BUILDING STAIRS  
SITE EXAMINATION AND MATERIALS TESTS  
FOR DEPARTMENT OF BUILDING AND HOUSING  
22ND SEPTEMBER 2011

Report Issue Date: 22 September 2011

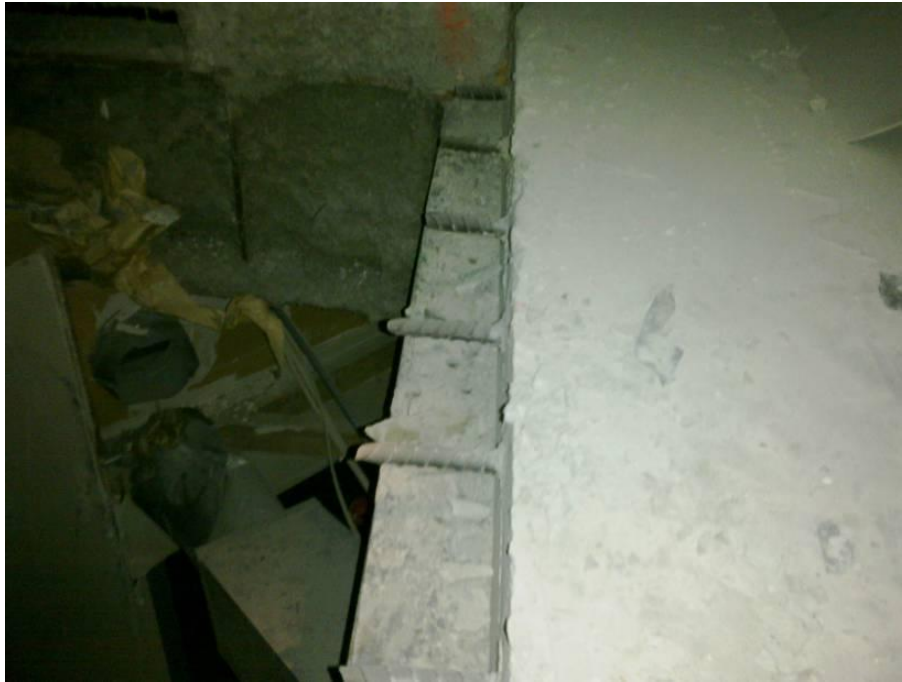
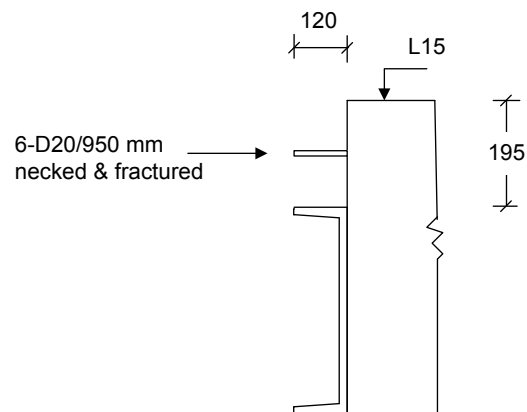
The fractured D20 reinforcing steel at the top supports of the stair flights from which the stair flights had broken away was visible (Figure 1).

Figure 1 – Level 15 Southwest Exit L15 to L14 stair upper landing with fractured D20 reinforcing steel above 381x102 mm RSC steel channel support

- f. At the upper supports from which stairs had fallen, the necked and fractured ends of six D20 reinforcing steel bars protruded 120 mm out of the concrete beams, just past the tip of the supporting 102

- mm wide flange of the supporting 381 × 102 RSC steel channel. The steel channel had not suffered any obvious damage (Figure 1).
- g. The ends of a number of lower landings of the stair flights had been saw-cut. However the saw-cutting stopped above the 80 mm × 80 mm steel seating angle embedded in the end of the landings, resulting in no change to the seismic separation gap at the base of the landing.

Necked and fractured reinforcing bars are left with 110 mm stick out from the upper, similar to what was seen on other upper landing supports (Figure 1).

The stair flight had fallen away and six D20 bars spaced evenly over 950 mm were exposed that had necked and fractured 120 mm from the edge of the concrete slab above the edge of the 102 mm wide top flange of the 381x102 mm RSC steel channel supporting it.

The top flange of the RSC steel channel appeared to be undamaged (Figure 1).

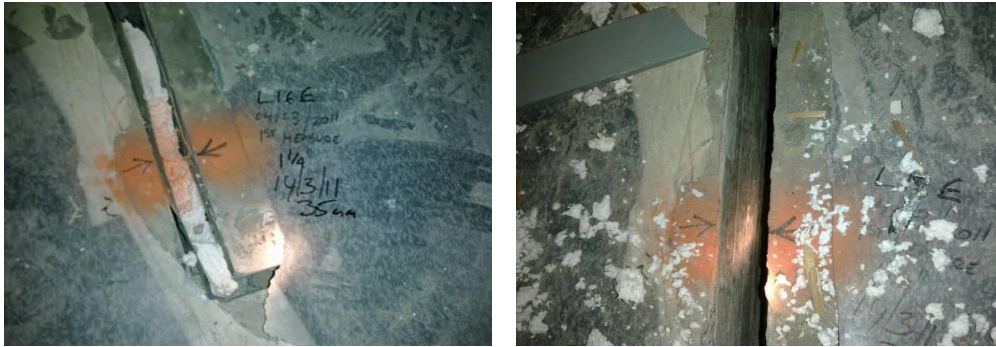
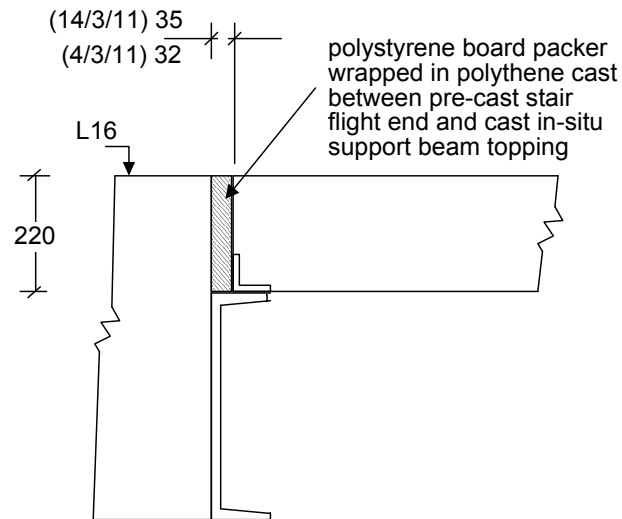
During the Stairwell Examination a polystyrene construction packer was found in the gap in one of the remaining stair flights. In that instance it had not been subsequently removed to provide the specified gap shown in the Drawings (Figure 2).

Figure 2 - Level 16 Northeast Exit L 16 to L 17 Stair Flight lower landing and support: (photos from left to right): (a) Polythene wrapped polystyrene packer in seismic gap; (b) Seismic gap with packer removed during Stairwell Examination showing in-situ casting marks on support beam topping from packer wrapping.

A polythene wrapped polystyrene construction packer was found in this seismic gap. The packer was removed during the Stairwell Examination revealing casting marks on the support slab which was evidence that it had been installed during the original construction of the stairs.

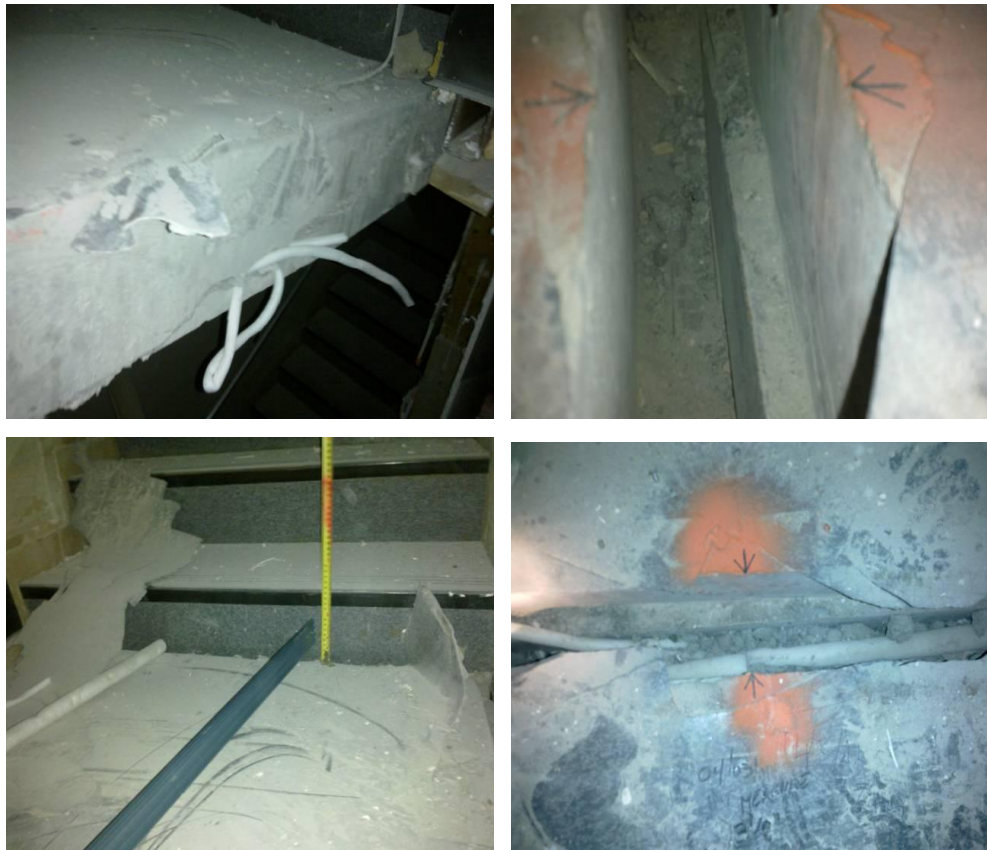
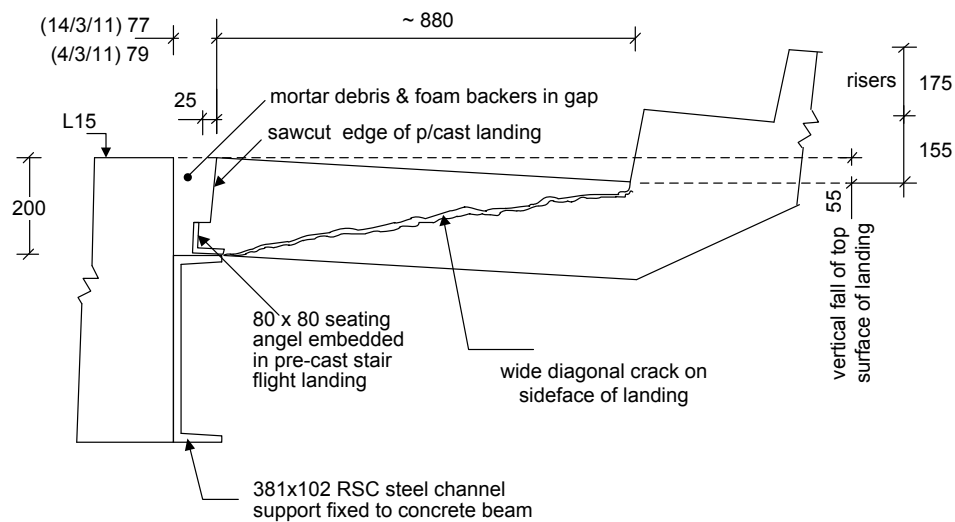
Figure 3 - Level 15 Southwest Exit LI5 to LI6 stair lower landing and support: (photos clockwise from top left): (a) Diagonal crack in the side face of the stair flight landing with expanded foam tube caught in it; (b) Seismic gap with debris removed showing saw-cut end and ledge at seating angle; (c) Seismic gap measurement with debris; (d) Vertical slumping of the landing at the first riser

- e. The L15 to L16 stair flight observed at the Level 15 Southwest Exit had visibly slumped downwards 55 mm at the junction of the lower landing to the first riser (Figure 3). At Level 16 Southwest Exit the lower landing of the L16 to L17 stair flight had dropped 25 mm at the junction of the landing with the first riser (Figure 4).

This stair flight remained in place but was not examined below its upper support from this location due to safety reasons. However the condition of its lower landing is described in the Level 12 Southwest Exit L15 to L16 Stair Flight section (Figure 3).

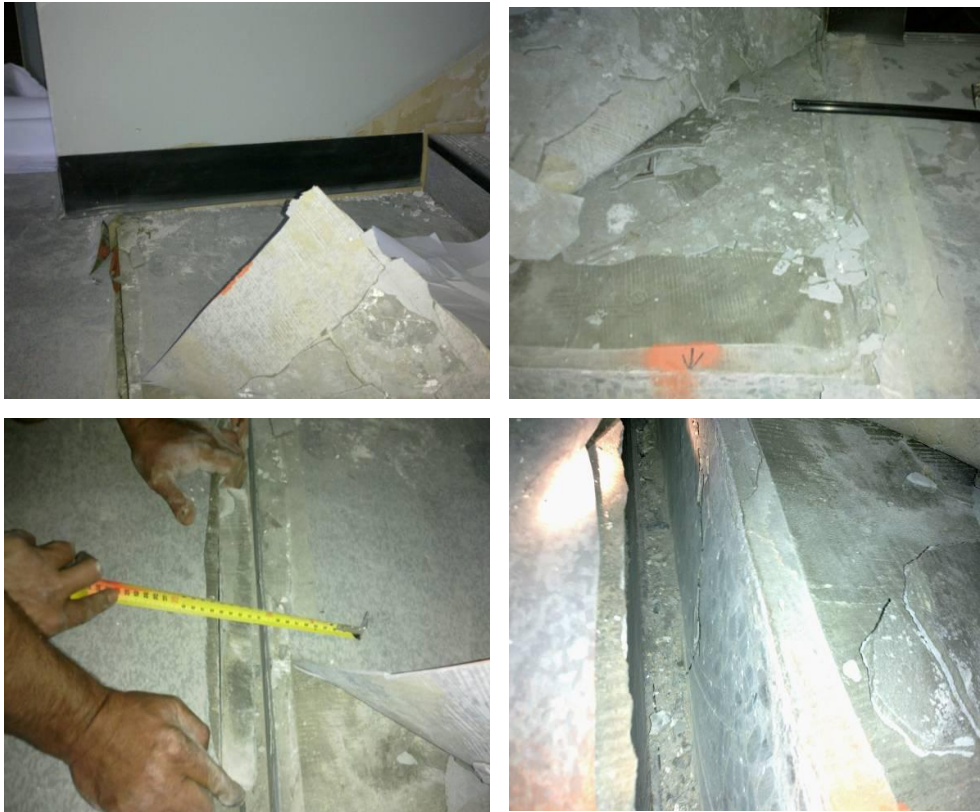
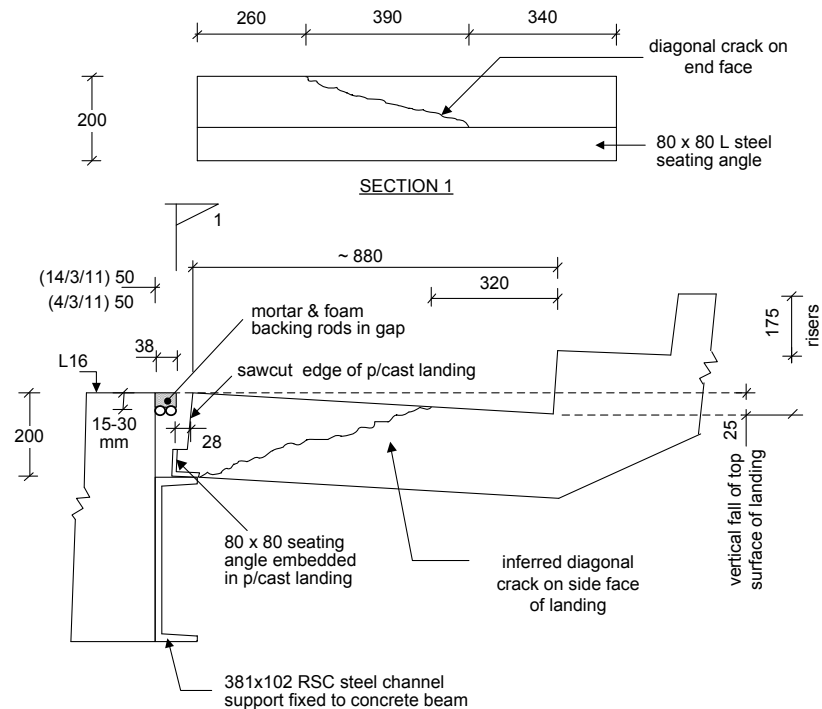
It was also found that the seismic gaps had also been compromised in a number of instances by the installation of a rigid mortar strip up to 30 mm thick seated on expanded foam rods, rather than being filled with flexible sealant as specified in the Drawings (Figure 4).

Figure 4 - Level I6 Southwest Exit L16 to L17 Stair Flight lower landing and support: (clockwise photos from top left): (a) 25 mm drop in landing at first riser; (b) Diagonal crack along top face of landing; (c) Adjoining diagonal crack in sawn face of precast landing; (d) 38 mm wide mortar remnant held back in original location.

- h. The gap at the top of these saw-cut landings had been filled with up to 30 mm thick of mortar on expandable foam backing rods (Figure 4 and Figure 11). This mortar strip was found by testing to have an average compressive strength of 20.4 MPa. This compromised the ability of the stairs to slide and was evidently strong enough to transmit compressive actions sufficient to cause damage to the landings. Mortar debris was also found in the gaps of some saw-cut landings.

The lower landing had a diagonal crack on the top surface that linked to a matching one on the end face. It is therefore surmised that a corresponding diagonal crack occurred on the side face. But this was obscured by the upper L16 to L15 stair flight landing which was still in place (Figure 4).

Mortar remnants up to 30 mm thick and 38 mm wide were found that had been supported by two expanded foam rods over part of the seismic gap. Mortar debris was also found in the gap.

Compressive strength testing of the mortar strip by Opus International Consultants Ltd Christchurch Laboratory, ("Opus Laboratories Christchurch") found it to have an average compressive strength of 20.4 MPa.

The stair flight was still in place but was not examined below its upper supports from this location for safety reasons. However the condition of its lower landing is described in the Level 16 Southwest Exit L16 to L17 Stair Flight section (Figure 4).

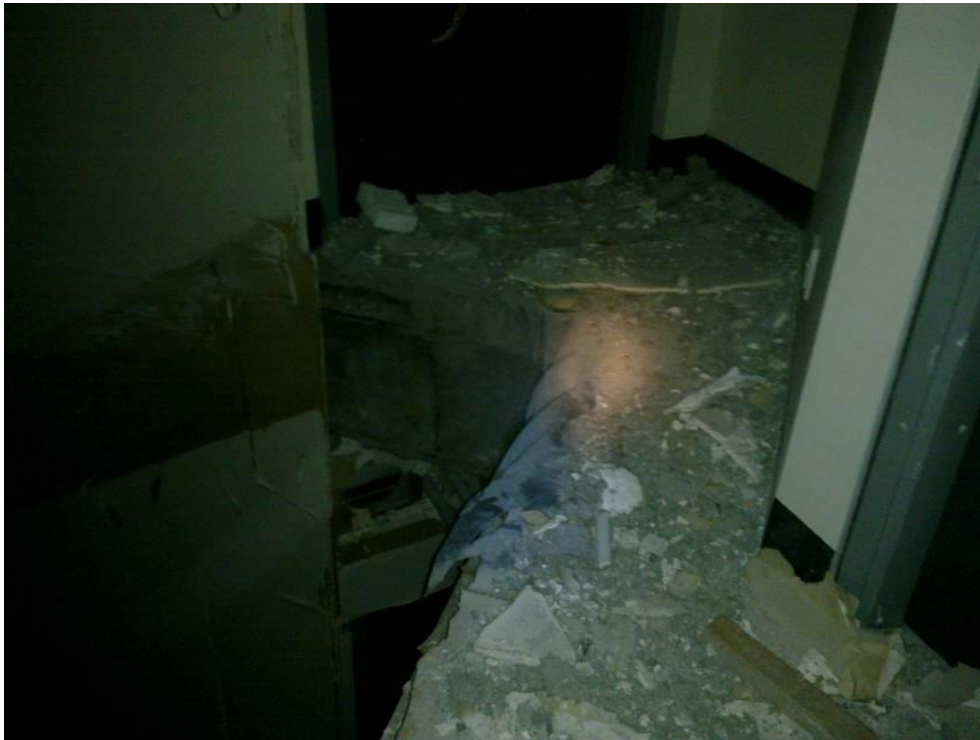
It is likely that this stair collapsed after it was hit by stairs falling from above judging by the tearing pattern in the lino (Figure 6).

Figure 6 - Level 9 Southwest Exit L9 to L8 Stair Flight upper support with fractured D20 reinforcing and lino that appears to have been torn by stairs falling from above

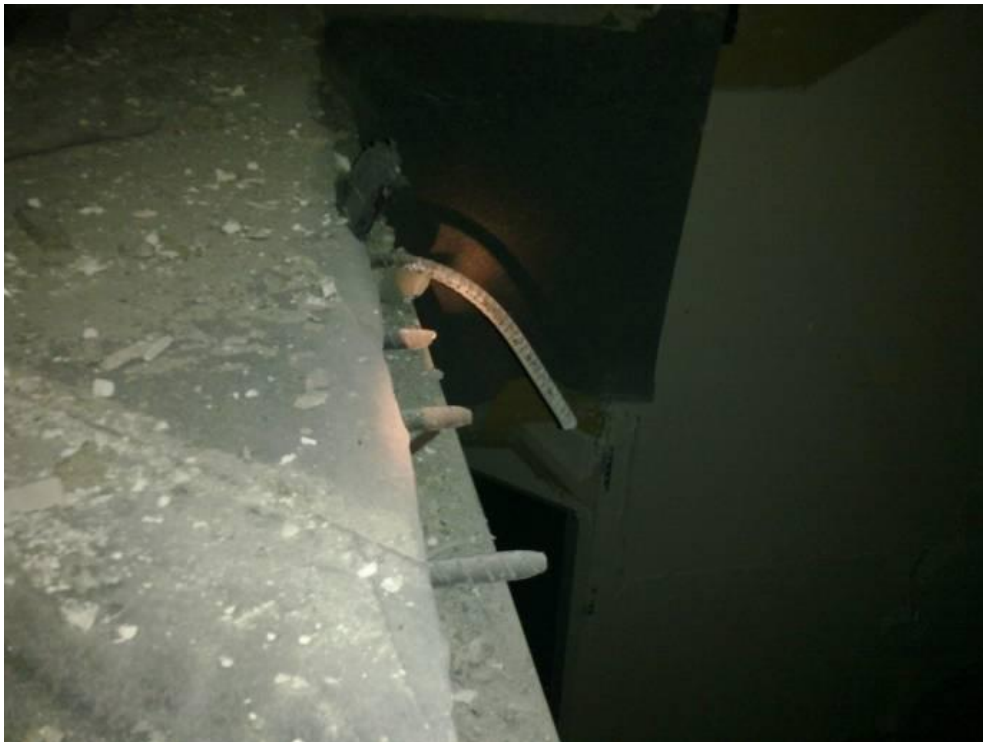
One bar had de-bonded from the precast stair whereas the other five D20 bars have necked and fractured in a similar manner to other landing supports. The remaining D20 bar stubs extend 120 mm out from the supporting concrete beam face.

Figure 7 -Level 12 Northeast Exit L12 to L11 stair flight upper support with one de-bonded bar and five fractured D20 bars extending out from the support beam. The 381 x 102 RSC steel channel is undamaged and continues over to the L12 to L13 lower support.

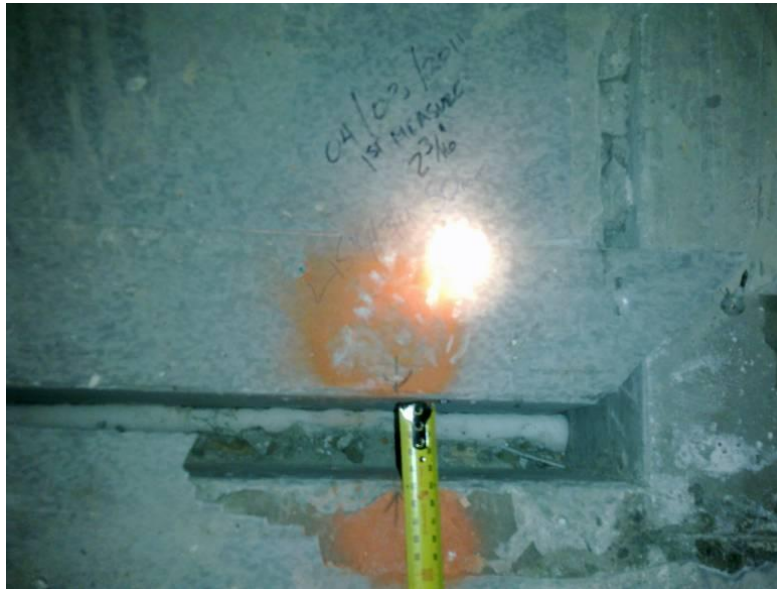
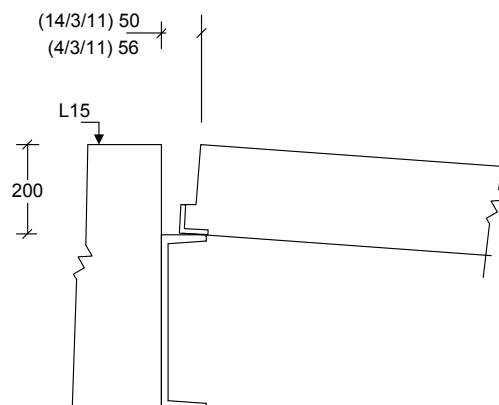
Figure 8 - Level 15 Northeast Exit L15 to L16 Stair Flight lower landing seismic gap

This stair flight was still in place but was not examined from this location below its upper support for safety reasons. However the condition of its lower landing is described in the Level 15 Northeast Exit L15 to L16 Stair Flight inspection (Figure 8 and Figure 9).

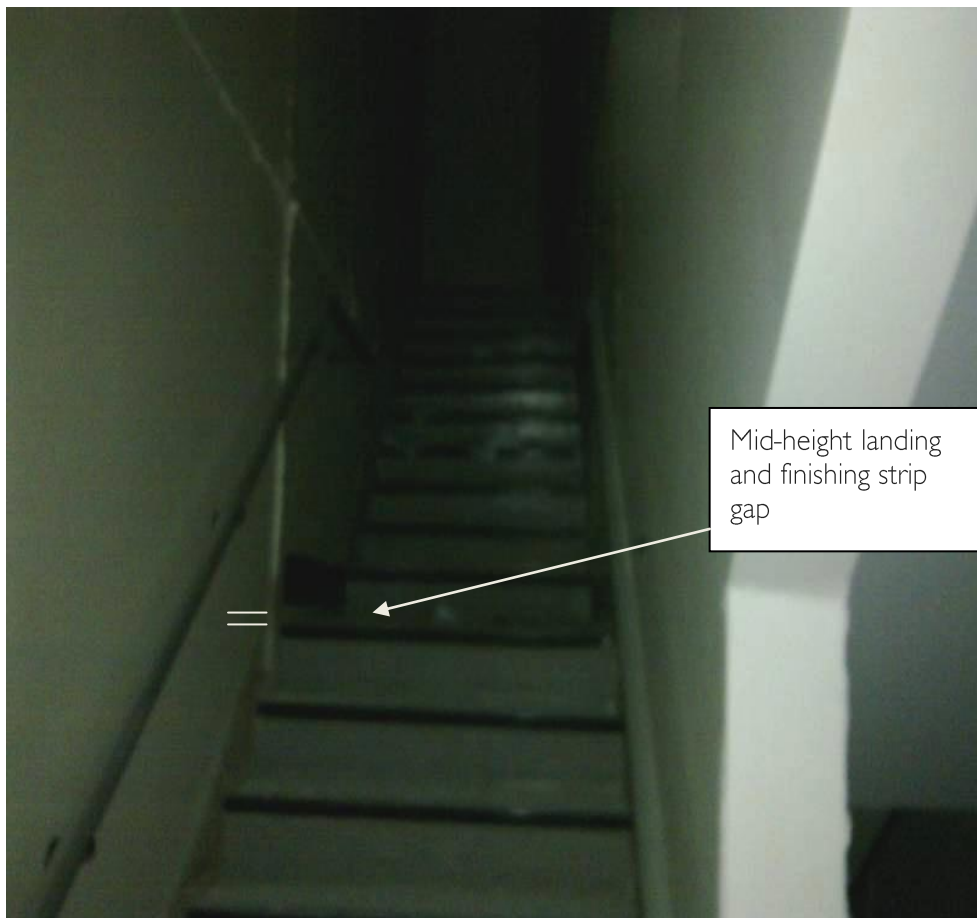
Figure 9 - Level 15 Northeast Exit L15 to L16 Stair Flight showing vertical displacement at mid-height landing relative to black finishing strip.

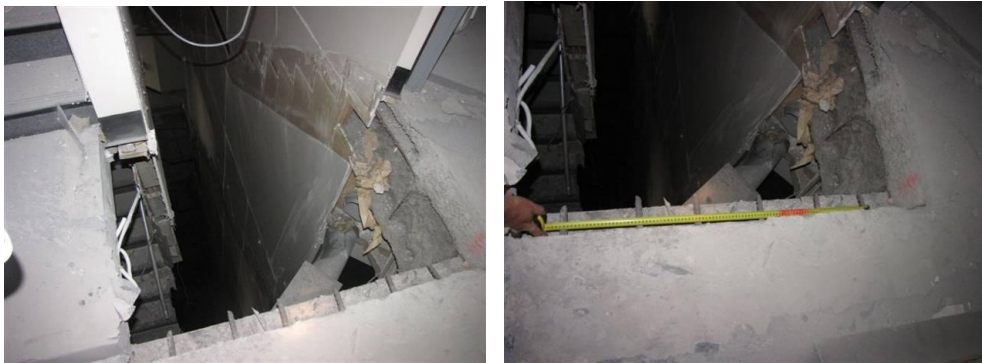
The stair flight was still in place but was not examined below its upper supports from this location for safety reasons. This stair flight could also be seen below the Level 15 Southwest Exit L15 to L16 Stair Flight (Figure 10).

There is a void where the stair flight had fallen away (Figure 10).

Figure 10 - Level 15 Southwest Exit: (photos from left): (a) Remaining Level 15 Southwest Exit L15 to L16 stair flight lower landing with the remaining Level 14 Southwest Exit L14 to L15 Stair Flight able to be seen directly below. All flights below and including the Level 15 Southwest Exit Level 15 to 14 stair flight have fallen away; (b) Fractured reinforcing remnants at upper support of the Level 15 Southwest Exit L15 to L14 flight which has fallen away.

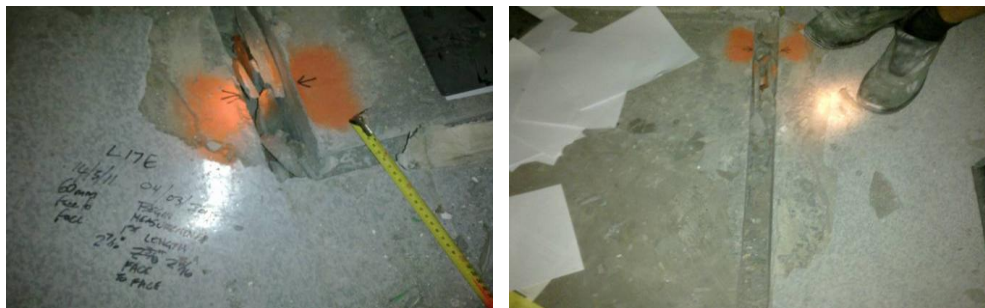
Figure 11 - Level 17 Northeast Exit (left to right) (a) L17 to L18 stair flight seismic gap measurement where a portion of the mortar strip had been removed previously by other parties; L17 to L16 stair flight in foreground. (b) Extent of remaining mortar filling of seismic joint of L17 to L18 stair flight.

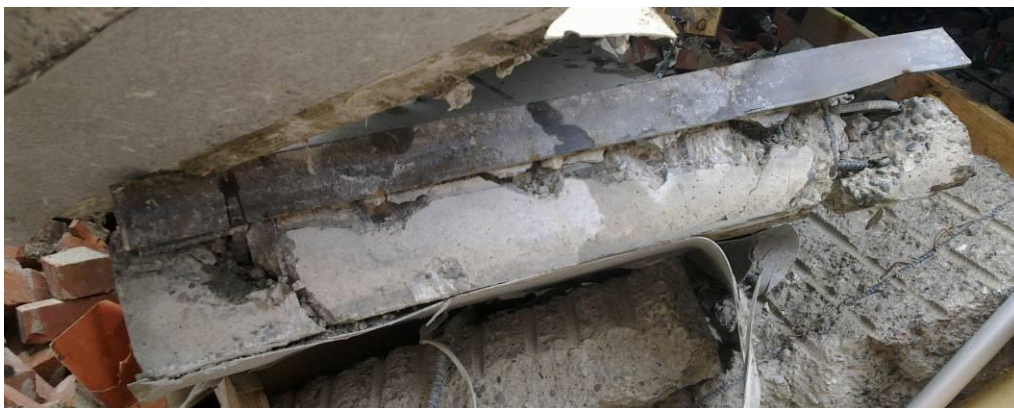
Necked and fractured reinforcing steel at the precast stair upper landings corresponding to that found in the stairwell supports was observed in a number of the stair remnants (Figure 15).

Figure 15 - Upper landing reinforcing steel fractures matching those seen in the stairwell supports. The steel seating angle to the underside and end of the stair flight landing is visible at the top

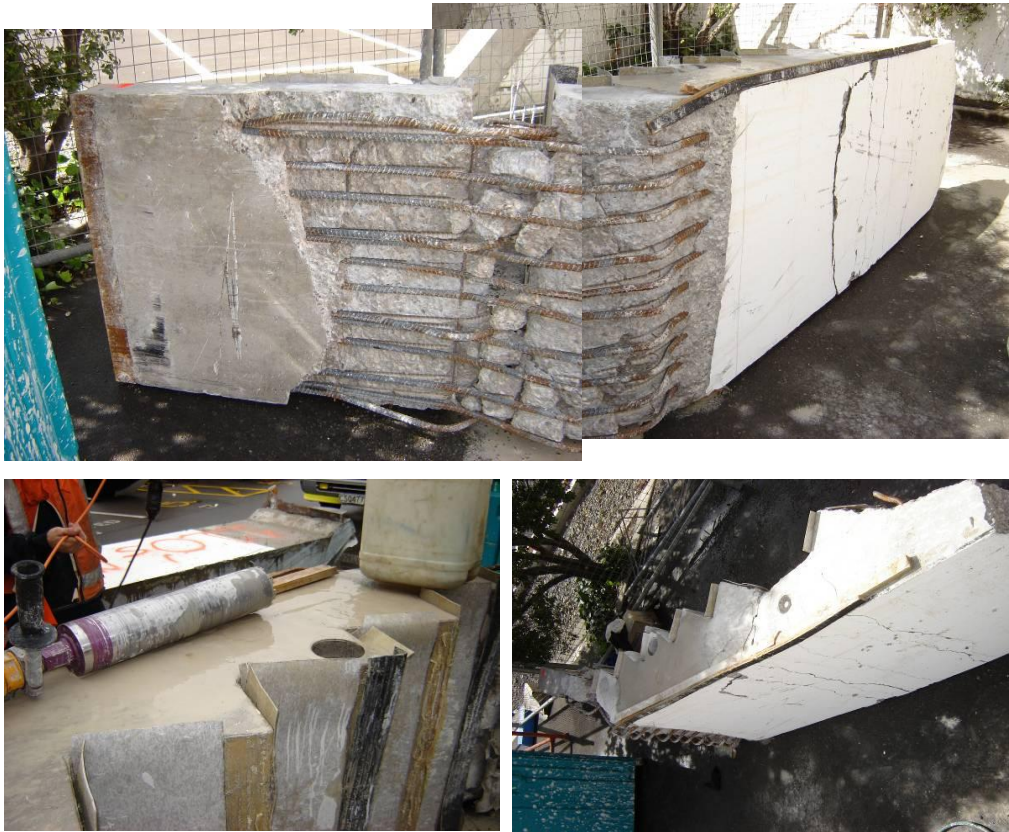
### A. UNIT 1

Figure 16 - Unit 1 (clockwise from top): (a) Flexural damage at underside of lower landing; (b) Flexural cracks in underside above lower landing; (c) Concrete core test location in tread.

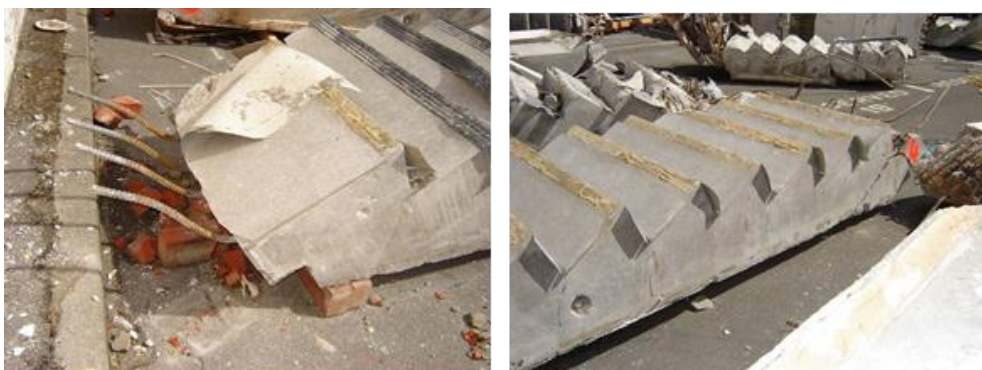
## D. UNIT 4

Figure 19 - Unit 4 (left to right): (a) De-bonded top landing bars (possibly from Level 2); (b) Cracks across stair throat at toes of risers.

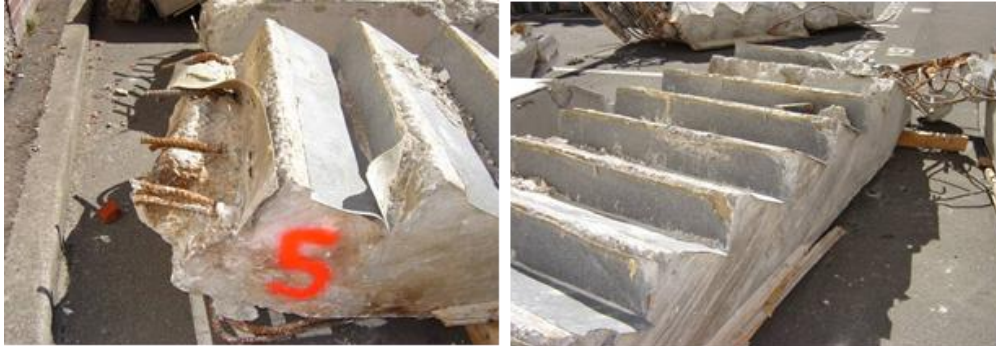
## E. UNIT 5

Figure 20 - Unit 5 (Clockwise from top left): (a) Gas cut rebar at mid-height landing; (b) Damaged upper landing.

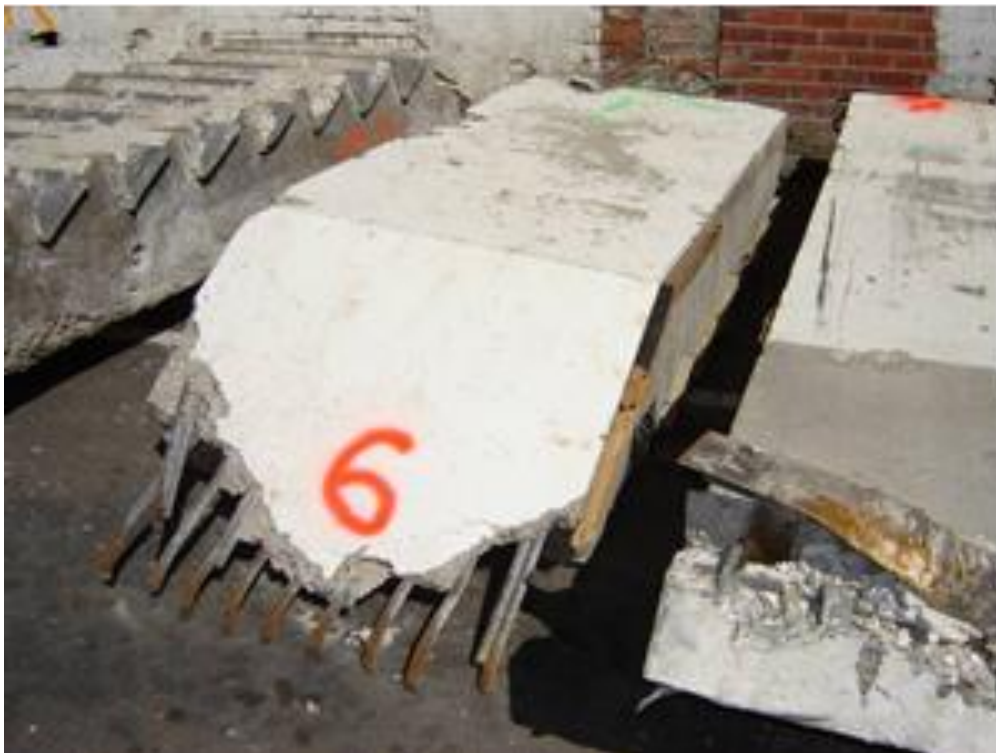
## F. UNIT 6

Figure 21 - Unit 6 broken up and gas cut landing. 30 to 50 mm cover to ten D20 reinforcing at underside of lower landing. The Unit 7 upper landing is at the right.

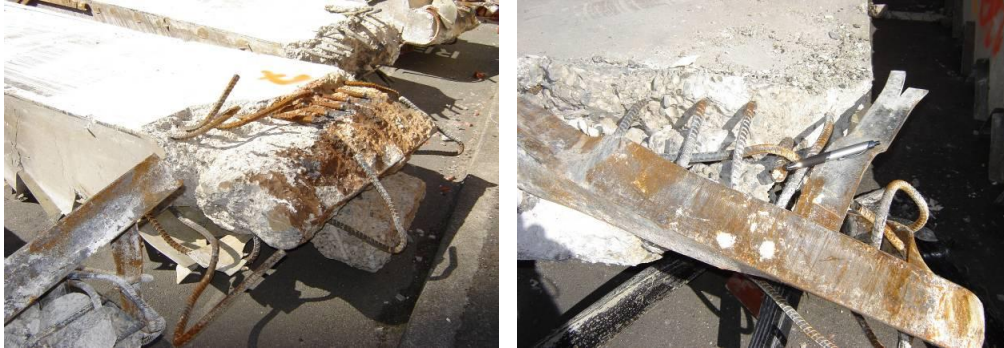
**G. UNIT 7**

Figure 22 - Unit 7 (left to right): (a) Gas cut mid-height landing bars. Cracks across throat at toe of risers; (b) Damaged upper landing steel seating angle.

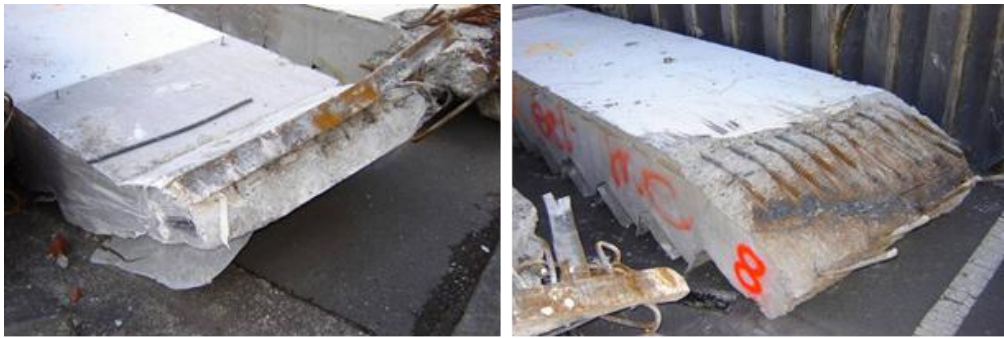
**H. UNIT 8**

Figure 23 - Unit 8 (left to right): (a) 300 mm long upper landing with 45 degree shear crack and damaged seating angle. Fractured D20 bar remnants in end face; (b) Gas cut mid-height landing b.

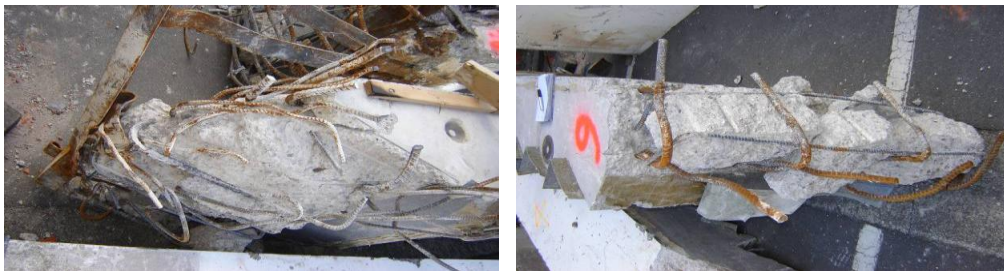
**I. UNIT 9**

Figure 24 - Unit 9 (Left to right): (a) Damaged upper landing; (b) Damaged mid-height landing with crushed concrete and de-bonded reinforcing.

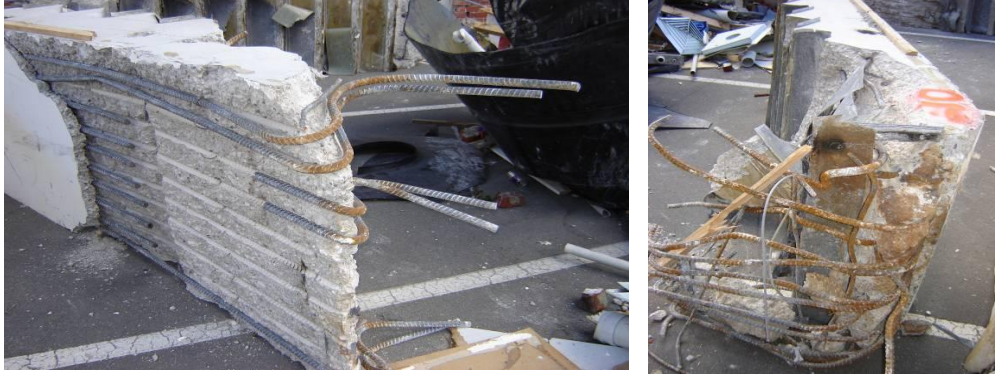
**J. UNIT 10**

Figure 25 - Unit 10 (left to right): (a) Underside near mid-height landing where D20 reinforcing steel samples were extracted for testing; (b) Damaged lower landing.

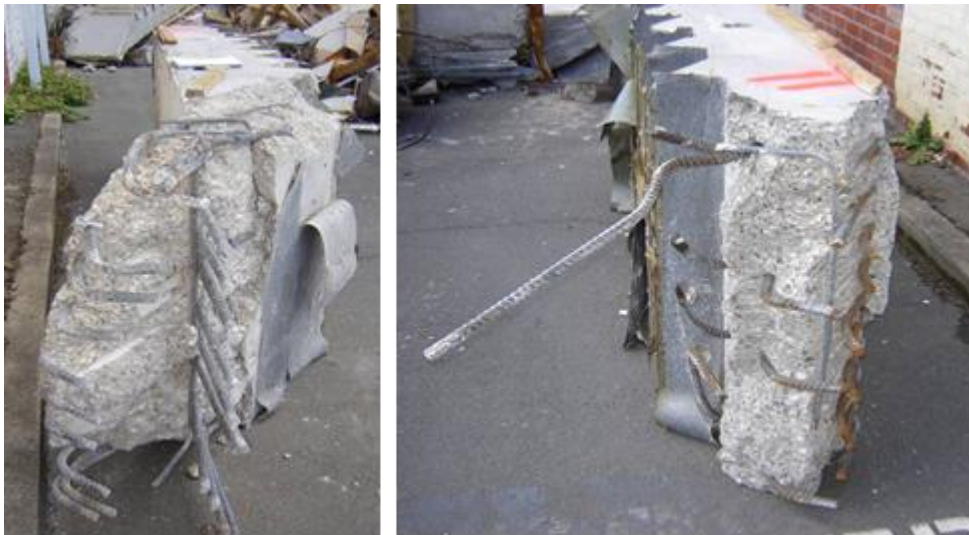
**K. UNIT 11**

Figure 26 - Unit 11 (left to right): (a) Damaged mid-height landing with hooked bottom bars (bars not gas cut); (b) Bottom rebar gas cut at lower landing junction to first riser.

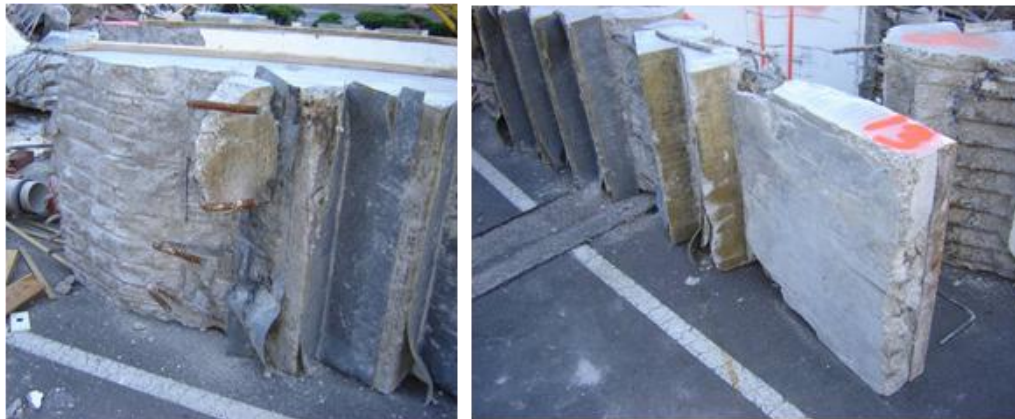
## M. UNIT 13

Figure 28 - Unit 13 (left to right): (a) Mid-height landing; (b) Lower landing 600-700 mm long with flexural damage at first riser

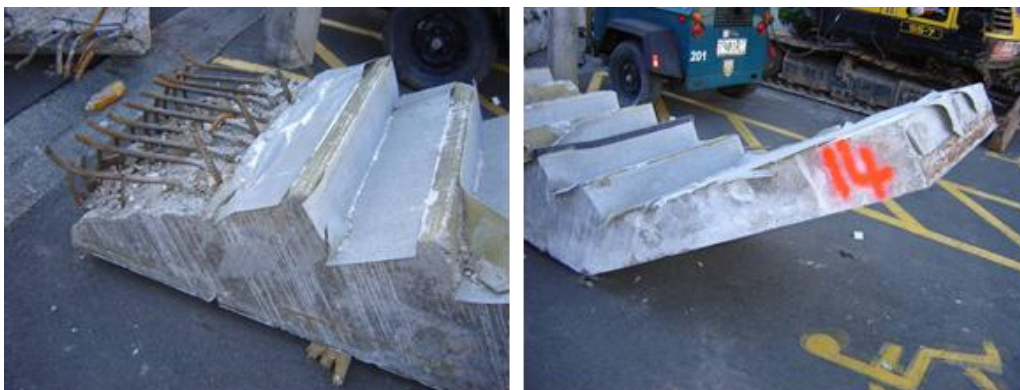
## N. UNIT 14

Figure 29 - Unit 14 (Left to right): (a) Mid-height landing bars gas cut; (b) Lower landing intact.

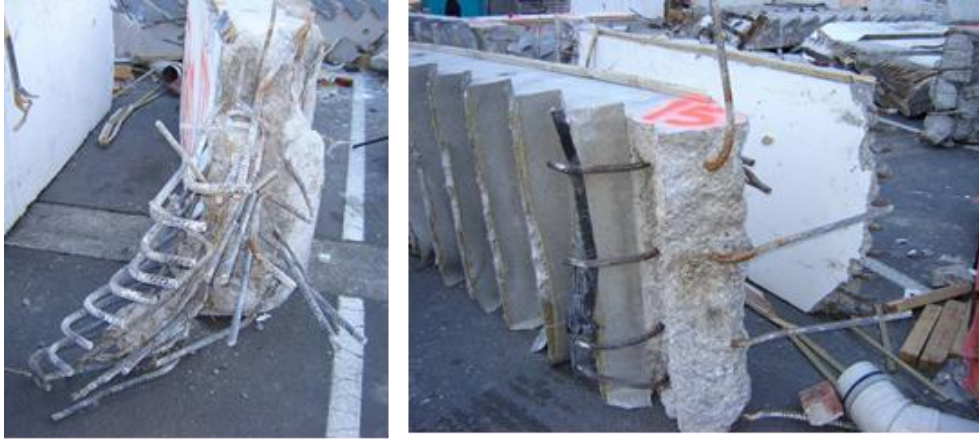
## O. UNIT 15

Figure 30 - Unit 15 (Left to right): (a) Damaged mid-height landing with hooked bottom bars; (b) Gas cut bars at lower landing which has broken away near first riser.

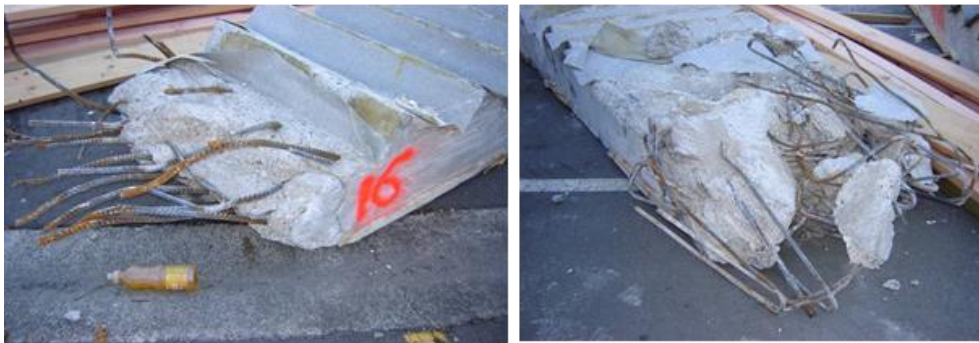
## P. UNIT 16

Figure 31 - Unit 16 (left to right): (a) Mid-height landing bars gas cut; (b) Damaged upper landing.

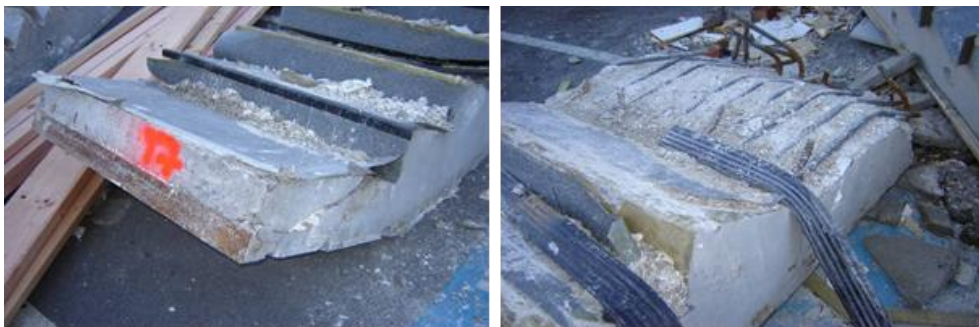
## Q. UNIT 17

Figure 32 - Unit 17 (Left to right): (a) Lower landing with compression support lateral impact shear cracking and saw cut end; (b) Mid-height landing ten D20 bottom bars bent and developed to underside of second riser below landing exposed, four D20 top bar stubs visible.

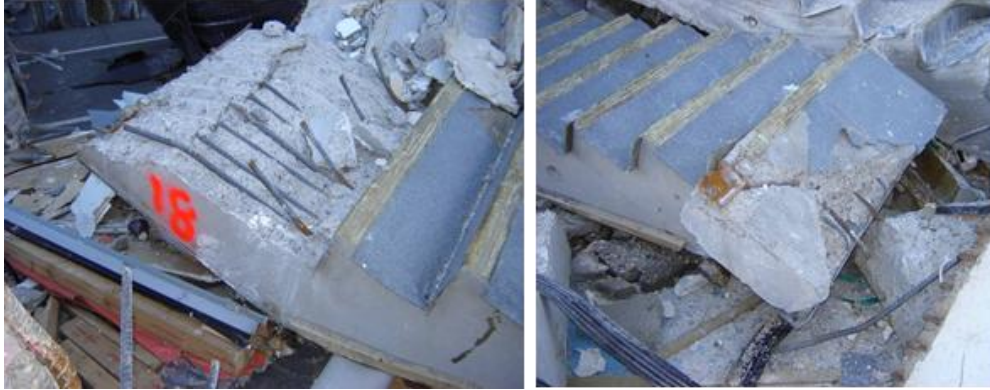
## R. UNIT 18

The Stair Remnants Examination found no evidence of there being a construction joint at the mid-height landings. The author considers that the stair flights were therefore cast as single pre-cast units able to be installed to span directly from the lower to the upper support without any temporary propping. The top bars from the pre-cast stair flights were then cast into the upper support.

Figure 33 - Unit 18 (Left to right): (a) Gas cut bars at mid-height landing. No construction joint apparent in side face indicating stair was precast as one unit; (b) Cut support bars at upper landing.
