Madras Equities Ltd

249 Madras Street

Damage Report

4 September 2010 Earthquake

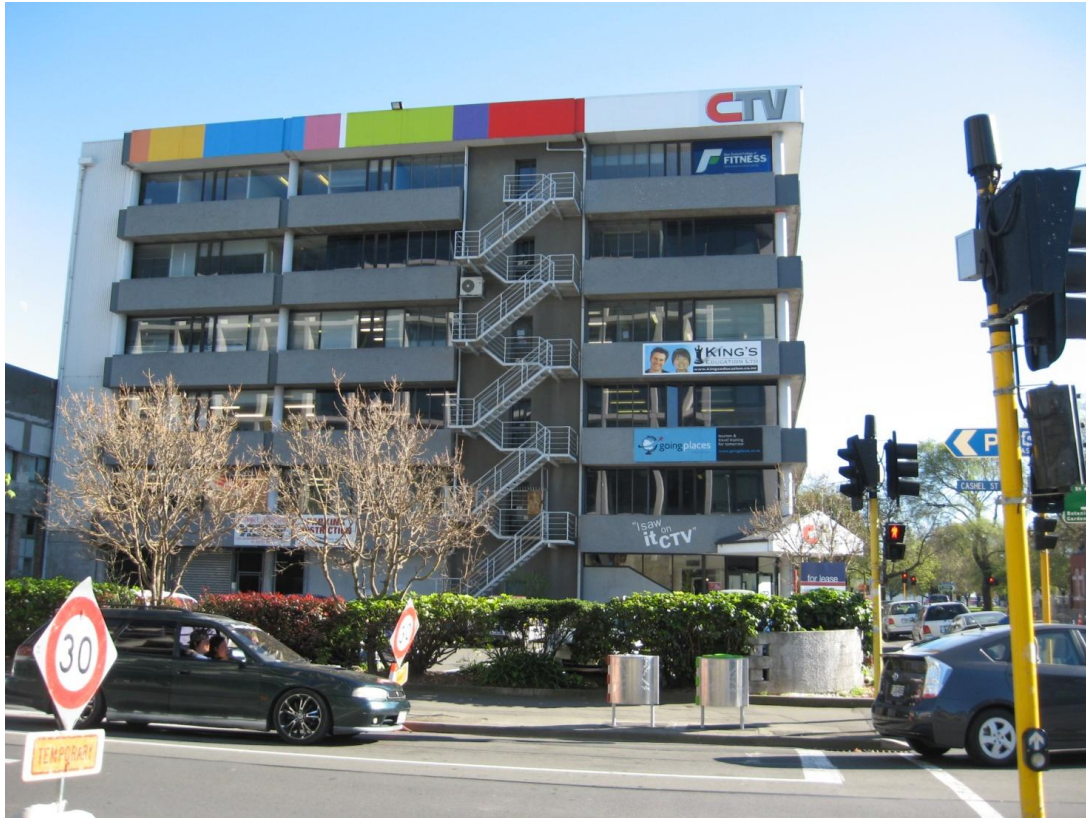
Photo 1 South Elevation of Building

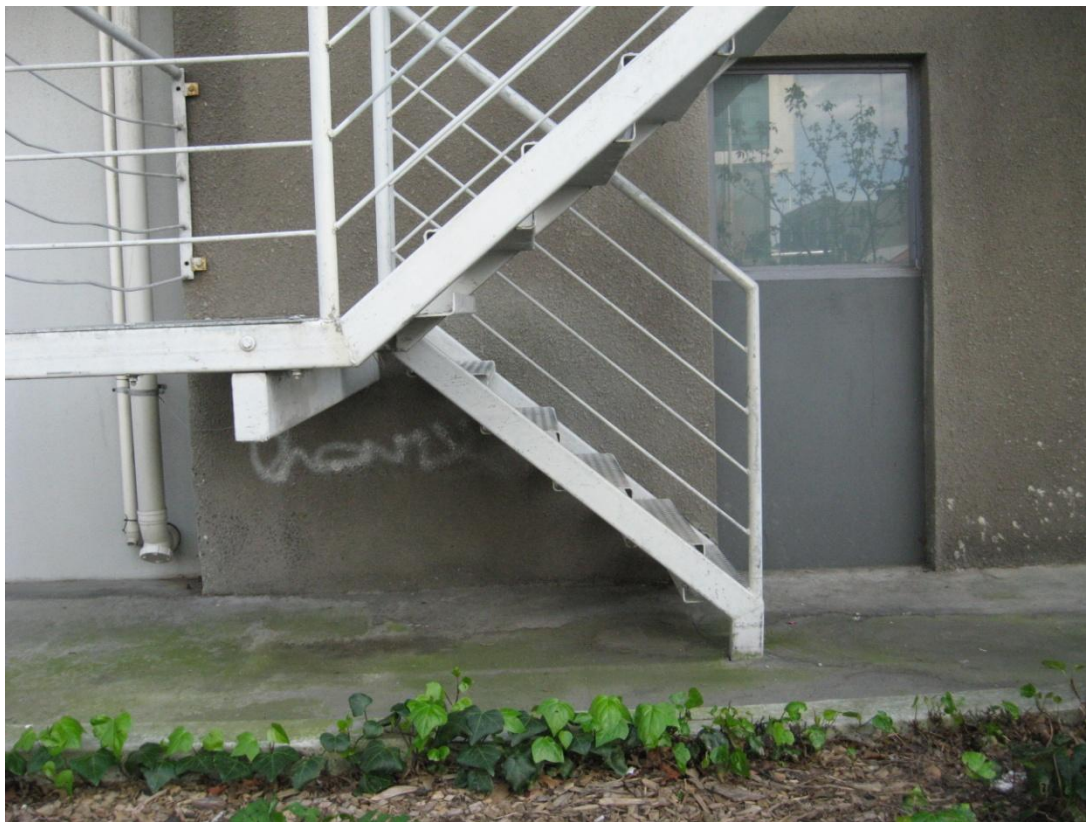
This wall is in fact what is termed a coupled shear wall. It has door holes in the middle of the wall at each storey providing access to the external fire escape. Beams across the door heads couple the walls, each side of the doors, together. The exterior of this wall is coated with a plaster splash coat. The rough texture of the finish on the wall makes it difficult to detect any cracking on the outside face, but there is one diagonal crack visible on the outside ground storey just below the fire escape landing. Photo 2.

Photo 2 Cracking in south shear wall (not visible in photo) under fire escape landing

No cracking was observed in the gypsum plaster lining of this wall at levels above the second floor. It seems likely that cracking is present in the ground storey portion of the wall, similar to that of the first storey. We would expect that any cracks present are relatively fine and similar in width to those on the first storey. We recommend that the internal ground storey strapping and plaster board lining be removed to view the structure behind. The lining is damaged and would have to be replaced anyway. Cracks greater than 0.2mm in width should be repaired with epoxy injection. The external surface of the wall should be protected against the ingress of water in any fine cracks with the application of a silicon sealer or similar.

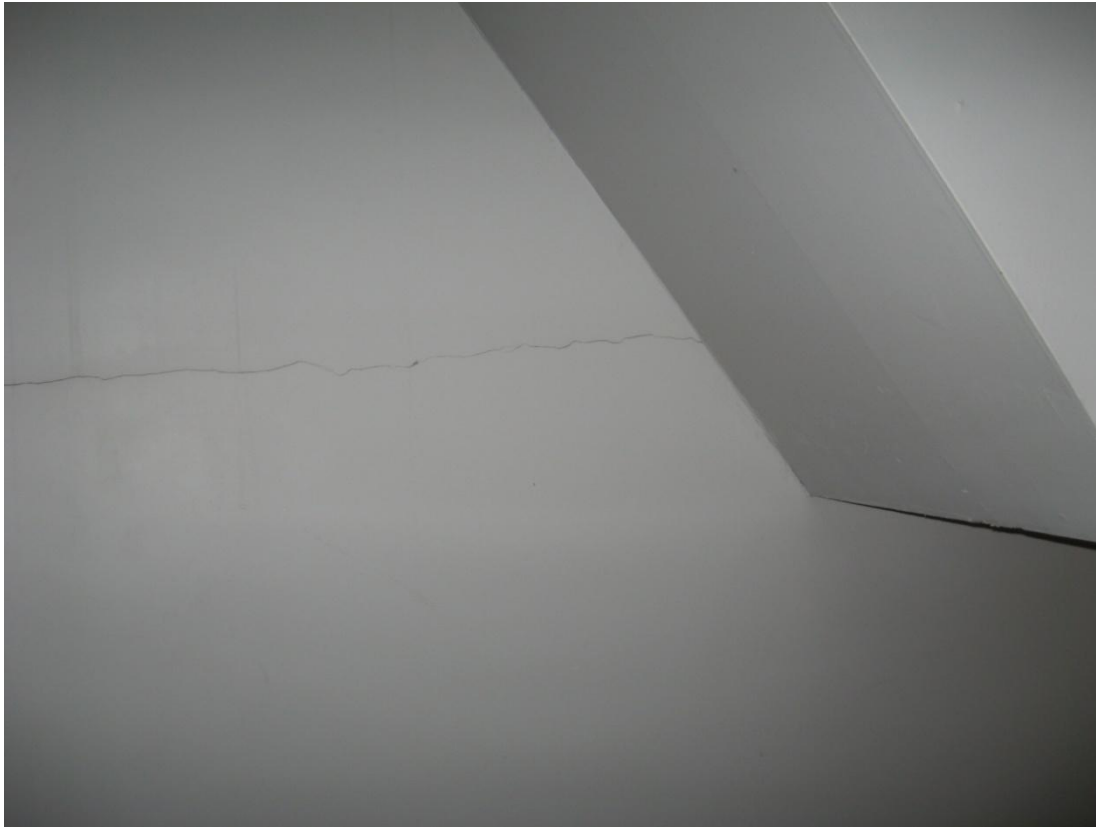
As visible in the stair well, there are construction joints in the walls immediately below and above each floor level. This is a normal construction practice. At almost all floor levels, cracking has occurred along part of the length of these construction joints and these cracks measure generally in the order of 0.2mm in width but with a few up to possibly 0.35mm in width. Photo 3. Again the cracks larger than 0.2mm in width should be repaired with epoxy injection and the external surface weather proofed.

Photo 3 Cracking in floor level construction joints in stair well

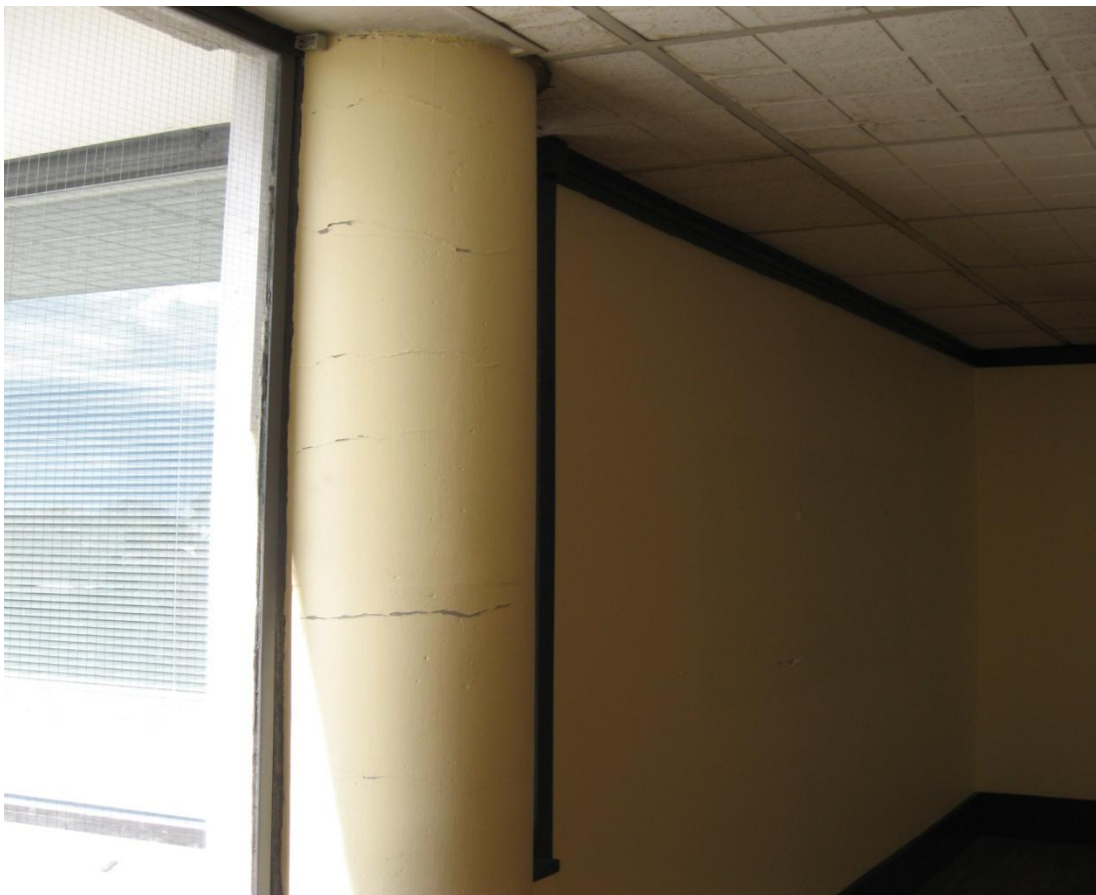
As stated above, we believe that the columns and beams provide gravity support only and have not been designed to resist lateral loads. However, they do have some stiffness and when the building moves in an earthquake and they do attract some load. Generally we observed very little damage to beams and columns. However there are a few exceptions. The north-east corner column immediately above the third floor spandrel exhibits some minor cracking which is very fine and in our opinion requires no treatment. At the top storey, the first column west of the north-east corner of the building also exhibits some cracking. The appearance of the cracking is accentuated because the paint has chipped off at the cracks (photos 4). One of the south side columns at the top storey also exhibits some fine cracking. We recommend that the cracks in these upper storey columns be injected with epoxy resin.

Photo 4 Cracking in top storey column adjacent to lift lobby.

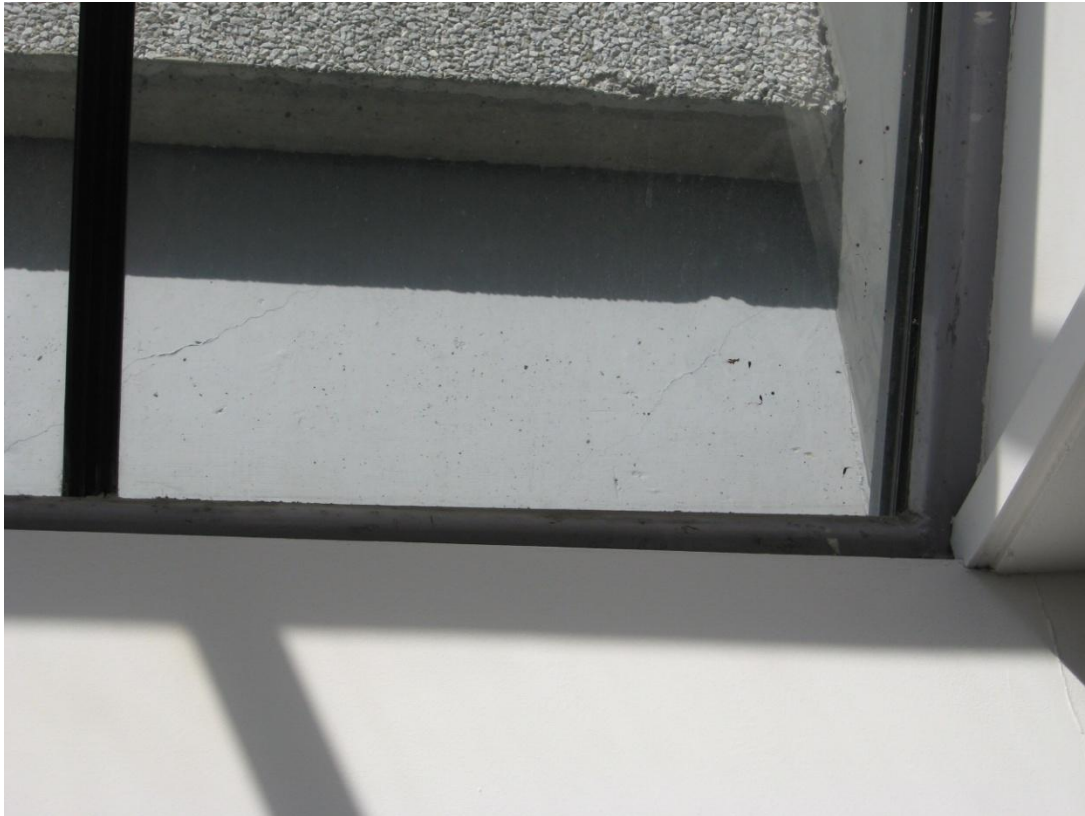
The first floor beam on the north face of the building in the span between the north-east corner of the building and the adjacent column to the west has some fine diagonal cracking (Photo 5). We recommend that this crack be injected with epoxy resin. We did not see any signs of distress in beam column joints.

Photo 5 Cracking in first floor beam north elevation over entry.

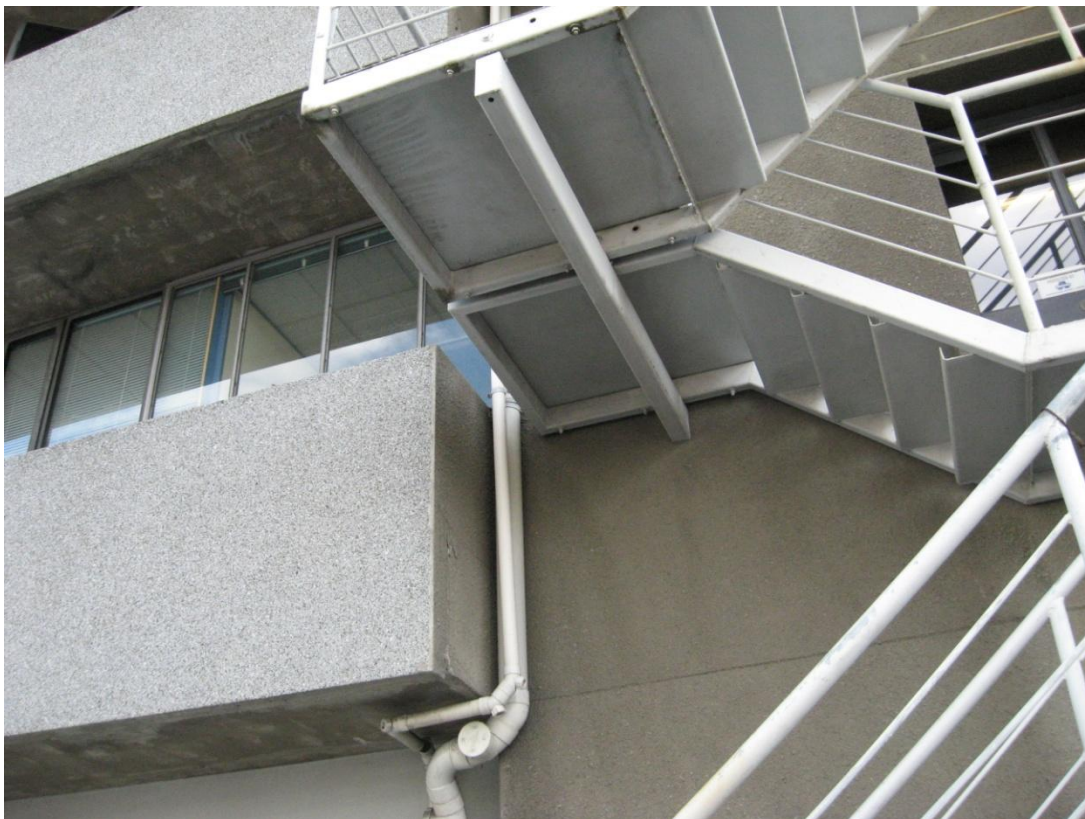
The precast concrete spandrel panels appear to have sustained very little damage. However, each side of the south side shear wall, the ends of the spandrels have been plastered. This plaster is spalling off at most levels as a result of differential movement caused by the earthquake. It is a hazard to people below. It should be removed, the concrete surface properly prepared and a strong bonding epoxy plaster re-applied. (Photo 6).

Photo 6 Spalling of plaster off ends of spandrel panels.

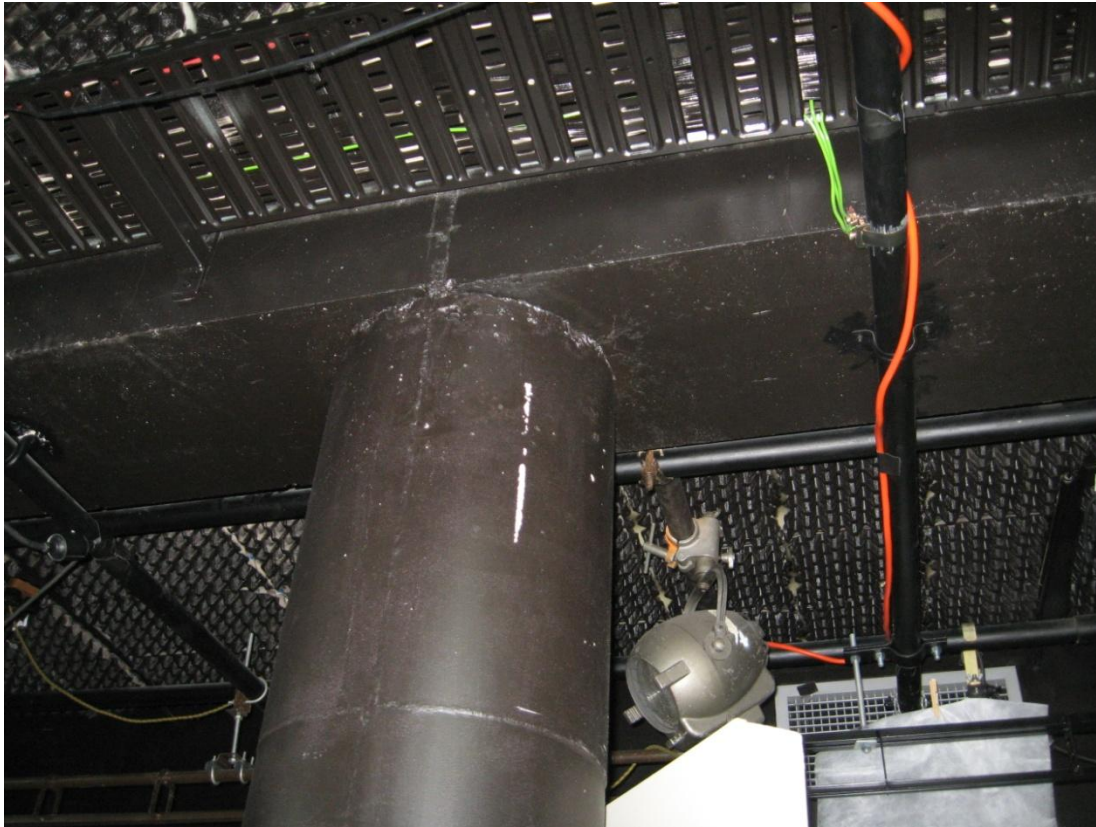
In the limited number of locations where we removed ceiling tiles and observed the floor to beam connections we did not see any signs of distress. (Photo 7).

Photo 7 Internal beam column joint under first floor – no evidence of damage.

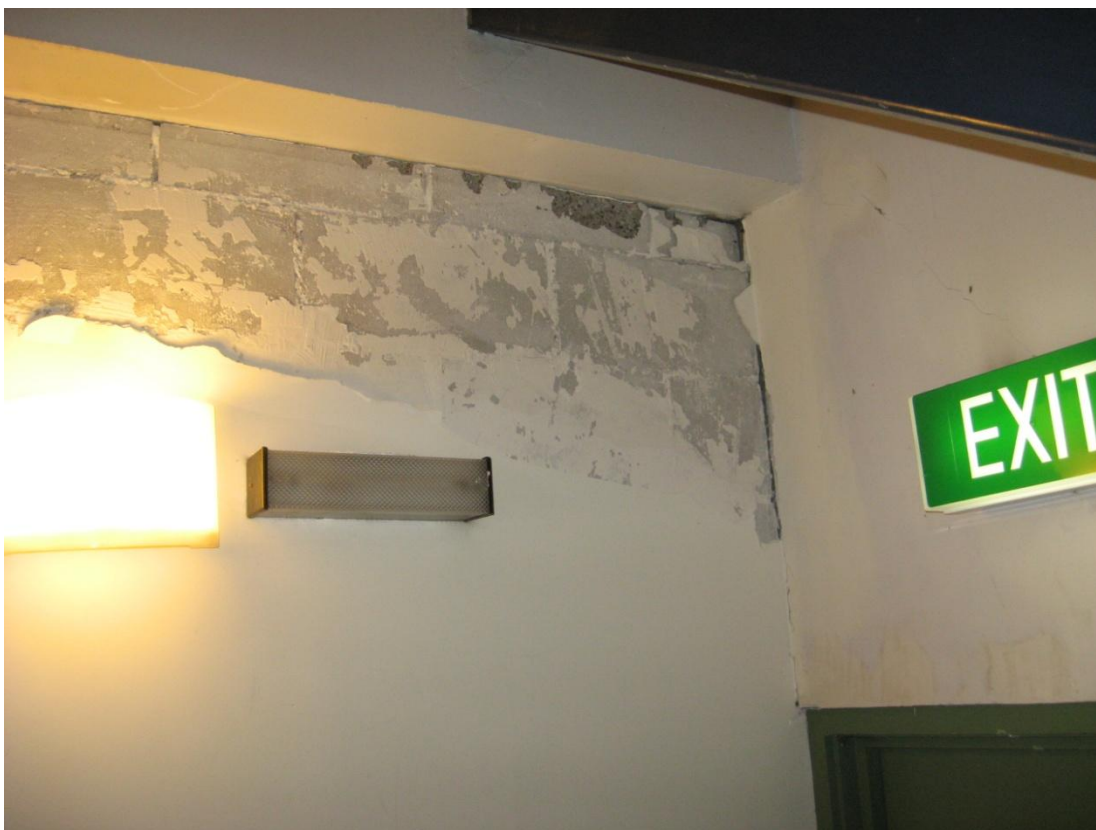
At ground storey, there is a concrete block wall parallel to the north side shear wall but on the opposite side of the stair well. This wall has a thin gypsum plaster coating in the stair well. At the top of the wall the plaster coating has been peeled off. It appears that it was touching one of the stair well structural walls and the differential movement has damaged the plaster. There may also be some minor cracking of the top block course which should be repaired. However, this is not a structural component and does not contribute to the integrity of the building. Photo 8.

Photo 8 Spalling gypsum plaster off non-load bearing concrete block wall in stairwell.

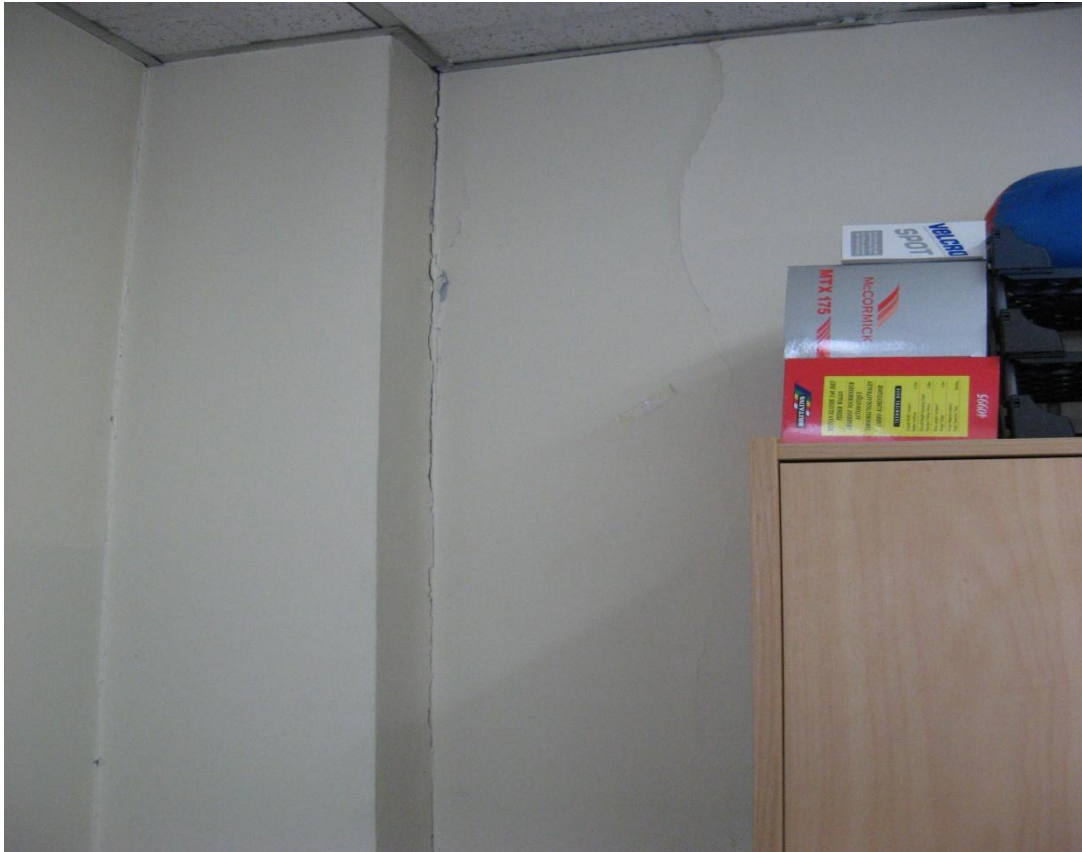
Photo 9 Partition lining damaged at junction with concrete column.

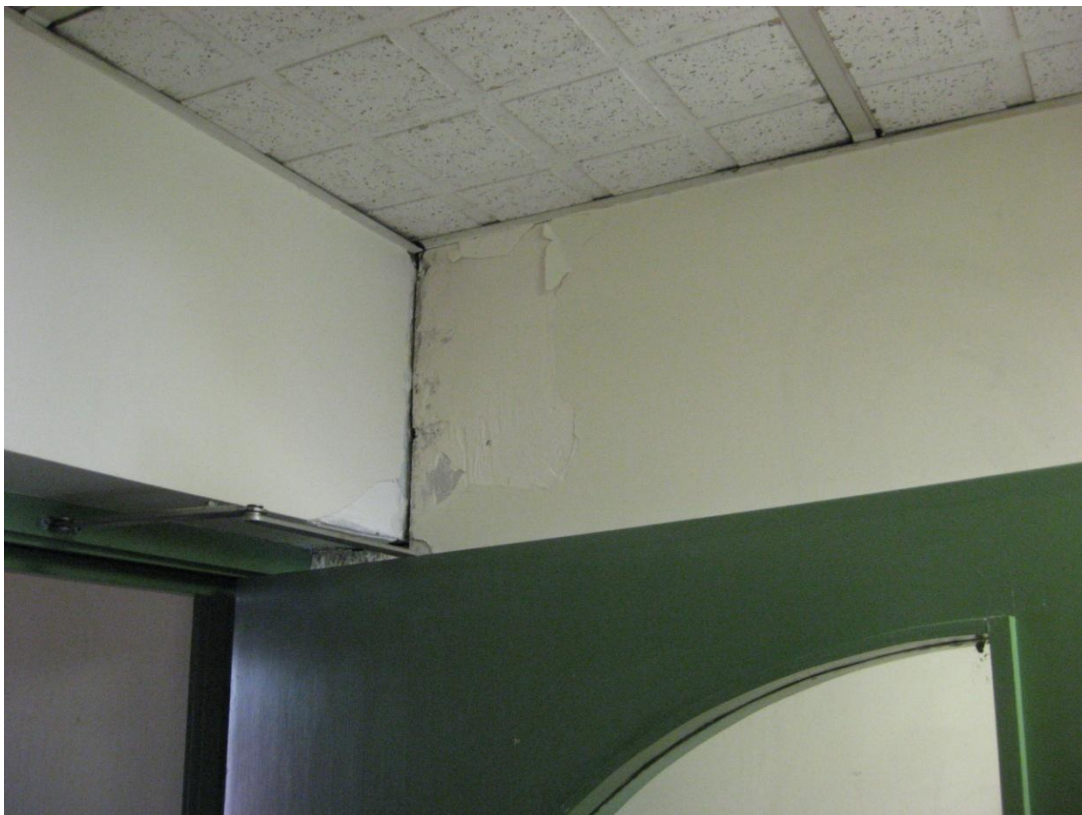
Photo 10 Partition lining damaged at junction with concrete beam.

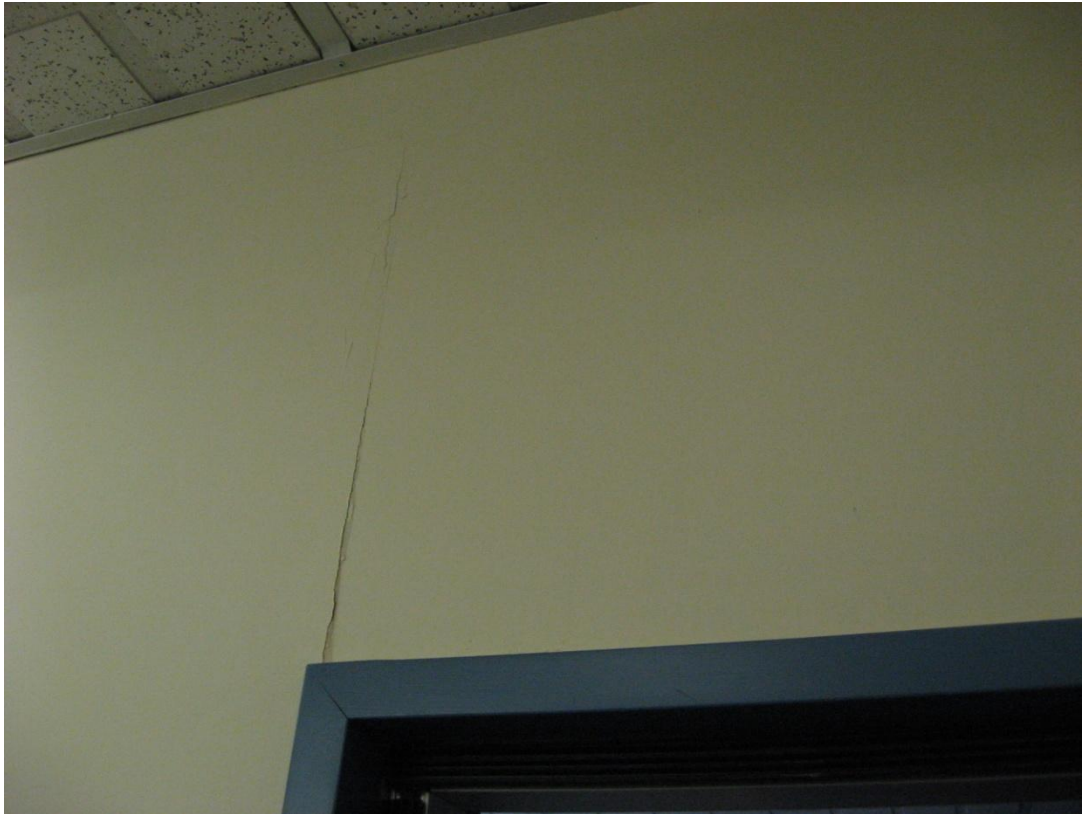
Photo 11 Cracking in linings over door head

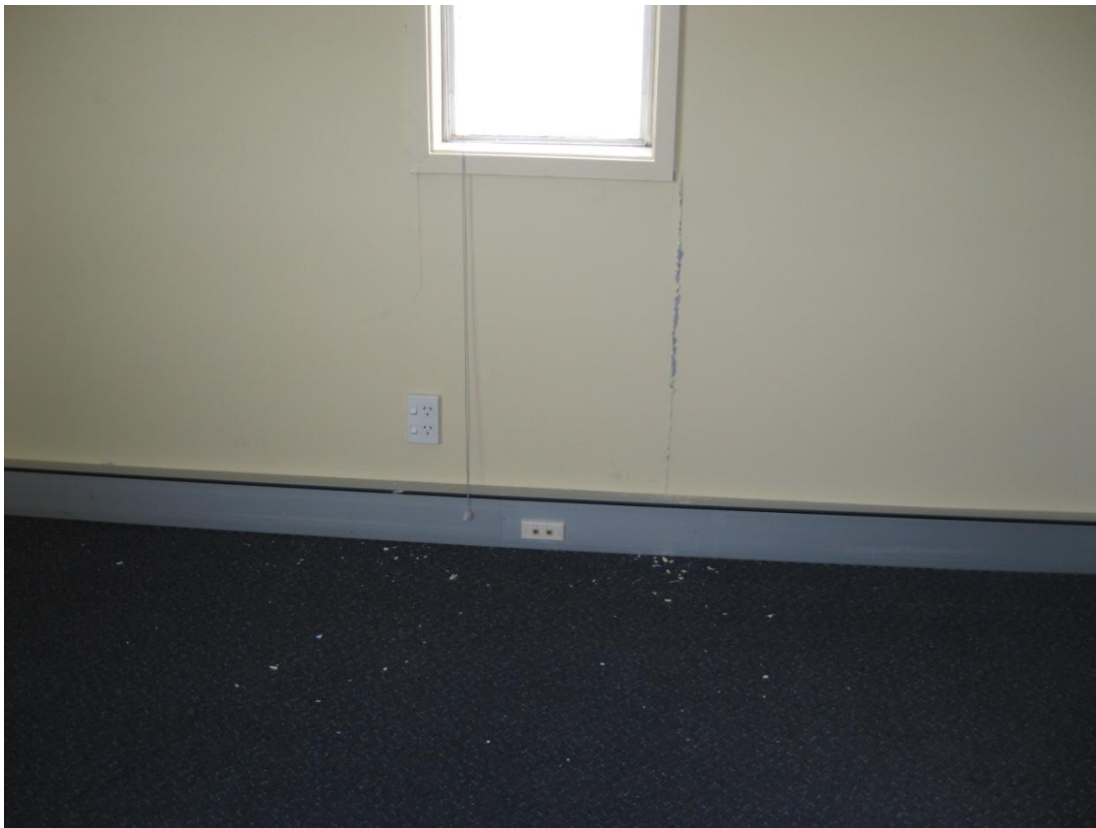
Photo 12 Cracking in linings under window.

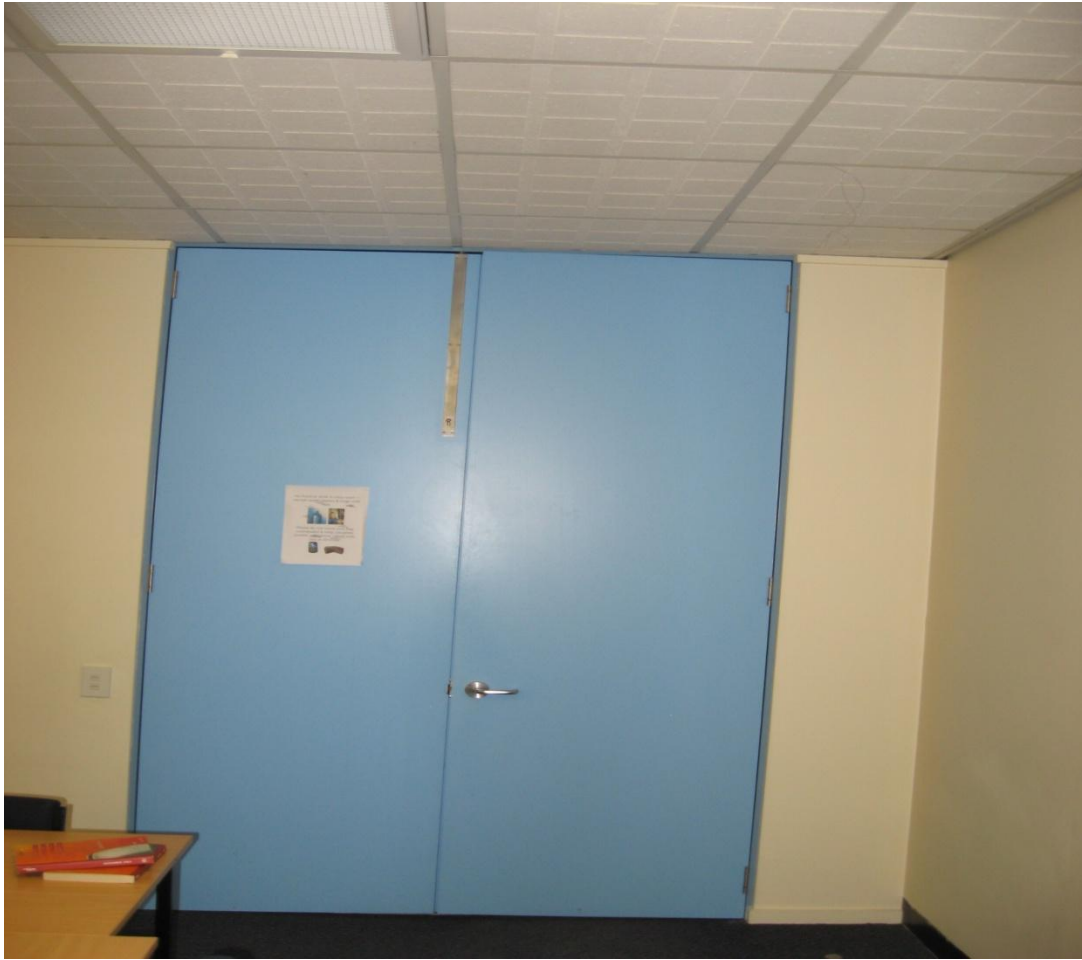
At numerous locations at all levels, there is damage to internal framing and linings. Commonly, internal walls and their linings have been finished hard against structural walls and columns. With movement of the building during the earthquake(s), the structural components have applied in-plane loads to the stiff plaster board lined walls. There are many instances where the plaster board linings have been damaged where they adjoin the structural components. Sometimes, the plaster board has buckled some distance away from the structural wall or column. Photos 9 and 10. There are also numerous instances of plaster board cracking over door heads and under windows and elsewhere. Photos 11 and 12. Ceiling covings and skirting boards have also been damaged. At the south end of one internal north south wall on the second floor, the partition wall has racked sufficient for the double doors contained in the wall to be binding. Photo 13.

Photo 13 Racked second floor partition wall and binding double doors.

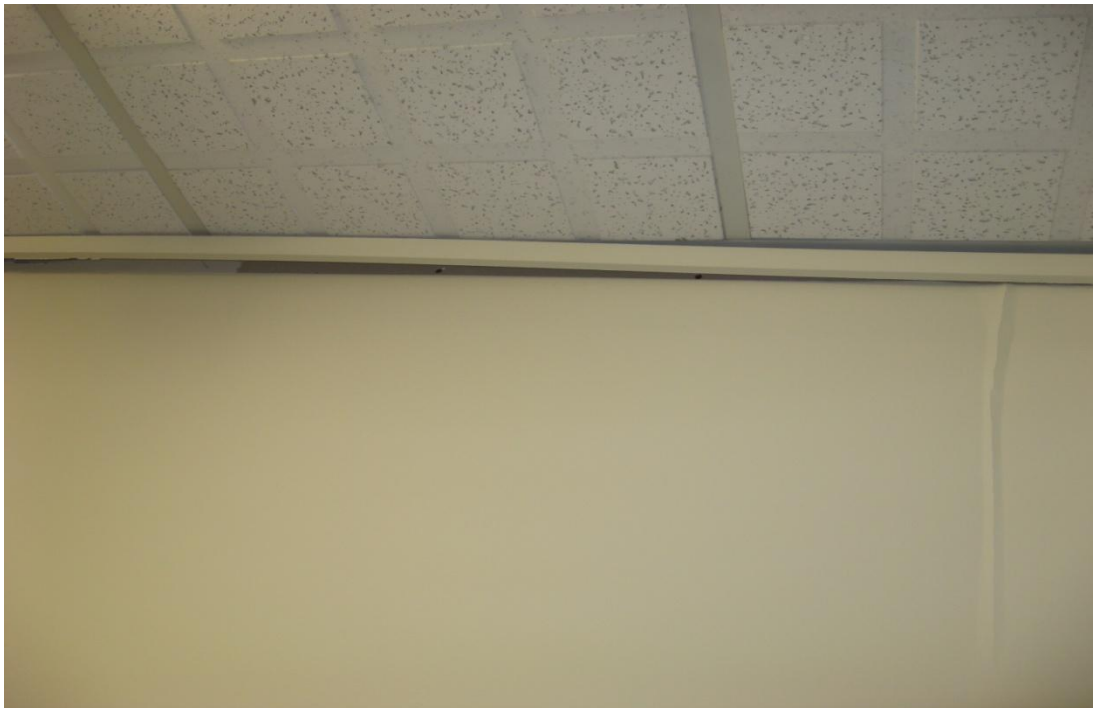
Where ceiling linings adjoin concrete columns, the plaster linings have been damaged. In some cases the rails for the suspended tiled ceilings have been buckled. Photo 14.

Photo 14 Cracked wall lining and damaged ceiling coving.

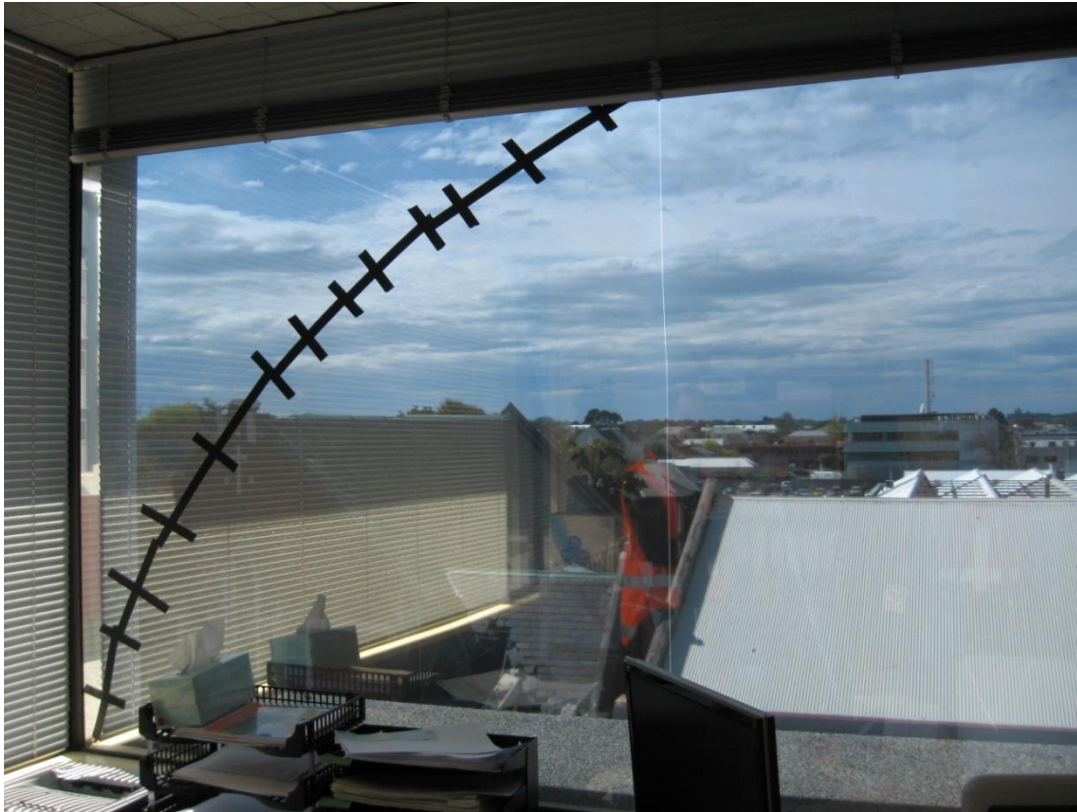
A few windows, particularly in the east elevation have been broken. Photo 15. This may also reflect greater movement of the building in the north-south direction. There are no windows in the opposite west wall but the damage to interior linings on that west wall is significant.

Photo 15 Broken window.
