T&T Ref: 52118
11 July 2011

CTV Building Geotechnical Advice

This report presents the review of geotechnical conditions at the site of the CTV building, 249 Madras Street, Christchurch, together with the results of an assessment of the dynamic response parameters for the foundations of the building.

CTV Building Geotechnical Advice - Addendum

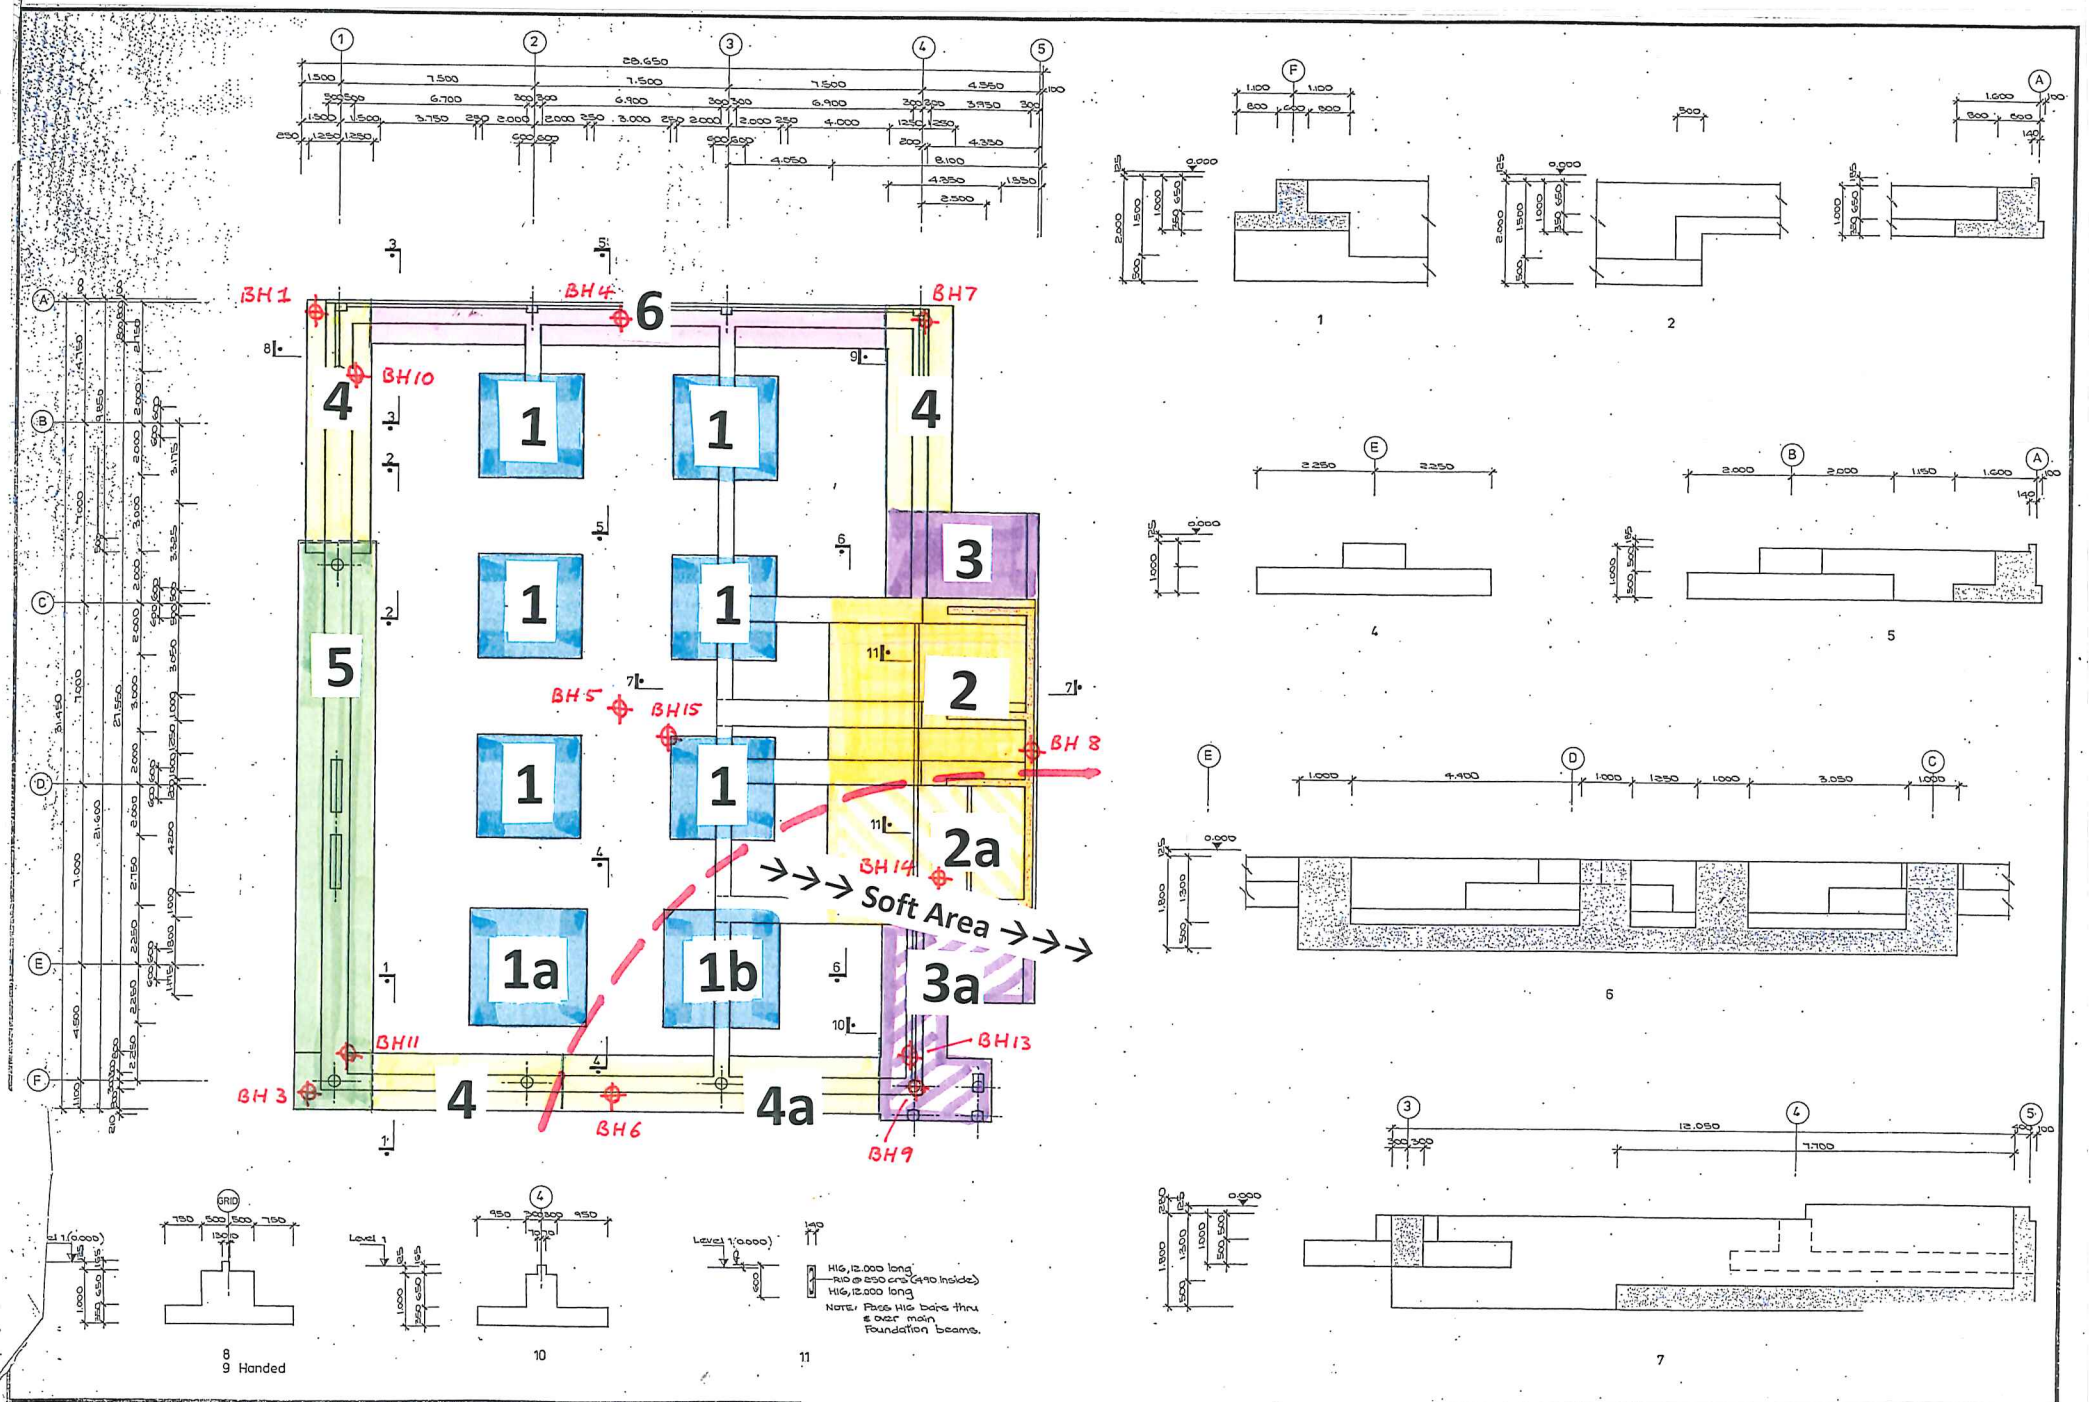
Figure 1: Foundation Types

Because of the different shapes, sizes and depths, and because of need to provide details for the two characteristic soil profiles, the various foundation elements have been assigned Type Numbers, as shown on Figure 1.

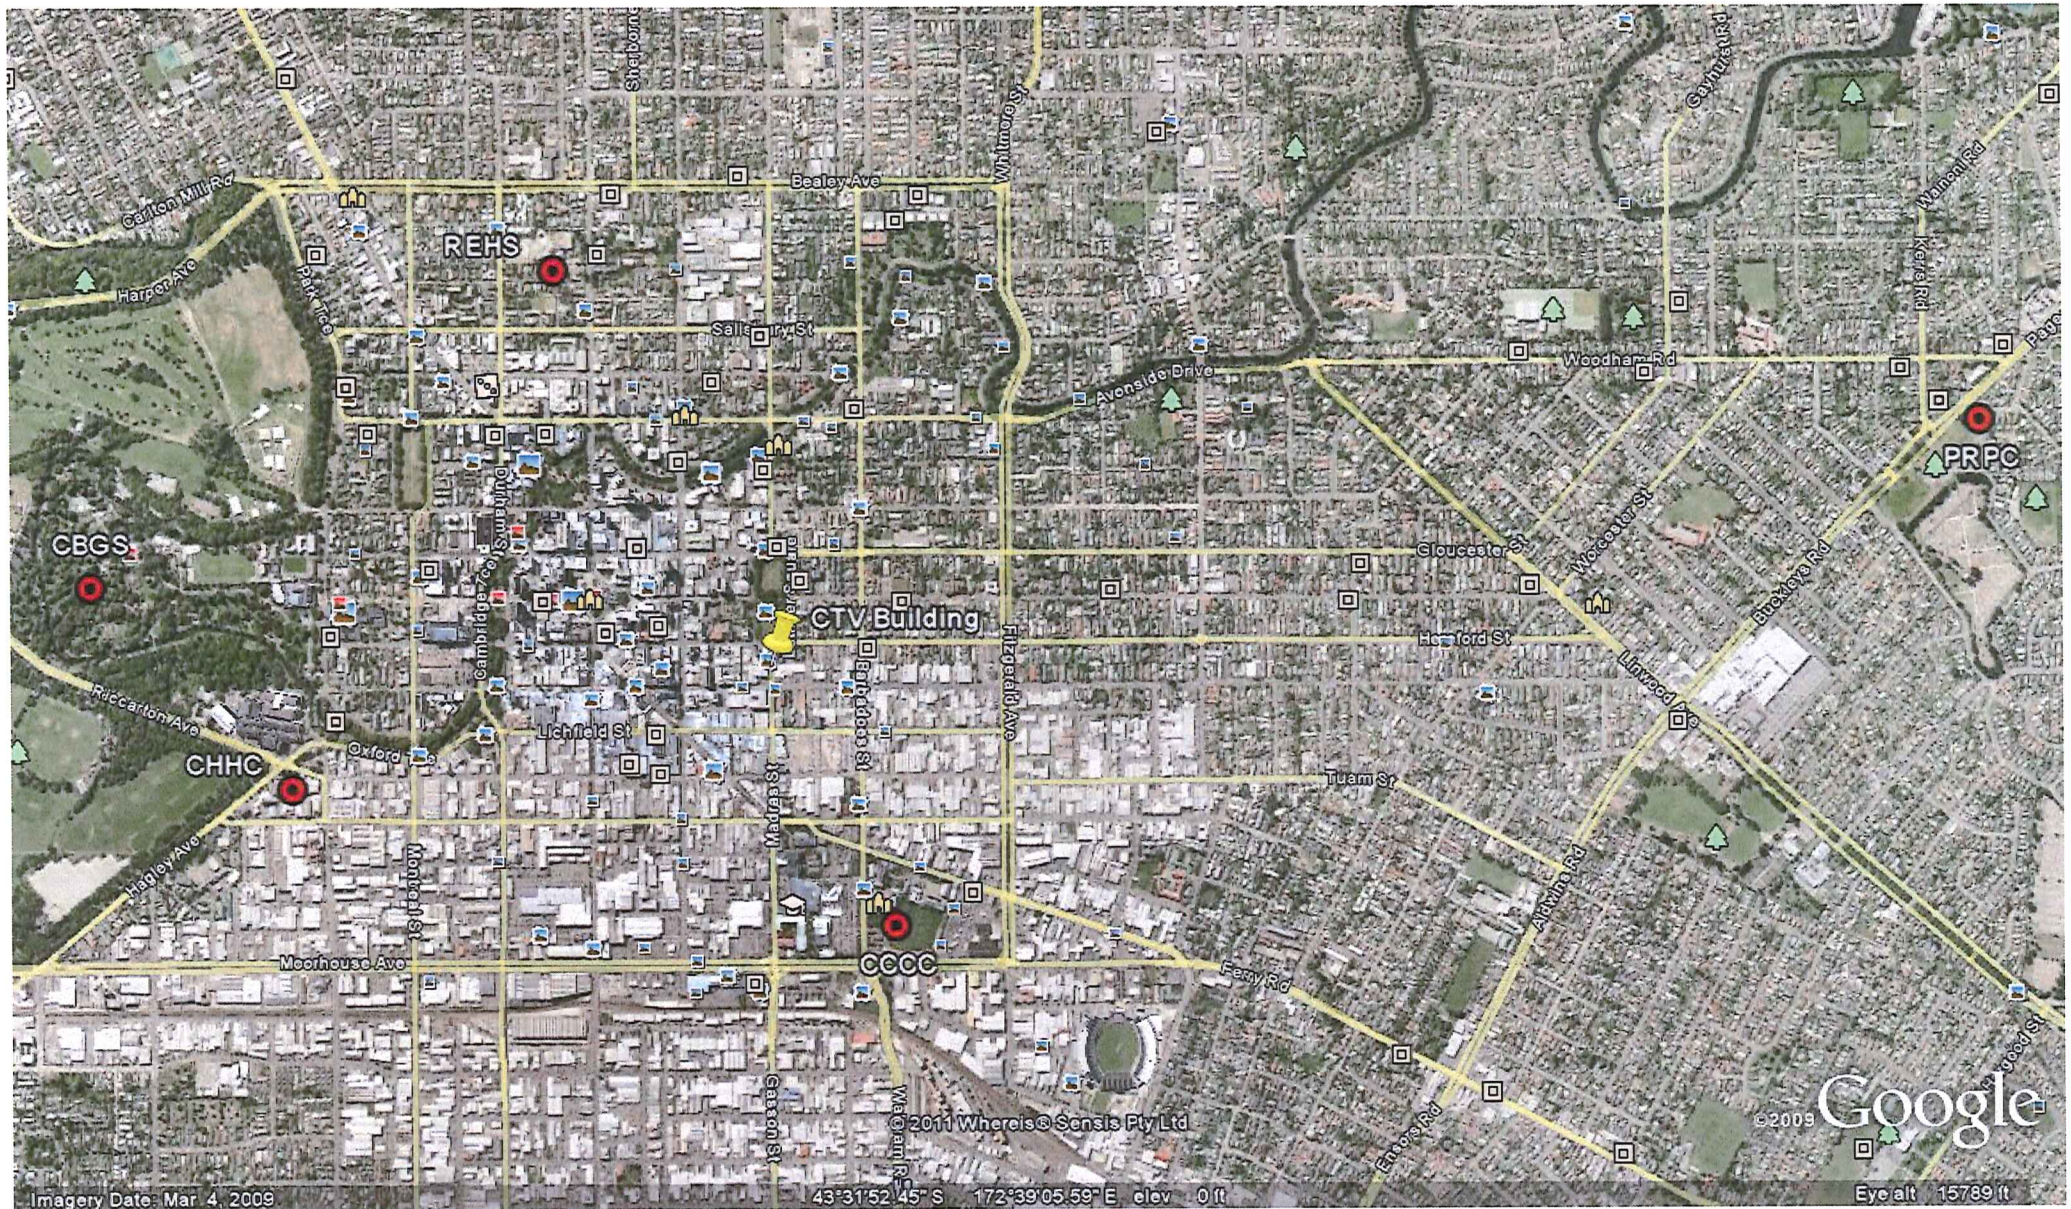
Figure 2: Locations of Strong Motion Recording Stations

The five stations of interest are shown on Figure 2 and are listed below:

The last two of these (REHS and PRPC) show significantly higher amplification than the others, both with respect to Peak Ground Accelerations (PGA) and spectral accelerations.

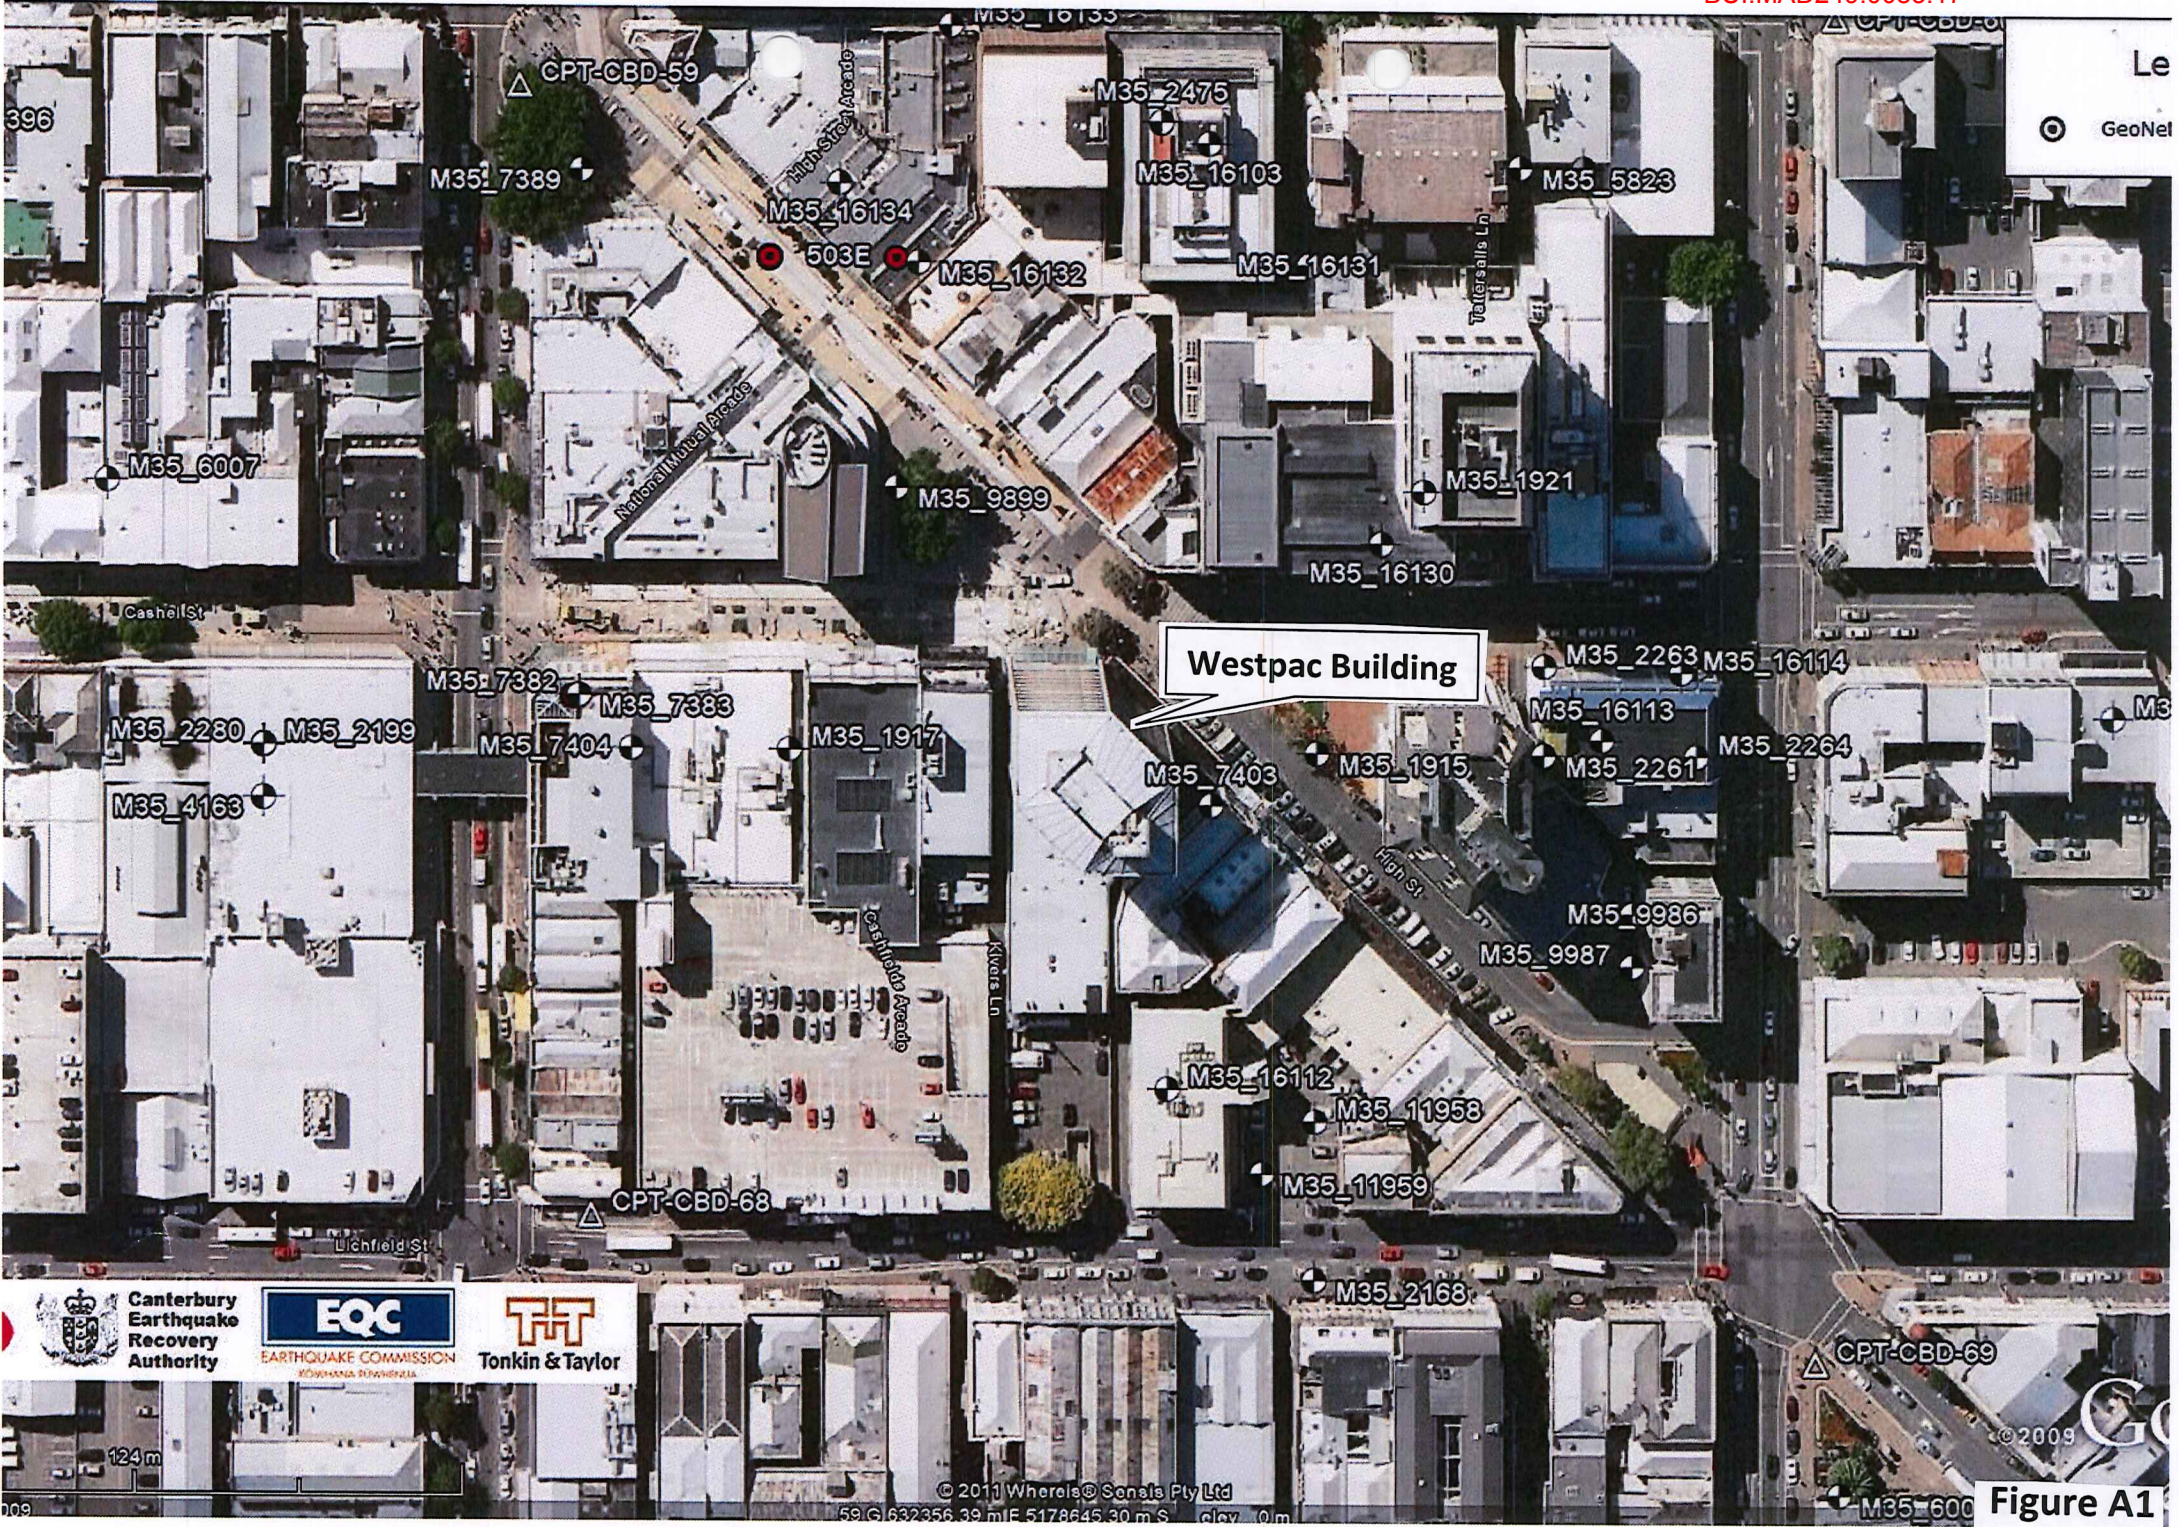
- i. The locations for the site investigation points surrounding the Westpac Building are shown on Figure A1 attached. (Note: Station 503E is marked on this plan but not in exact location due to co-ordinate discrepancy.)

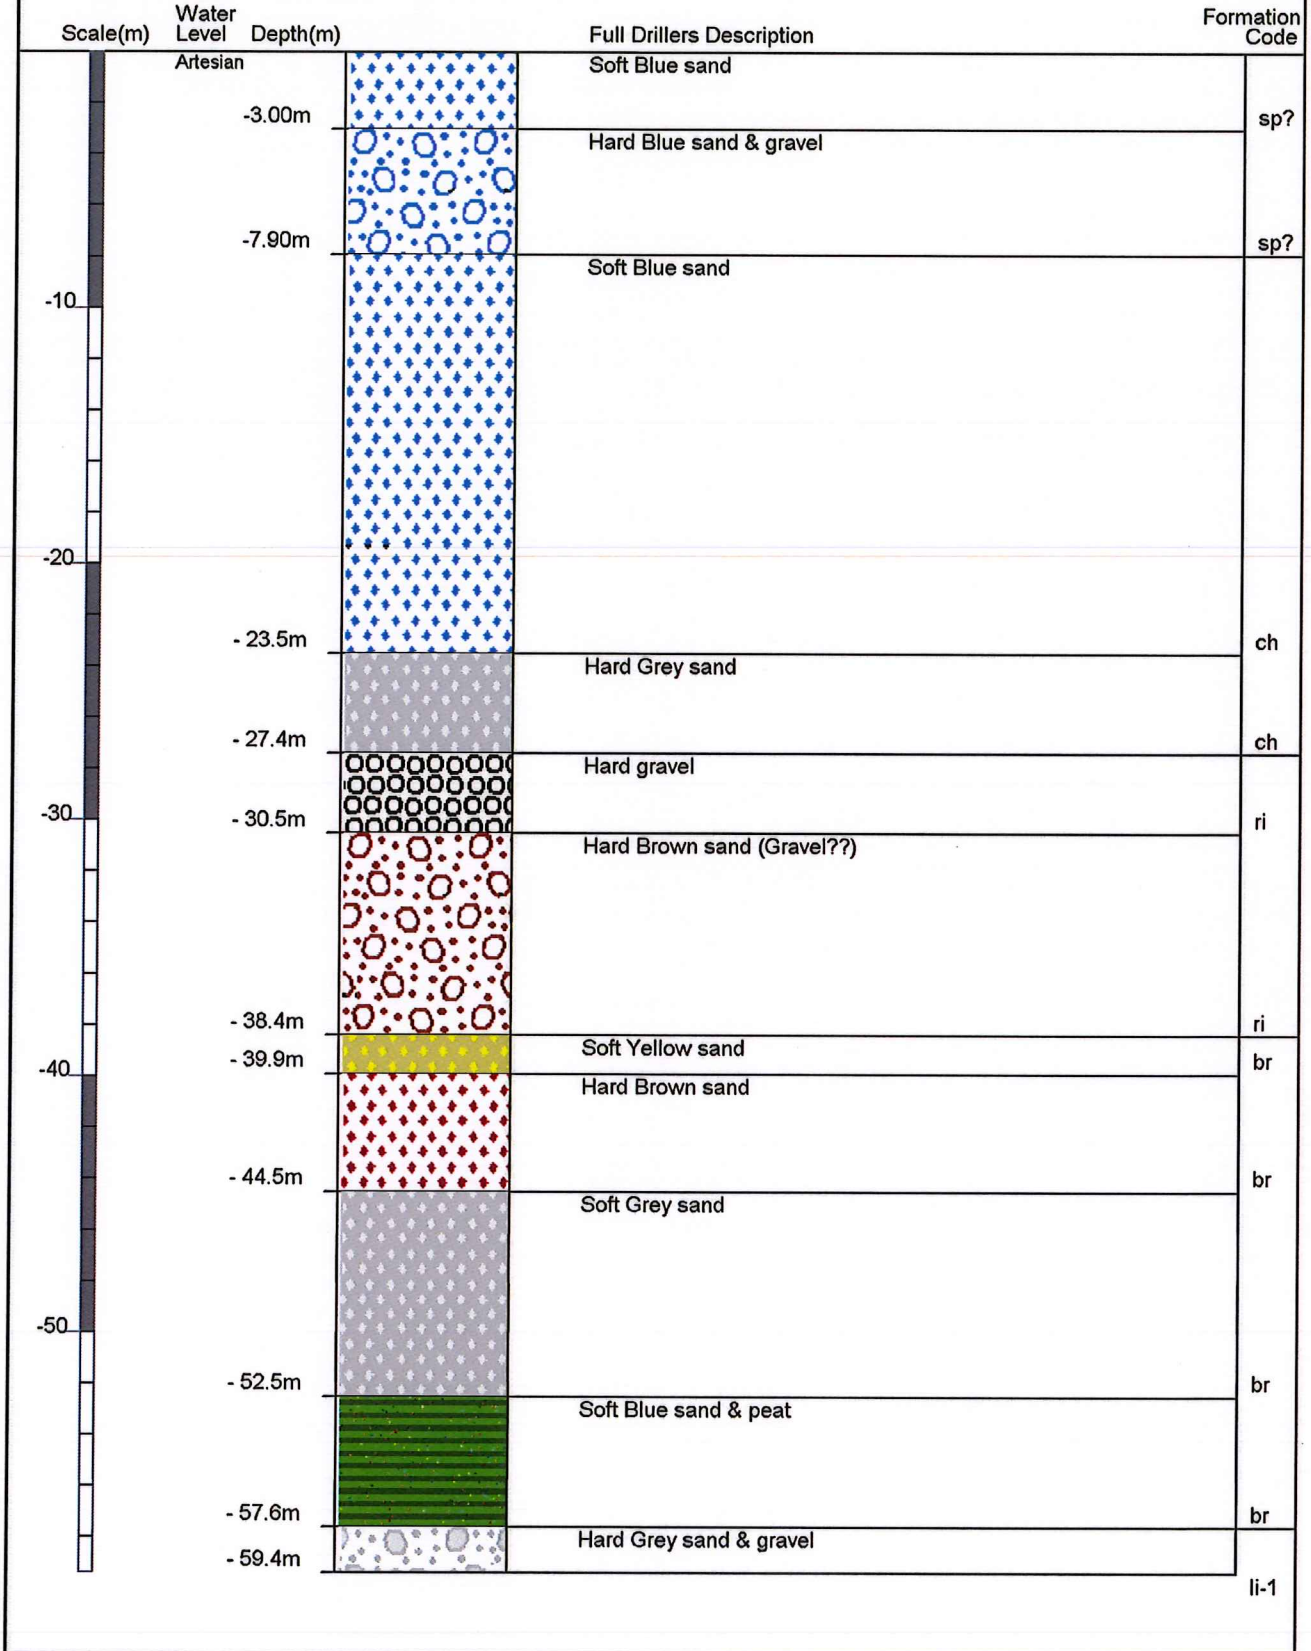
Borelog for well M35/7403

- ii. One ECAN borehole log is available at this location (M35 – 7403), attached for information as Figure A2.
- iii. Tonkin & Taylor have carried out investigations for the Triangle Centre (T&T Ref No. 52157) immediately north west of the Westpac Building. The logs of boreholes give detailed subsurface information to about 27 m depth. Whilst not being able to include the logs of boreholes and cone penetration tests (CPT), the information enables us to have confidence in interpretation of the subsurface profile.

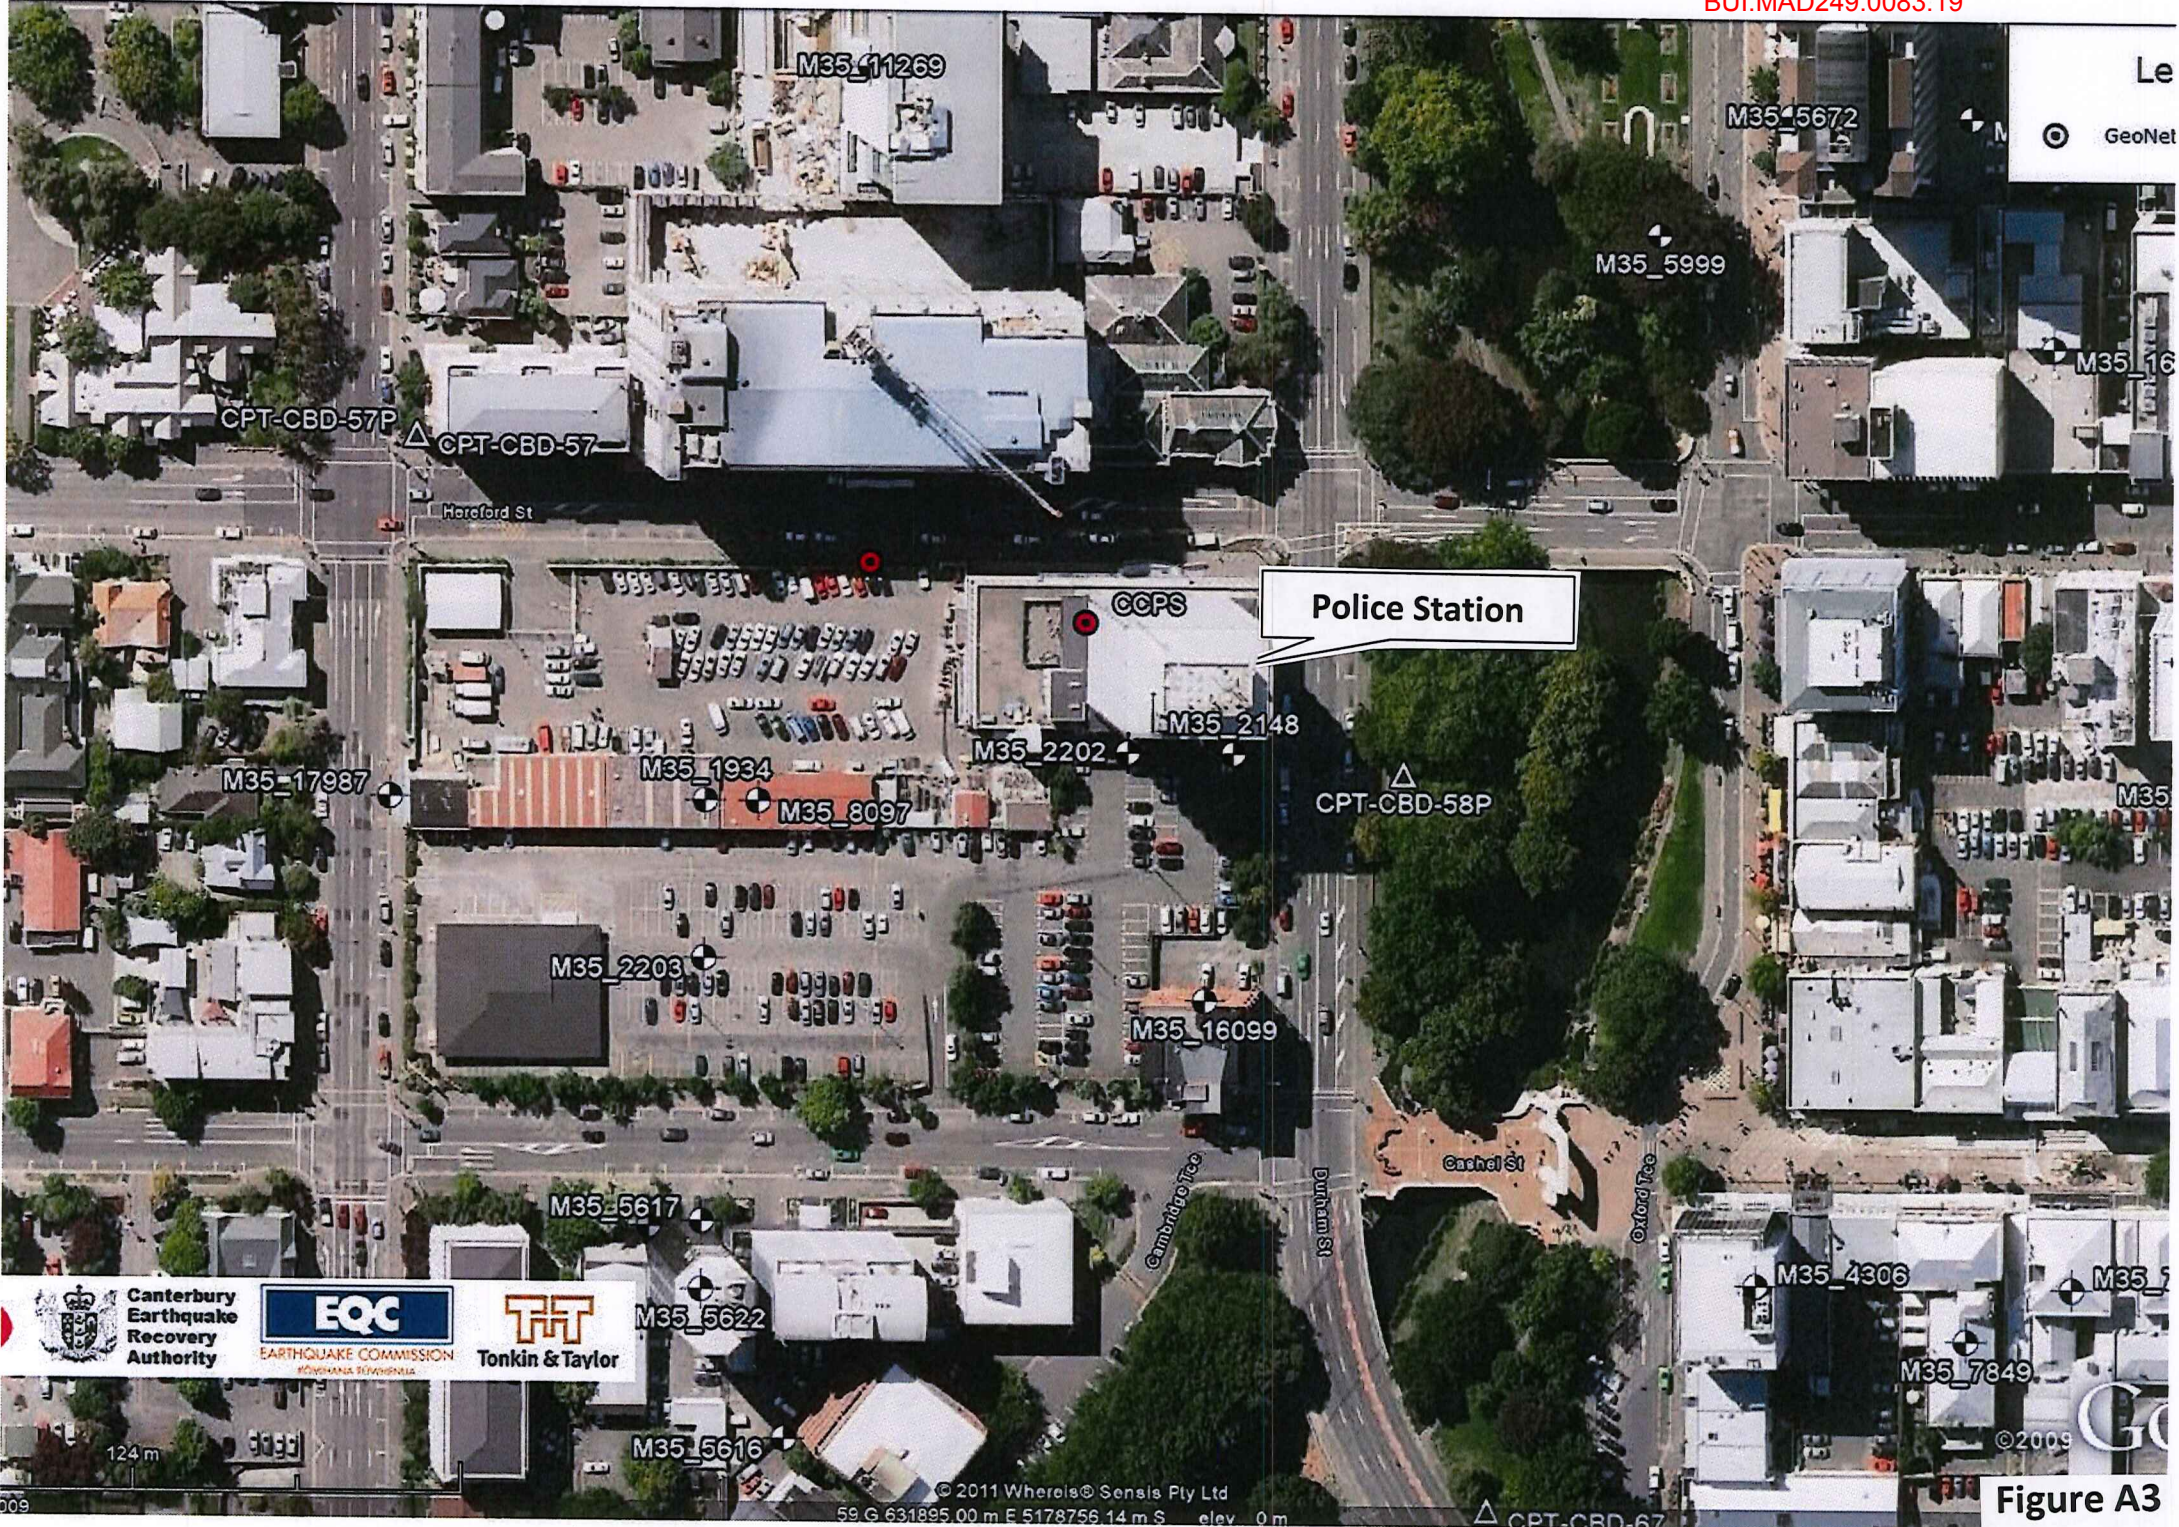
- i. The locations of the site investigation points surrounding the Police Station are shown on Figure A3 attached. The recording station CCPS (501) is also marked.
- ii. Several ECAN borehole logs are available for the immediate vicinity of the Police Station. Log for M35-2148 and M35-8097 are attached for information as Figures A4 and A5 (1 & 2)
- iii. Recent CBD investigations give detailed near-surface information (ref CPT CBD-58 attached as Figure A6- 1 & 2).
- iv. The GeoNet DELTA site gives information that is reasonably consistent with the other sources.
- v. Conclusion: The site conditions at the Police Station are similar to those at CTV Building site, though slightly more favourable/stiffer due to greater depth of near-surface gravel.
