POWELL FENWICK
CONSULTANTS LIMITED

Our Ref: 100781/S/1

**RE: EARTHQUAKE DAMAGE TO BUILDINGS AT BALLANTYNES: OLD
STABLES, 1950'S BUILDING, 1965 BUILDING, ANDERSON BUILDING, LOW
LEVEL INFILL**

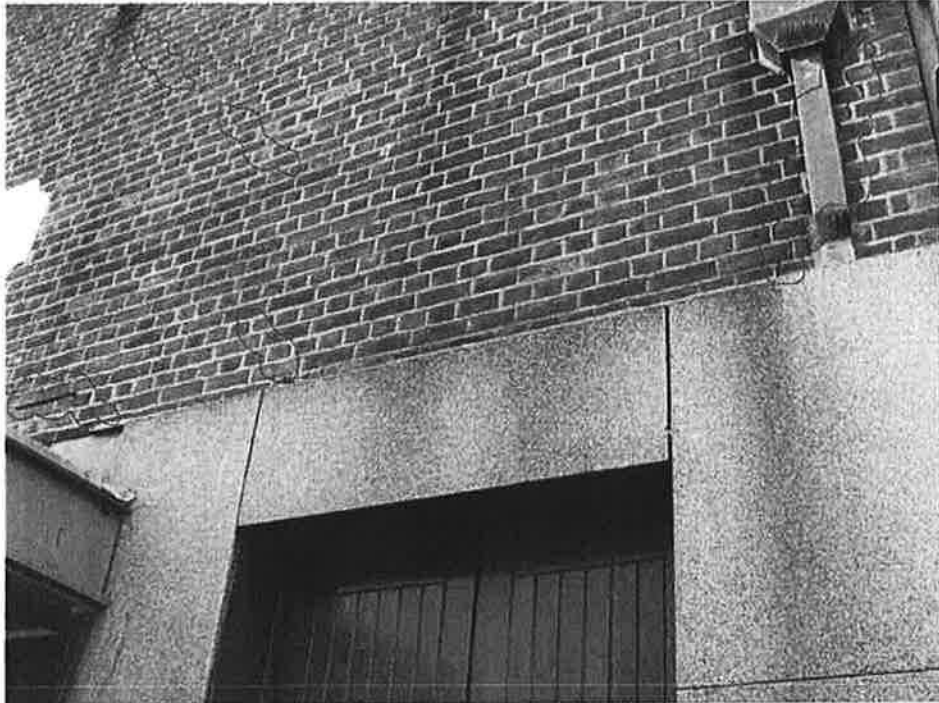
- Cracking to bricks within mortar course at South Gable, these are to be re-pointed
- Loose flashing to top of Eastern side of South Gable is to be refixed
- Perceived movement in floor is existing hogging of floor over brick wall below, no work is required here.
- Gap between joists where the span direction changes is not a structural concern as these joists cantilever over the wall below, and as such are not supported off the joist running perpendicular; no existing fixings could be seen.

Cracking to brick gable

- Repoint bricks to South Gable
- Refix loose flashing to top of Eastern side of South Gable

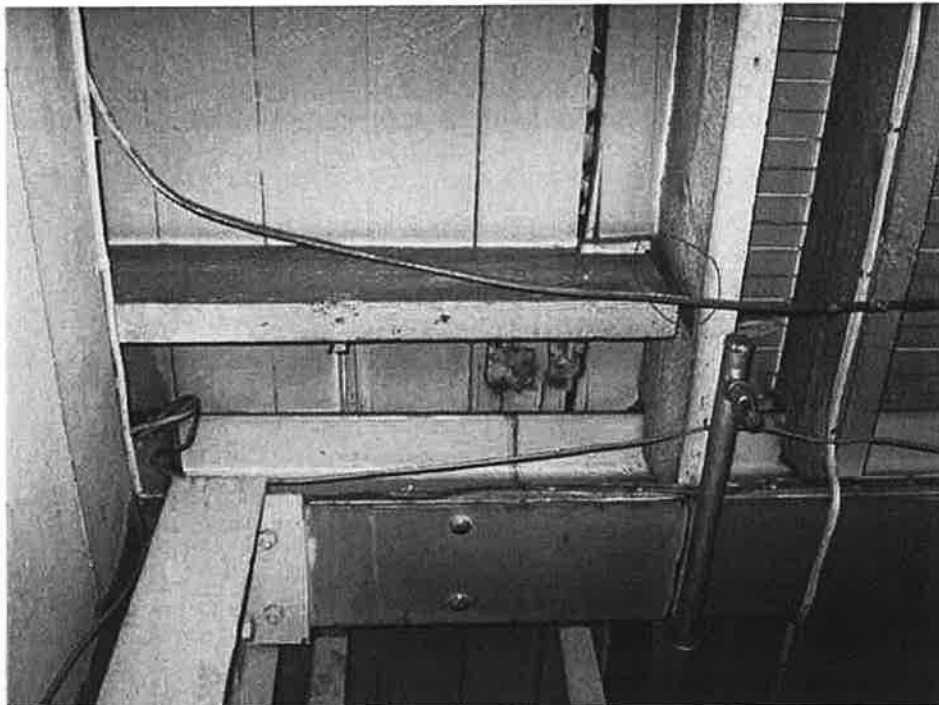
Gap between perpendicular joists, not of structural concern

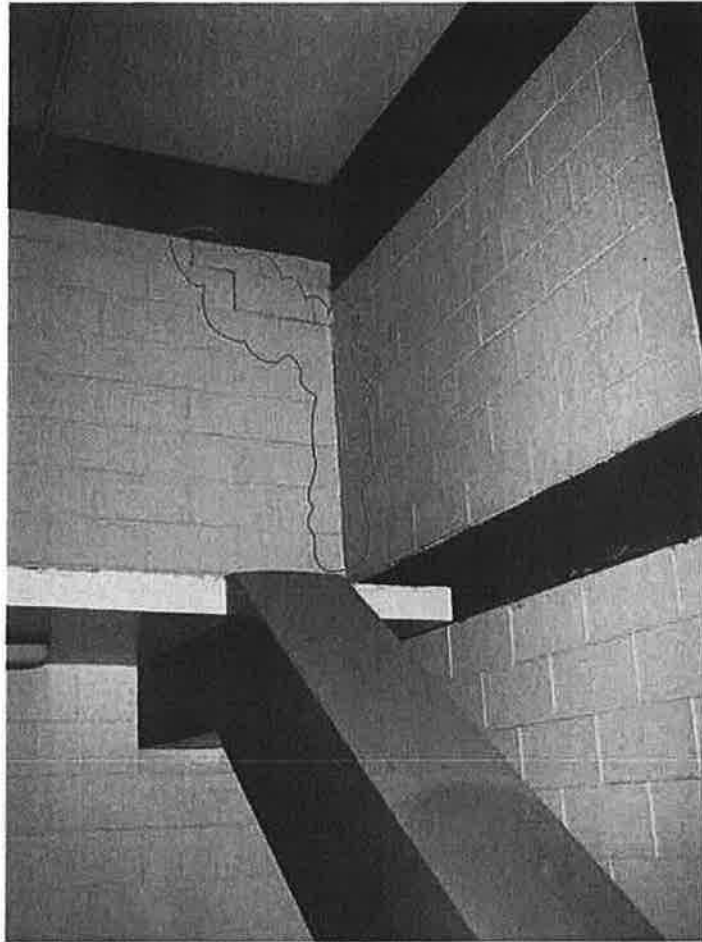
- Diagonal cracking of mortar joints in unreinforced unfilled block infill with no physical offset of blocks, these cracked mortar lines are to be re-mortared.

Diagonal cracking of mortar joints in unreinforced unfilled block infill

- Remortar cracked blockwalls to exposed faces, note this is to happen full depth of the face shell. This applies to the cracked mortar in the infill walls and the unfilled partition walls in the basement. Repaint walls, and where required in the toilets re-lay tiles.
- Chase out cracks to exposed face in blocks to unfilled partition walls and mortar/groutfill chase to allow wall to be re-plastered and painted.
- Breaking out of damaged concrete to concrete frames with infill walls and repair with Sika MonoTop Structural Mortar repair system; refer to appended specification.

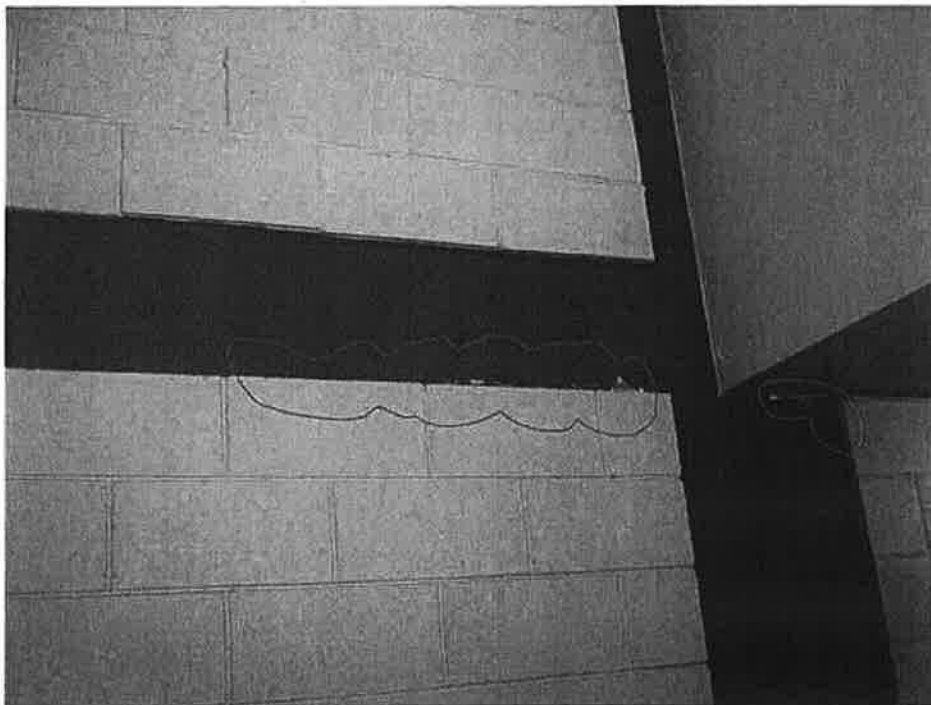
- Cracking of joint and spalling of concrete where concrete frames meet unreinforced unfilled block infill. Spalled concrete is to be repaired with structural mortar.

Cracking of joint and spalling of concrete/plaster

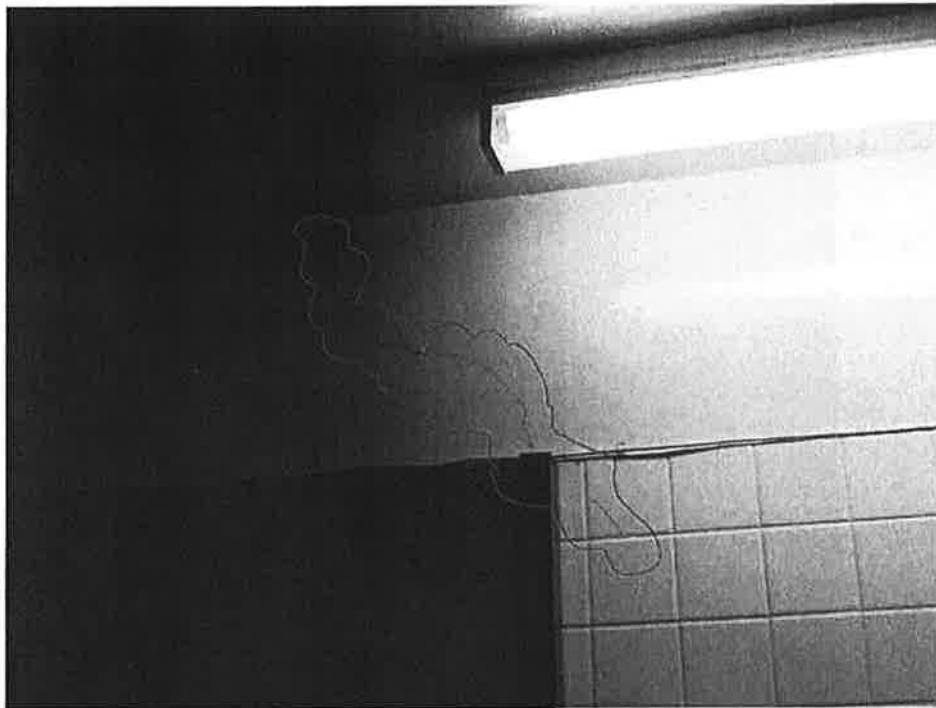
- Diagonal cracking in un-reinforced unfilled concrete block partition walls to toilets in basement. These walls does not form part of the lateral load resisting structure of the building and as such the cracking to the wall is only an aesthetics issue. These cracked mortar lines are to be re-mortared, and cracked blocks chased out and mortared; the internal finish should then be reinstated.

Cracking in un-reinforced unfilled concrete block partition walls to toilets in basement

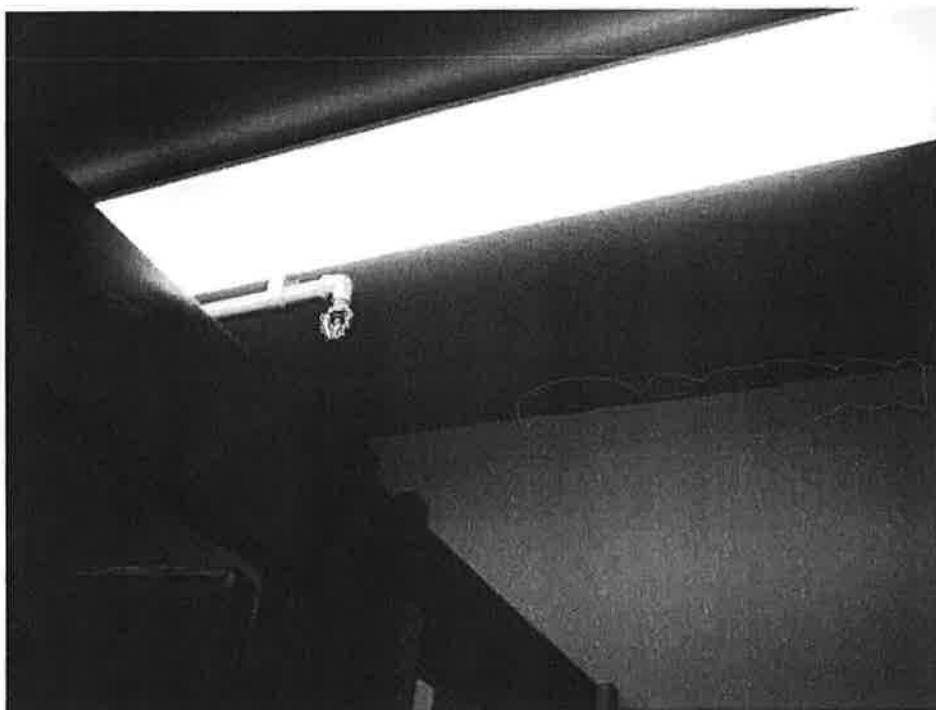
- Cracking between soffit and wall, note this cracking is mostly in the paint and very little movement has occurred in the concrete. The paint should be removed and cracks injected.

Cracking between soffit and wall in toilets

- Remove paint at cracked soffit and wall junction within basement toilet and expose any cracks. Cracks should be injected using Sika Injectokit TH system; refer to appended specification
- Remove and re-fix tiles which have erupted to exterior wall on the north side above the canopy.

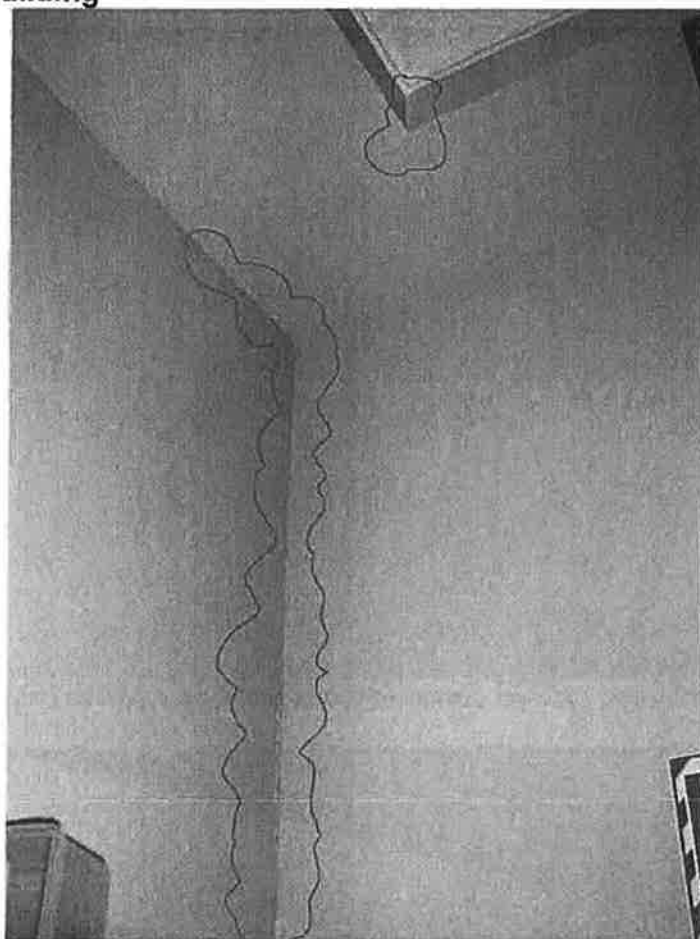
- Significant cracking in internal linings in kitchen area for Tea Rooms; this cracking is not of structural concern as the linings are not structural. The linings should be repaired and reinstated.
- Movement in carpet over seismic joint will require the carpet to be lifted and re-laid.

Cracking to Lining in Tea Rooms Kitchen

- Re-plastering of damaged internal linings in Tea rooms kitchen and ceilings where possible or replacement
- Lift and re-lay carpet over seismic joint.

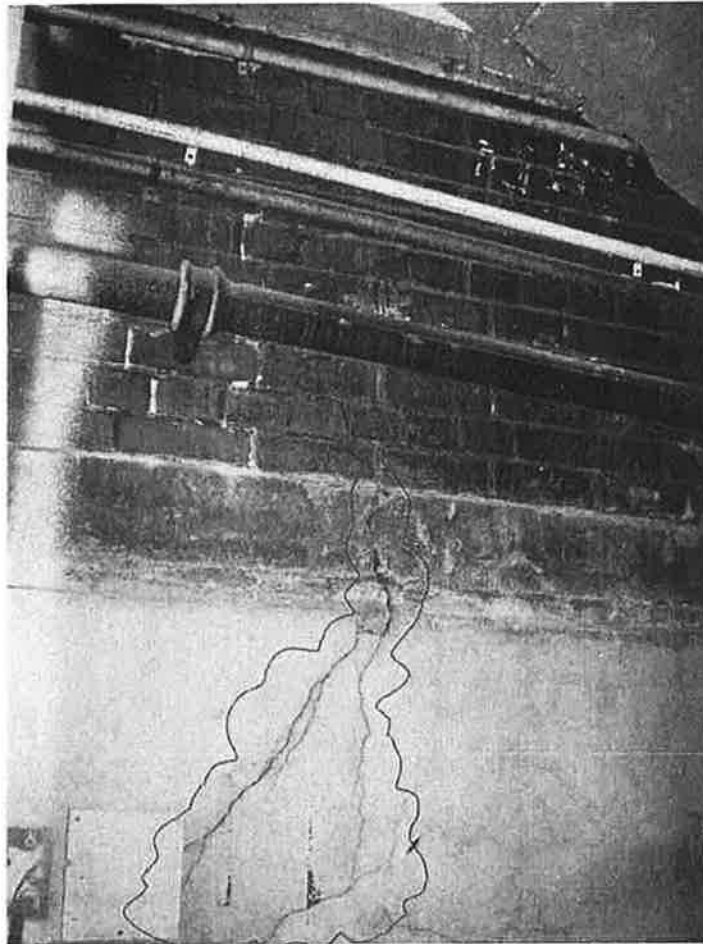
- Cracking in basement wall of ramp to low level infill. Indications are this is existing, however the earthquake may have caused further movement. These cracks should be epoxy injected.

Cracking to Basement Ramp Wall

- Cracking in basement wall of ramp to low level infill to be epoxy injected with Sika Injectokit TH; refer to appended specification.
