# Addendum Report to the Royal Commission of Inquiry

## The Performance of Earthquake Strengthened URM Buildings in the Christchurch CBD in the 22 February 2011 Earthquake

Associate Professor Jason M. Ingham

Professor Michael C. Griffith

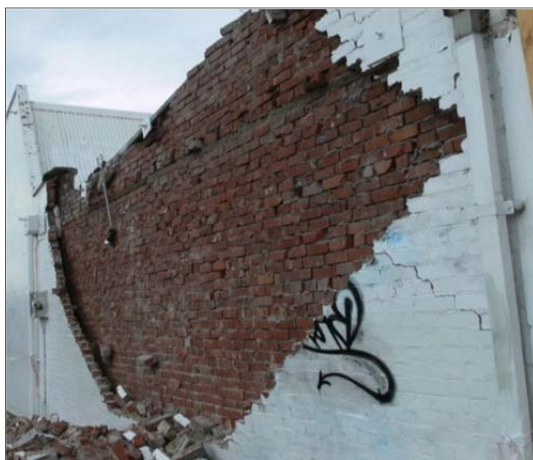
(a) Out-of-plane failure of a single leaf veneer

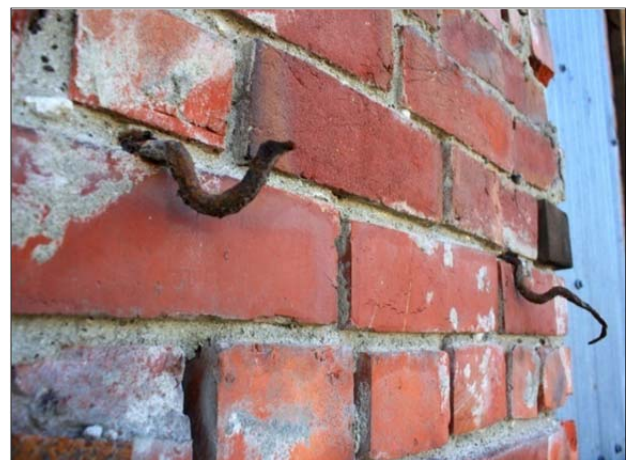
(b) Metal cavity ties in poor rusted condition

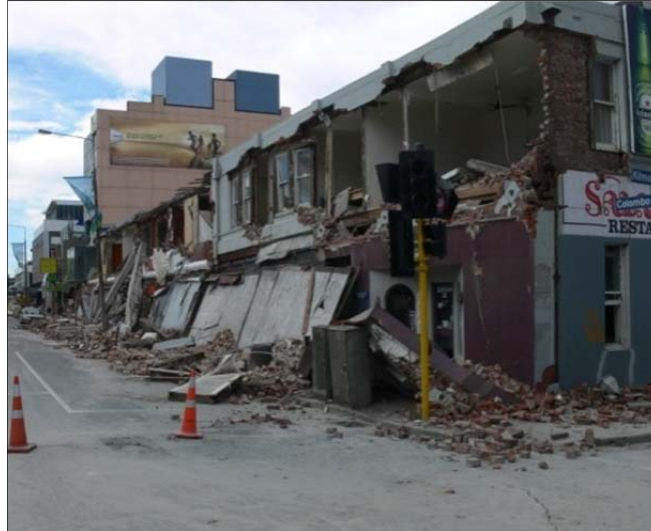
Awnings (also called canopies) frequently sustained significant damage due to masonry debris falling from collapsed parapets, gable ended walls, or upper storey walls. An example of a collapsed awning is shown in Figure 3.6.

**Figure 3.6 Collapse of awnings due to falling debris, at the corner of Colombo and Kilmore Streets looking north-east**

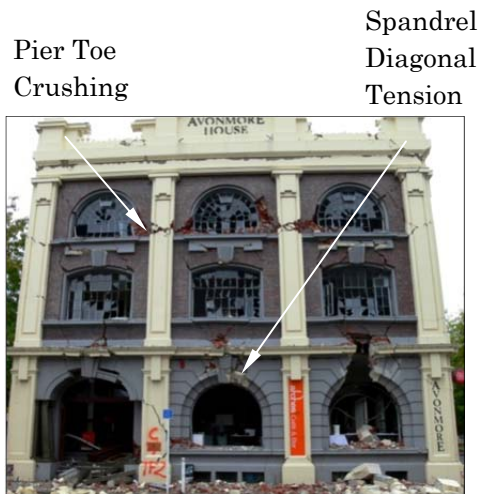
(a) Spandrel failures, 203 Hereford Street

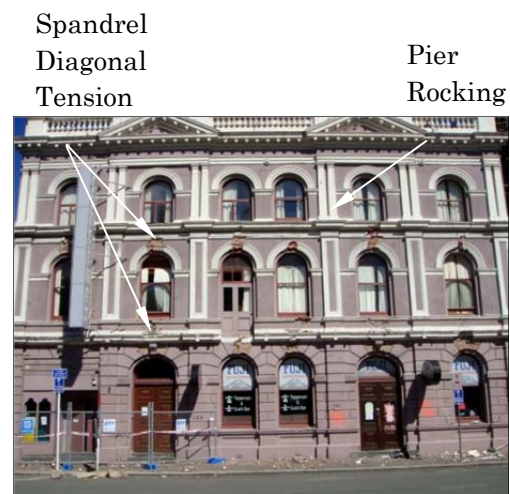
(b) Spandrel failures, 144 Gloucester Street

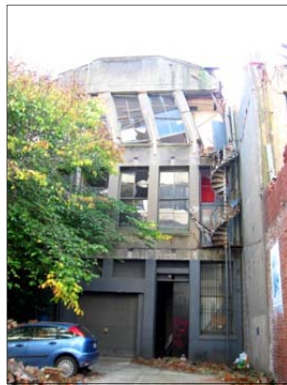
(c) Weak piers, pier rocking, 82 Lichfield Street

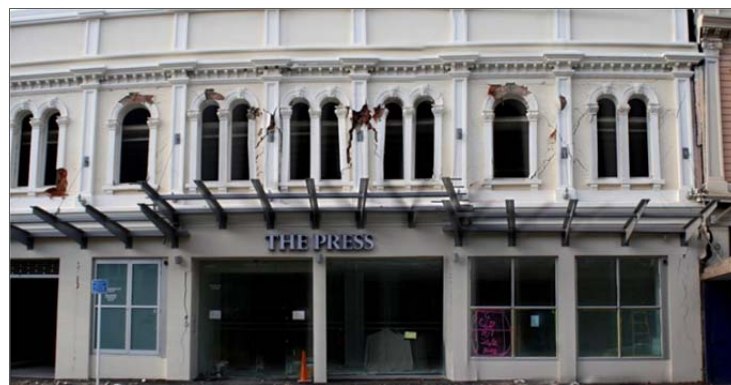
(e) Weak piers, 156 Gloucester Street

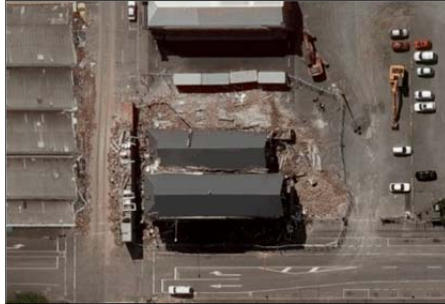
(a) Aerial view of damage, 202-204 Madras Street

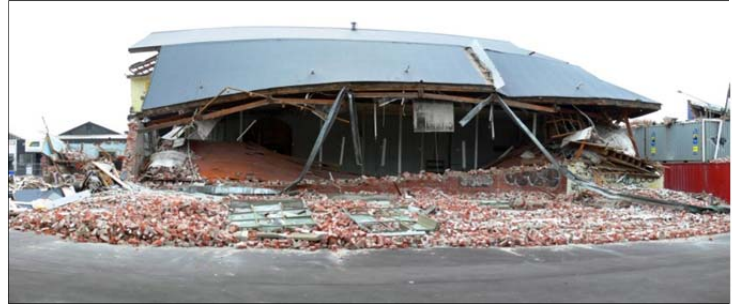
(b) North elevation damage view, 202-204 Madras Street

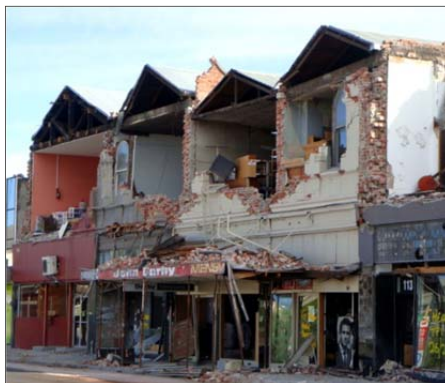
(c) Out-of-plane collapse of parapet and facade, 105 -109 Manchester Street

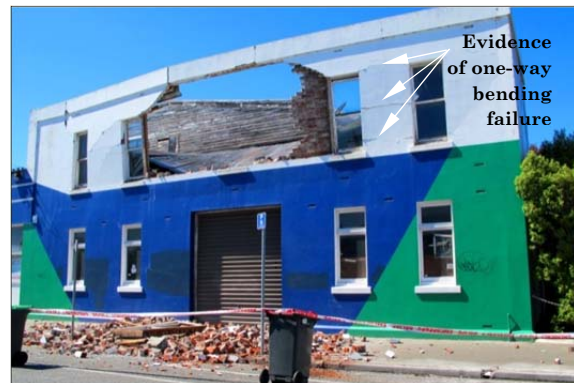
(d) One-way out-of-plane bending wall failure below a concrete ring beam (building located outside CBD)

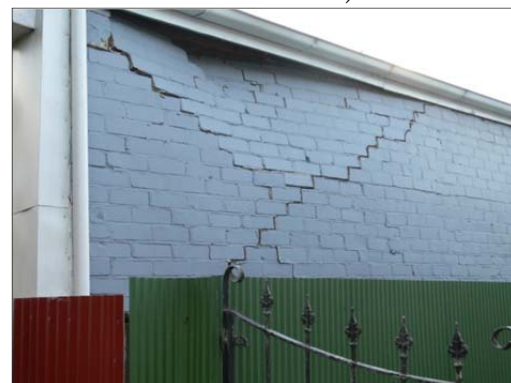
(f) Two-way bending out-of-plane wall failure

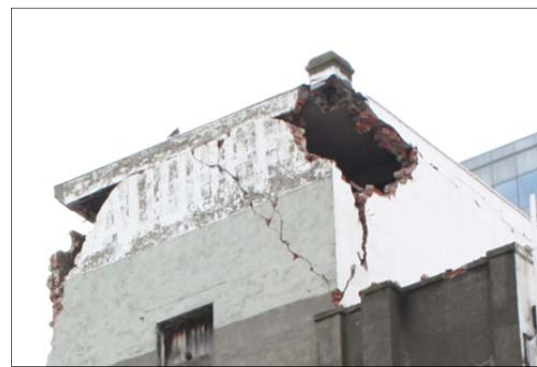
(b) Corner failure

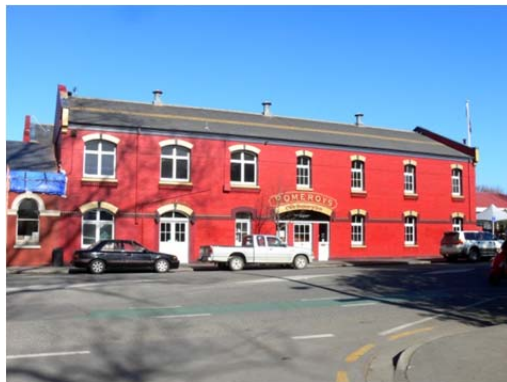
(a) Damage classification - Insignificant  
Damage level – A  
(292 Kilmore Street)

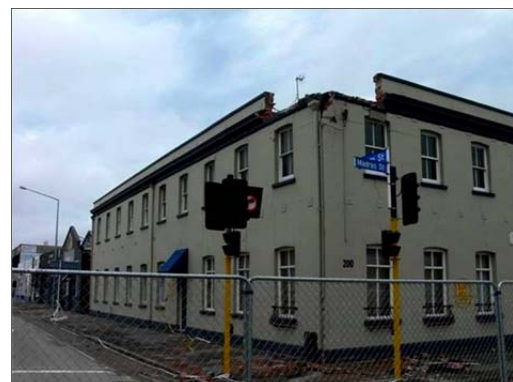
(b) Damage classification - Moderate  
Damage level – B  
(200 Madras Street)

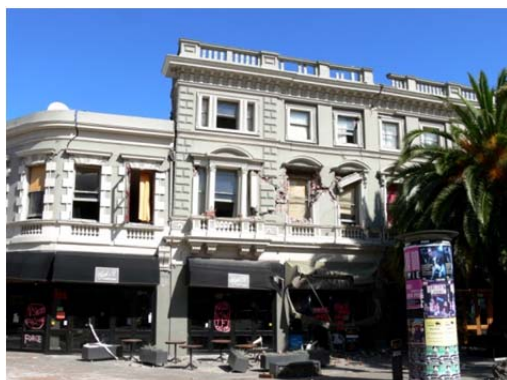
(c) Damage classification - Heavy  
Damage level – C  
(120 Manchester Street)

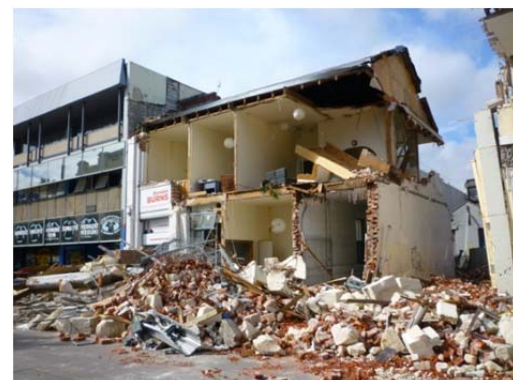
(d) Damage classification - Destroyed  
Damage level – D  
(202 Hereford Street)

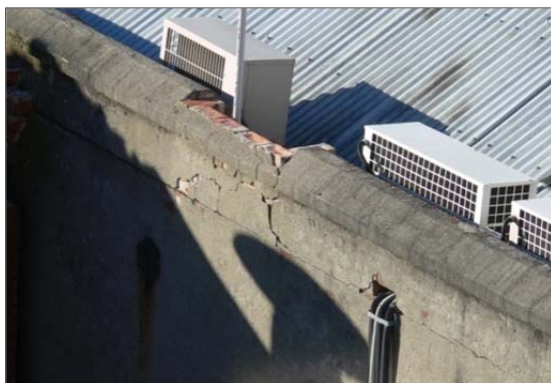
(a) Moderate damage to parapet

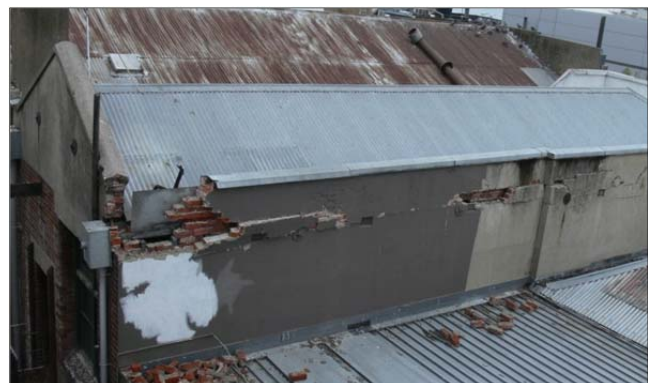
(b) Heavy damage to parapet

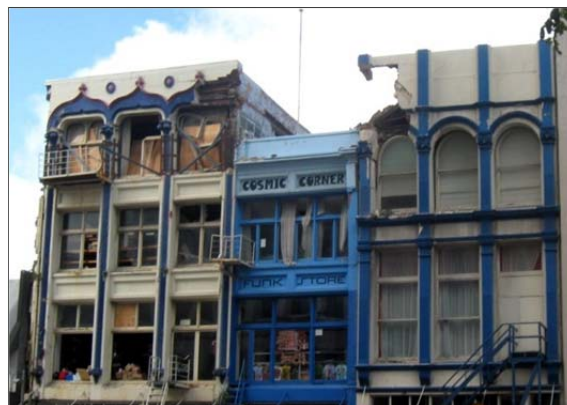
**Figure 3.13 Example of building pounding causing in-plane failure, High Street**

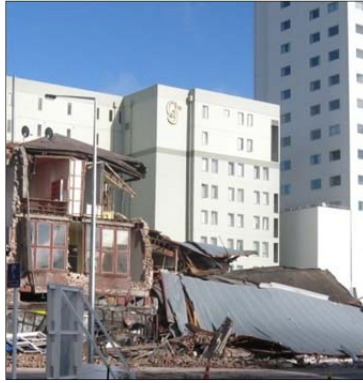
(a) Entire collapse of a building on to a road, near certain risk to building occupants and to public space, 225-227 Manchester Street

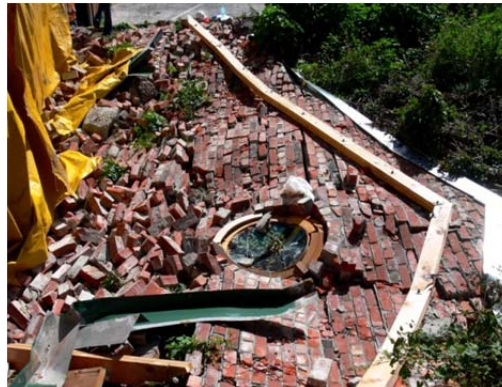
(d) Gable collapse due to inadequate connections

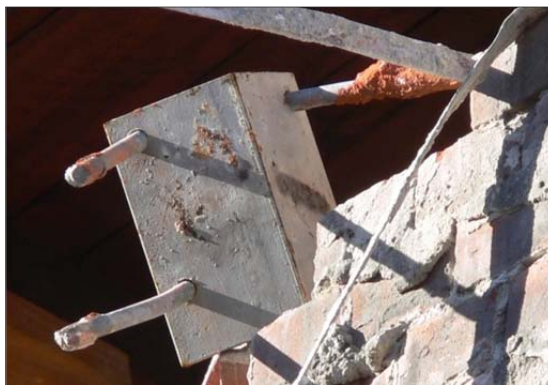
(a) Poor installation of adhesive anchors

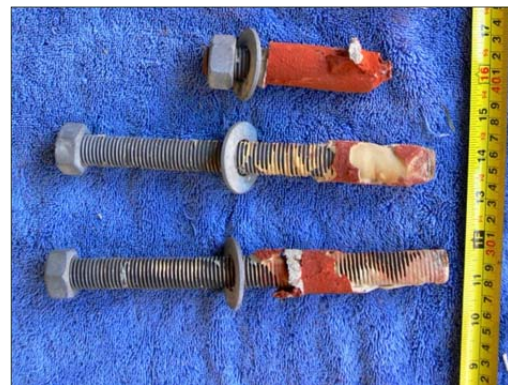
(b) Recovered adhesive anchors that performed inadequately

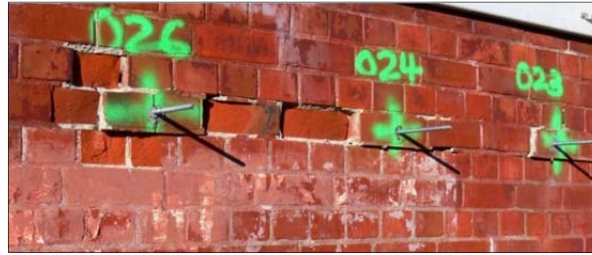
**Figure 7.6** Typical masonry pullout type failure observed

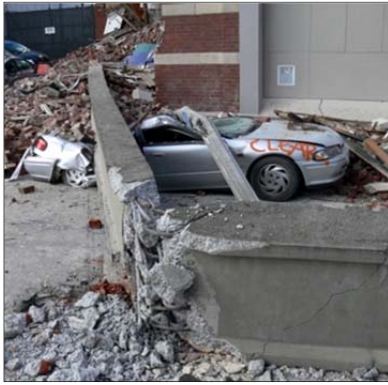
(a) Collapse of concrete capping beam used to replace the original masonry parapet

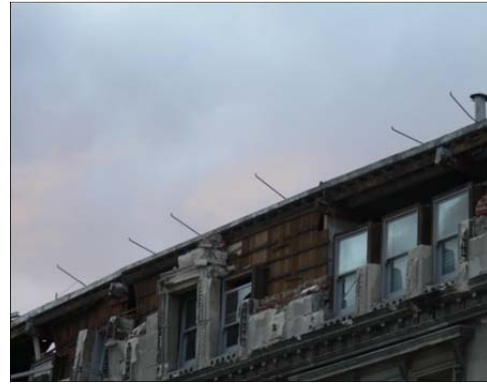
(b) Thin and flexible restraint rods failed to restrain the parapet
