**SUBJECT: REVIEW FOR ROYAL COMMISSION**

*Structural Performance of Christchurch CBD Buildings in the 22  
 February Aftershock: Stage 1 Expert Panel Report dated 30 September  
 2011 (DBH Expert Panel)*  
*Investigation into the Collapse of the Pyne Gould Corporation Building on  
 22<sup>nd</sup> February 2011 dated 26<sup>th</sup> September 2011 (Beca)*  
*Report on the Structural Performance of the Hotel Grand Chancellor in  
 the Earthquake of 22 February 2011 dated 26 September 2011 (Dunning  
 Thornton Consultants Ltd)*  
*Investigation into the Collapse of the Forsyth Barr Building Stairs on 22<sup>nd</sup>  
 February 2011 dated 26<sup>th</sup> September 2011 (Beca)*

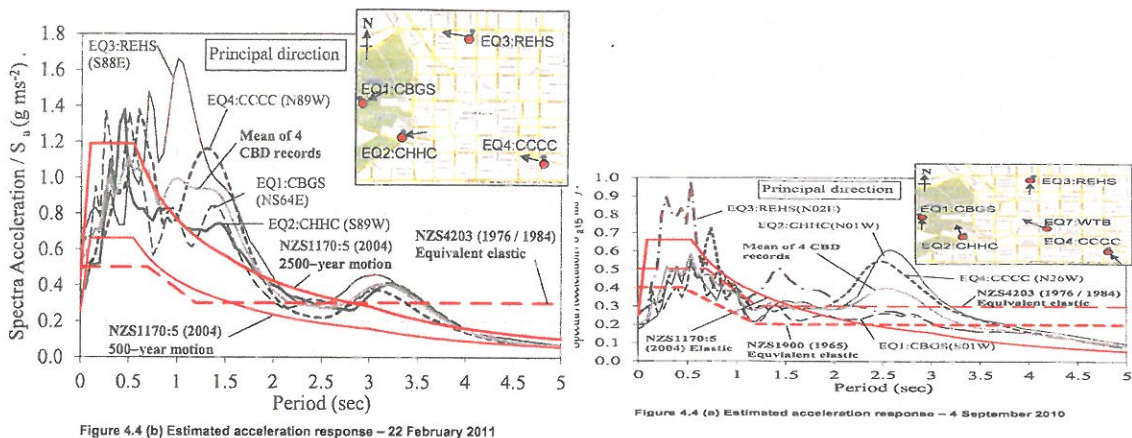
The perception of the differences between the September 4 and February 22 shaking intensities is also minimized by the fact that the comparison figures (Figure 4.4 (a) and (b) and Figures 4.5 (a) and (b)) are drawn to significantly different scales, each with a predominant and similarly shaped red response spectrum curve. However, the two red curves are very different, the one in the (a) figures being the 500 year return spectrum and the one the (b) figures being the much larger 2500 year return spectrum. The figures have been digitally manipulated to approximately the same scale in Figure 1 below and the visual impression is very different.

**Figure 1:** Figure 4.4 (a) and Figure 4.4 (b) drawn to the same scale
