STEEL BUILDING DAMAGE FROM THE CHRISTCHURCH EARTHQUAKE SERIES OF 2010 and 2011

Charles Clifton¹, Michel Bruneau², Greg MacRae³, Roberto Leon⁴, and Alistair Fussell⁵

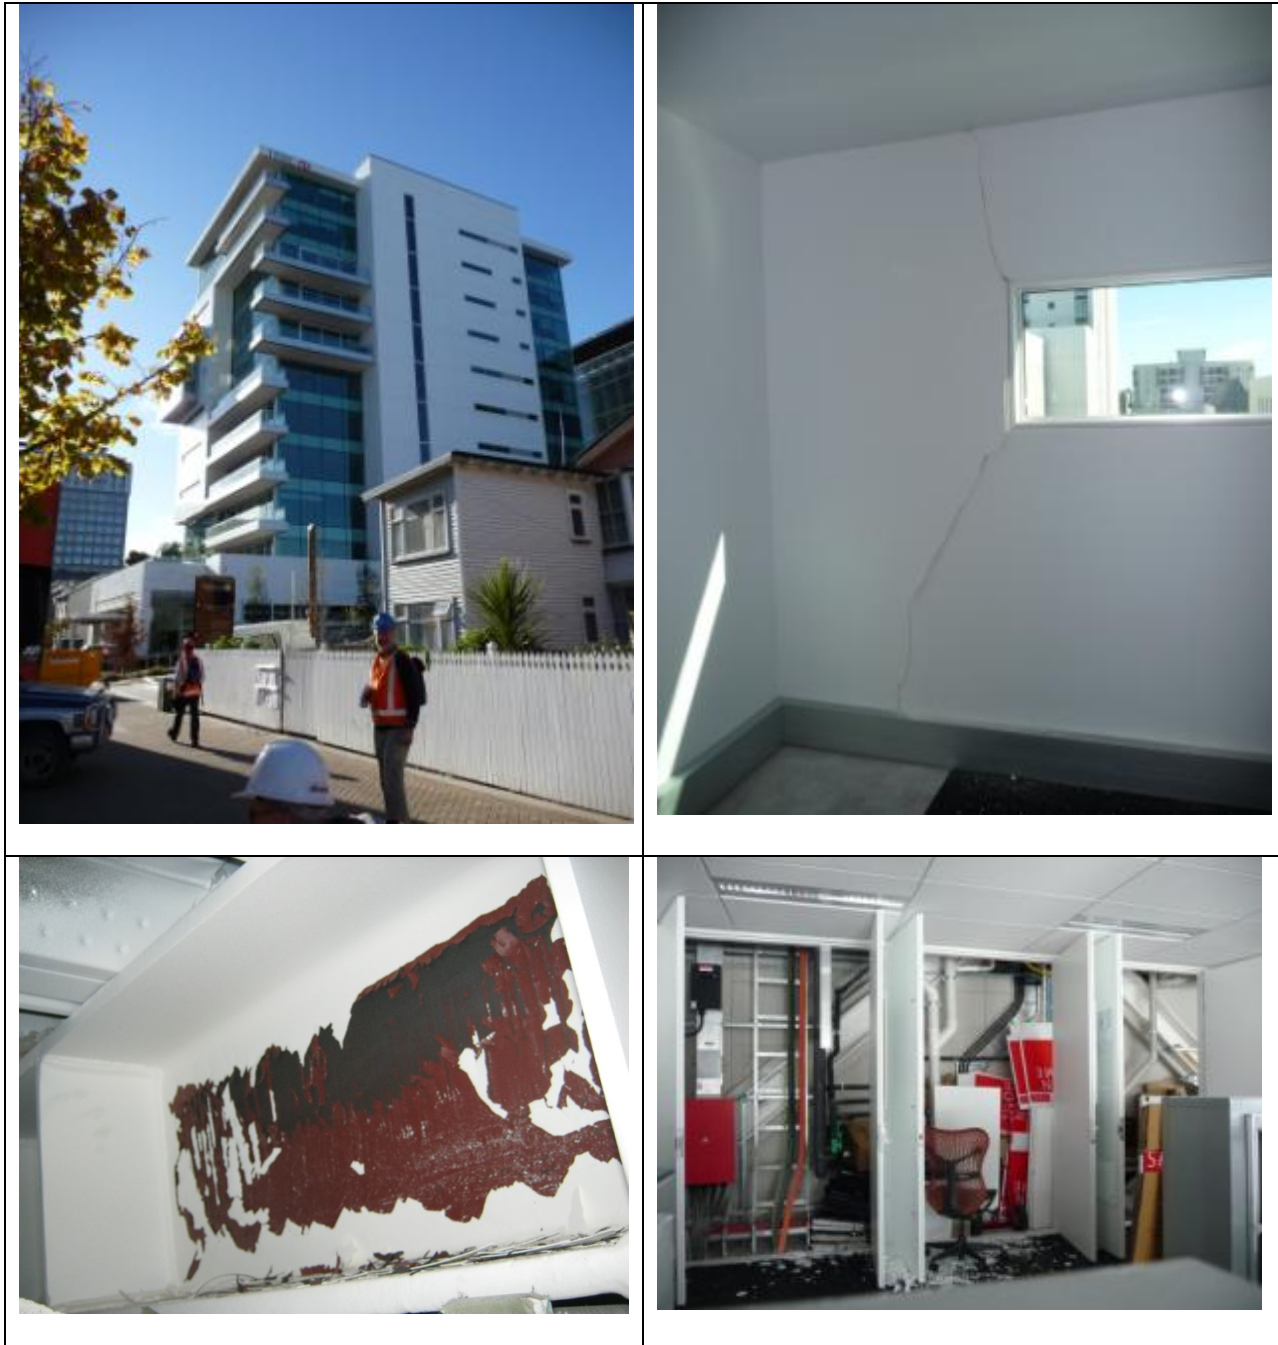
The Club Tower Building (Figure 3a) has eccentrically braced frames located on three sides of an elevator core eccentrically located closer to the west side of the building, and a ductile moment resisting frame (DMRF) along the east façade. The steel frame is supported on a concrete pedestal from the basement to the 1st story, and foundations consist of a 1.6m thick raft slab. Only the EBFs on the east side of that core could be visually inspected without removal of the architectural finishes (Figure 3d), however more detailed investigation was made of the South side active links through removal of ceiling tiles to ascertain the most significantly yielded braces. Figure 3c shows a link at level 3 on the South side which has the greatest observed inelastic demand. Estimates of the peak inelastic demand in that brace were made by two independent means. First was through assessment of the visible state of the metal in the yielded web of the active link and secondly through estimate of the peak interstorey drift. Both methods gave a peak shear strain of between 3% and 4%. The links were free of visible residual distortions. Assessment of damage accumulation in the steel at a peak shear strain of 4% over an estimated two complete cycles of loading using the damage criterion developed by (Seal, 2009) and change in

transition temperature based on the work of (Hyland, 2006) showed that the yielded active links have sufficiently robust metallurgical properties to be left in place. Previously reported slab cracking (Bruneau et al. 2010) could not be detected as the concrete floor slab was covered by floor carpeting, except at one location at the fixed end of a segment of the floor cantilevering on one side of the building (a feature present only over two stories for architectural effect). Crack widths after February 22, 2011 appeared similar to what had been observed after September 4, 2010, being localised only. Substantial shear cracking of the gypsum plaster board (sheetrock) finish on the exterior wall of that cantilevering part of the floor was also observed (Figure 3b); only hairline cracking of gypsum plaster board finishes was observed elsewhere throughout the building, supporting post-earthquake survey measurements showing that the building has a post-earthquake residual drift of only 0.1%. One non-structural masonry block wall installed for sound proofing purposes adjacent to mechanical units on the pedestal roof suffered minor shear cracking, where it had been placed hard against a cantilevering floor beam.

Figure 3: Club Tower [Photos by M. Bruneau and C Clifton]: (a) Global view; (b) cracking of partition in cantilevering portion of story; (c) paint flaking of partially hidden EBF link; (d) global view of EBF braces obstructed by various utility runs.

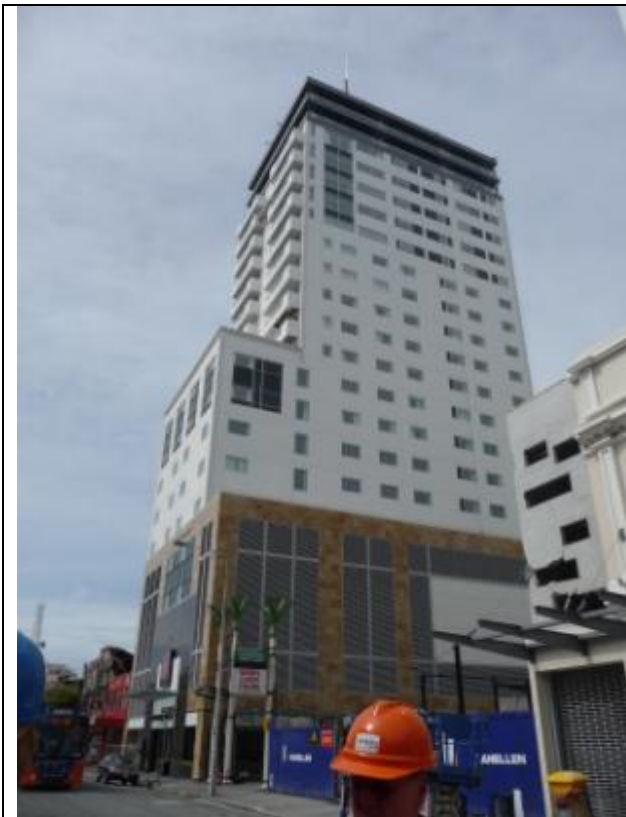
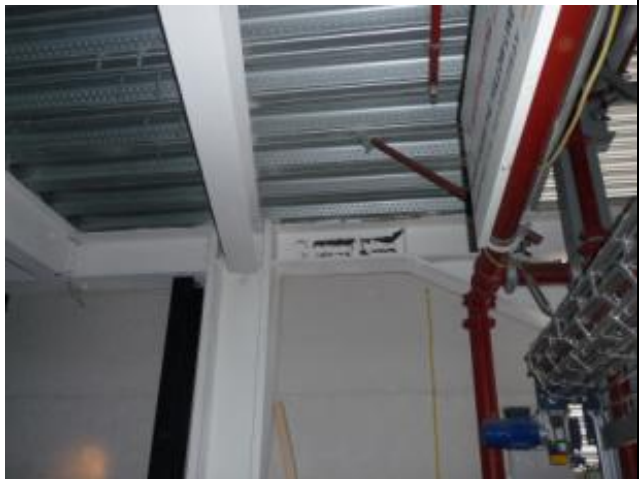
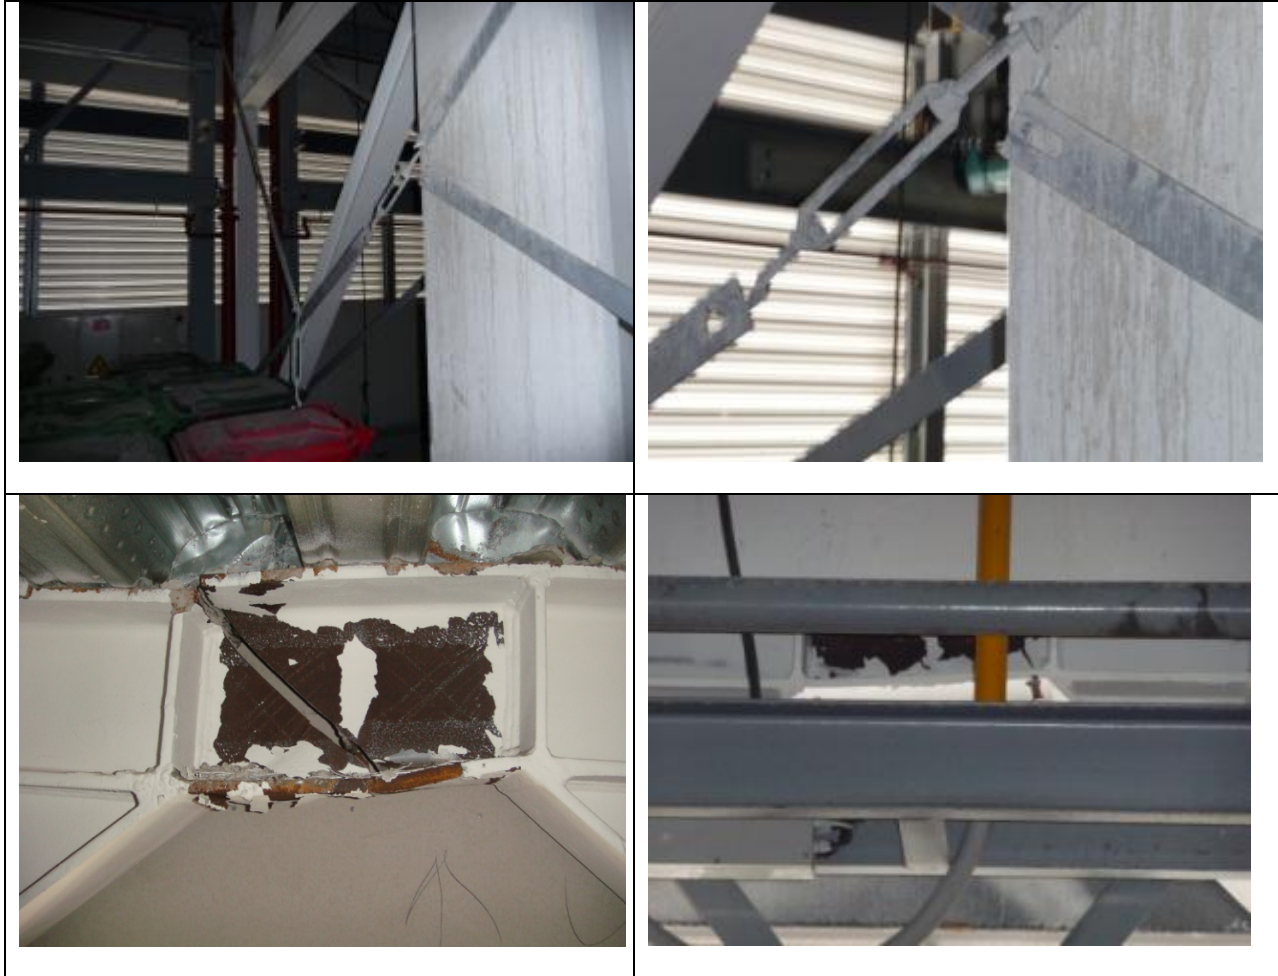
Paint flaking and residual link shear deformations were observed in the EBF links at those levels. Design of the EBFs in that building was governed by the need to limit drift, with a corresponding resulting design ductility factor (μ) of 1.5 (even though up to 4.0 is permitted for EBF systems, as mentioned earlier). This is typical of EBFs in tall buildings in New Zealand's moderate to low seismic zones; Christchurch is moderate in accordance with the earthquake loadings standard, NZS 1170.5 and a more typical design ductility level factor range for such buildings is 2 to 3. When the initial internal inspections were undertaken, there was an absence of significant damage to architectural and other non-structural finishings except at level 6 where a few of the hotel room doors along the corridor could not be closed, suggesting greater residual deformations at that level. This level was the first in which a detailed evaluation was undertaken. One fractured EBF active link was discovered (Figure 4e) in the top level (underside of Level 6) of the EBF system at the North-Western corner of the building. The frame sits behind the louvre system nearest the camera in Figure 4a. This link had undergone at least one full cycle of web panel yielding prior to a fracture propagating from one top corner across the active link region and resulting in significant residual deformation. Temporary strap cross-bracing was welded to the active link frame to provide lateral load resistance while a repair strategy was implemented, which comprised cutting out the damaged link, welding on an endplate system to each collector beam/brace face and replacing with a site bolted endplate active link. The replacement is scheduled for early October 2011 and is the only repair to the structural frame required for this building. A detailed evaluation was undertaken of all active links in the adjacent storeys and throughout the building, with the frequency of inspection reduced as no further examples requiring replacement were found. This inspection required removal of architectural finishes.

This type of failure has not been reported in either EBFs tested in the laboratory or from damage reports from other earthquakes; the reasons for this link fracture are not currently clear and it is to be the subject of a detailed metallurgical and structural evaluation once removed..

Figure 4 Pacific Tower [Photos by M. Bruneau and C Clifton]: (a) Global view;(b) Flaked paint on EBF active link; (c) and (d) Multi-story mechanical garage stacker failed braces; (e) Fractured EBF active link in top level of EBF system in front face of atrium; (f) Residual shear deformations of EBF link in car stacker tower.

As with Club Tower, some repair of dry-wall cracking and realignment of lift shaft guide rails is the only other work required and the intention is to have this completed in time for the building to be fully opened when public access is restored into this area. It is also worth noting that this is likely to be the only one of the six high-rise buildings in Christchurch that will be returned to service.

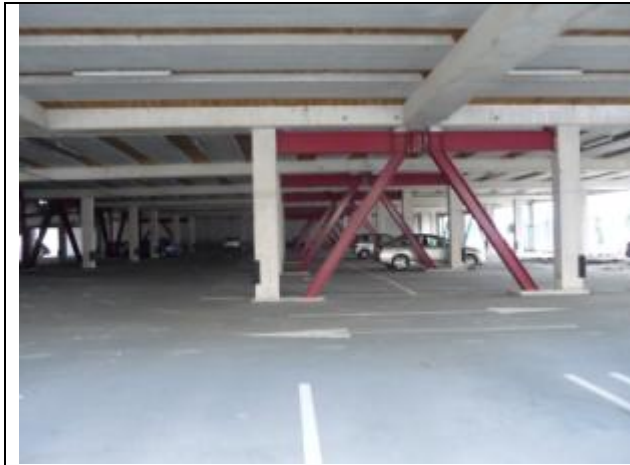
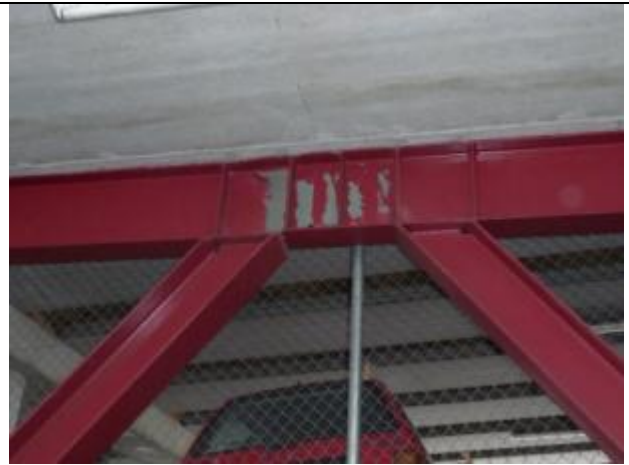
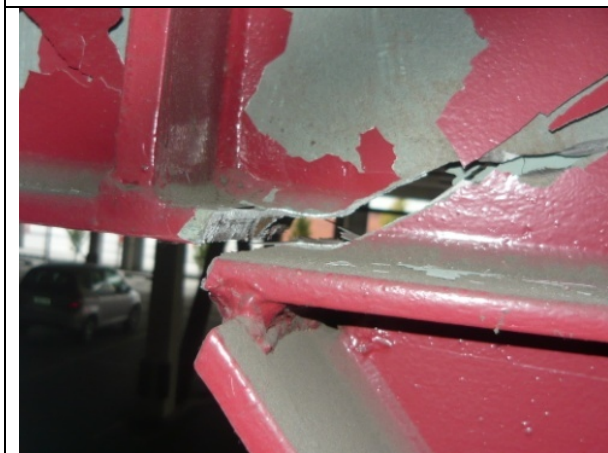
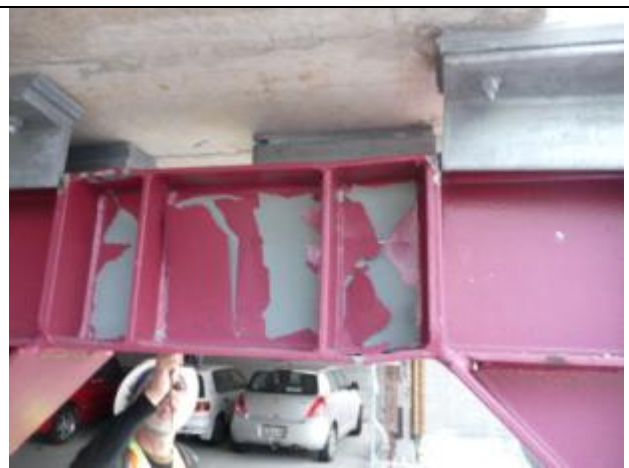
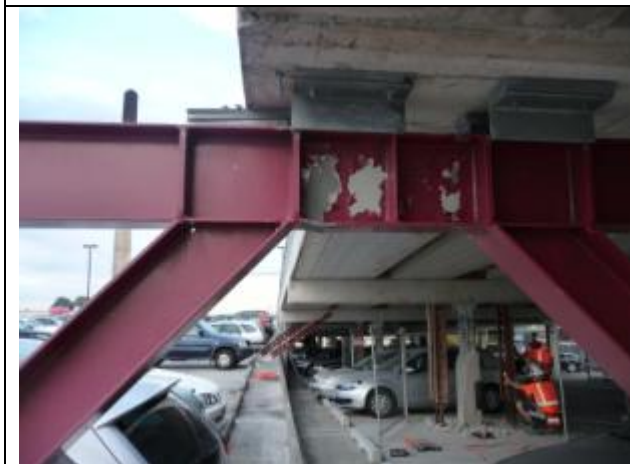
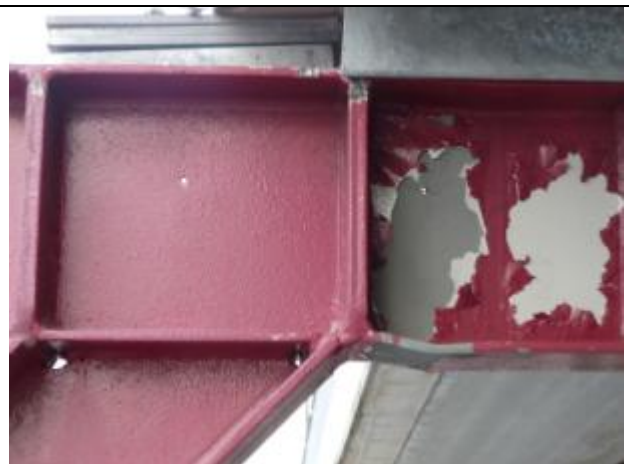
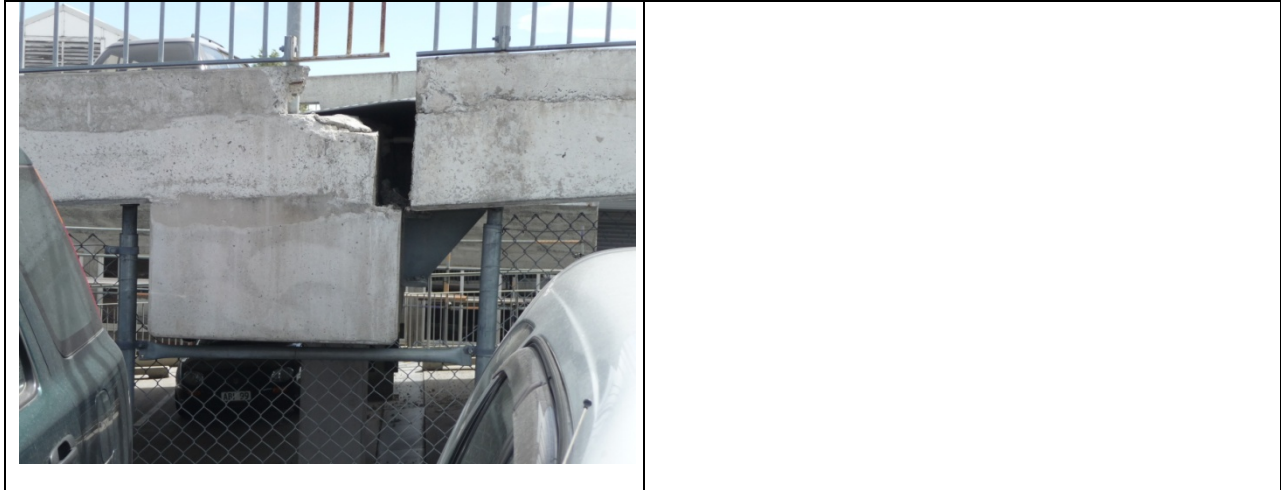
The EBFs in a hospital parking garage closer to the epicentre (Bruneau et al. 2010) also performed well, although some link fractures were observed in two braced bays (Figure 6). Note that at least six EBF frames were used at each level in each of the buildings' principal directions, and that this significant redundancy contributed to maintain satisfactory seismic performance of the building in spite of those significant failures. Residual drifts of the parking structure or damage to the gravity load carrying system were not visually noticeable, which suggests that these fractures would have not have been discovered if hidden by non-structural finishes.

The fractures, as shown in close-up in Figure 6(c), were of particular concern as these were the first fractures recorded in EBFs worldwide (the Pacific Tower fracture as mentioned above was discovered later). Further puzzlement was added by the fact that the fracture plane, shown in Figure 6(c), indicated a ductile overload failure rather than a brittle fracture. However, the likely explanation lies in the offset of the brace flange from the stiffener. This offset is shown in Figure 6(c) and means that, when the brace was loaded in tension, the axial tension force in the brace fed into the active link/collector beam panel zone through a flexible beam flange rather than directly into the stiffener. This meant that the junction between the unstiffened beam flange and the beam web was severely overloaded, leading to fracture between these two surfaces and this fracture spreading across the beam flange and through the web. Evidence in support of this is from the following:

- where the flanges of the brace line up with the stiffeners, as in the right hand side of the active link shown in Figure 6(b) or the panel zone shown in Figure 6(e), there was no damage to this panel zone region
- the damage to the panel zone region is directly proportional to the eccentricity between the brace flange and the active link end stiffener

The lateral bracing of the active links in the building shown in Figure 6 was only in the form of a confining angle each side of the top flange, as shown in Figure 6(d) and 6(e). No lateral movement or twisting of the ends of the active links was observed, indicating that the lateral restraint provisions had been adequate in practice, despite only being applied to the top flange and for EBFs not integral with the slab above also being non-compliant with NZS 3404.

Figure 6: Parking garage on St Asaph St and Antigua St, Christchurch [Photos by M. Bruneau]; (a) Redundancy provided by multiple EBF bays; (b) Evidence of EBF link yielding; (c) Fractured link at lower level EBF; (d) Evidence of inelastic deformations at top level EBF; (e) Close-up view of same; (f) Displacement at expansion joint, top ramp.

As of mid 2011, the fractured active links have been cut out and are being replaced to bring the building back into service in advance of when public access is restored to this area.

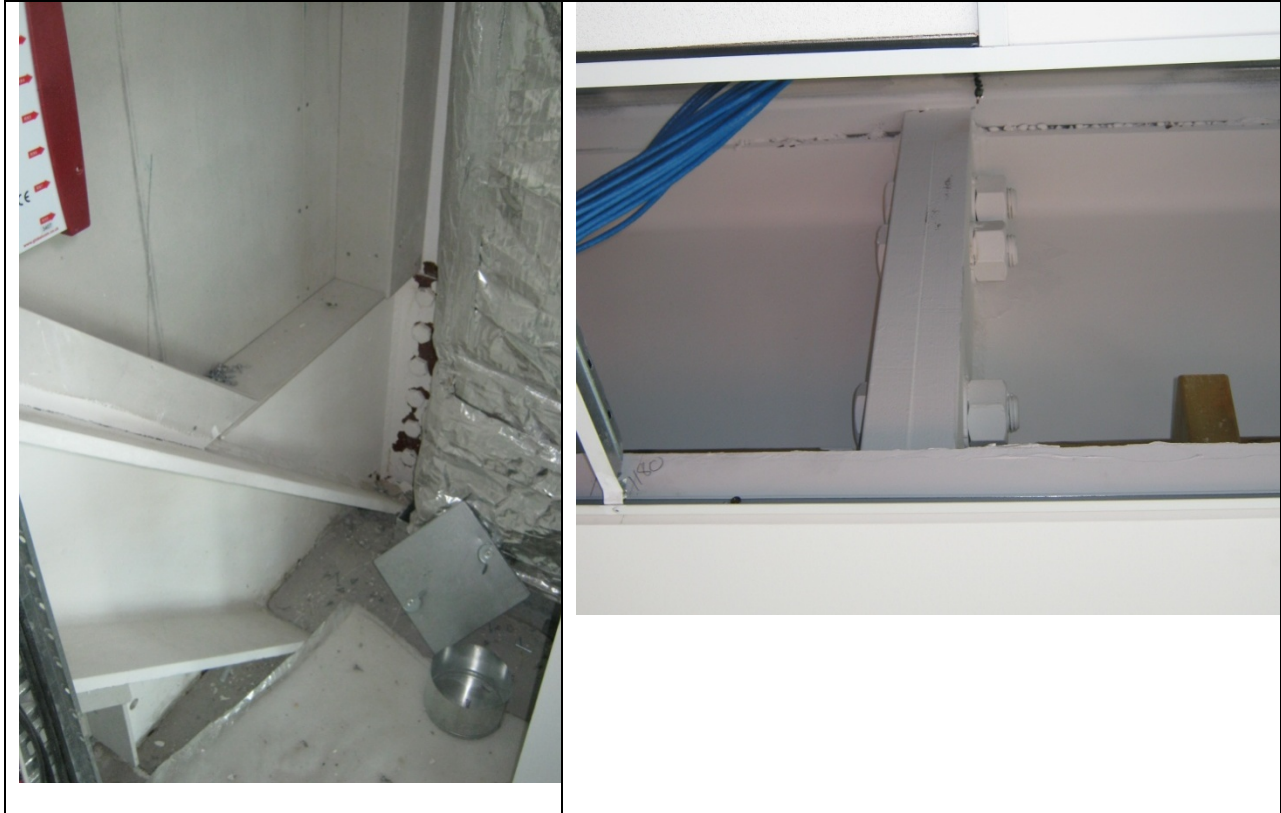
Connections in modern steel frames performed very well and as expected. Figure 7 (a) shows a brace/beam/column connection in which the gusset plate is welded to the beam and bolted to the column with a flexible end-plate connection, which is designed and detailed to be rigid for vertical load transfer and flexible in the horizontal direction, to accommodate change in the angle between beam and column during the earthquake. This flexible end-plate has undergone limited out-of-plane yielding, protecting the gusset plate from inelastic demand. Figure 7 (b) shows a flush endplate splice in a MRF beam that has performed well.

Figure 7: Connections in Club Tower Building, Christchurch [Photos by G C Clifton]; (a) Brace/beam/column connection showing out-of-plane yielding in endplate but no inelastic demand in gusset plate; (b) Flush moment endplate splice connection

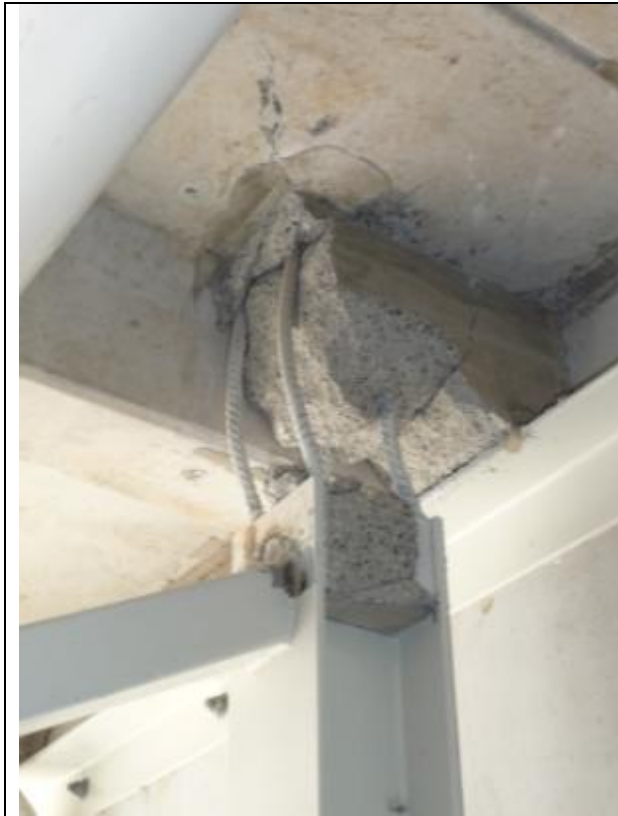
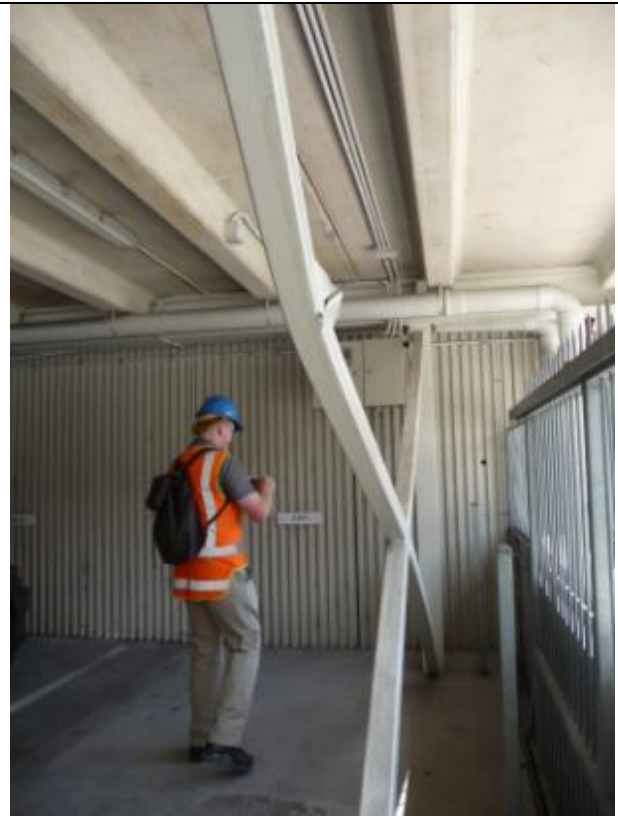
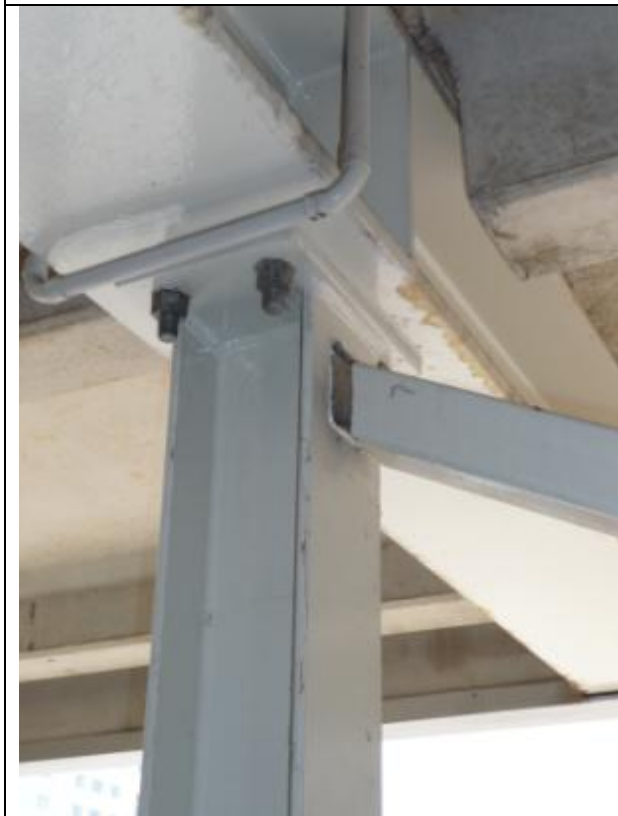
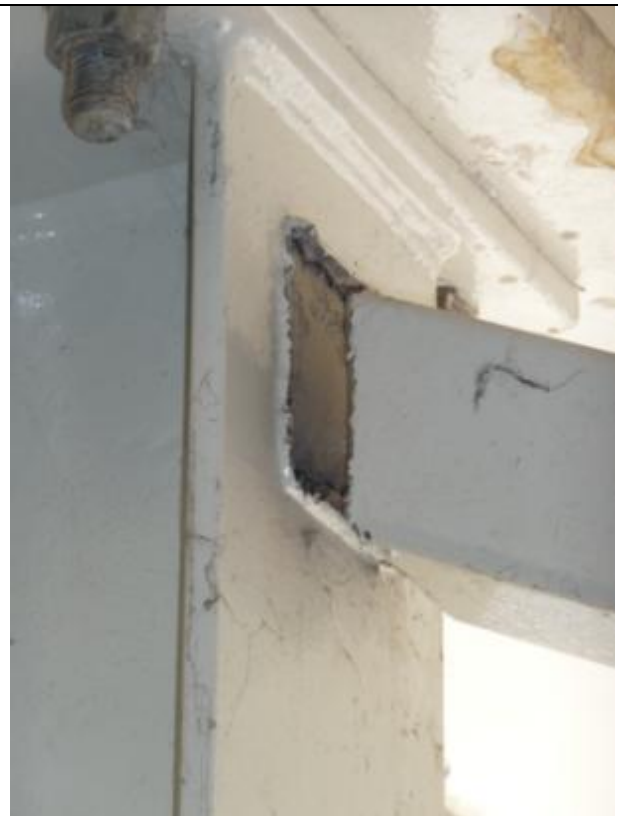
A single suspended level parking garage with concentrically braced frame (CBF) was found to have performed poorly (Figure 8). The garage had solid pre-cast panel walls on three sides, and two individual CBF bays along the fourth side (one bay on each side of the garage door). While the columns of the westernmost CBF tied to a steel beam at their top, the easternmost CBF was not similarly aligned with a steel beam. A non-ductile reinforced concrete extension framing into a concrete beam at the top performed poorly. The other brace of that frame failed at the welds under tension loads; these welds did not appear to be designed to develop the tension capacity of the brace according to the capacity design principles of NZS3404. The westernmost CBF performed better, without fractures and with proper attachment to the supported floor at both columns, with visible post-earthquake residual buckling as a consequence of brace elongation.

Figure 8: Low-rise CBF parking garage [Photos by M. Bruneau]: (a) Poor column connection detail; (b) Buckled brace; (c) and (d) Fractured non-ductile brace-to-column connection.

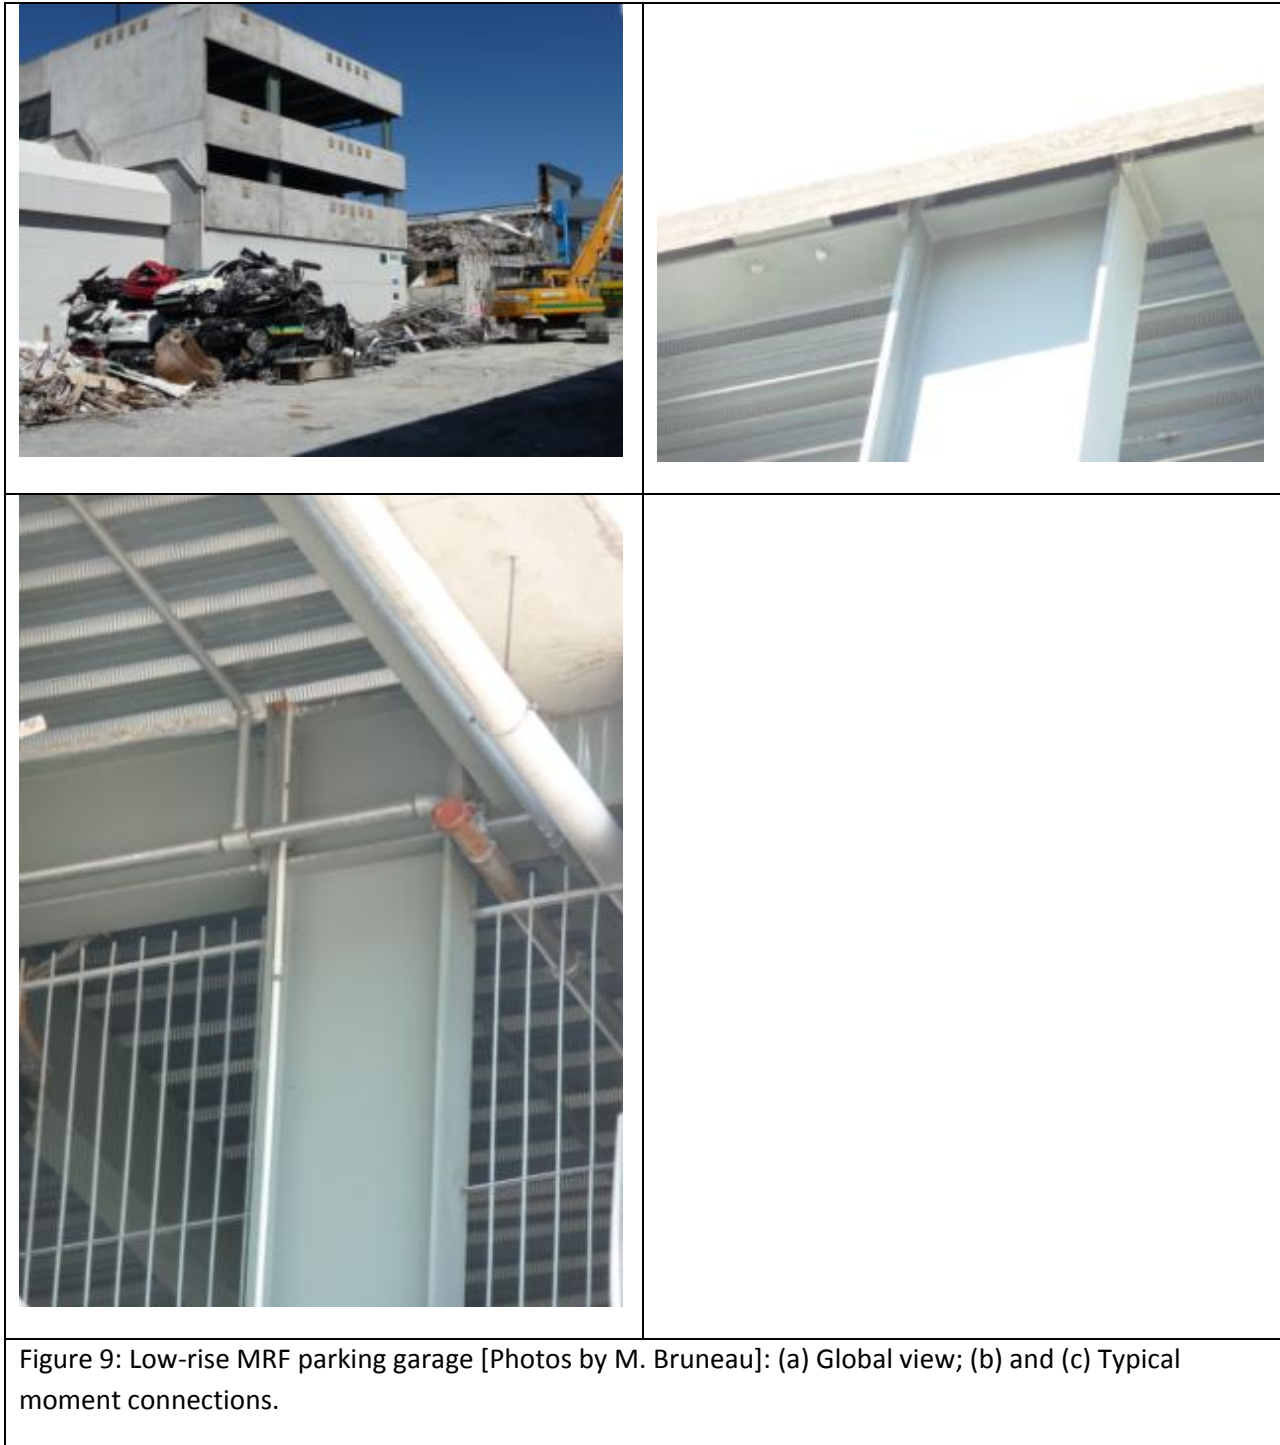
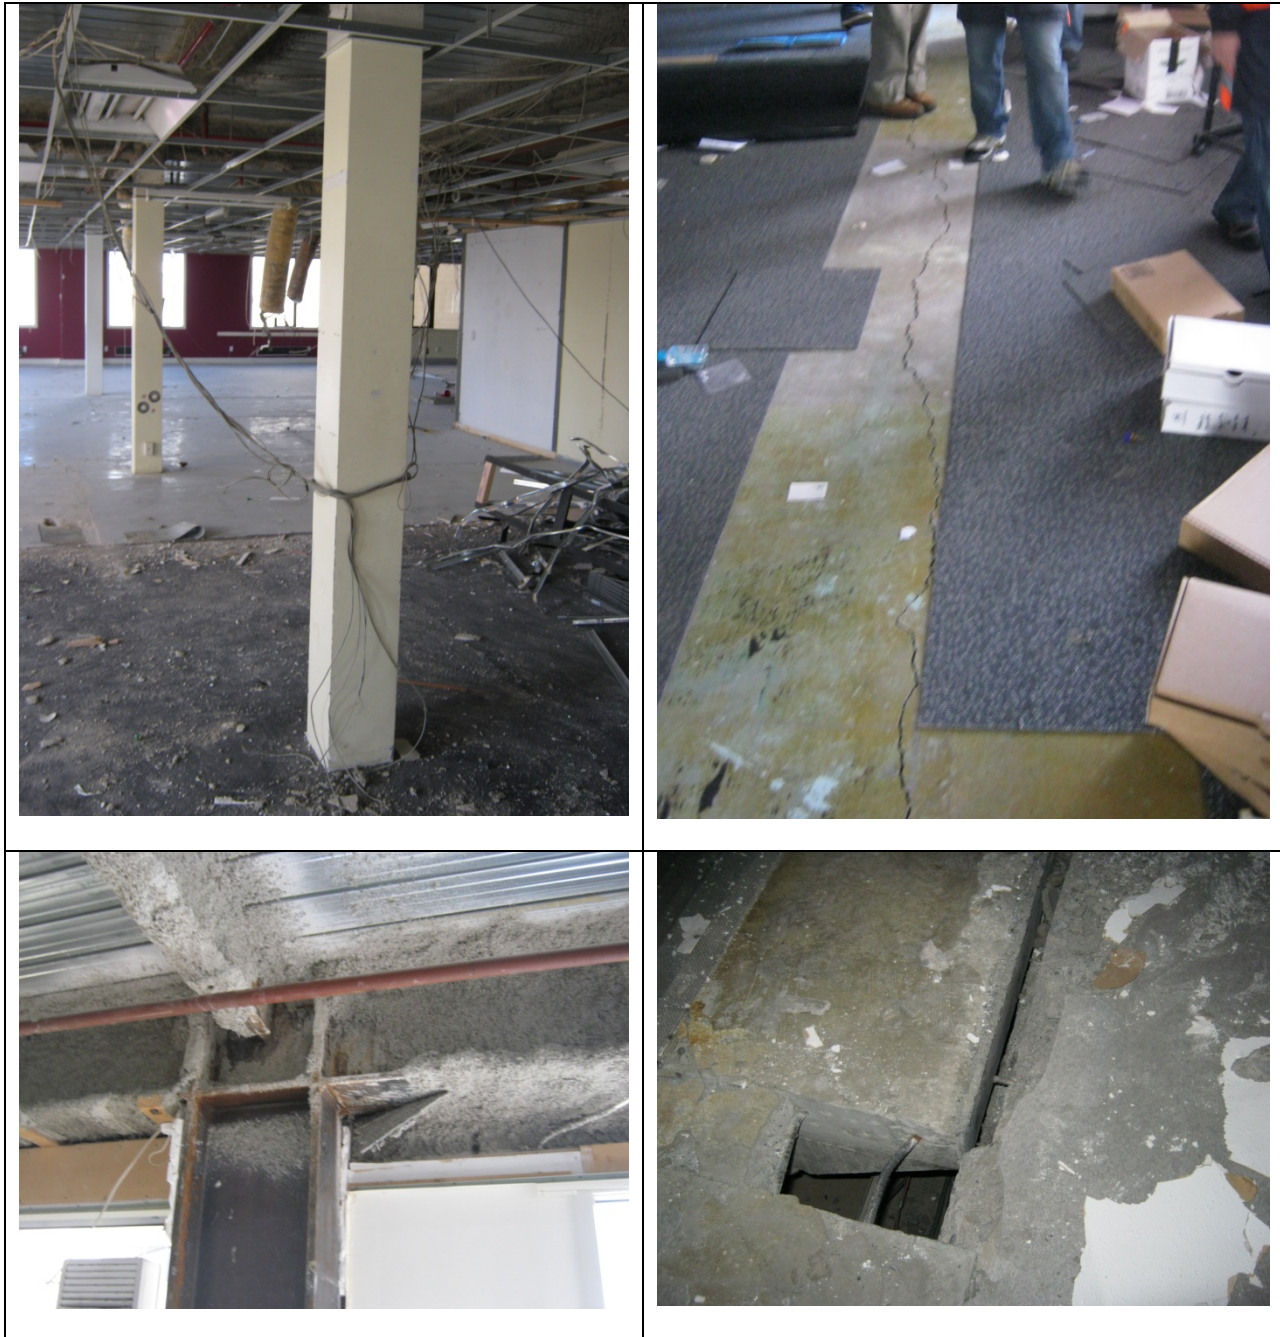
Finally a 7 storey building located in the region of the CBD that exhibited significant ground instability was inspected inside and out. The structure comprises a perimeter moment resisting frame along all 4 sides, with a non-structural stair and services core and composite floor. Inspection of the steel frame and floor showed no visible damage, however the perimeter frame had sunk a noticeable amount in relation to the core (Figure 10b) and had acted as pinned base, causing significant interstorey drift which has subsequently significantly damaged stairs (Figure 10d) and non-structural components. The extent of ground movement around the building was considerable and it is likely that significant foundation movement has occurred. The question of what to do with this building will rest on what has happened below ground.

Figure 10: Seven storey PMRF building [Photos by C Clifton]: (a) Internal view of partially stripped floor; (b) Crack in ground floor slab where perimeter (to the right of the crack) has moved downwards relative to the core; (c) Typical beam to column connection with fire protection partially removed for inspection; (d) Gap opening in stair at landing due to lateral movement (stairs had independent structural support).

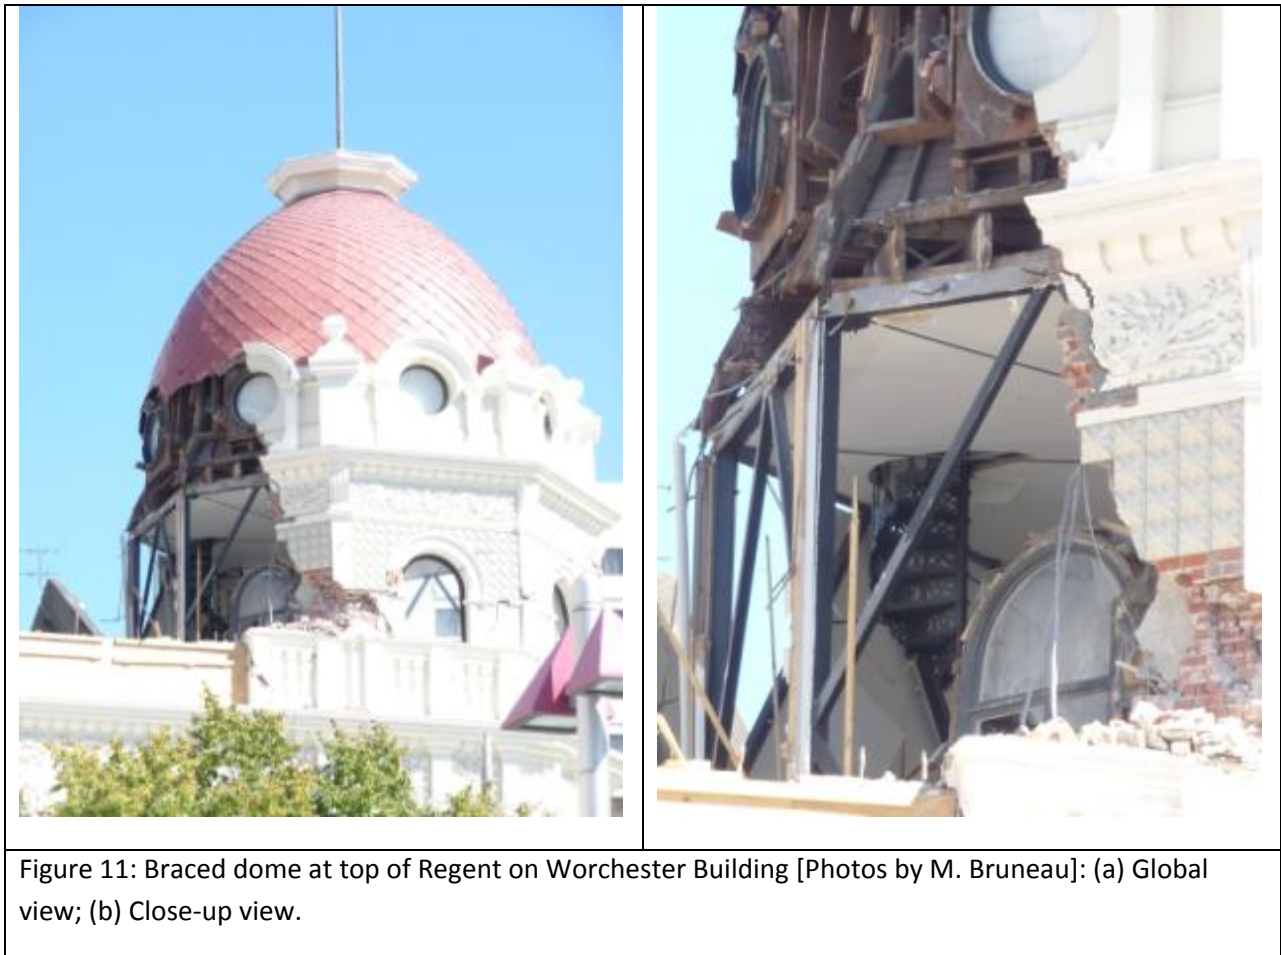
Partial out-of-plane failure around the dome at the top of the Regent Theatre) Building revealed that a braced steel frame had been used there (Figure 11). Although subsequent inspection will be required to verify the integrity of the connections, it appeared to be in good condition from a distance. The building was built before 1910 and the scene was reminiscent of pictures of similar buildings following the 1906 San Francisco earthquake. However, the CBFs appeared to be welded construction (to be verified) which means they are likely to be newer than the rest of the building and had been added in a subsequent retrofit.

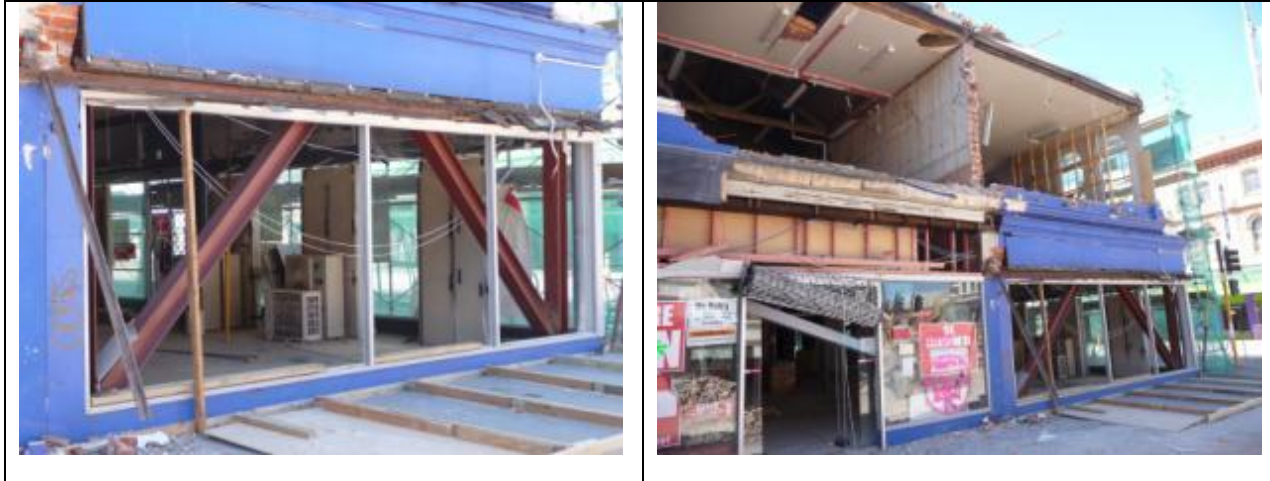
Steel braced frames were sometimes used to retrofit unreinforced masonry structures (e.g. Figure 12). Drift limits to prevent failure of the unreinforced masonry typically govern design in those instances, which explain the significant member sizes of these frames proportional to the reactive mass, and their elastic response.

Figure 12: Braced frame as a retrofit to unreinforced masonry building [Photos by M. Bruneau and C Clifton]: (a) Close-up view; (b) Global view.

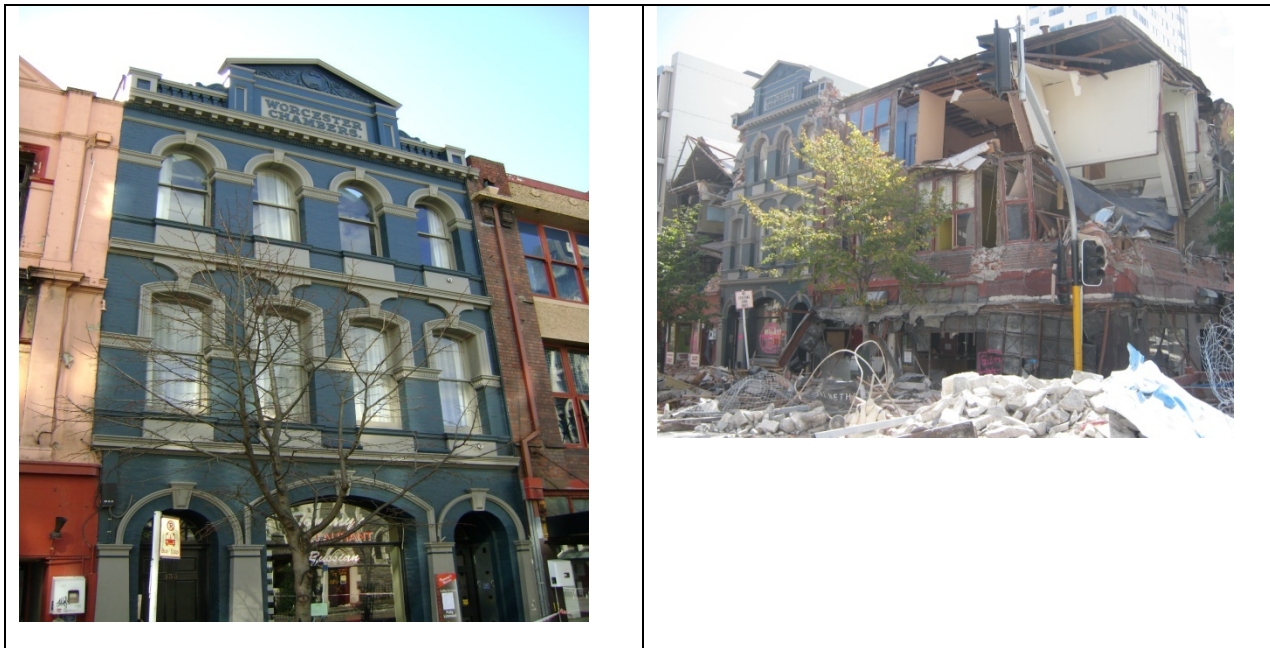
Buildings in the CBD that had been strengthened prior to the September 2010 earthquake typically suffered minimal to no damage in that event. They were not so fortunate in the much stronger February 2011 event. Figure 13 shows one group of three buildings, with (a) showing these following the September 2010 event and (b) showing (from a different vantage point) the three following the February 2011 event. Note especially the strengthened building on the corner has collapsed

Figure 13: Strengthened URM buildings[Photos by C Clifton]: (a) is following the September 2010 event and (b) following the February 2011 event, taken from a slightly different view-point.

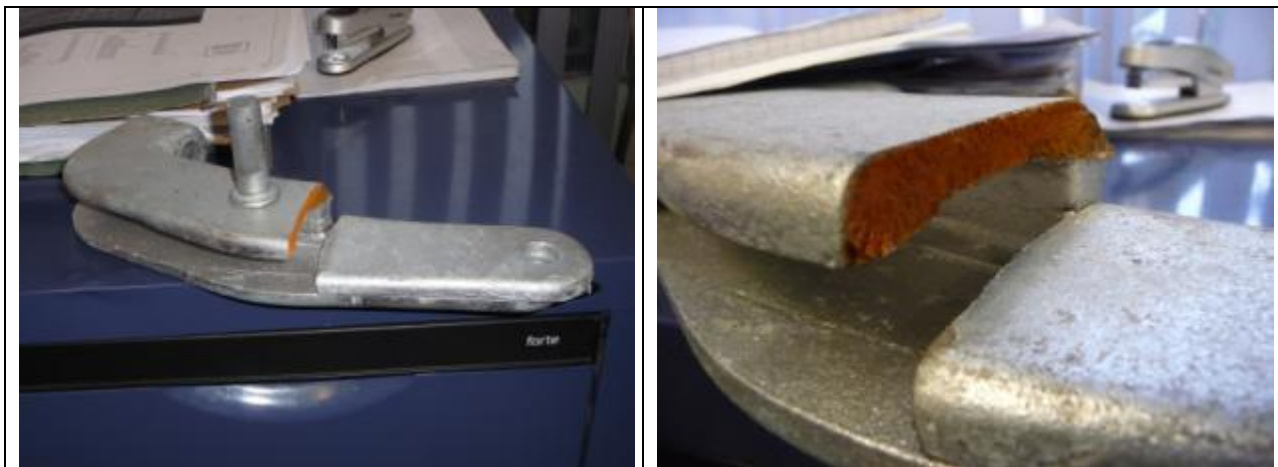
As was the case following the September 2010 Darfield earthquake, a proprietary system often used in these warehouses (sold as a kit) which used a particular banana end fitting, suffered some brittle failures of the cast-steel connectors (as shown in Figure 14). These occurred in a new warehouse when the fitting fell to the ground following the shearing of the pin retaining clip. Given that these connectors are rated for earthquake loading based on static tests conducted by the manufacturer, in light of the few fractures reported following the two earthquakes, some engineers have expressed concerns regarding their potential brittleness. Performance of this and similar systems needs to be validated under a dynamic test regime more representative of their expected seismic demands, particularly simulating the impact forces applied when previously-buckled braces re-tighten during earthquake excitations.

Figure 14: Example of fractured banana end of proprietary brace connector in the roof plane of a long span steel portal frame building [Photos by M. Bruneau]: (a) Global view; (b) Close-up view.
