STEEL BUILDING DAMAGE FROM THE CHRISTCHURCH EARTHQUAKE SERIES OF 2010 and 2011

Charles Clifton¹, Michel Bruneau², Greg MacRae³, Roberto Leon⁴, and Alistair Fussell⁵

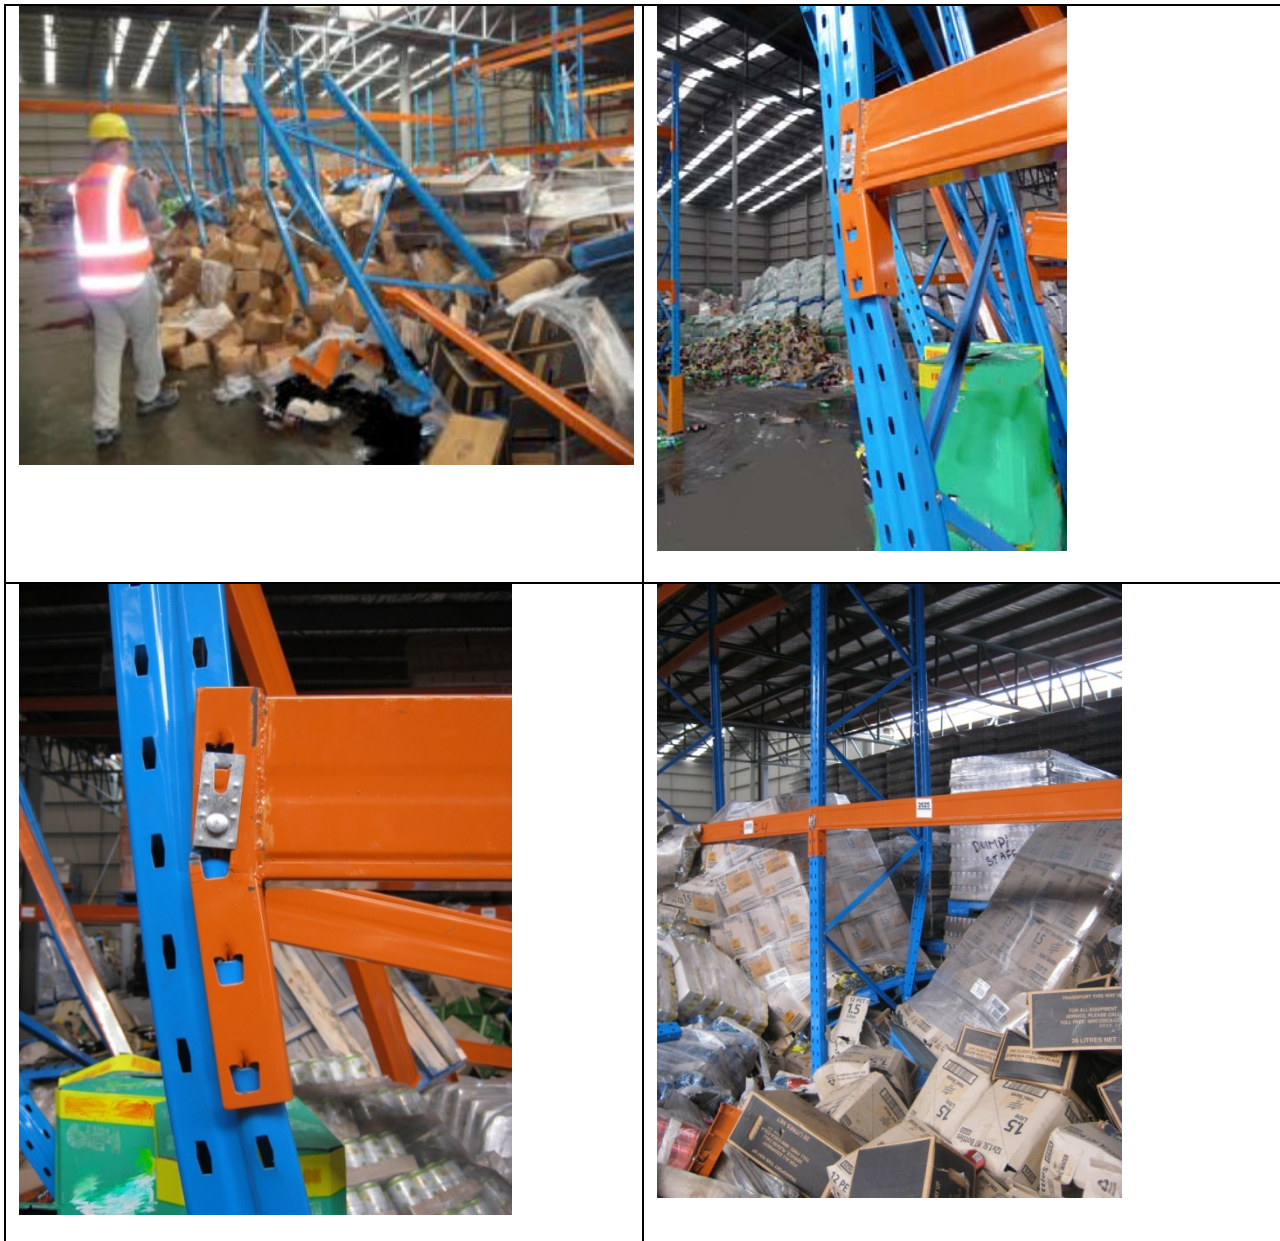
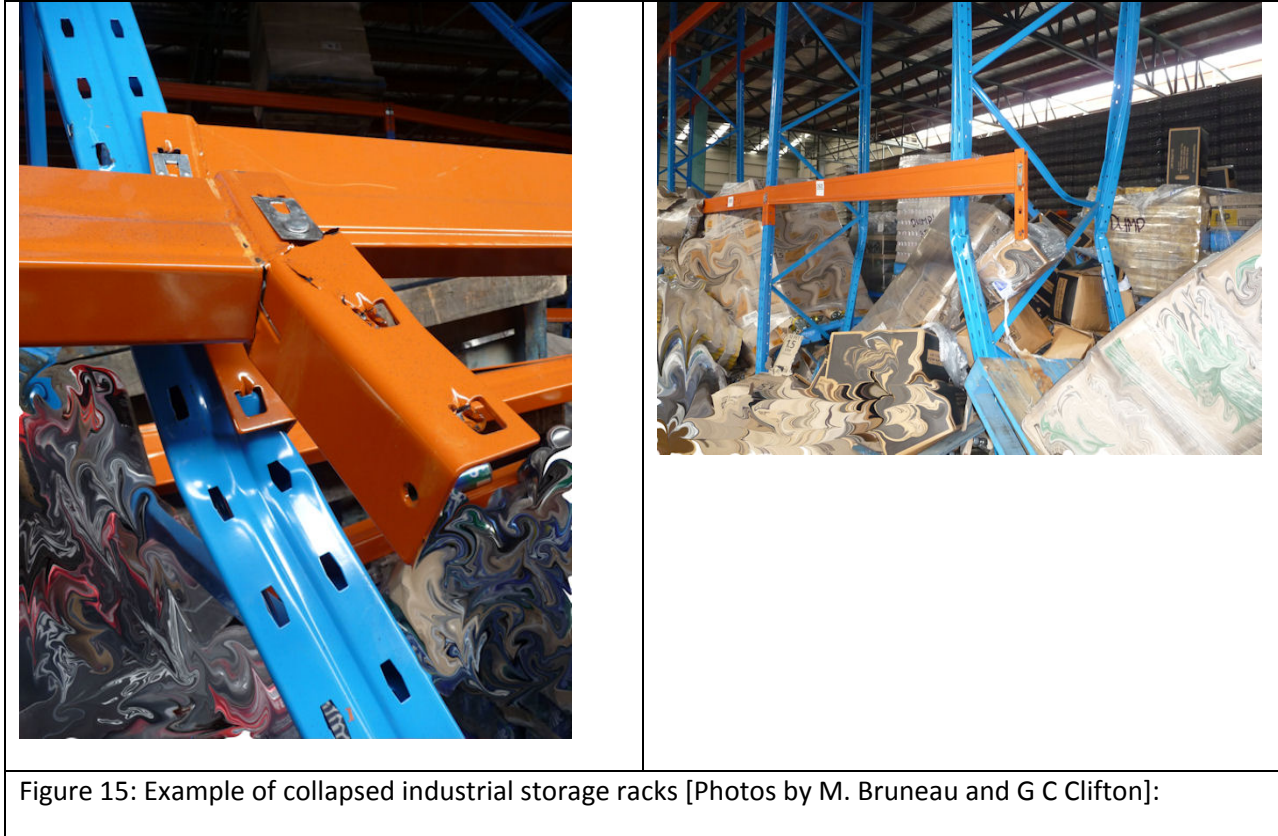
zone of] Wellington” and re-structured his operations to limit stacking to three levels. In spite of those measures, all racks experienced total collapse, as shown in Figure 15. While racks that failed in the transverse direction could have been pushed due to “spilling” of the pallets and piling up of the products into the aisles, this was not a factor in the longitudinal rack failures that exhibited a combination of overloaded and fractured beam to column connections, and column local buckling. It appeared that the semi-rigid beam to column connections in the longitudinal direction were too weak for the intensity of shaking and design gravity loads.

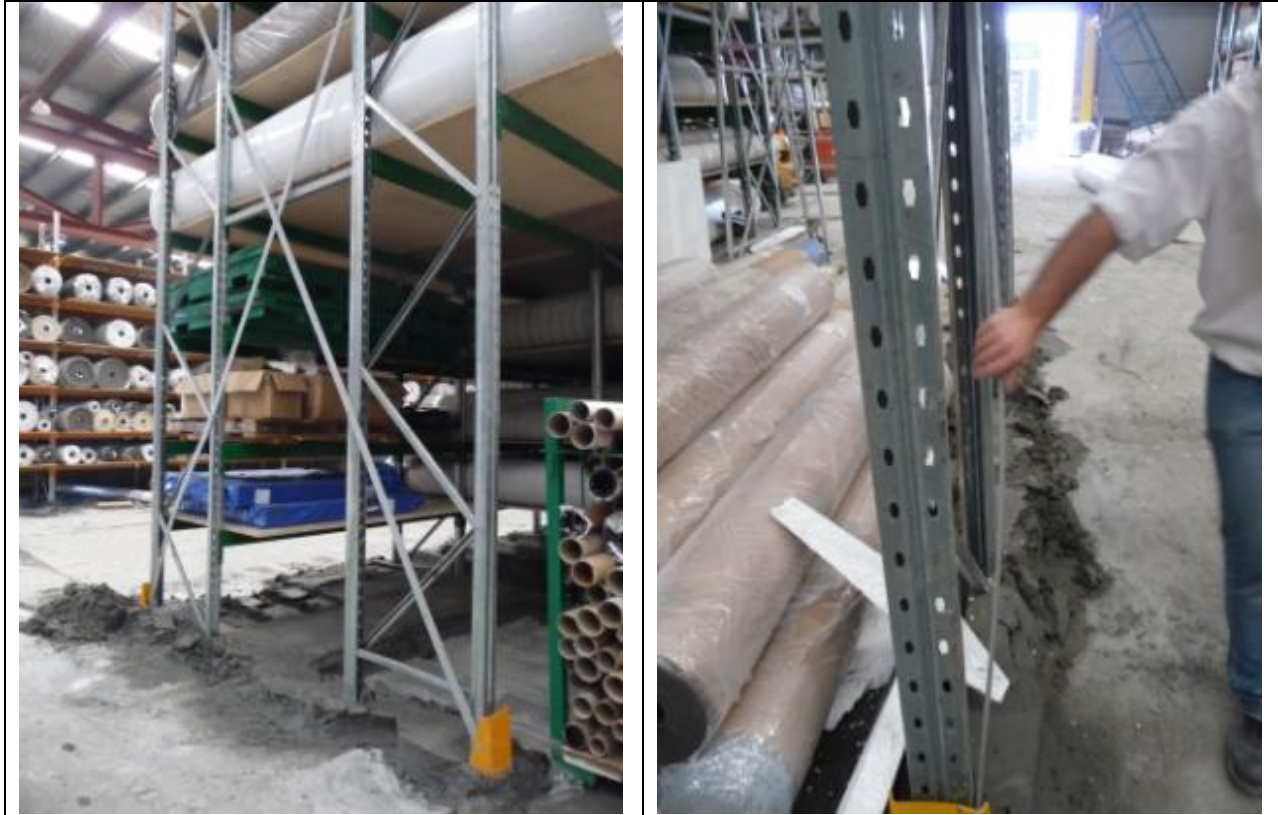
Anecdotally, in another facility, existing racks had been retrofitted by coupling two racks back-to-back with flat bar braces (Figure 16). These bars showed evidence of elongation and residual buckling, but did not collapse, in spite of floor movements due to liquefaction, whereas the only rack that was not retrofitted (for it was not adjacent to a second rack to which it could have been tied) collapsed. The racks has also been allegedly tied to the rafters to prevent longitudinal failures, but such ties could not be identified.

Figure 16: Industrial storage racks that survived, with evidence of soil liquefaction [Photos by M. Bruneau]; (a) Global view; (b) Close –up of buckled brace.

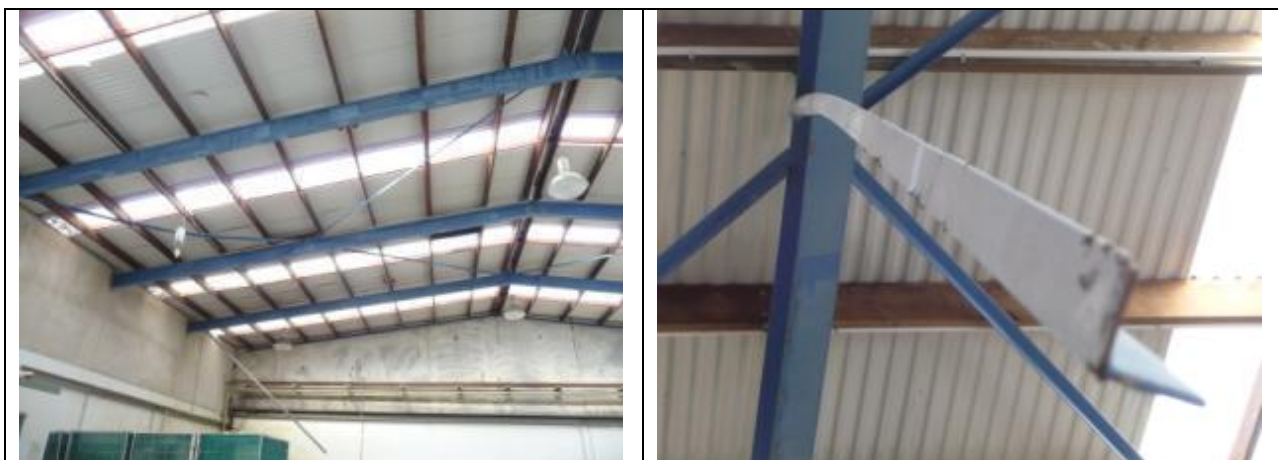
Multiple examples of tilt-up panel movements due to ground liquefaction were observed, sometimes leading to fracture of non-ductile braces unable to accommodate the imposed deformations. One such example is shown in Figure 17, showing a fractured brace and its counterpart buckled brace.

Figure 17: Industrial facility roof bracing [Photos by M. Bruneau]; (a) Global view, showing buckled brace

and fractured brace; (b) Close –up view of fractures weld of tension brace.

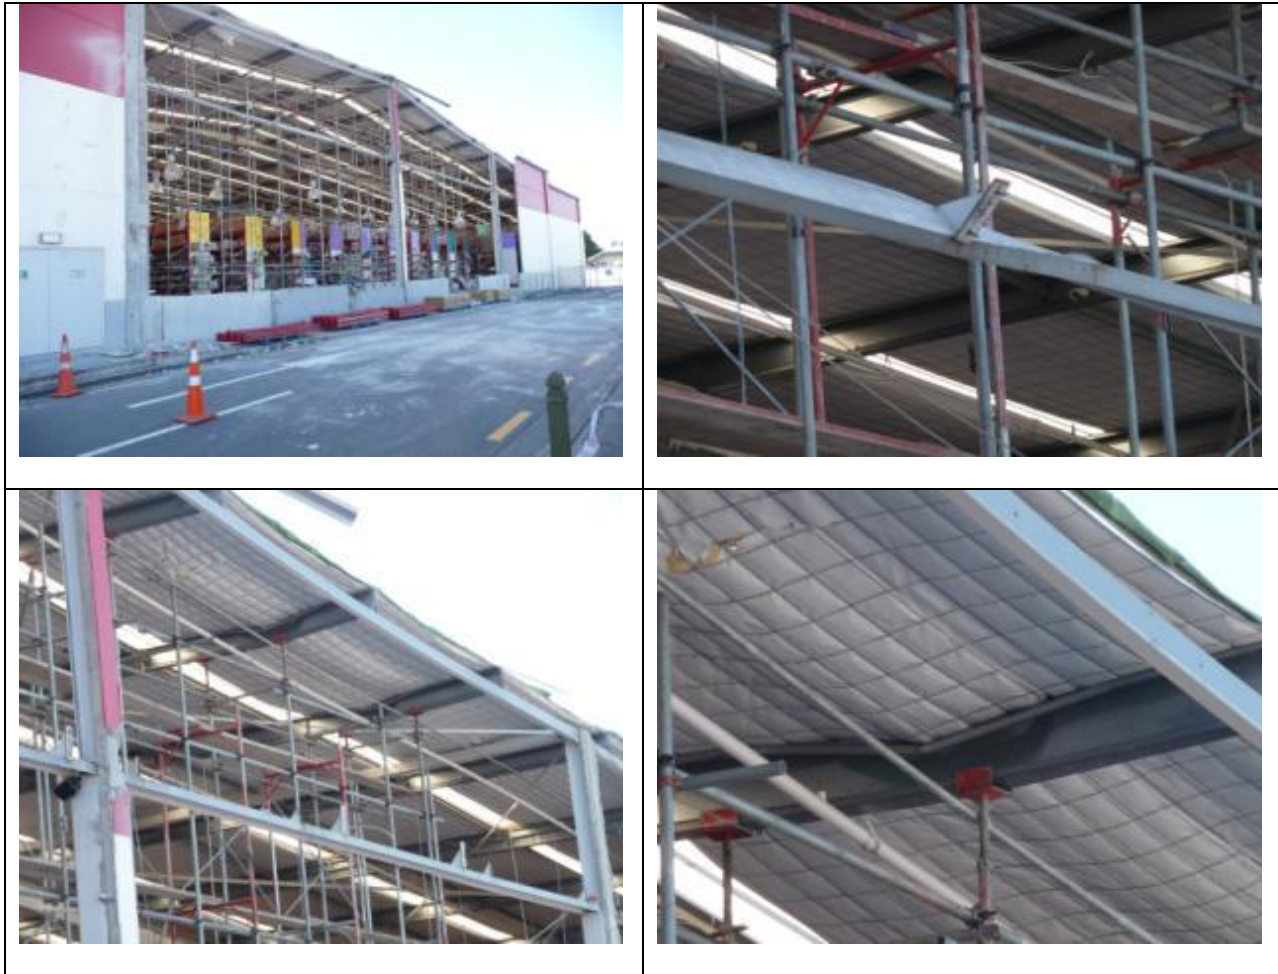
Anchorage of tilt-up walls to steel structures also failed in a few instances. Figure 18 shows roof beams buckled in compression by the inward movement of the tilt-up panels, and failure of the anchors due to their outward movement (i.e. away from the building). Given that this happened in modern construction, and because tilt-up walls of greater slenderness have progressively been implemented in New Zealand, a careful re-assessment of their seismic design provisions may be desirable.

Figure 18: Failure of tilt-up panel connections [Photos by M. Bruneau]; (a) Global view; (b) Close –up view of fractures connection; (c) Global view of buckled beams; (d) Local view of one such beam.

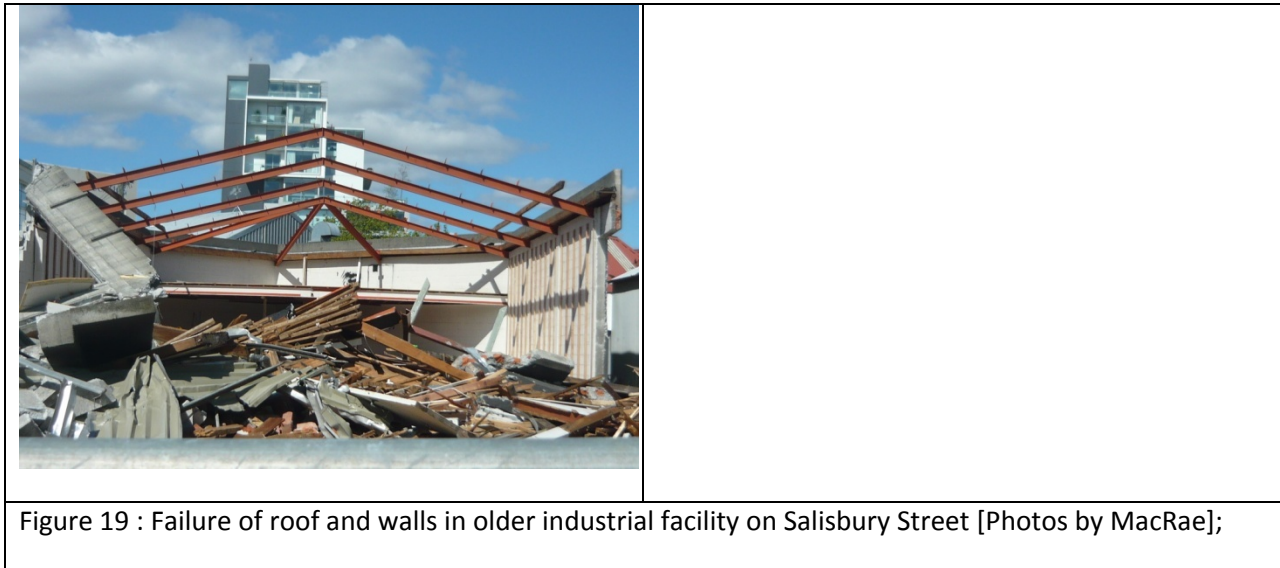
Figure 19 shows the steel structure standing when the roofing has collapsed. This shows very good performance of the steel members, but poor performance of the roofing/connections.

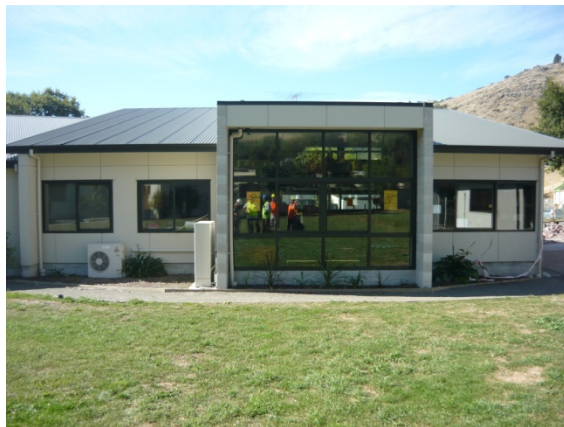
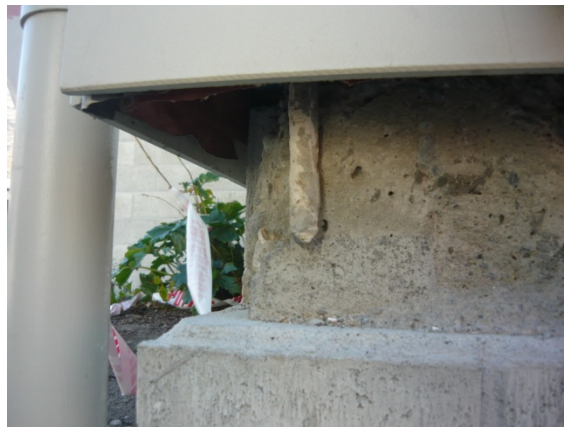
At Heathcote Valley Primary School some of the most extreme shaking during the event was recorded. There was one new single storey building with a steel moment frame and block walls as shown in Figure 20a . After the earthquake the wall was leaning to the east at the southern end, and to the west at the northern end. The concrete baseplate was blown out on the southeast side of the building as shown in Figure 20b.

(a) Overall View from the South (b) Baseplate bolt at SE corner of the building
Figure 20. Heathcote Valley Primary School Steel Moment Frame building (Photos: MacRae)

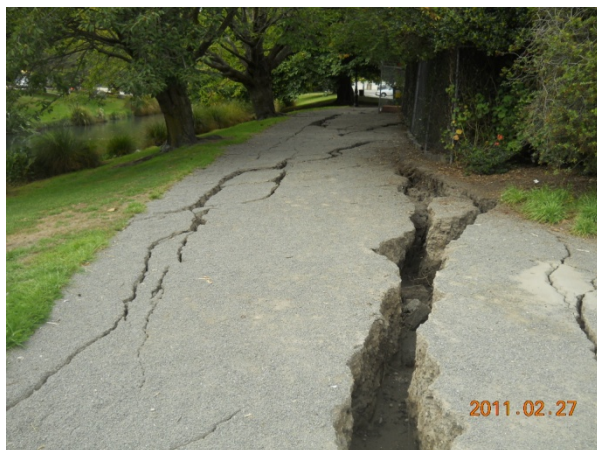
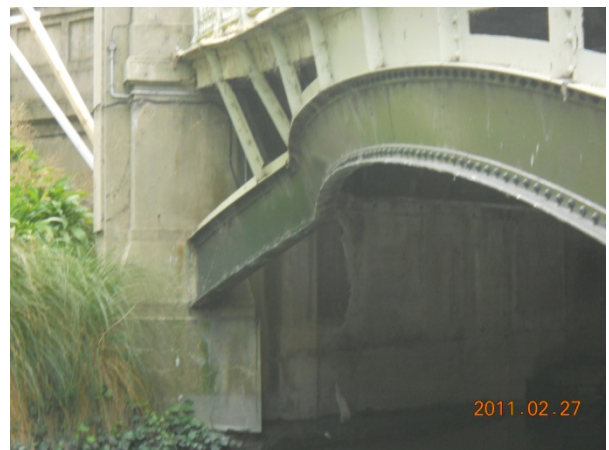
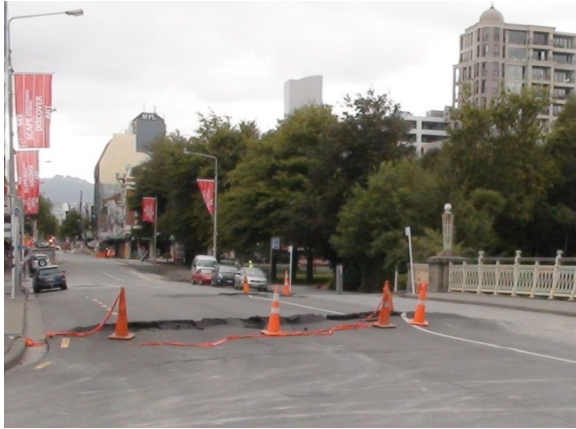
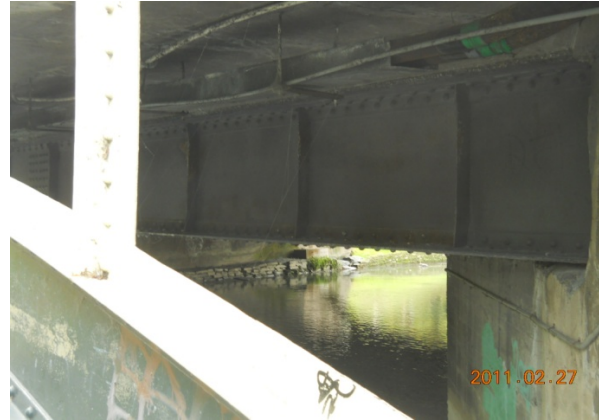
Although substantial liquefaction occurred along the Avon River near the CBD, the only older steel bridge in this area only showed spectacular buckling of its fascia arches; the actual bridge, supported on straight riveted girders appeared undamaged even though large settlements had occurred at the abutments (Figure 23). The old rail bridge over the Waimakariri river behaved well even though it was clear that the pier had moved over 100mm toward the river and back during this shake (Figure 24a). The old road bridge suffered some longitudinal buckling of the lower flange of one beam (Figure 24b) as well as some spalling of concrete on the west side of the abutment. The only major modern steel bridge at the Port of Lyttleton, a three-span continuous plate girder, had only minor damage at the abutment (Figure 25).

Figure 23 – Colombo Street bridge (a) Slumping of riverbank close to bridge; (b) Buckling of fascia arches; (c) Slumping of abutments at end of bridge; (d) Undamaged straight riveted girders. (Leon)

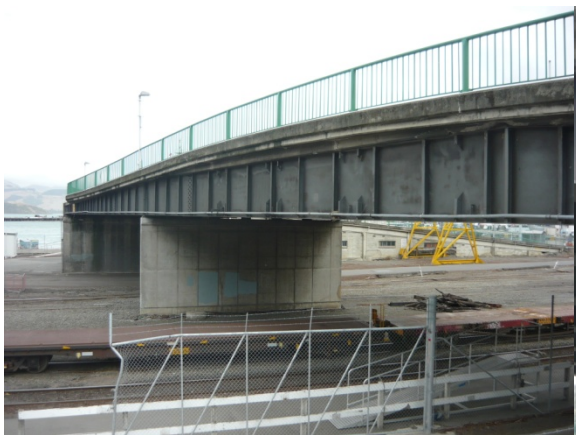
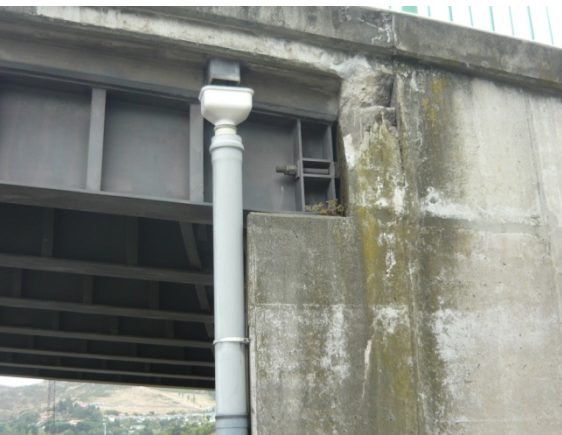
Figure 25 – Lyttleton Port Bridge (a) Plate Girder (b) Abutment Spalling (MacRae)

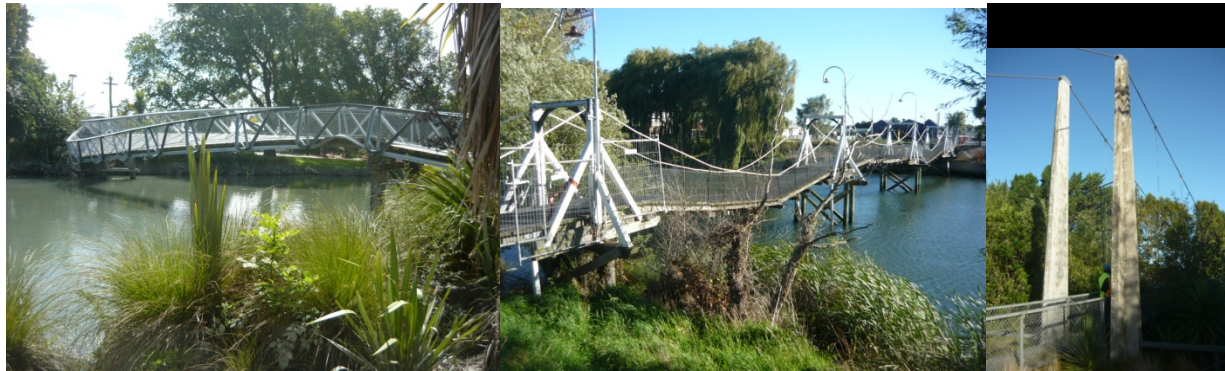
The footbridges shown in Figure 26 were damaged in the September 2010 earthquake and had not been repaired at the time of the February 22 event. Due to further lateral spreading and slumping of abutments, they were even more damaged in this shaking.

Figure 26 – Footbridges (a) Truss bridge over Avon River, (b) Suspension bridge with timber deck Over Kaiapoi river, (c) Suspension bridge at Groynes (MacRae)
