**INDEPENDENT ASSESSMENT ON EARTHQUAKE PERFORMANCE
OF
382 Colombo Street**

**FOR
Royal Commission of Inquiry into building failure
caused by the Canterbury Earthquakes**

**Report prepared by Peter C Smith and Jonathan W Devine
OF
Spencer Holmes Ltd**

November 2011

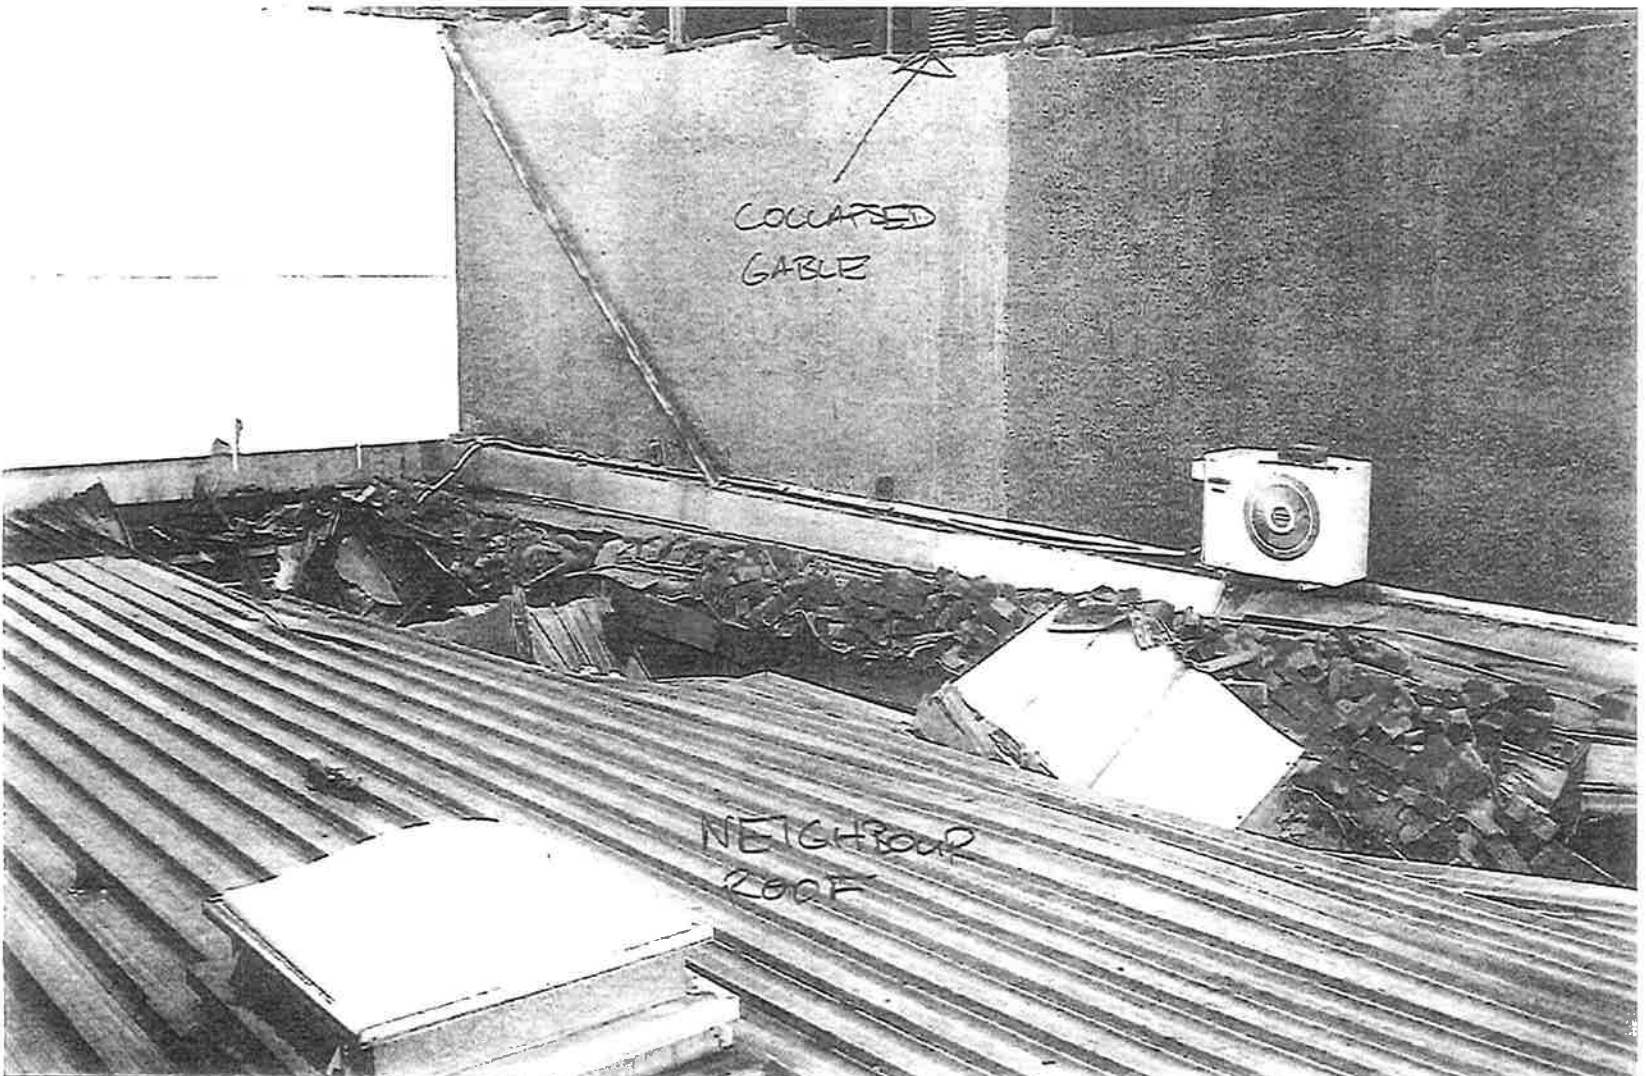
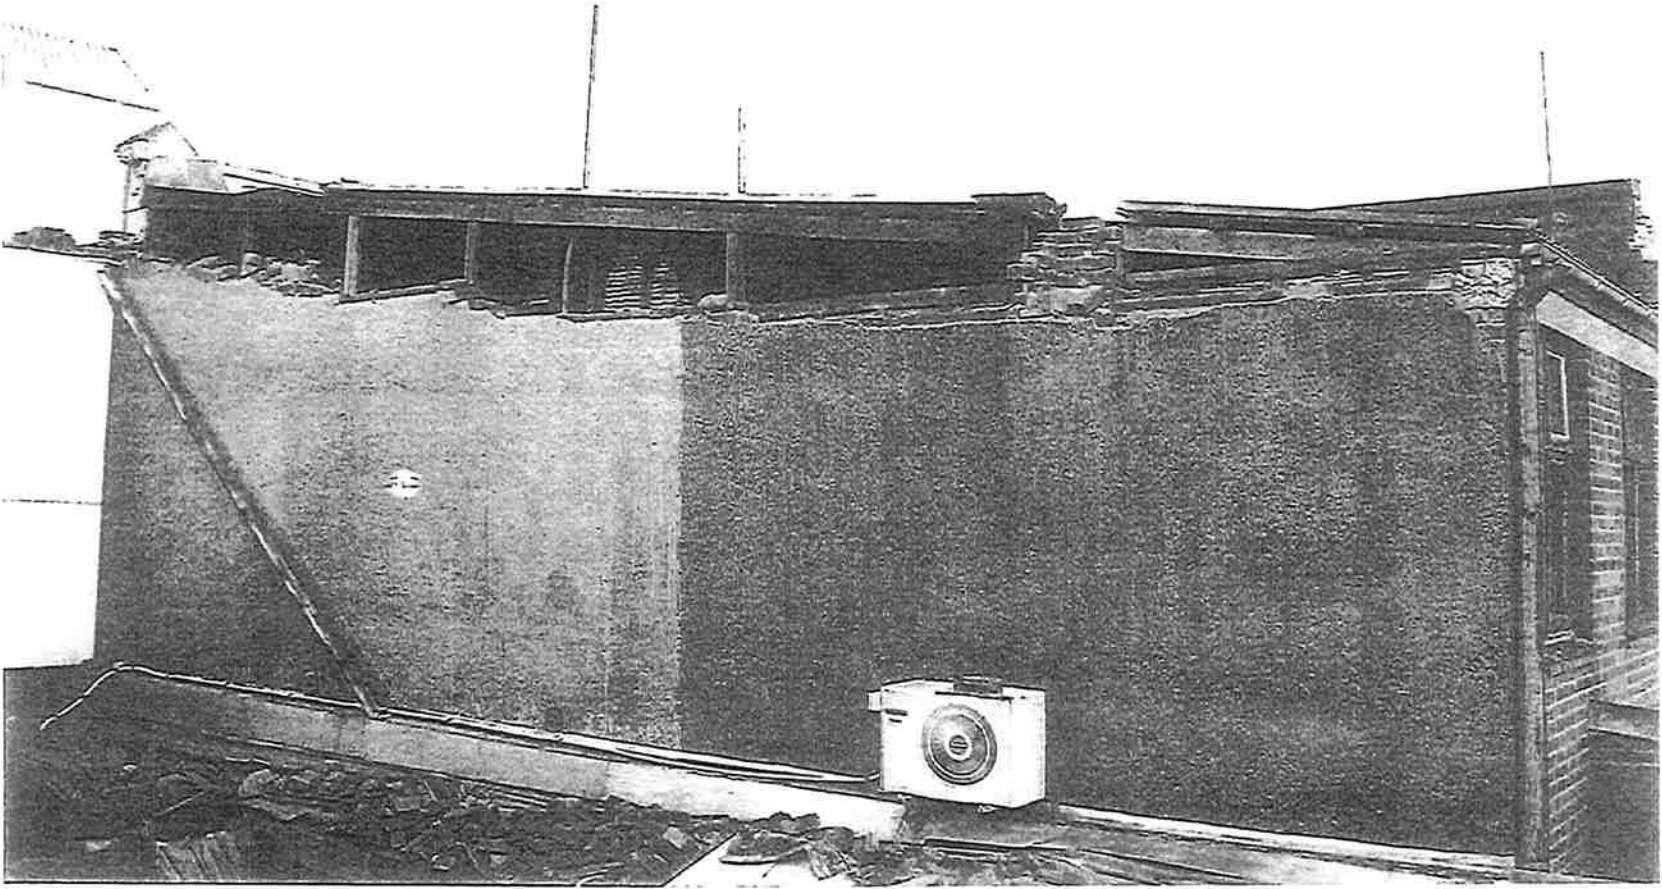
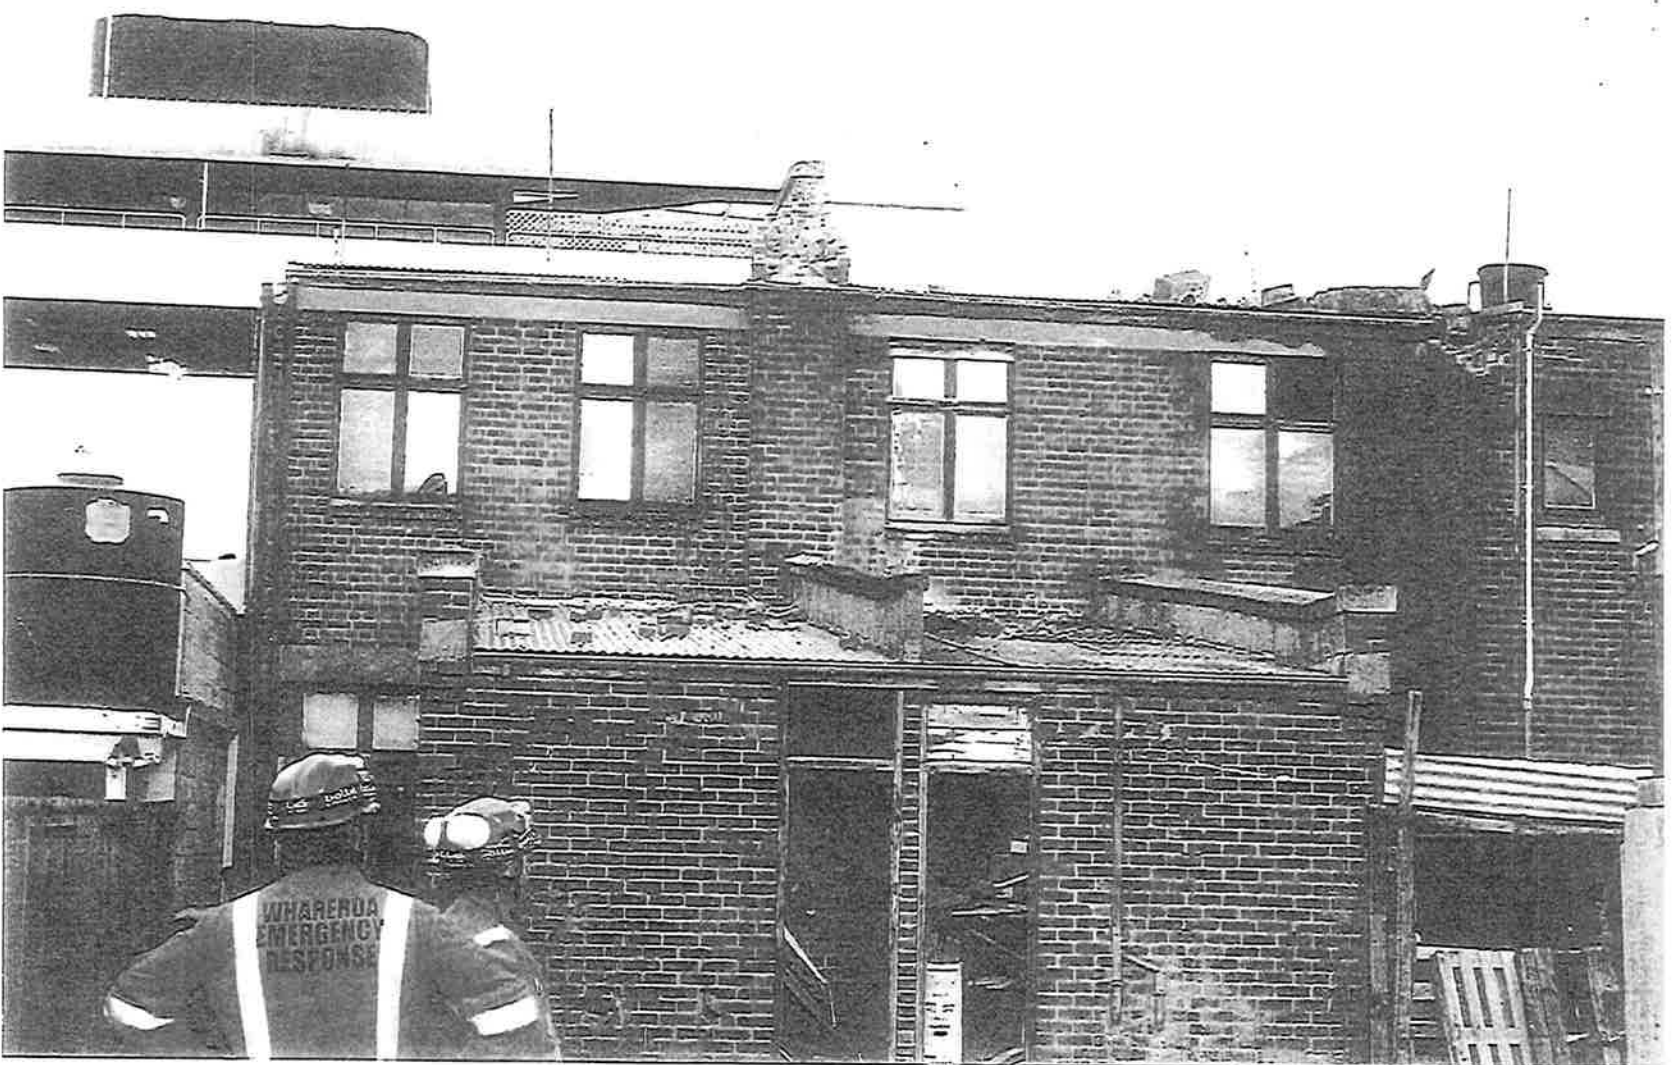
Damage resulting from 22nd February, 2011 earthquake

In the 22nd February, 2011 earthquake, the parapet and a section of the south wall of the building 382 Colombo Street fell on and penetrated the roof of the building at 380A Colombo Street.

We consider it likely that the failure mechanism in the 22nd February, 2011 earthquake was an outward rotation of the south wall parapet and the upper portion of the south wall approximately above first floor ceiling level in the building 382 Colombo Street. Refer photos Appendix 2. The wall appears to have rotated about the top of the remaining wall. We suspect that the inertia from internal party walls to the building 382 – 402 Colombo Street may have been transferred to the south wall through the roof framing, initiating the collapse. The failed section tragically fell on and penetrated through the roof of the single storey building at 380A Colombo Street. The failure occurred principally due to inadequate restraint of the wall at roof level.

In its poorly secured condition, failure of the parapet and upper portion of wall was almost inevitable in the severity of shaking experienced in the 22nd February 2011 earthquake.
