**INDEPENDENT ASSESSMENT ON EARTHQUAKE PERFORMANCE  
OF**

**603 Colombo Street  
Te@Net Internet Cafe**

**Royal Commission of Inquiry into building failure  
caused by the Canterbury Earthquakes**

**Report prepared by Peter C Smith and Jonathan W Devine  
OF  
Spencer Holmes Ltd**

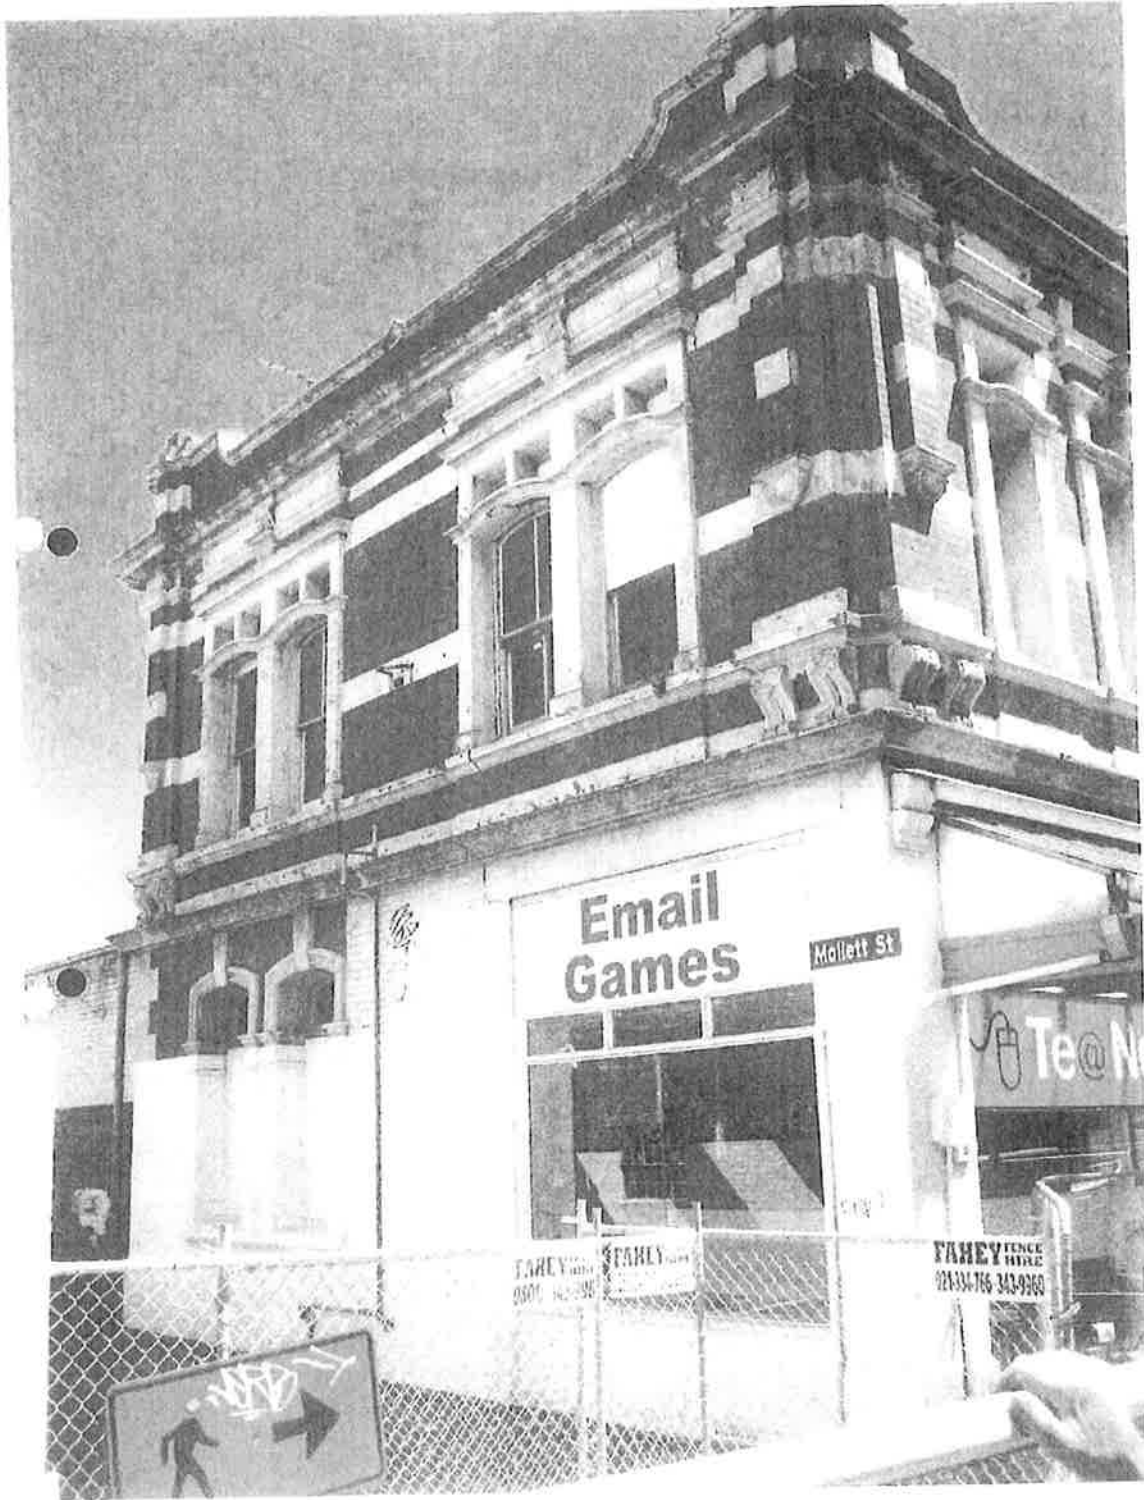
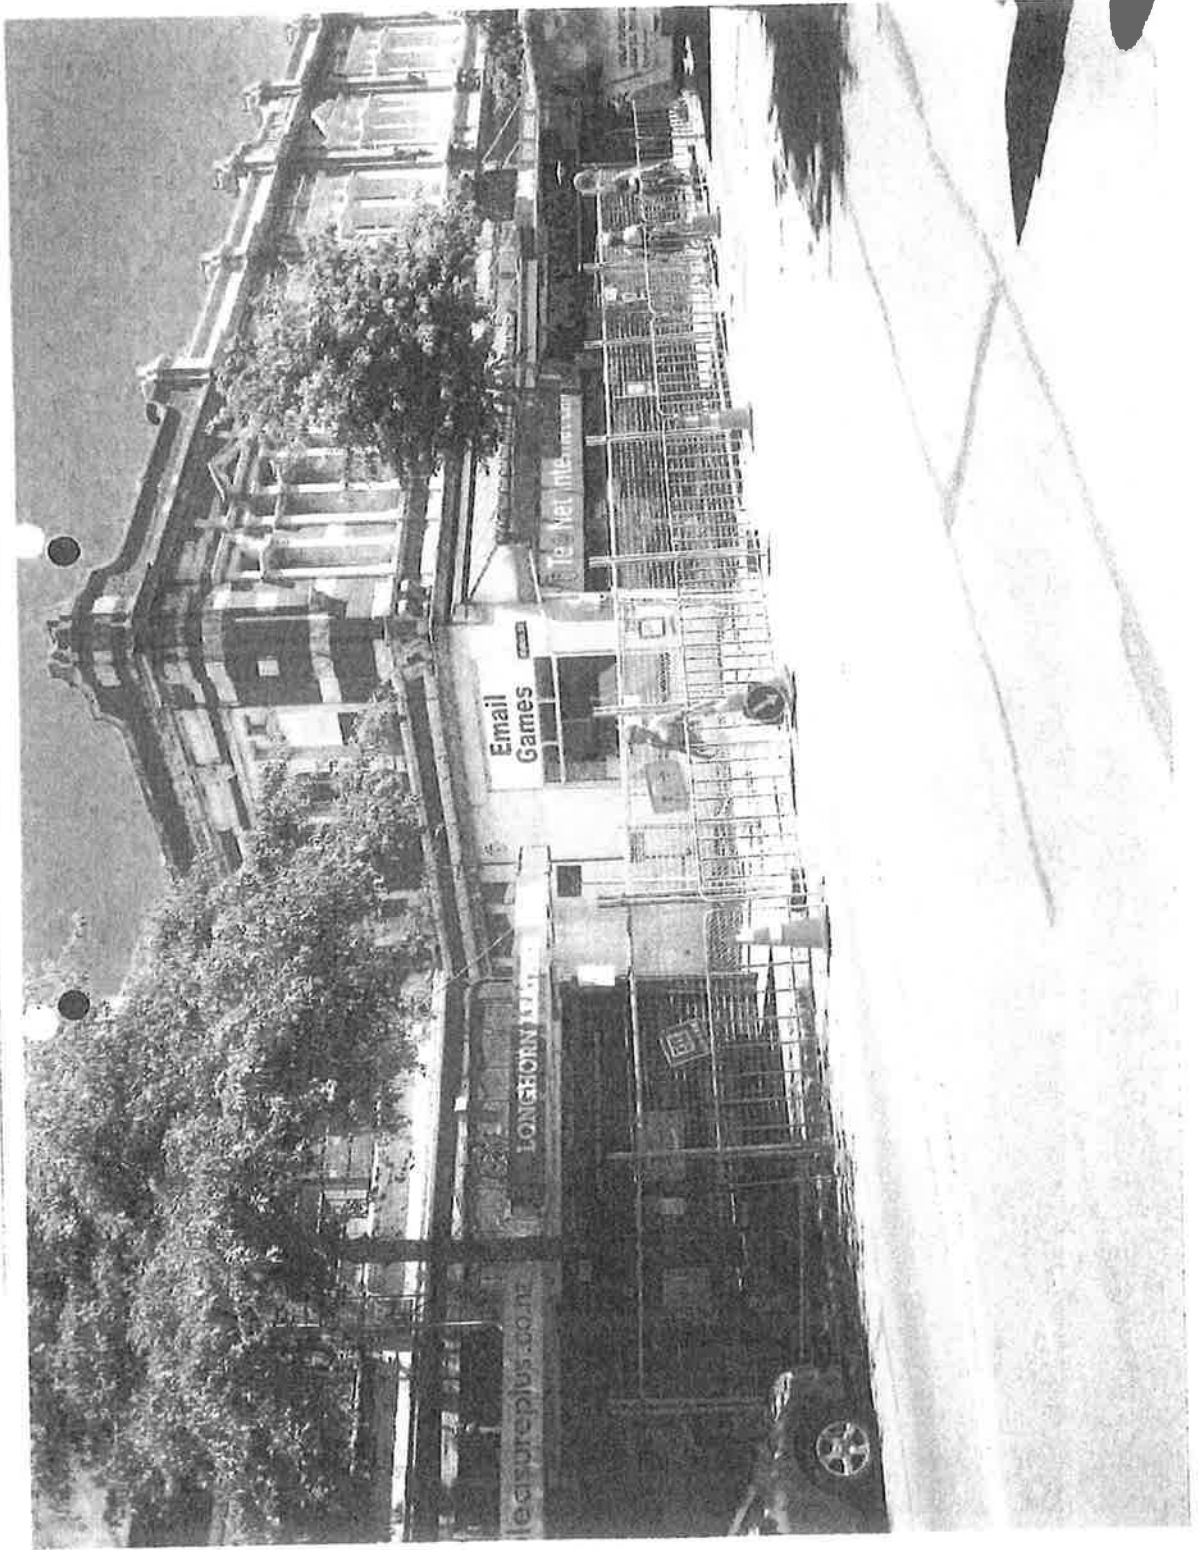
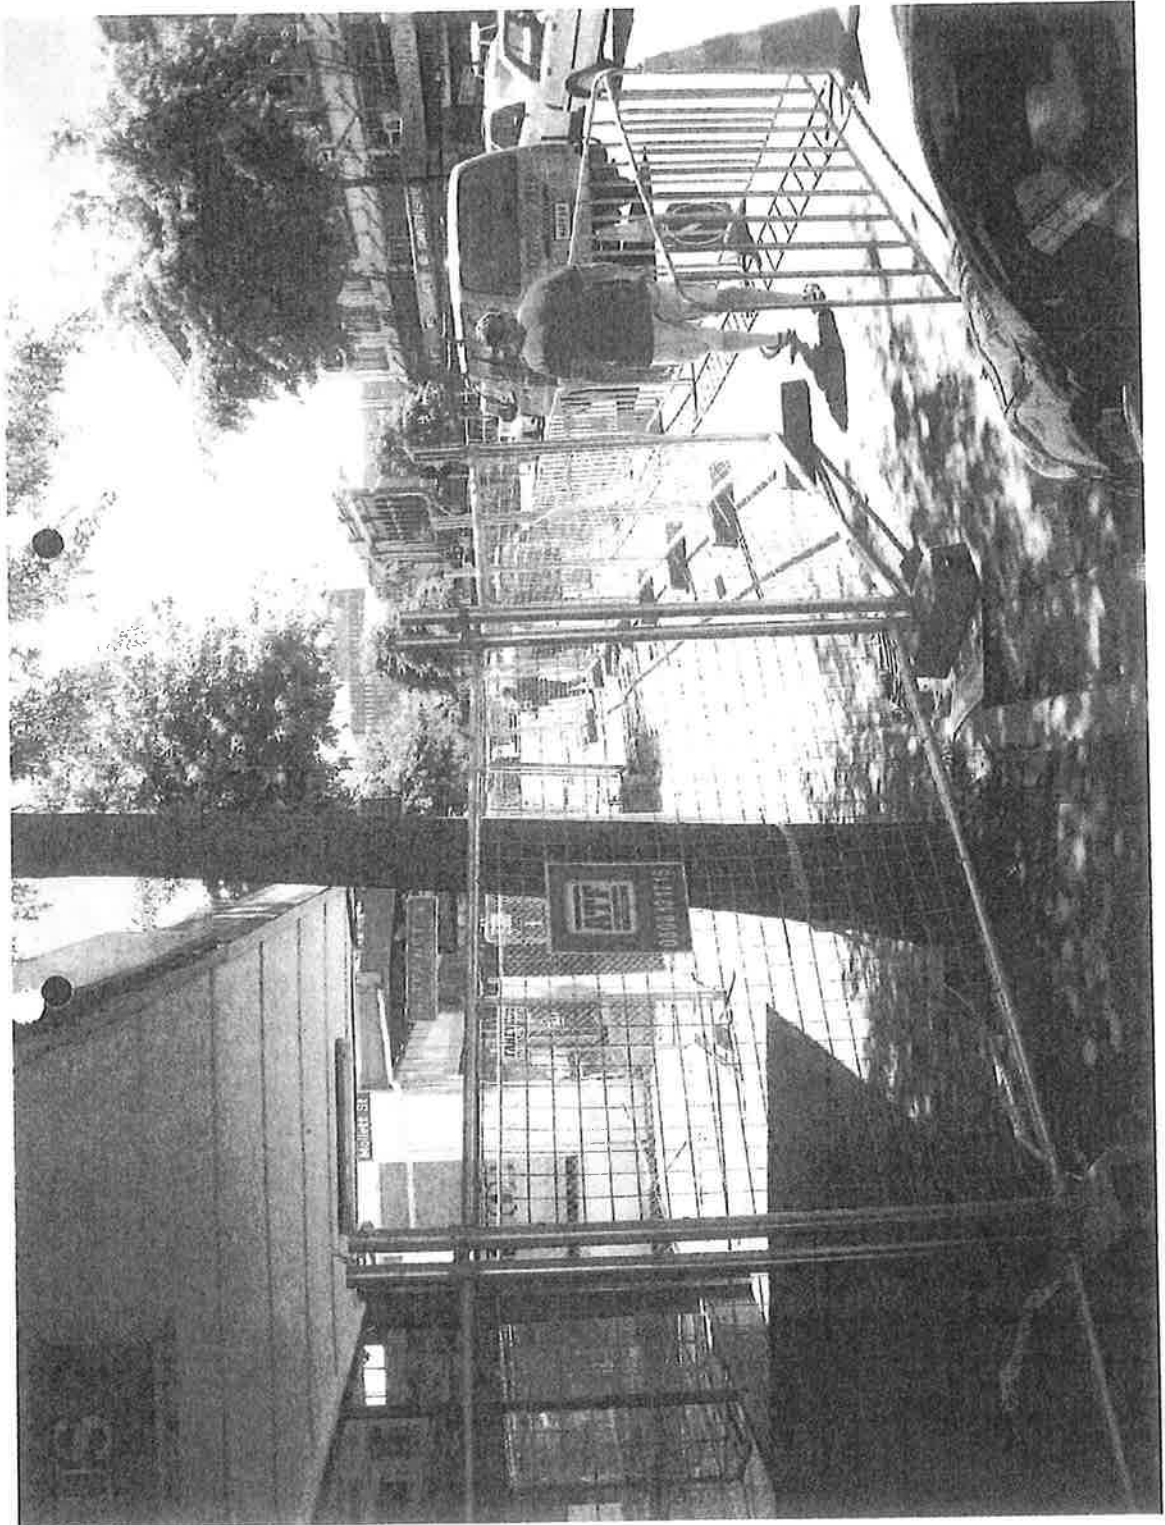
Photographs of the building following the 4<sup>th</sup> September, 2010 earthquake and prior to the 22<sup>nd</sup> February, 2011 earthquake established damage to the Mollett Street wall and barriers were noted as required along the Mollett Street frontage. (Refer photos in Appendix 2) The barrier requirements were extended on the 12<sup>th</sup> October, 2010. There is record of the yellow placard being changed to a red placard on the 26<sup>th</sup> December, 2010.

While the Christchurch City Council provided barriers to protect the public from a failure of the damaged Mollett Street façade, the barriers did not extend sufficiently out into Colombo Street to protect the public in Colombo Street from a failure of the apparently undamaged Colombo Street façade.

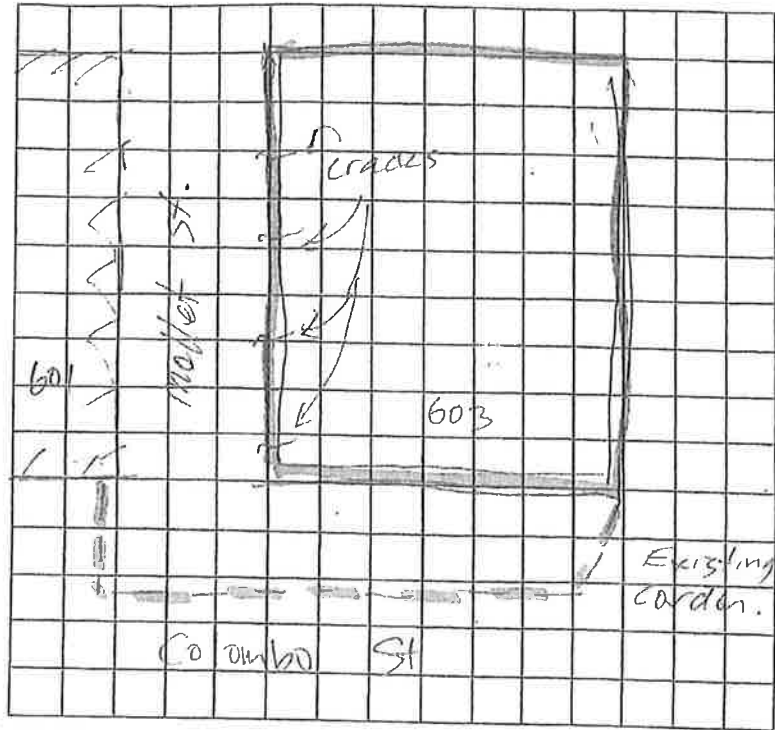
The building was assigned a yellow placard and the overall damage was assessed between 2 and 10%. The yellow placard was confirmed on the 11<sup>th</sup> September, 2010 after a Rapid Assessment Level-2 which identified that the south wall was at risk of collapse with significant cracking. The assessment noted that the barricades needed extension to cover the front of the Colombo Street entry to Mollett Street. The further Rapid Assessment-Level 2 on 12<sup>th</sup> October, 2010 referred to an engineers report required and a requirement for temporary propping of the south wall. The Christchurch City Council Enforcement Team Notices Coversheet of 12<sup>th</sup> October, 2010 identified "administration to update records as required Fencing to Colombo Street to remain in place." and "Provide temporary support to the south wall to prevent collapse of building materials falling onto the road and footpath."

- ① Engineer's Report required
  - ② Temp propping of stn wall.
- \_\_\_\_\_
- \_\_\_\_\_
- \_\_\_\_\_
- \_\_\_\_\_
- \_\_\_\_\_
- \_\_\_\_\_
- \_\_\_\_\_

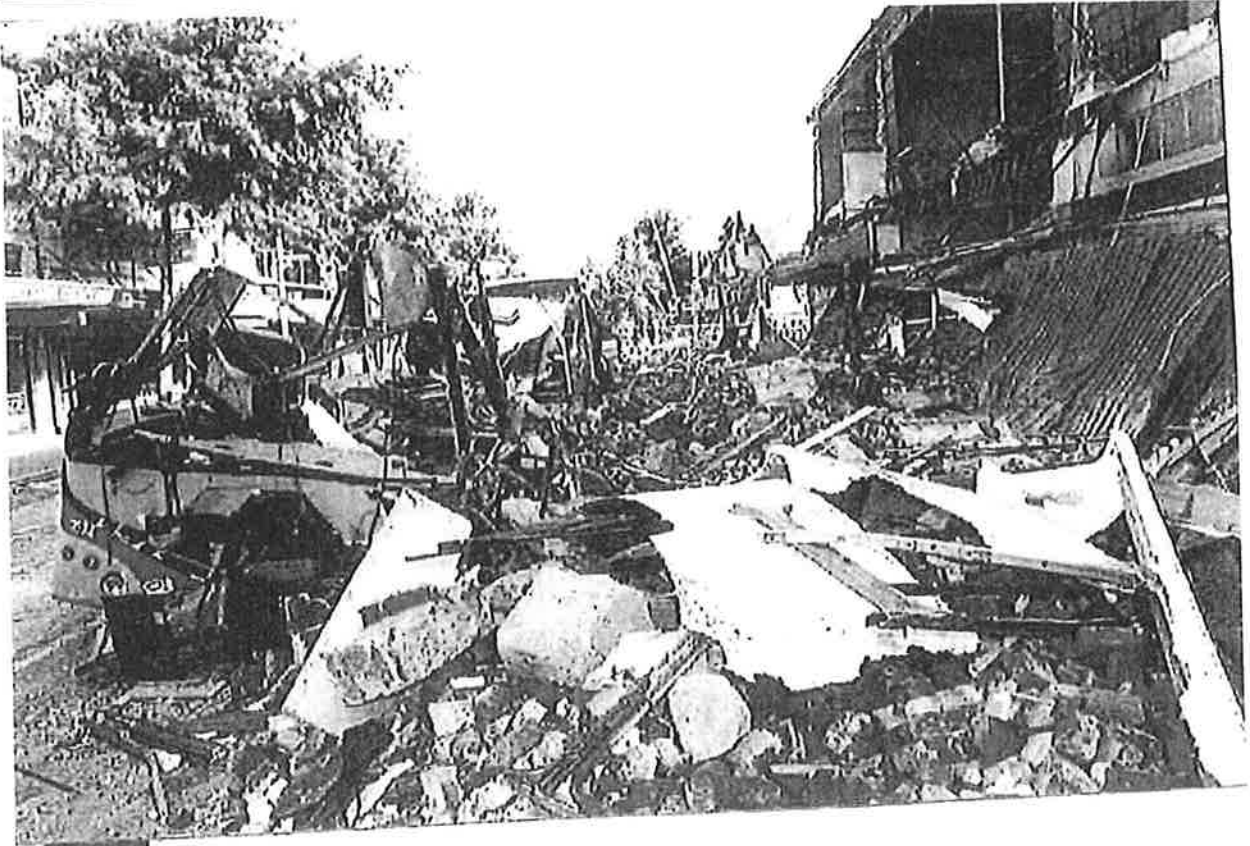
26

The building was significantly damaged in the 22nd February, 2011 earthquake. Both the Mollett Street and Colombo Street facades collapsed into the respective streets.

From the photos taken after the earthquake, it is evident that the failure of the Colombo Street façade at the junction with the north wall of the building is almost vertical indicating that the masonry was of low strength.

The first floor façade to Mollett and Colombo Street failed by an outward rotation of the façade about the first floor support in the severe shaking during the 22<sup>nd</sup> February, 2011 earthquake.
