CANTERBURY EARTHQUAKE ROYAL COMMISSION

Statement of Marton David Sinclair in relation to Building at 603 – 615 Colombo Street, Christchurch

Re: Post Earthquake Structural Report - 603 Colombo Street, Christchurch

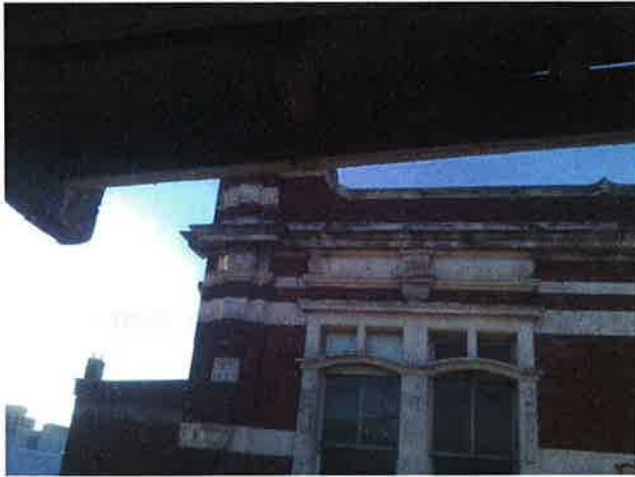
Figure 1 - 1st Floor Mollett Street Façade, 15th Sept 2010

Inspection of the exterior of the southernmost unit revealed significant cracking on the Mollett Street façade and deterioration of the ornate plasterwork. The Colombo Street façade is in much better condition and no major cracking is evident.

At the present time the southern unit is potentially unsafe given the extensive cracking in the Mollett Street façade and it should remain unoccupied until investigation and structural strengthening can be undertaken.

It is likely that any strengthening and crack repair on the southern unit will require building consent and that this will trigger the need for structural upgrading in accordance with the current Council policy which requires that the building meets 67% of the current code loadings. This will be a relatively expensive exercise and will have to take into account the five units in separate ownership. If these have already been strengthened as part of the refurbishment then this will simplify the matter. However please note that it is only the structural design that would need to take the five units into account. They would not need to be strengthened because of the strengthening to the southern unit.

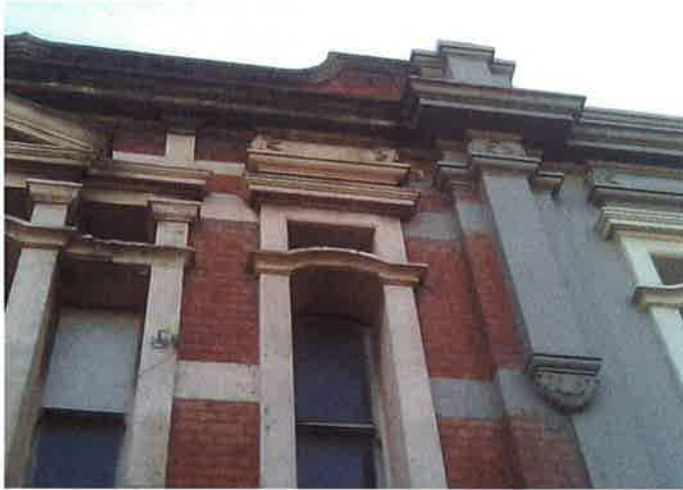
Figure 4 - 1st Floor Junction 603 & 605 Colombo Street, 15th September 2010

The presence of common firewalls between the units and the continuous façade indicates that restoration and repair work will have to be considered as a whole, especially as the units are all structurally interconnected.

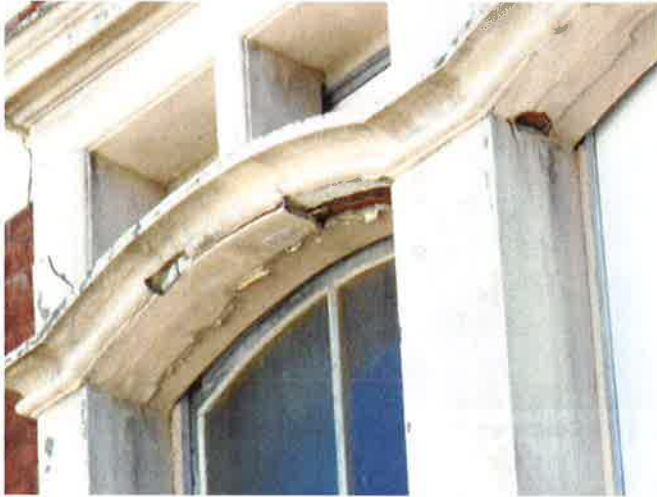
Figure 10 - 603 Window head deterioration, 9th September 2010

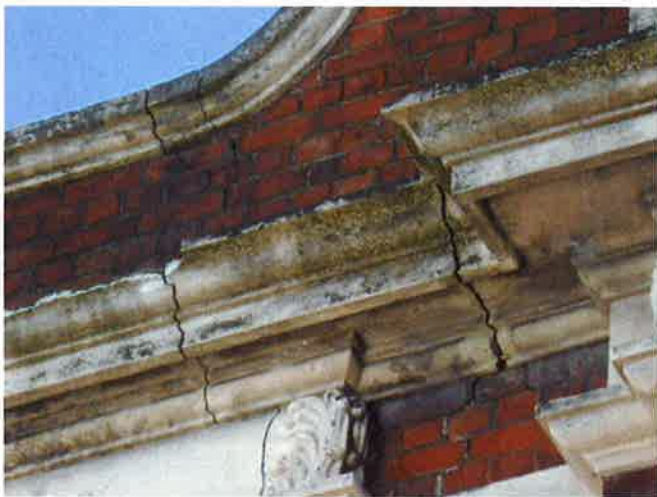
Figure 12 - Cracking generally old, 9th September 2010
