**INDEPENDENT ASSESSMENT ON EARTHQUAKE PERFORMANCE
OF
391-391A Worcester Street**

**FOR
Royal Commission of Inquiry into building failure
caused by the Canterbury Earthquakes**

**Report prepared by Peter C Smith and Jonathan W Devine
OF
Spencer Holmes Ltd**

November 2011

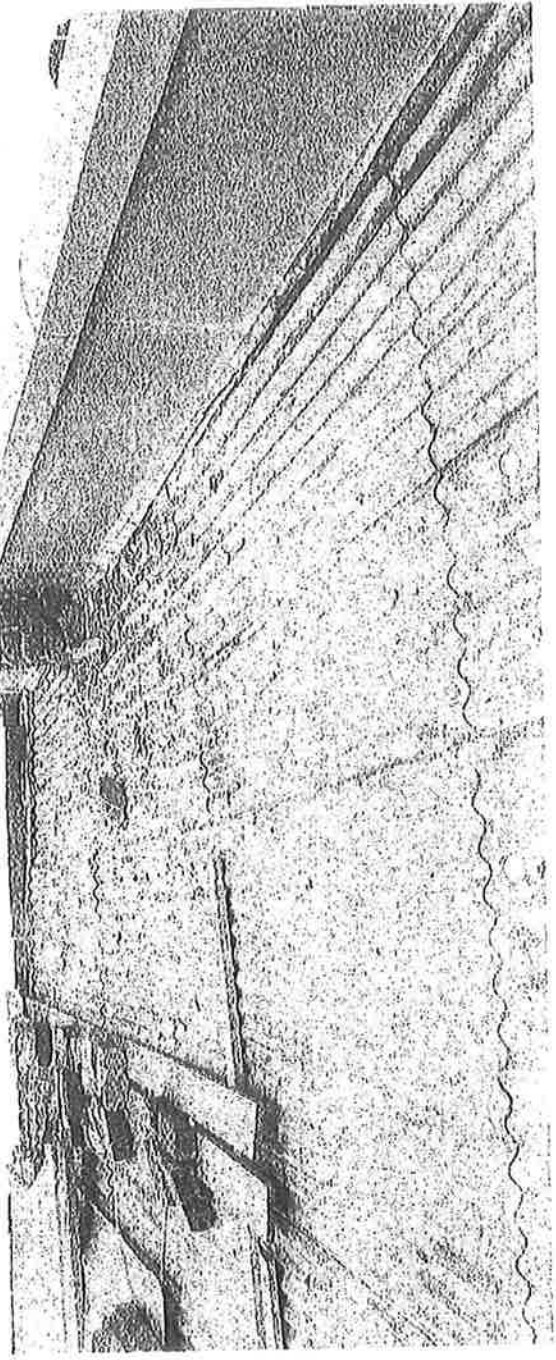
BUI.WOR391.0050.12
5280

Upper chimney that
fell in the first earthquake

This parapet cap was
cutting when we arrived
on site

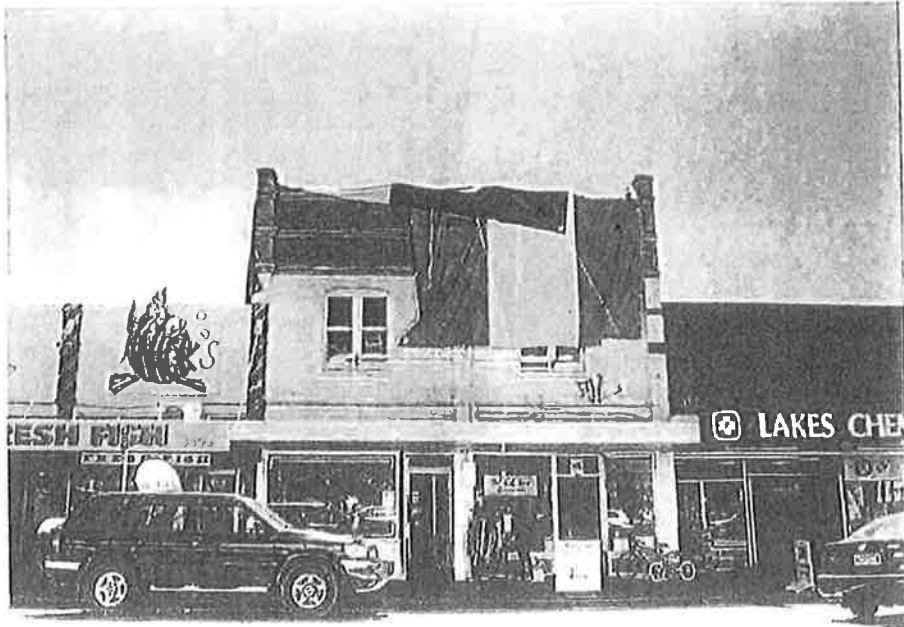
Photographic evidence following the 4th September, 2010 earthquake establishes that the upper portion of the parapet to Worcester Street fell back onto the roof of the building

Photo 2 : After the Sept 04, 2010 quake.

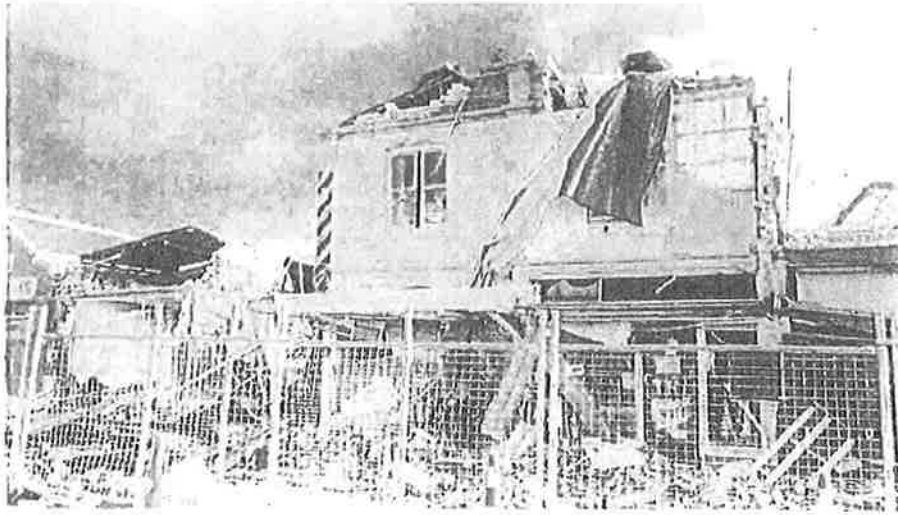
The parapet and portions of the west wall collapsed onto the roof of the building at 389A Worcester Street during the 22nd February, 2011 earthquake. Extensive damage occurred to the Worcester Street façade and to the east wall. Examination of photographs taken after the 22nd February, 2011 earthquake (Refer Appendix 3) establishes that the failure of a substantial portion

of the west wall and parapet in the 22nd February, 2011 earthquake was an out of plane failure of the wall, primarily above first floor level. While the south end of the wall remained standing, it is evident that a substantial portion of the wall above first floor level rotated at or near the first floor support and fell onto and through the roof of the adjoining single storey building at 389A Worcester Street. It appears that the chimney may have contributed to the failure.

Photo 3 : After the Feb 22, 2011 quake.

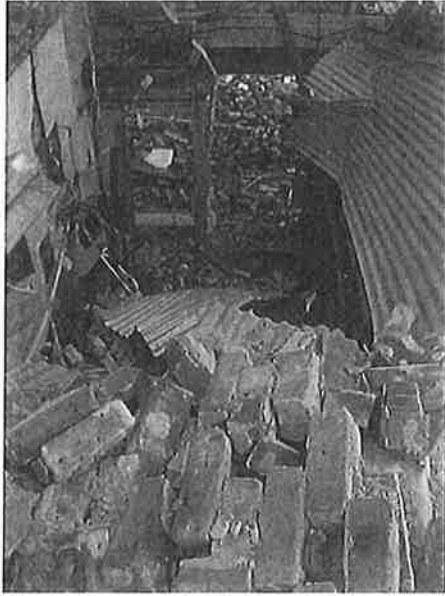
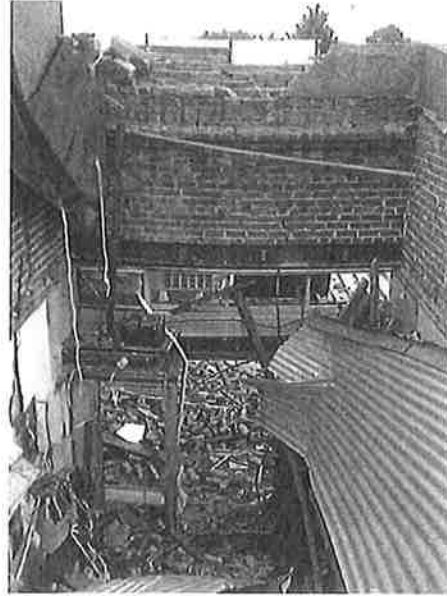
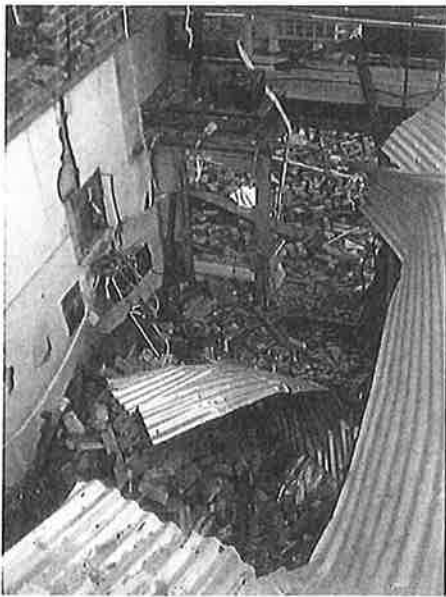
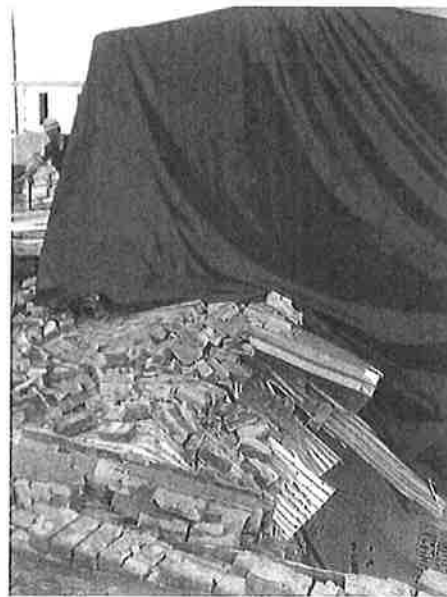
Worcester 391 (WICKS)

A review of photographic records established that a further portion of the front façade fell into Colombo Street and portions of the east and west walls fell onto adjoining buildings as a result of the 22nd February, 2011 earthquake. In particular a portion of the west wall tragically fell on and through the roof of the building 389A Worcester Street. Photos record that the south end of the west wall was intact after the earthquake and it is uncertain the actual extent of the west wall that failed.

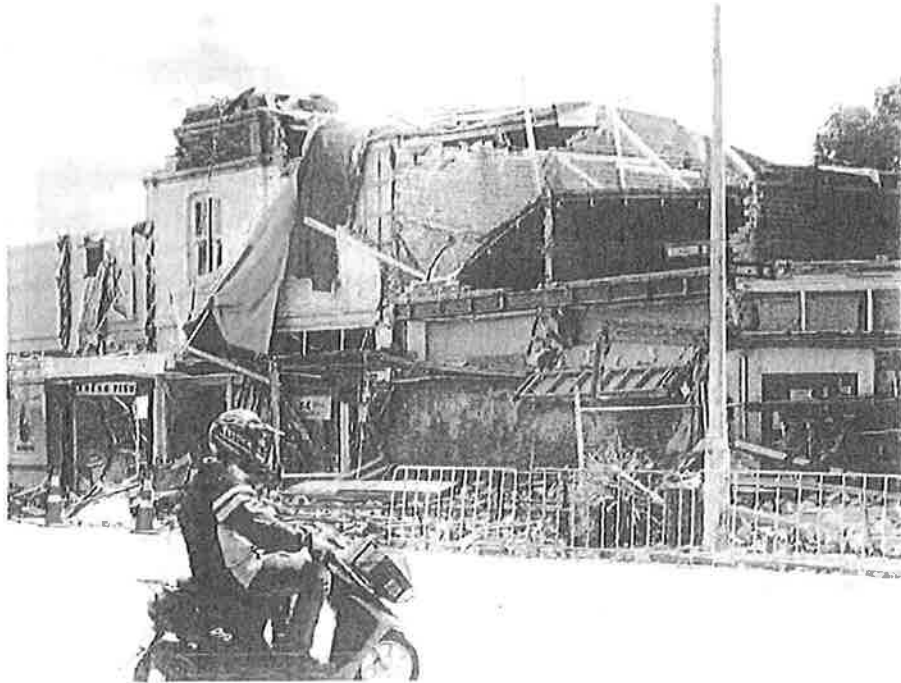
Photo 4: Block of Worcester St shops (from Stanmore Rd end).
