382 Colombo St
Statement of Peter Avnell

My name is Peter Avnell

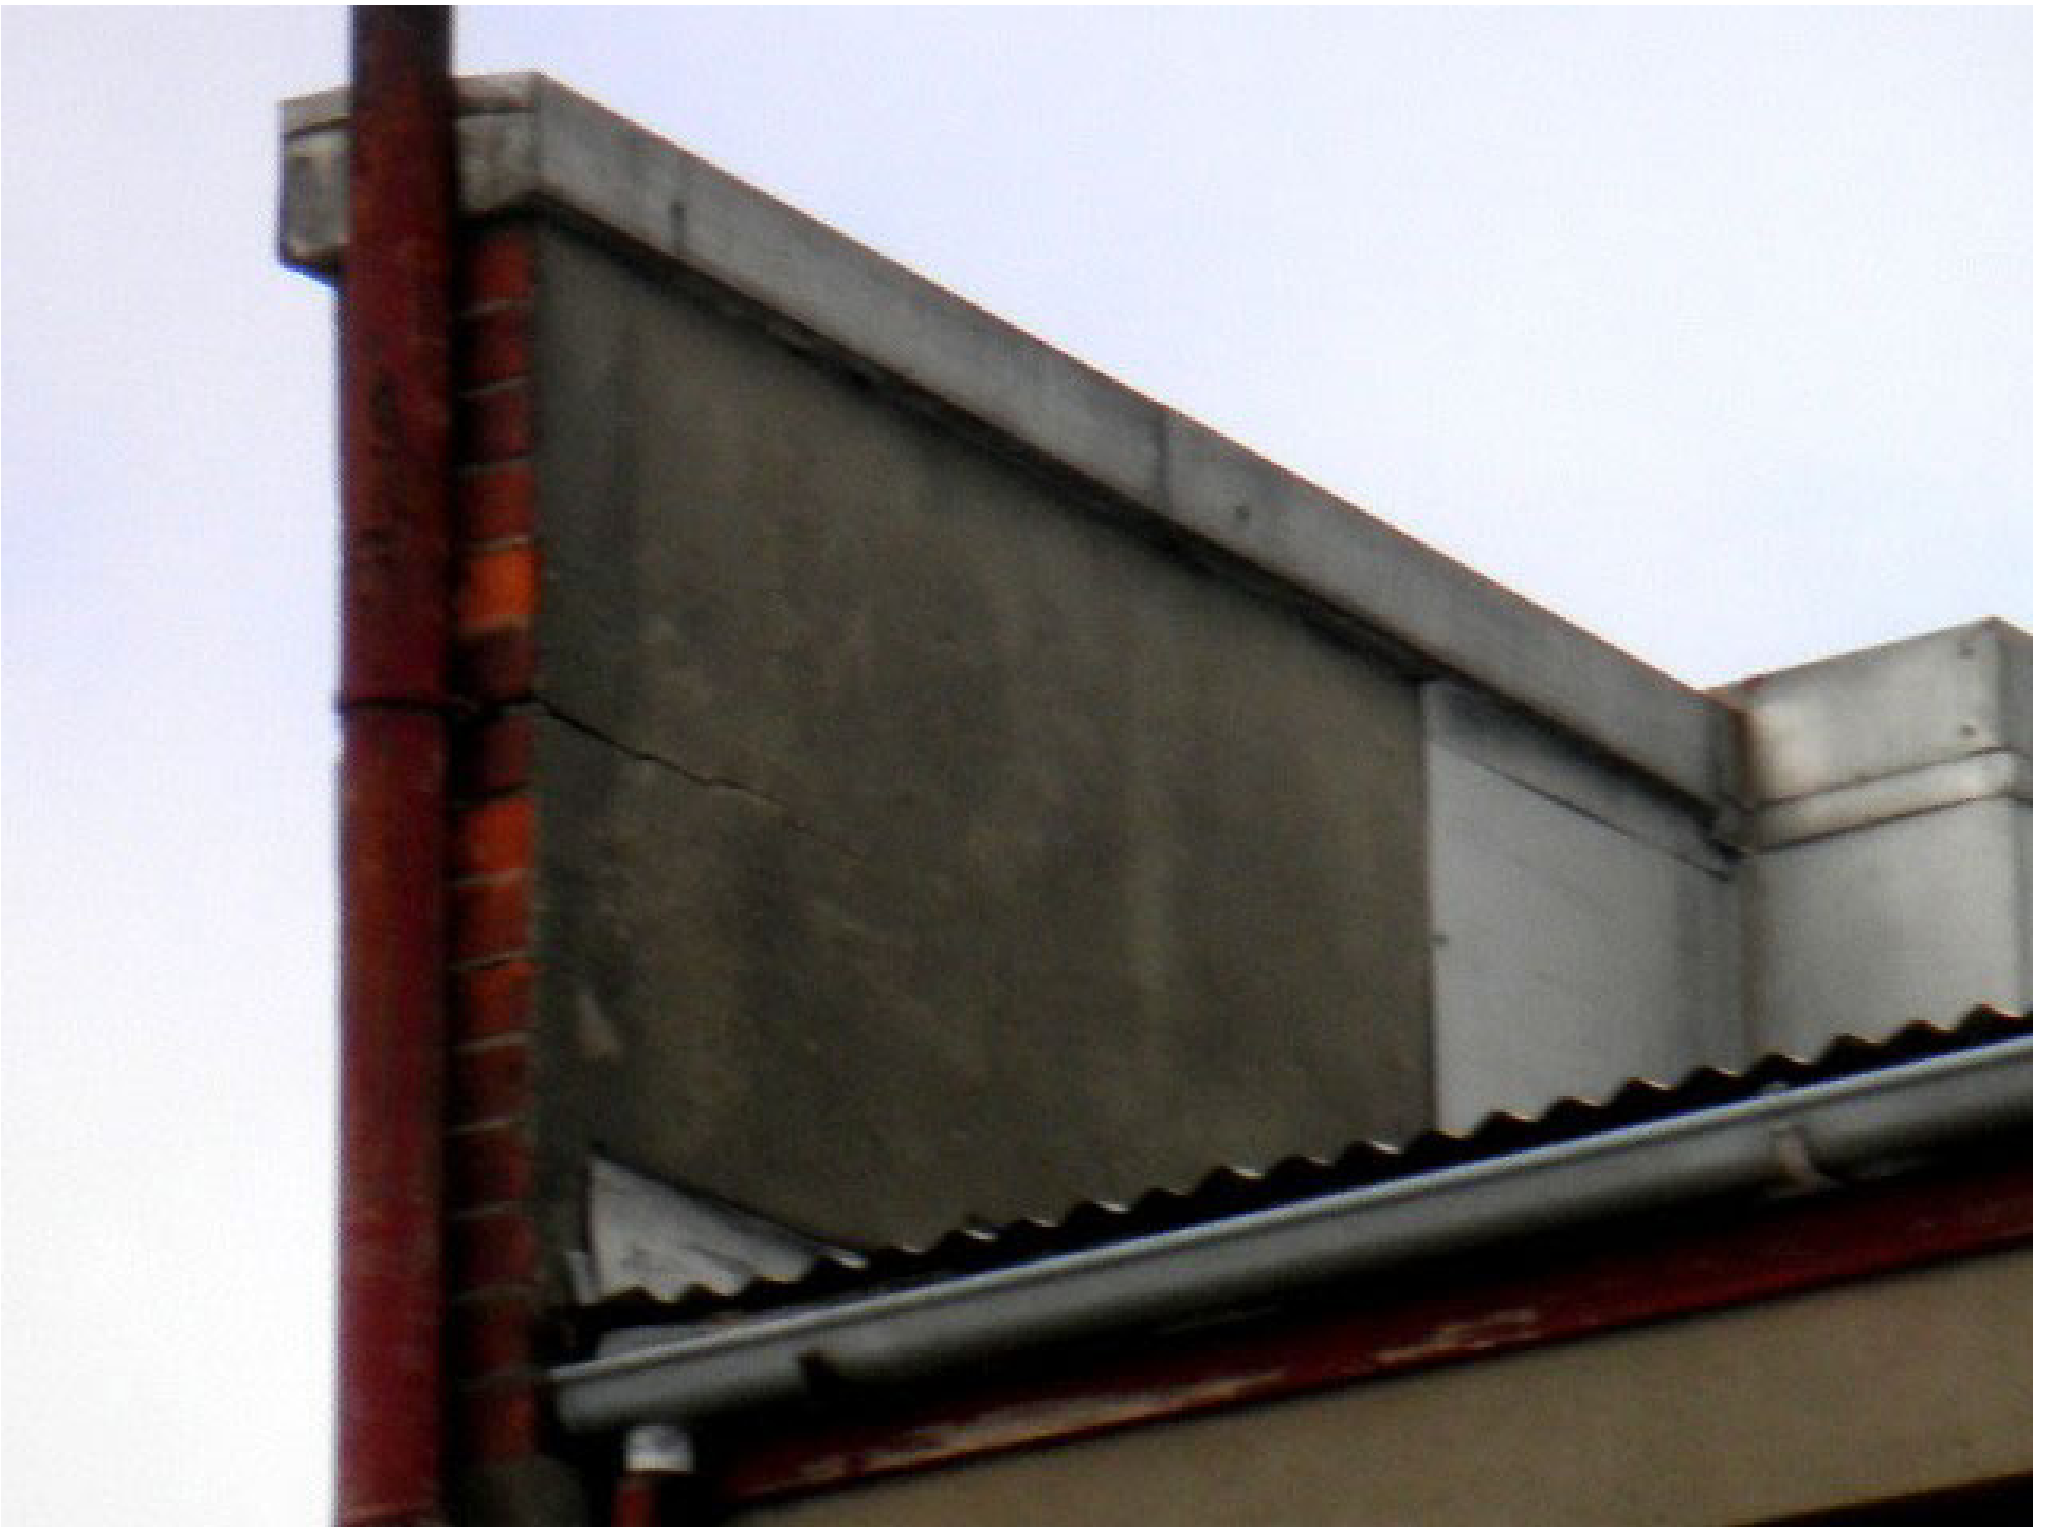
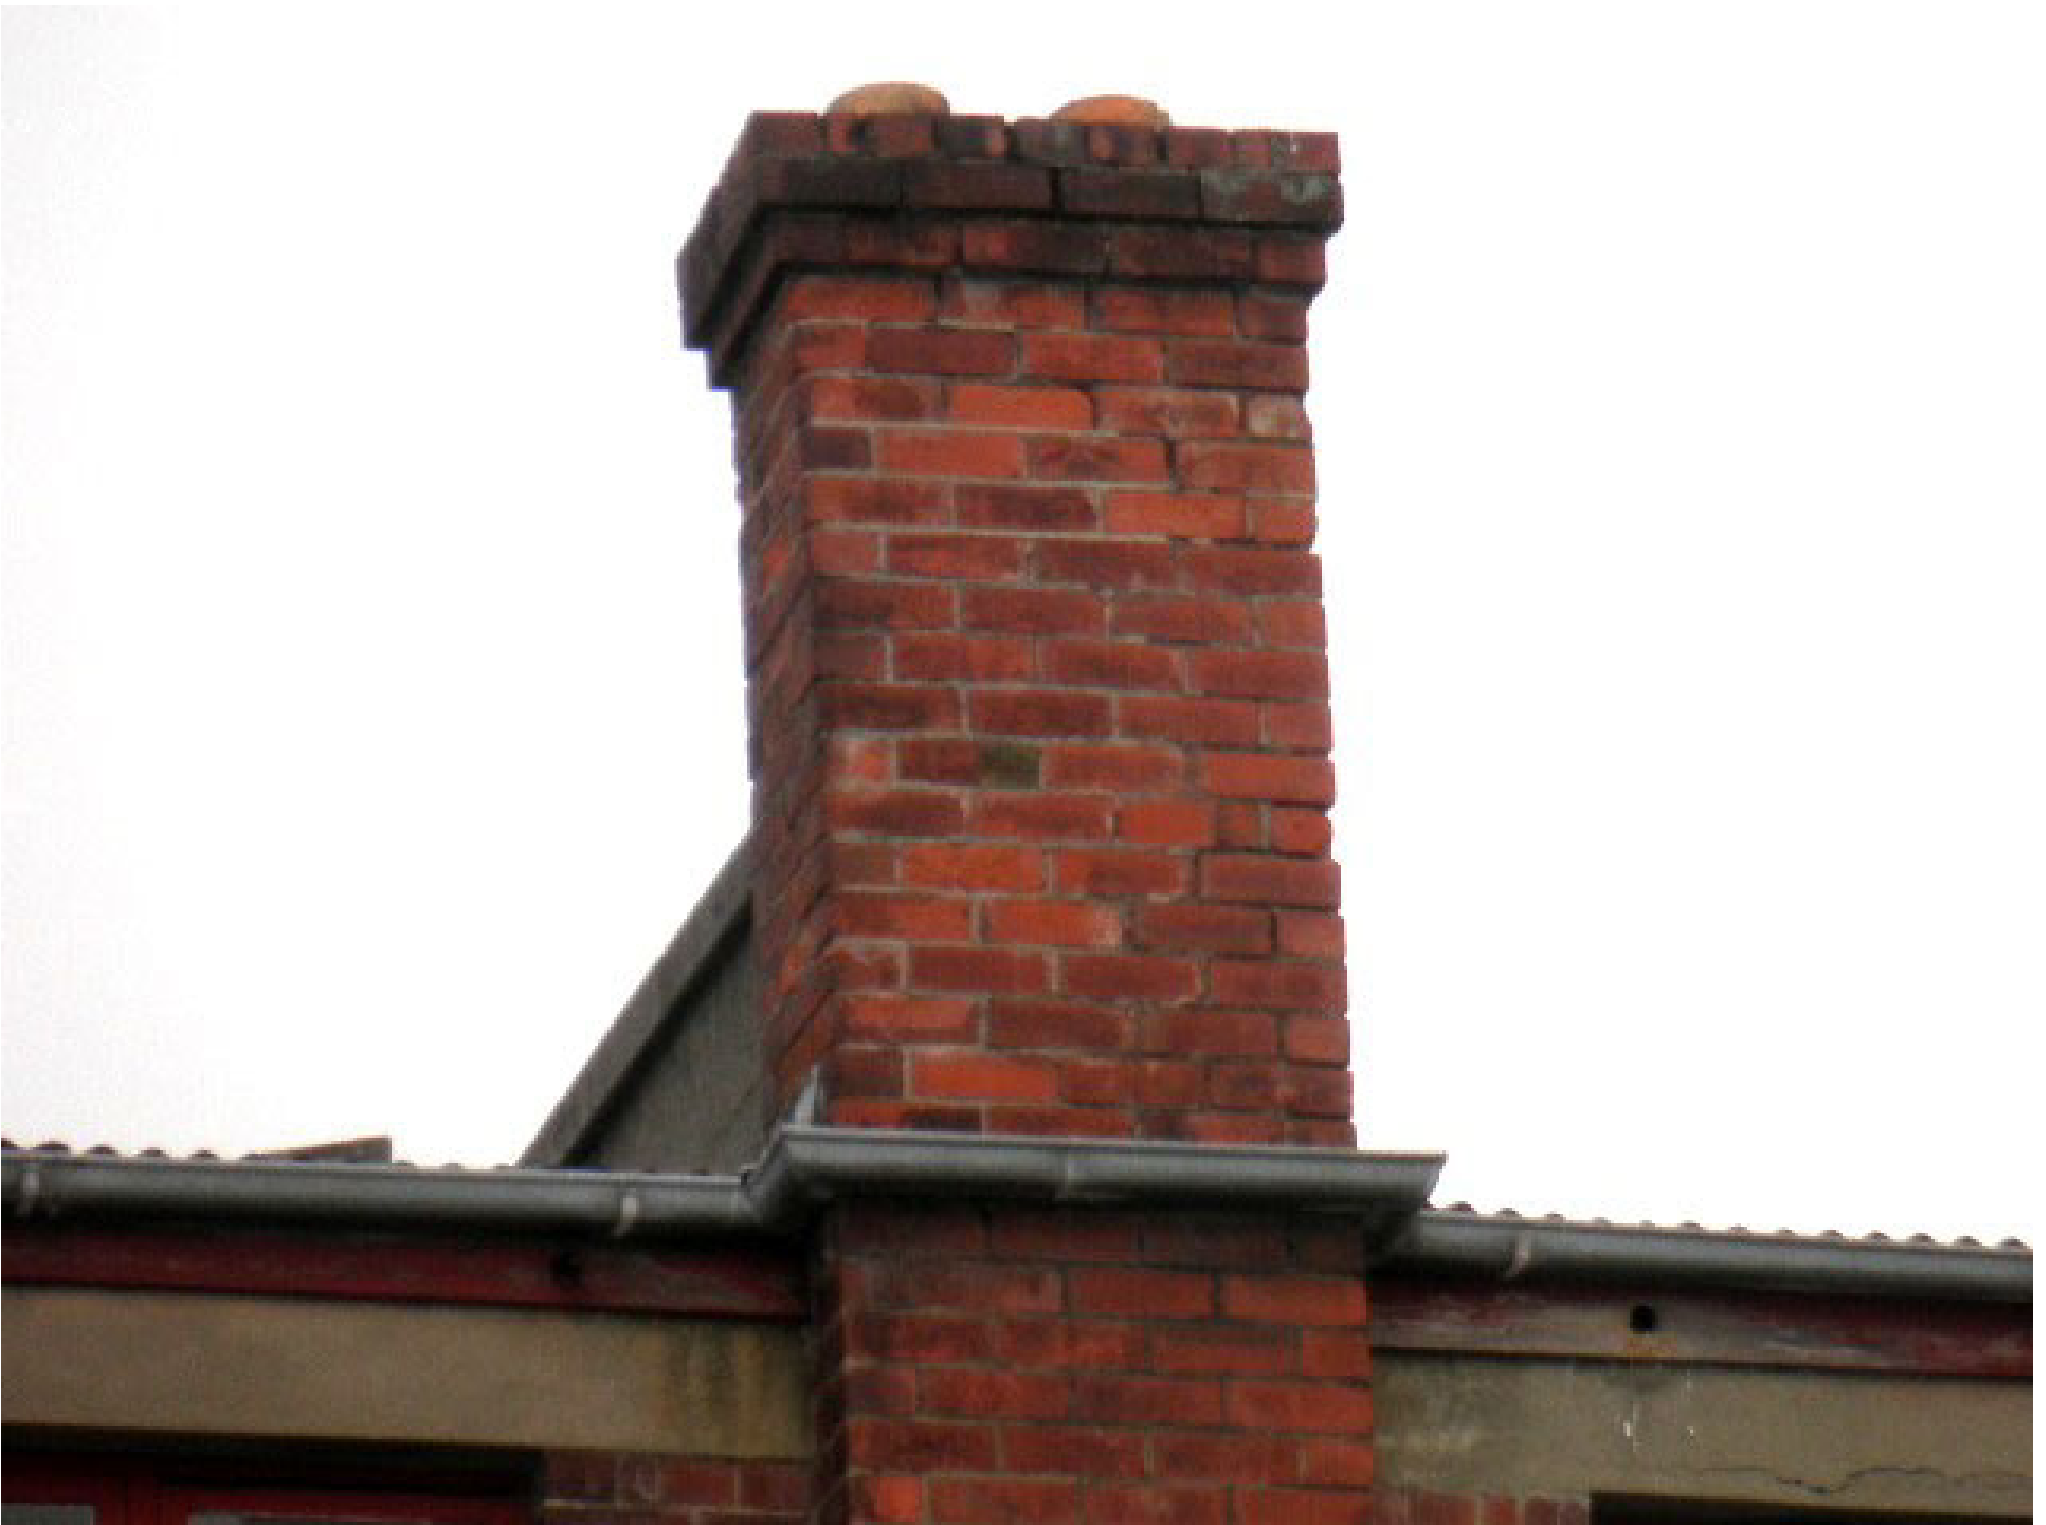
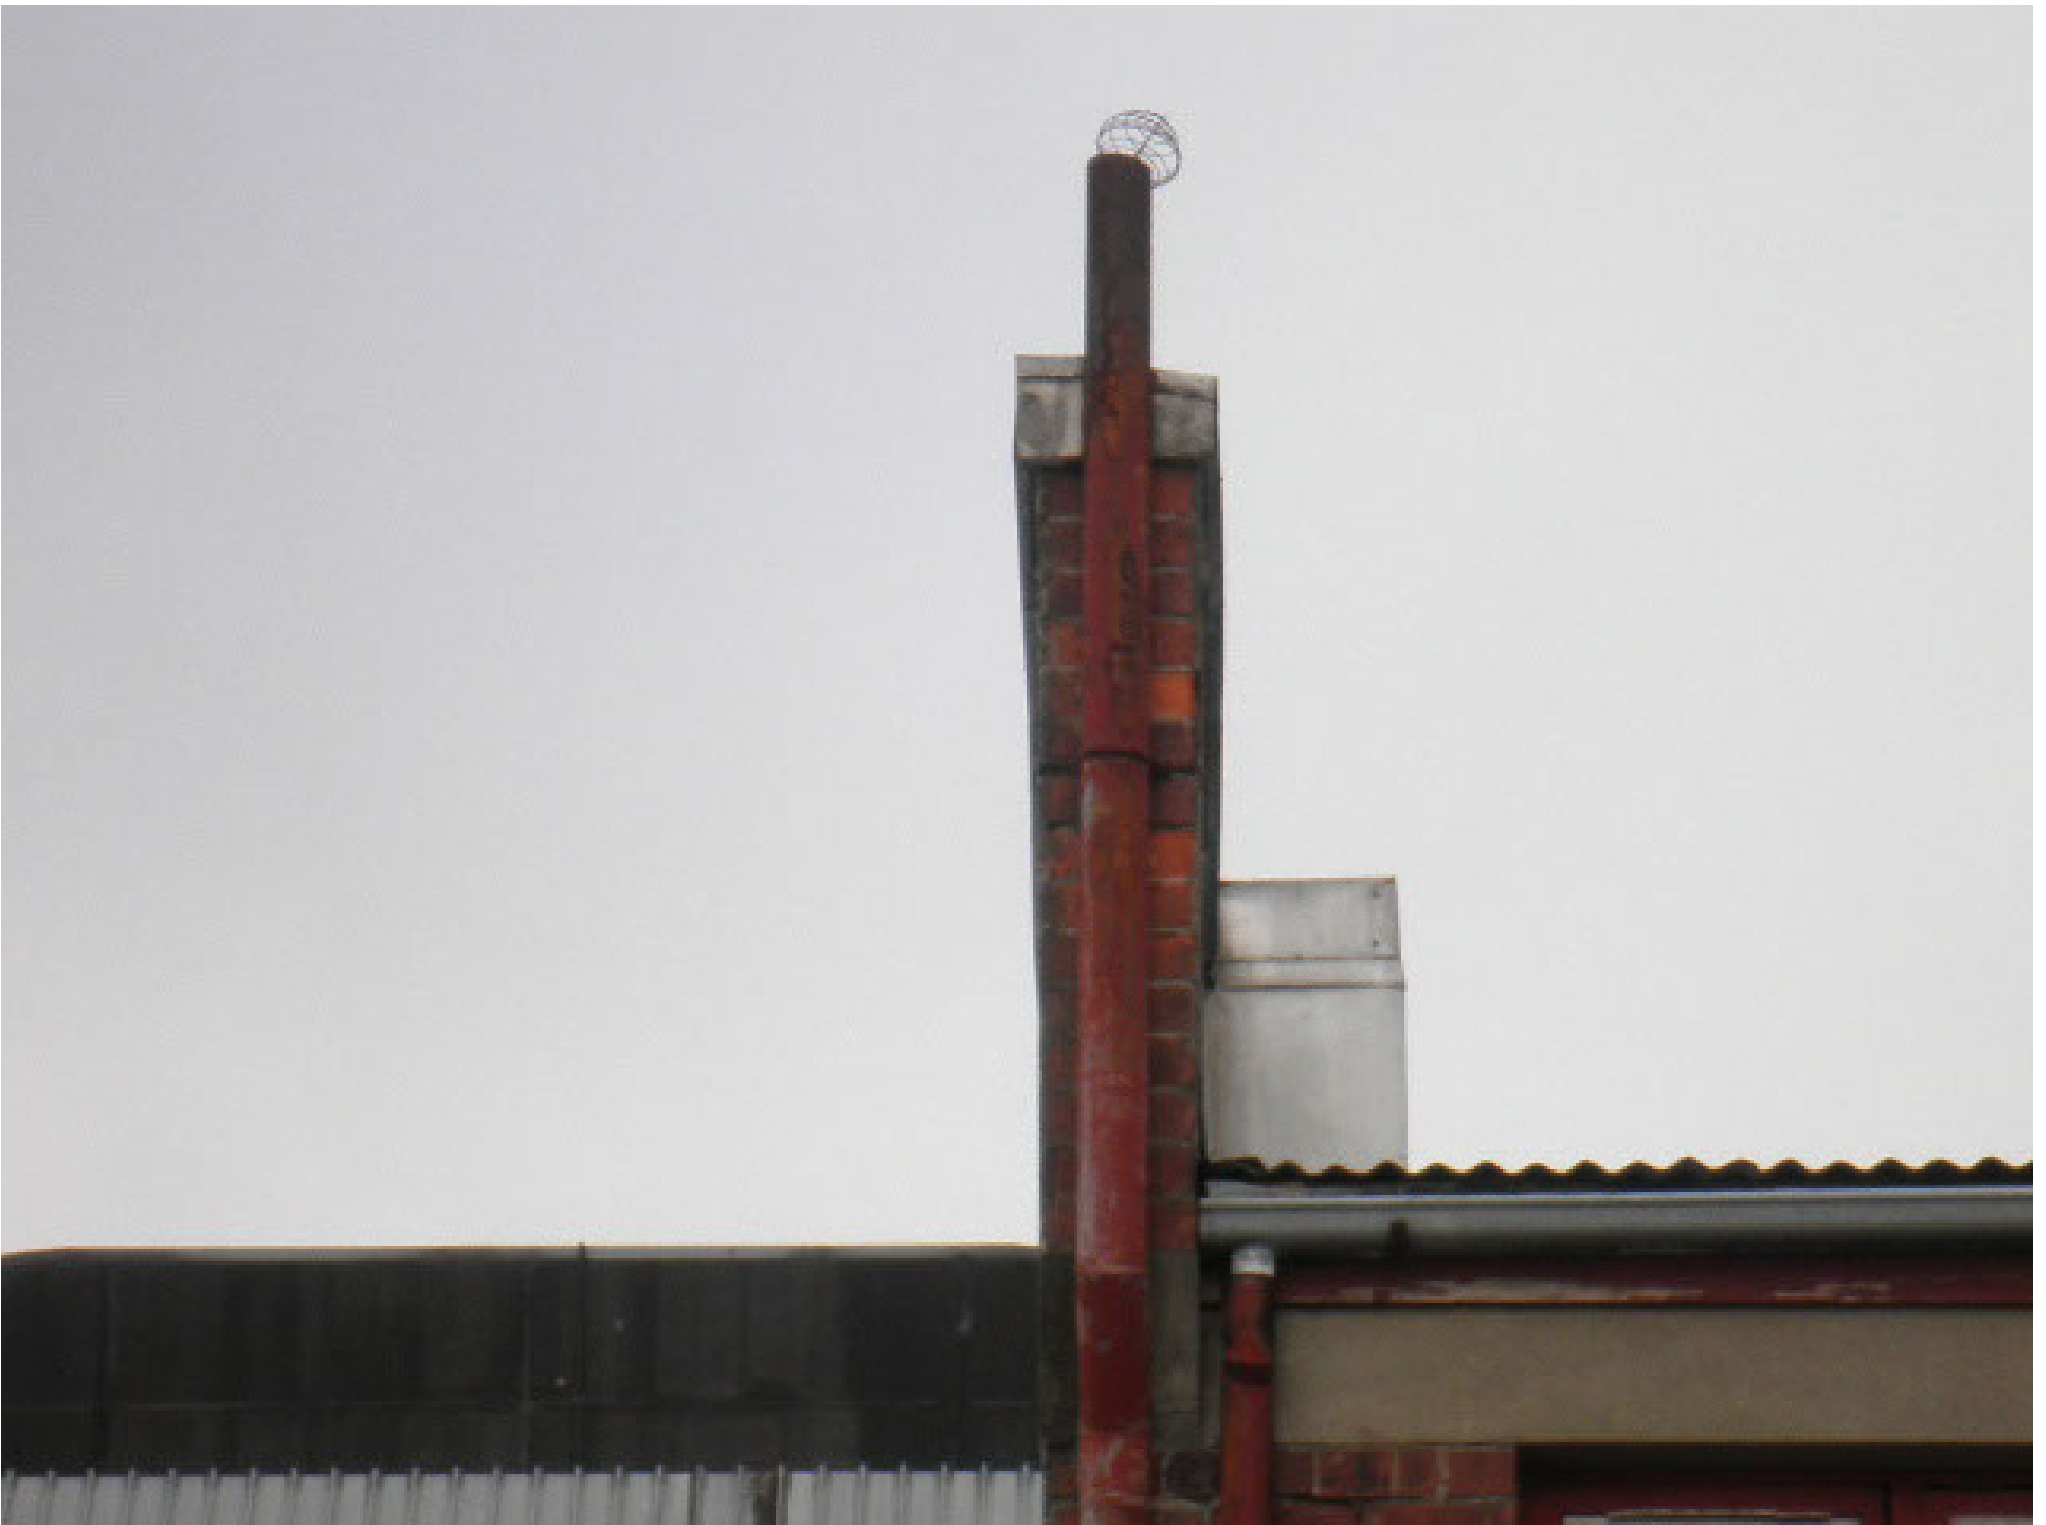
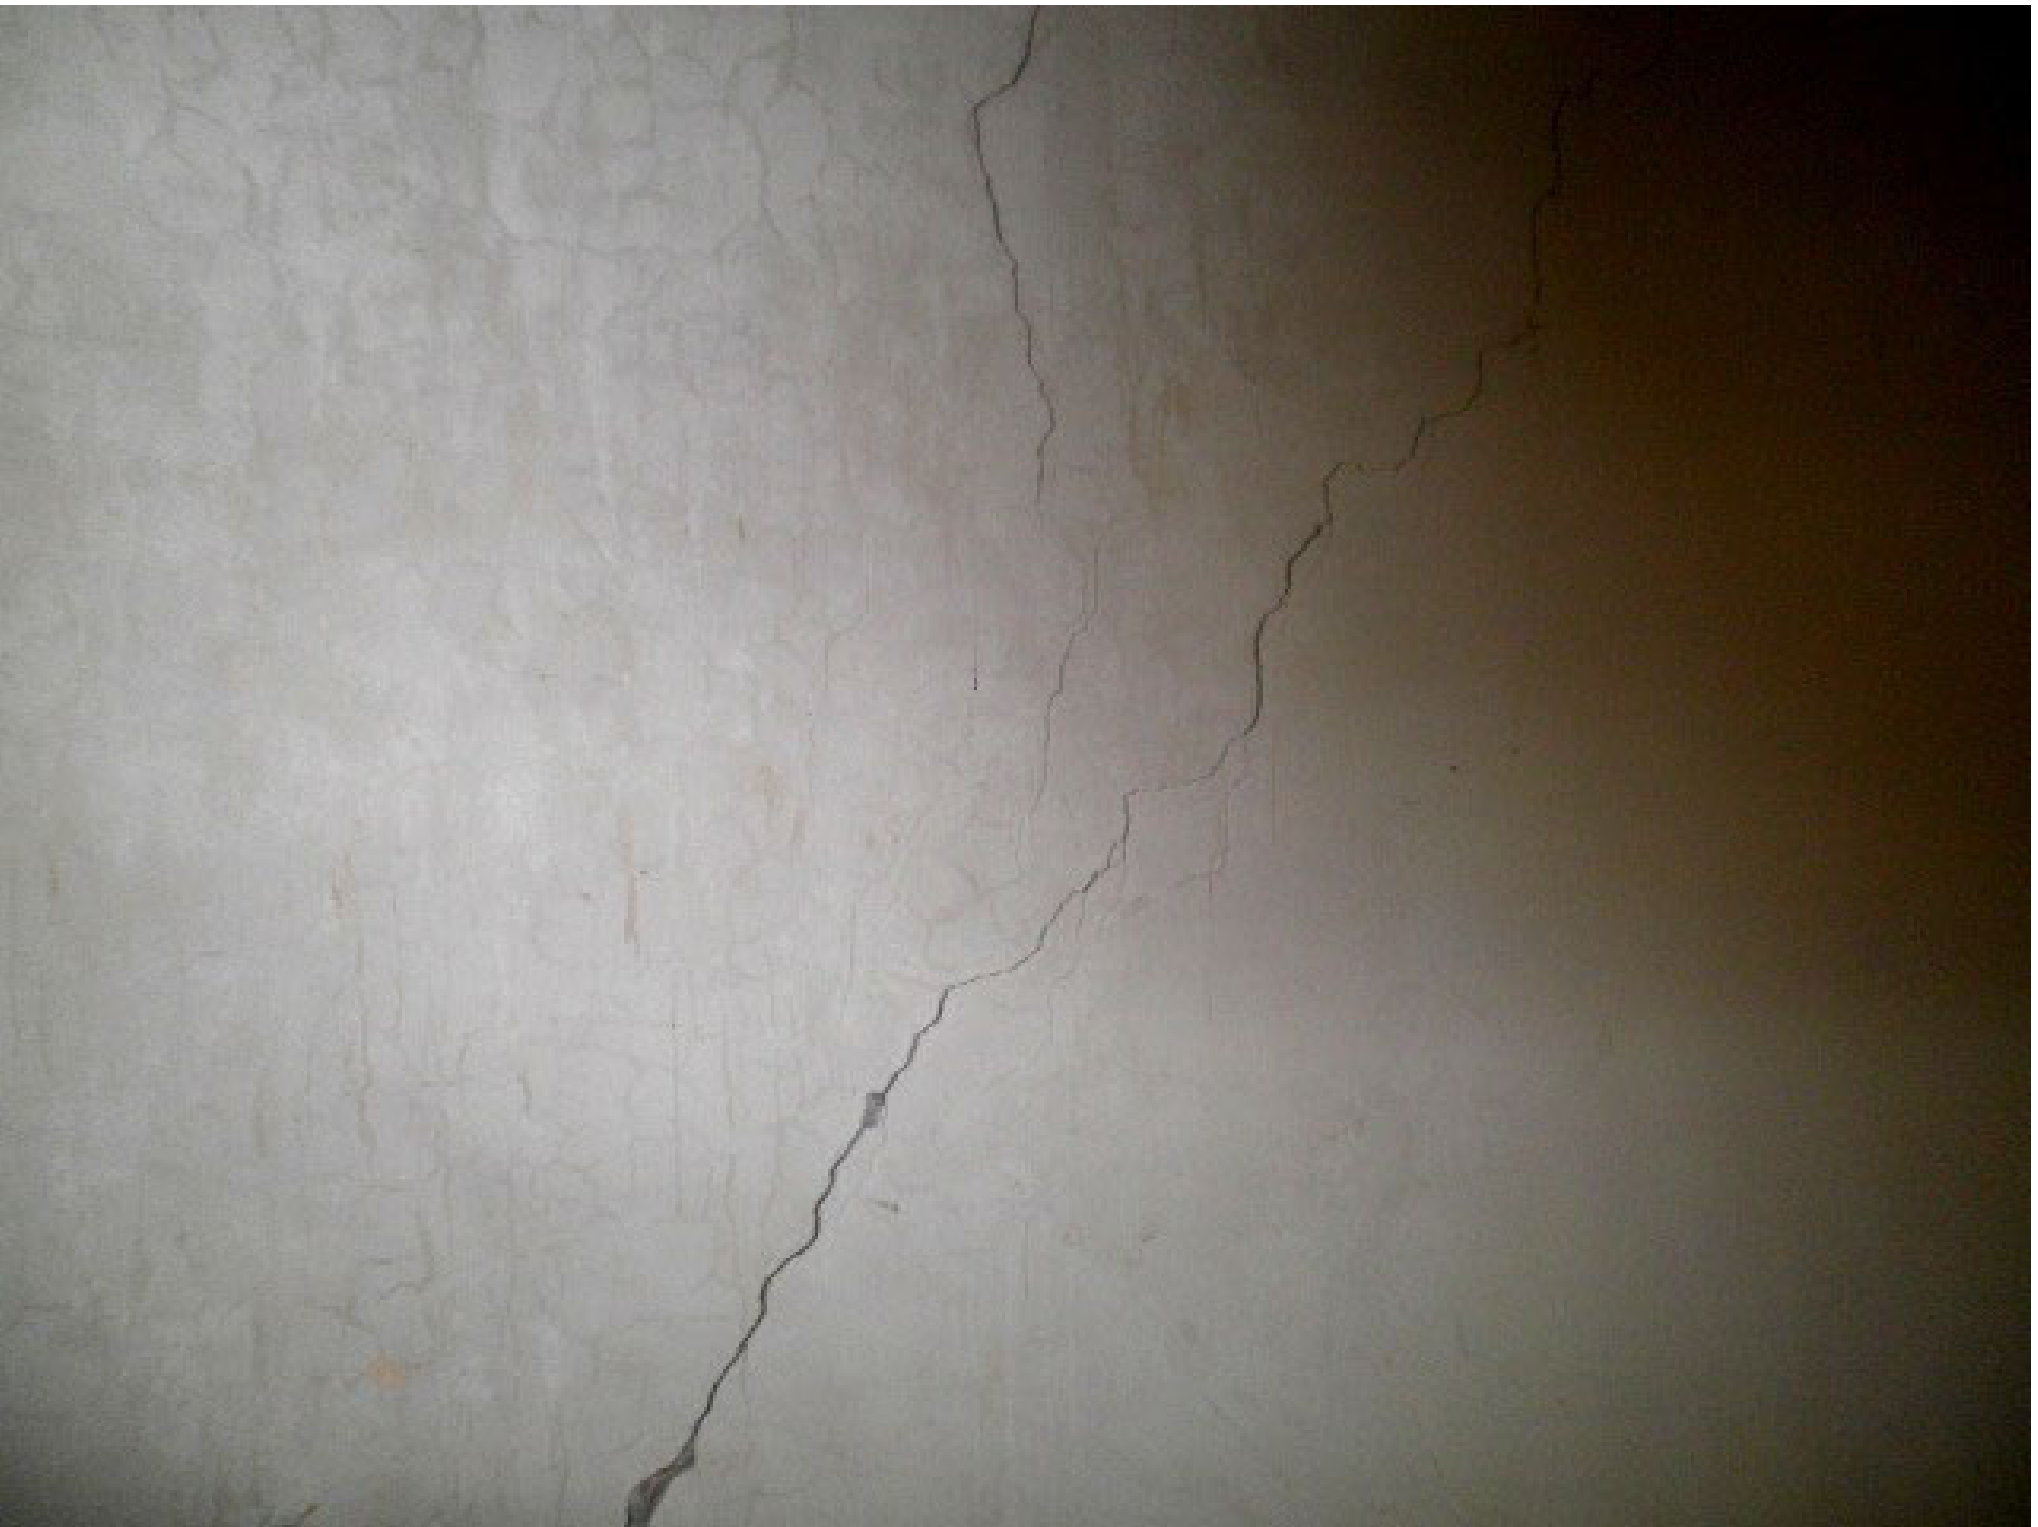
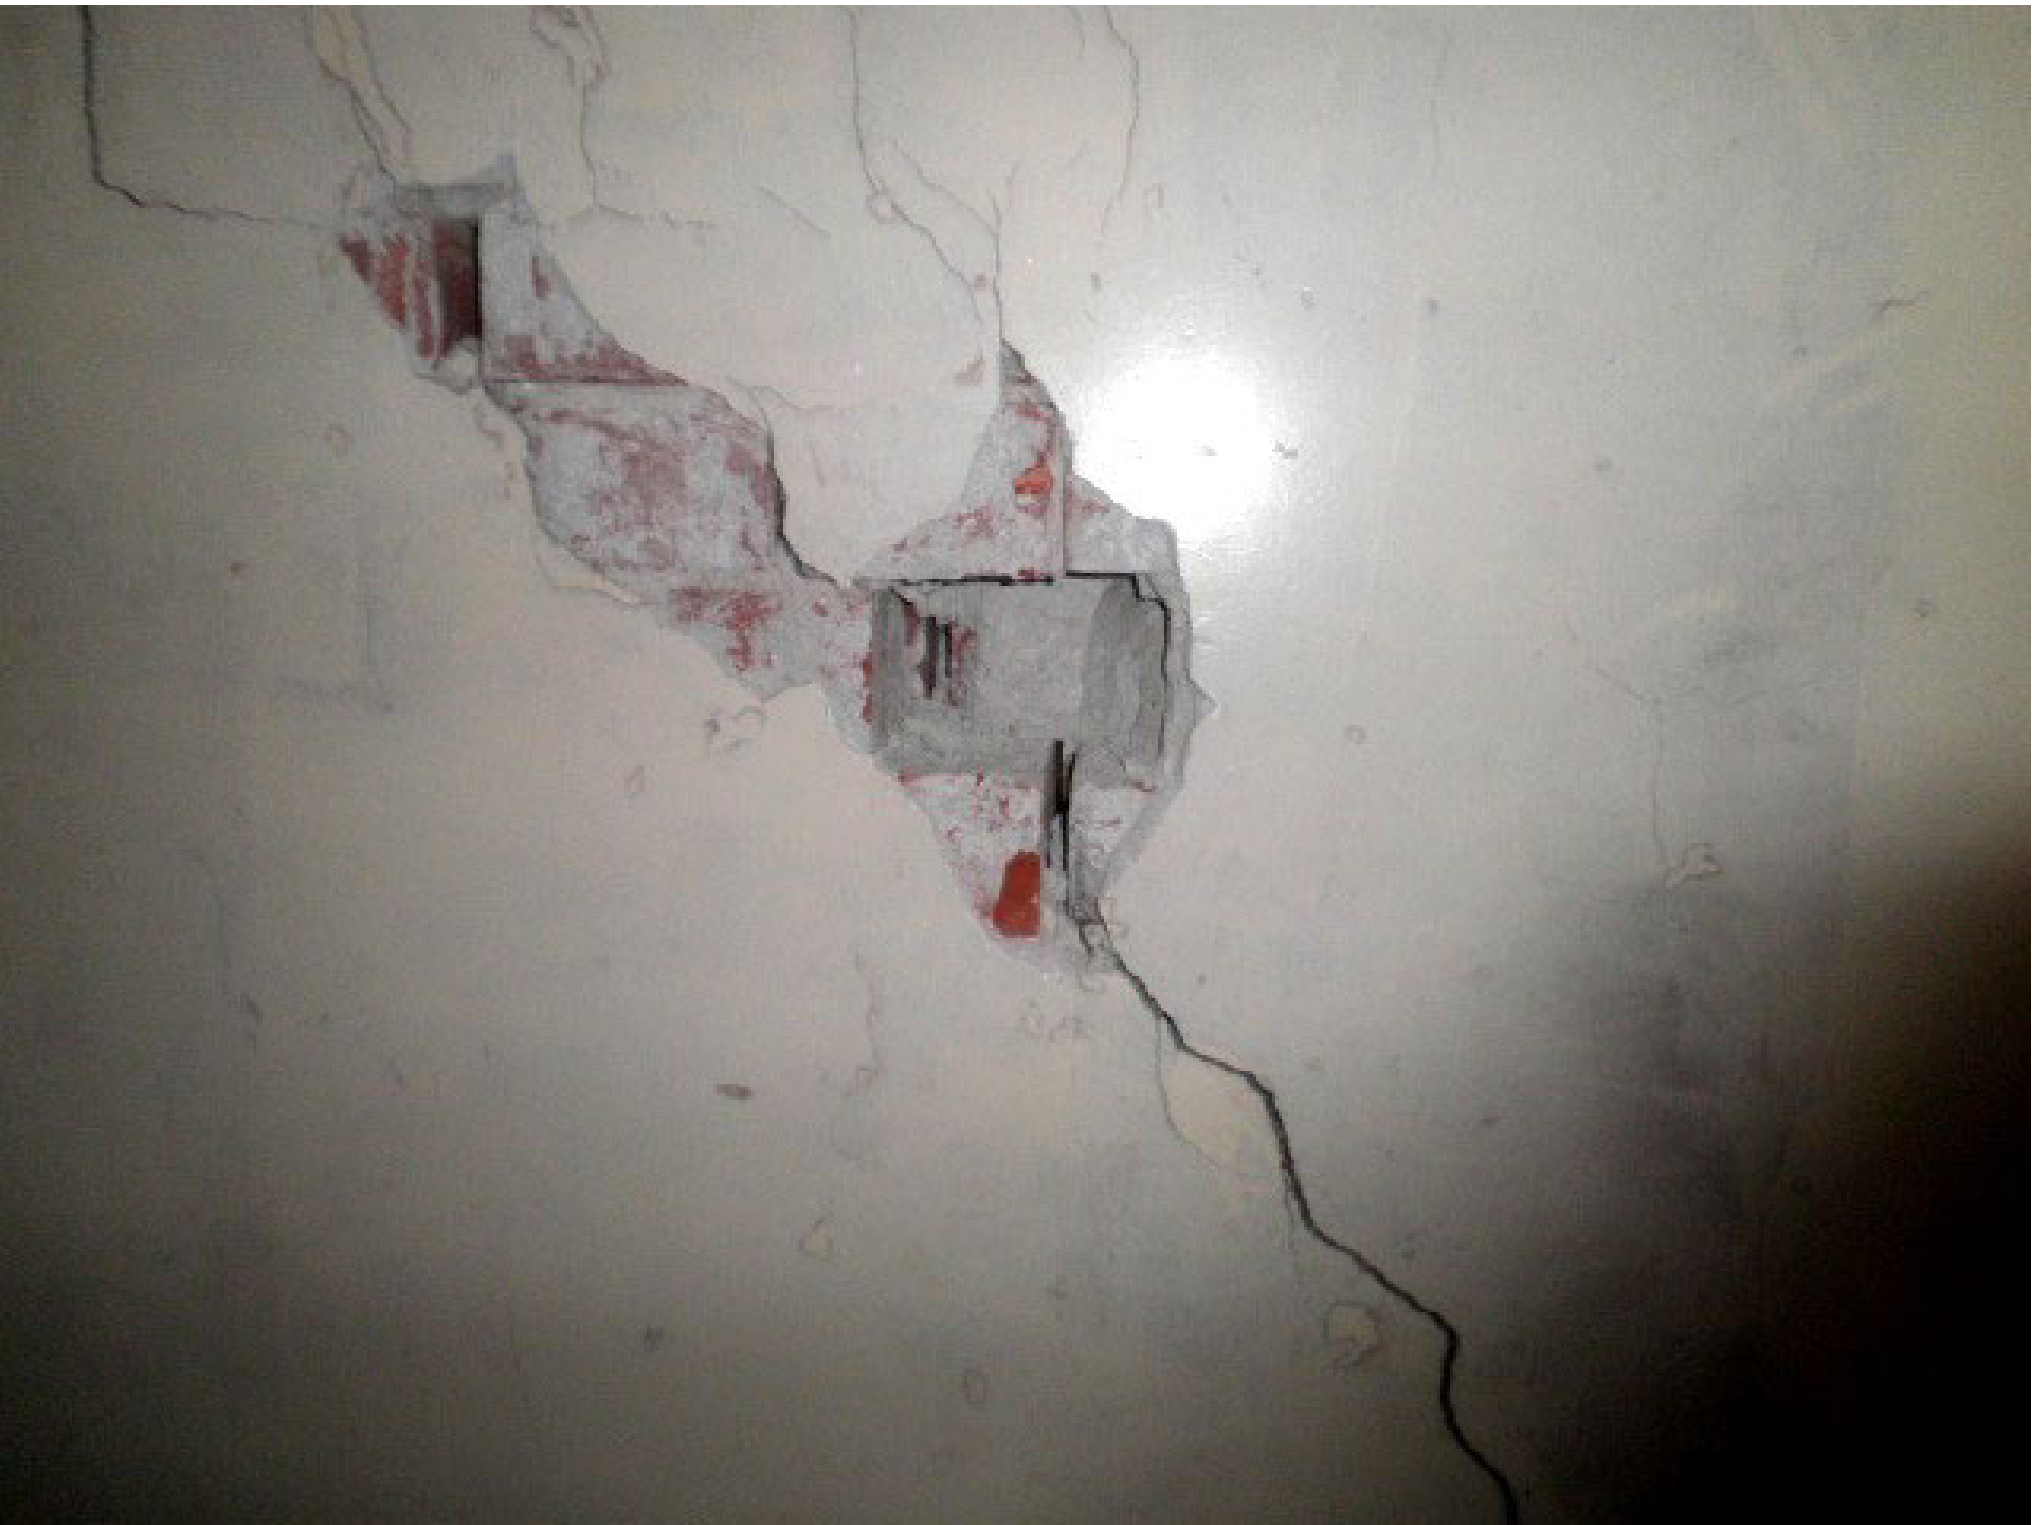
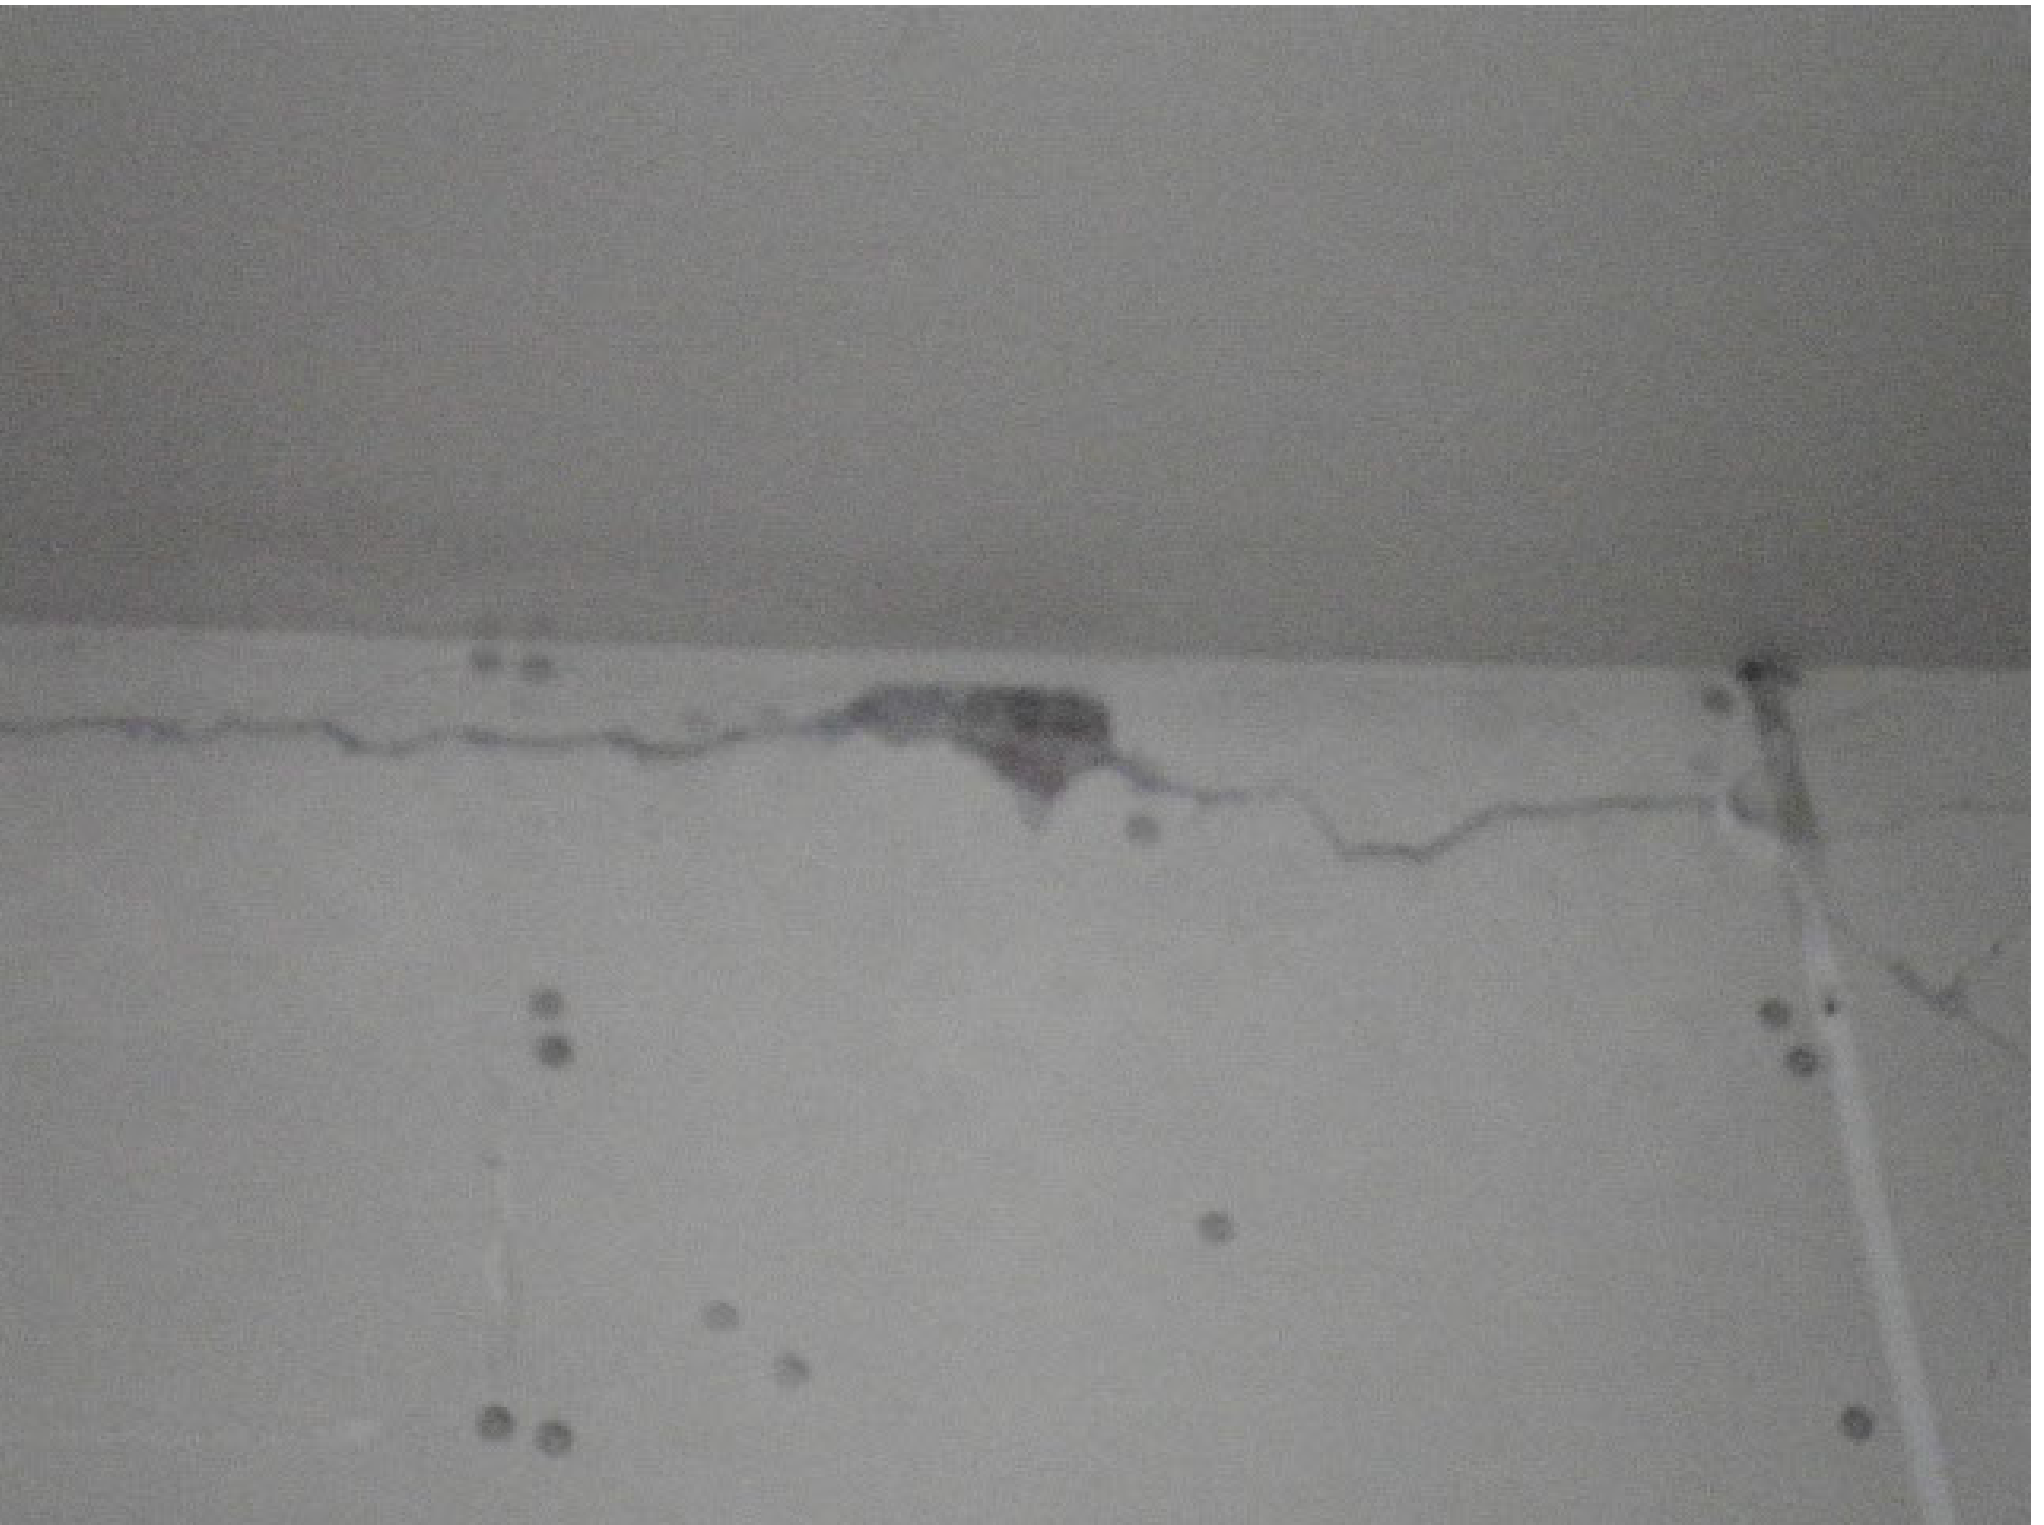
In the company of both David and the Engineer, I then inspected the properties at 382 and 384 Colombo Street. As far as 382 Colombo Street is concerned, I noted that tenants were still in occupancy. This building was showing its age. There were indications of old settlement and movement in the brickwork at the rear of the building and this was reflected inside as well. It was also quite evident that the two earthquakes had caused cracking of the internal walls. This is shown in the photographs attached.

In the company of the Engineer and David Yan, we ventured onto the roof and conducted an inspection. I made note of some cracking in a wing wall on the southern side (see photograph). This cracking appeared to be old. I recall seeing some hairline cracks in the parapet, which appeared to be old shrinkage related cracks. It was on a tilt, by about 3 degrees lean but going back towards roof, not the neighbouring property.

I recall making note of the chimney, which was also cracked but it showed signs of movement caused by natural settlement and age as well.

At the time of my inspection I was concerned about the wing wall, which was displaying signs of aged cracking. I considered it a potentially dangerous.
