**INDEPENDENT ASSESSMENT ON EARTHQUAKE PERFORMANCE  
OF**

**605 - 613 Colombo Street  
605 – 607 Khmer Satay Noodle House  
609 – 613 Kiwi-Disposables**

**Royal Commission of Inquiry into building failure  
caused by the Canterbury Earthquakes**

**Report prepared by Peter C Smith and Jonathan W Devine  
OF  
Spencer Holmes Ltd**

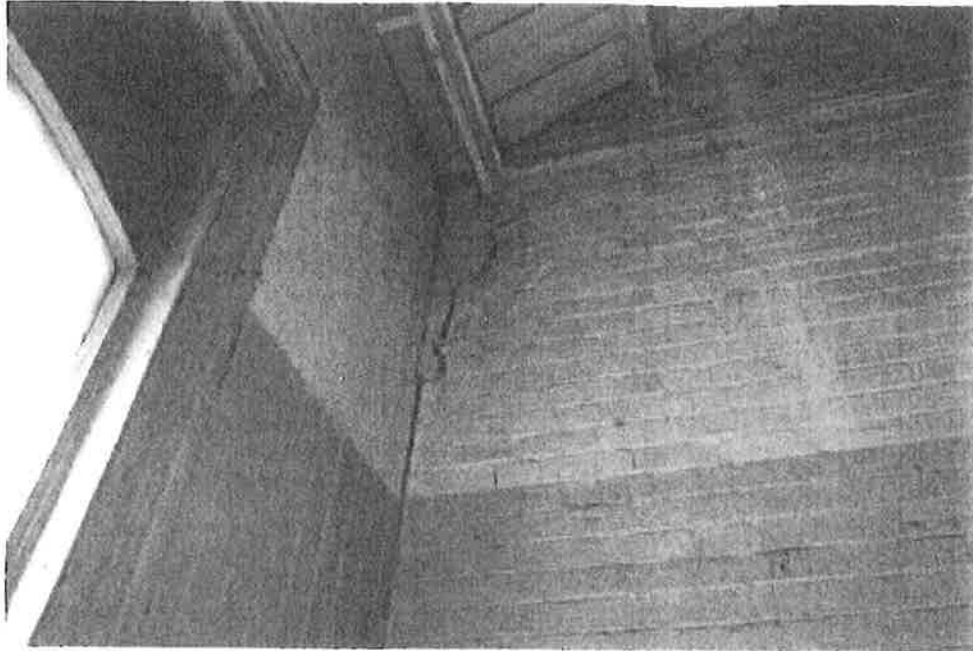
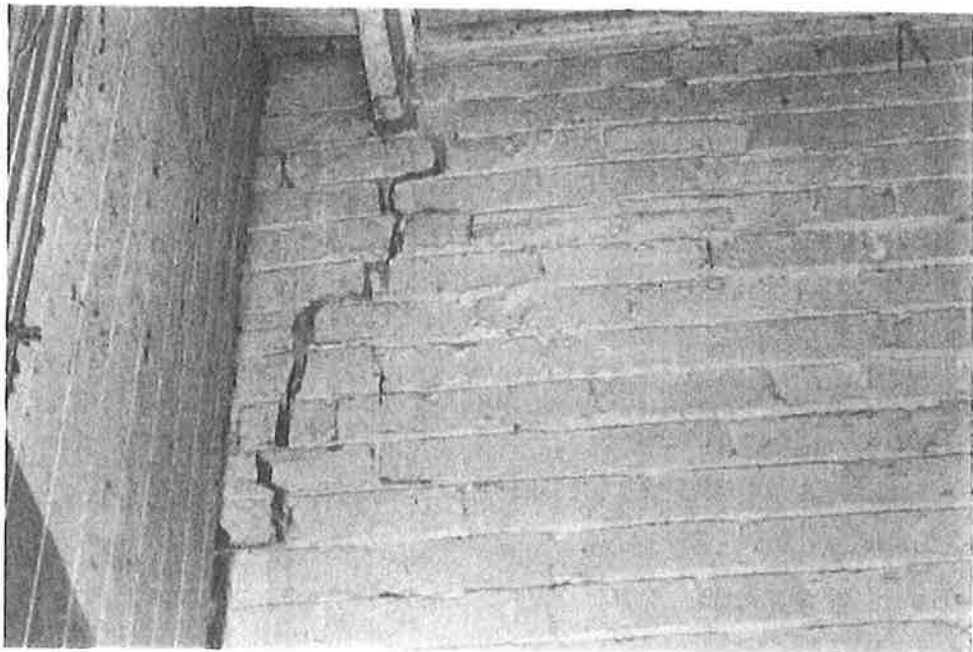
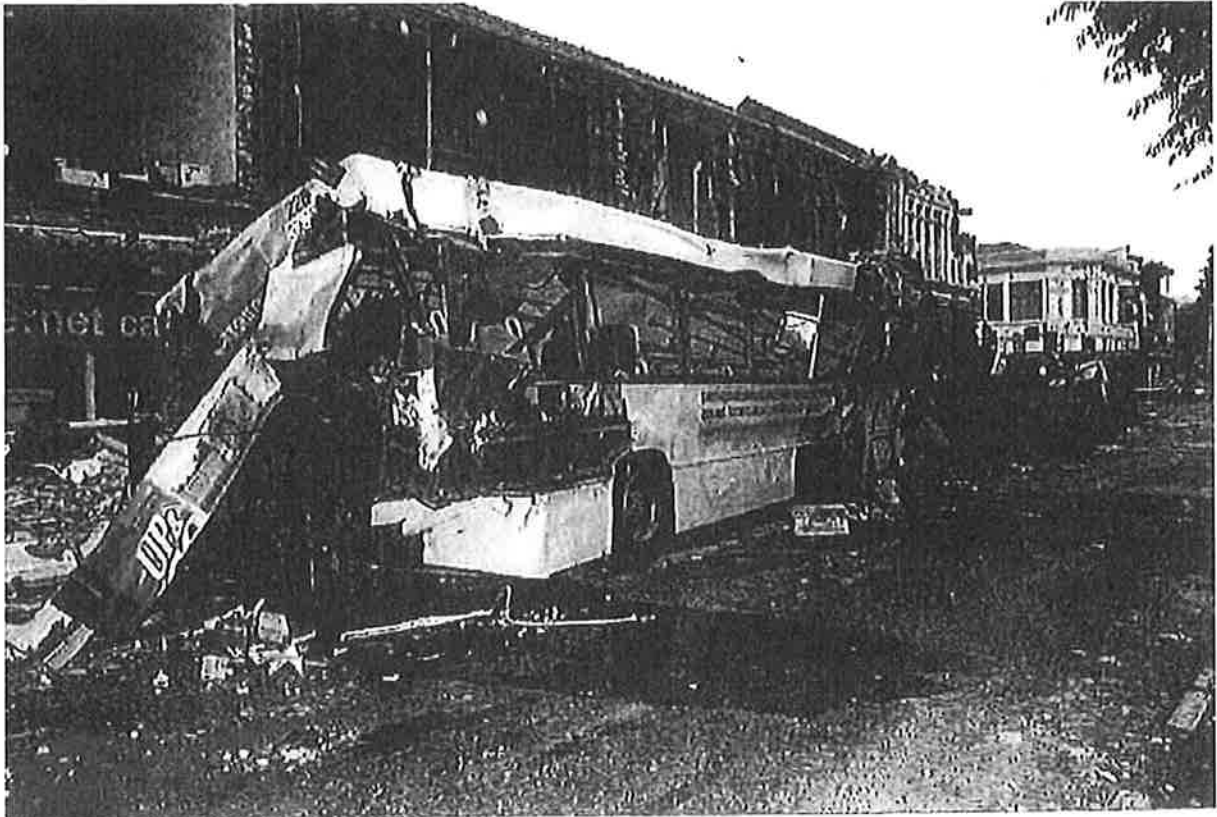
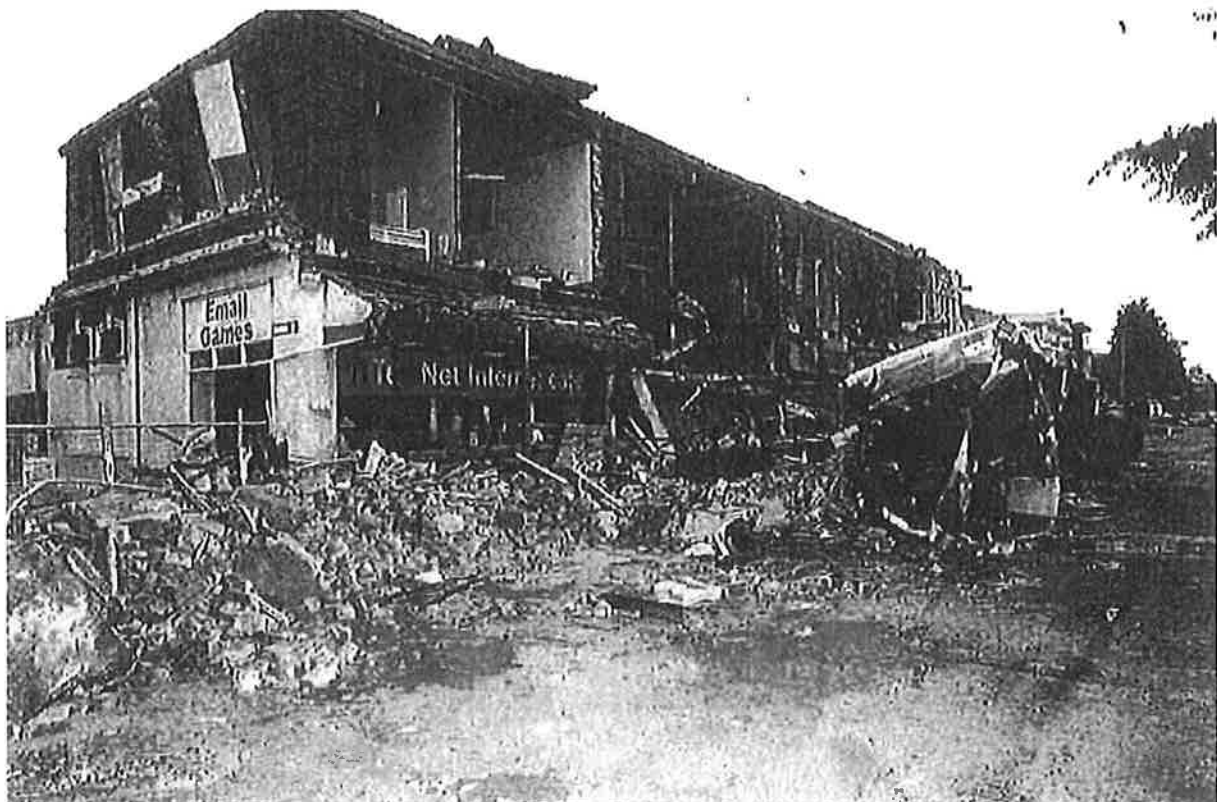
### **Records of damage following 4<sup>th</sup> September 2010 earthquake**

The buildings suffered minor damage in the 4<sup>th</sup> September, 2010 earthquake. The Rapid Assessment-Level 1 survey undertaken on the 5<sup>th</sup> September, 2010 identified minor parapet cracks in the back wall. Properties 605-613 Colombo Street were assigned a green placard.

Buchanan & Fletcher reported on 5<sup>th</sup> November, 2010. “There did not seem to be any new cracks in the cross walls near the east frontage. However, the existing cracks appear to have widened since our first inspection. Above the roof there is clear evidence that the east wall has separated from the cross walls at each end of the building with a gap of in excess of 20mm.” Buchanan and Fletcher recommended that the east wall and parapet be tied back to the cross walls”. On 23<sup>rd</sup> November, 2010 sketch details of the strengthening work were received from the engineers. On 30<sup>th</sup> November, 2010 Mainland Claims Management Ltd requested Buchanan & Fletcher to arrange a quote from builders for the tie back. On 13<sup>th</sup> December, 2010 a quote was received from the builders. Insurers gave approval for the temporary repair to be undertaken.

There is evidence of vertical cracking of the masonry party walls close to the front façade following the 4<sup>th</sup> September, 2010 earthquake. This cracking widened in the subsequent aftershocks. The first floor façade of the buildings failed by an outward rotation of the façade about the first floor supporting beams in severe shaking during the 22<sup>nd</sup> February, 2011 earthquake.
