PGC BUILDING BEFORE EQ

ROYAL COMMISSION HEARING
Nigel Priestley Presentation

PGC BUILDING AFTER EQ

BUILDING ISSUES

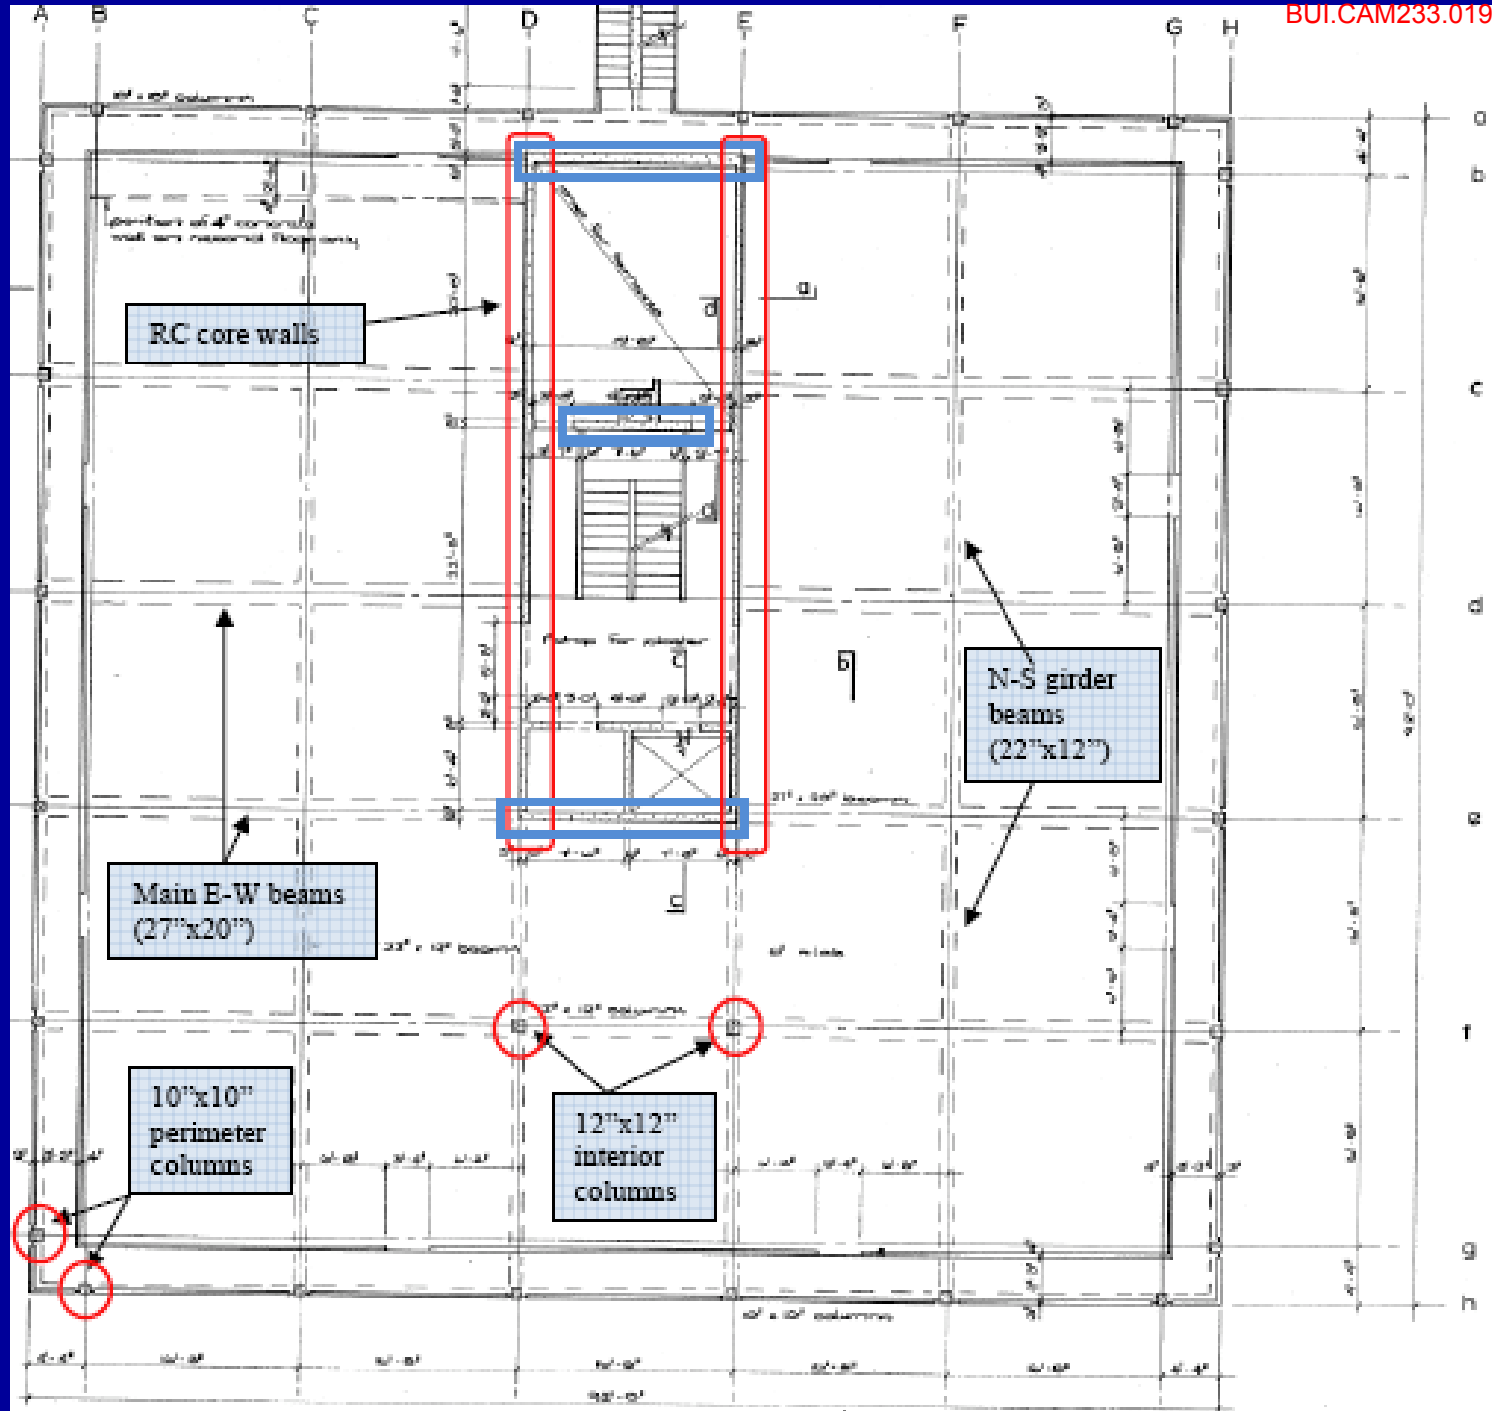
PGC STRUCTURAL FEATURES

RC core walls

Main E-W beams
(27"x20")

10"x10"
perimeter
columns

12"x12"
interior
columns

N-S girder
beams
(22"x12")

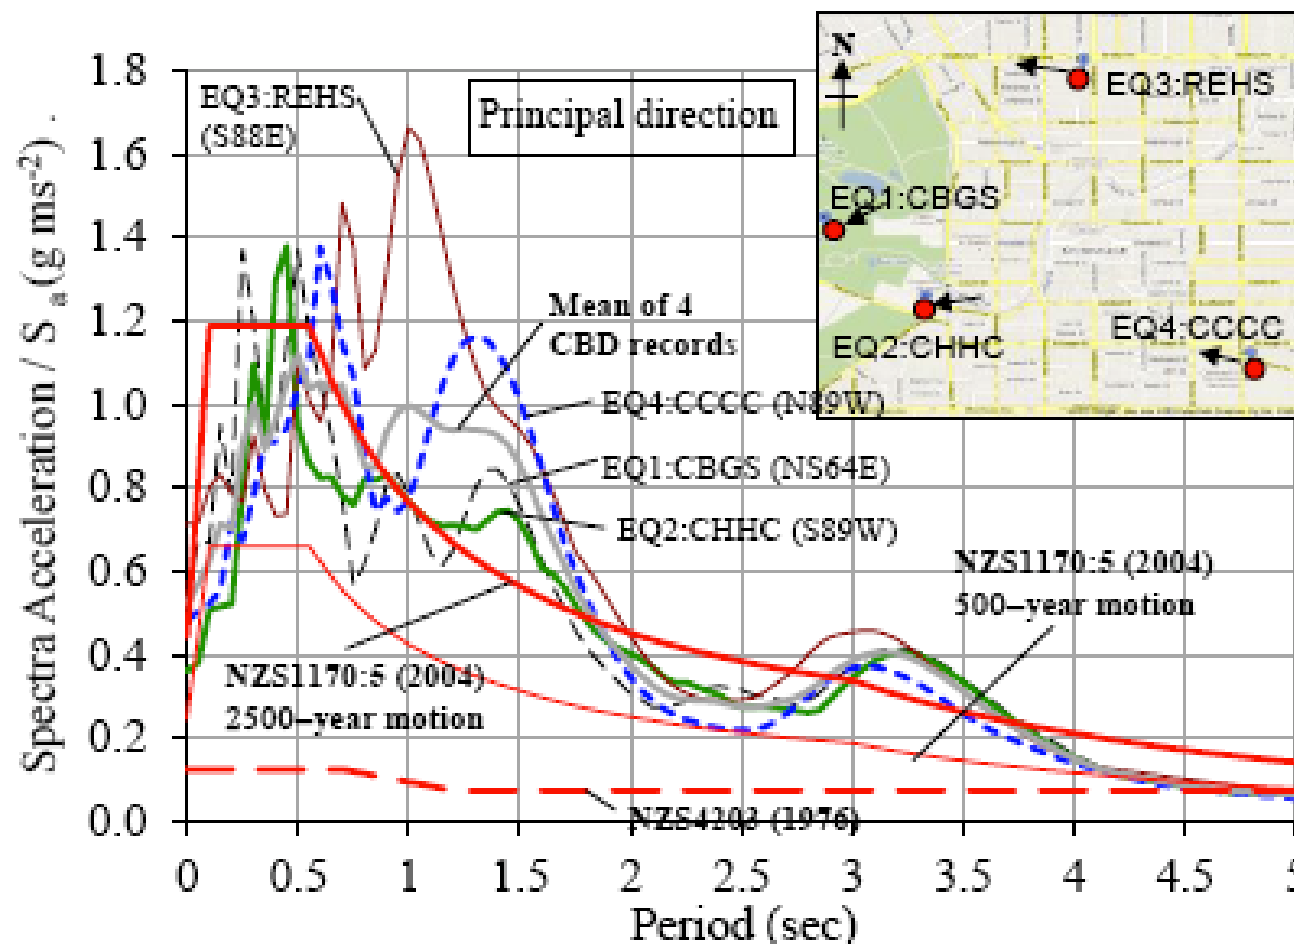
22nd Feb 2011 excitation

$T > 0.25s \sim$
 $\gg 500\text{-yr}$
design
motion

$T = 0.6s$ to
 $2.0s \sim$
2500-yr
design
motion

Significant displacement demand

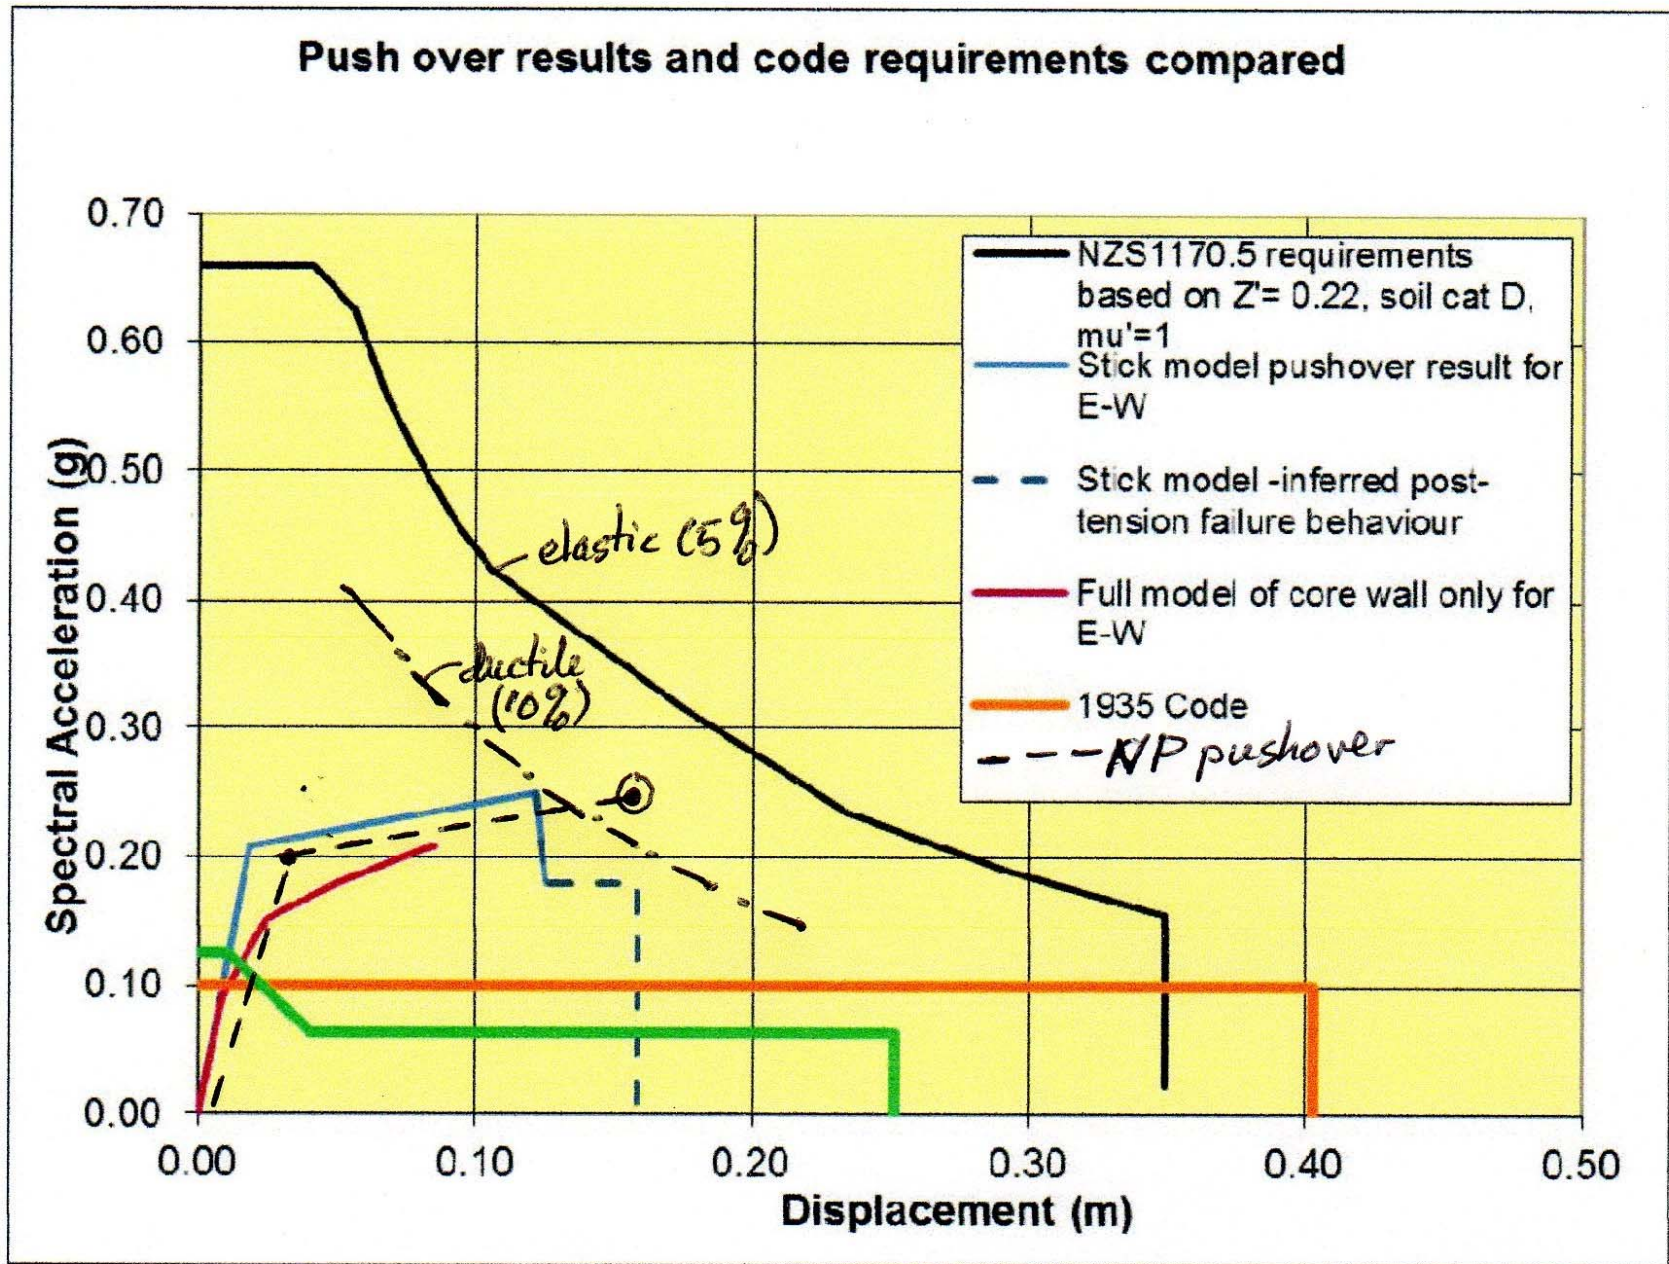
Figure A4.6.2: Pushover Analysis Results and Code Requirements Compared

- Pushover displacement capacity should be related to ductile, not elastic spectrum. Equivalent Viscous damping estimated as 10%: reduction to demand approx 24%.
- September 4 D/C apparently related to average of horizontal spectra at 4 sites
- February 22 D/C apparently related to average of SRSS combination.
- Displacement capacity could be 30% higher than “stick” model estimate, and 80% higher than “full” model

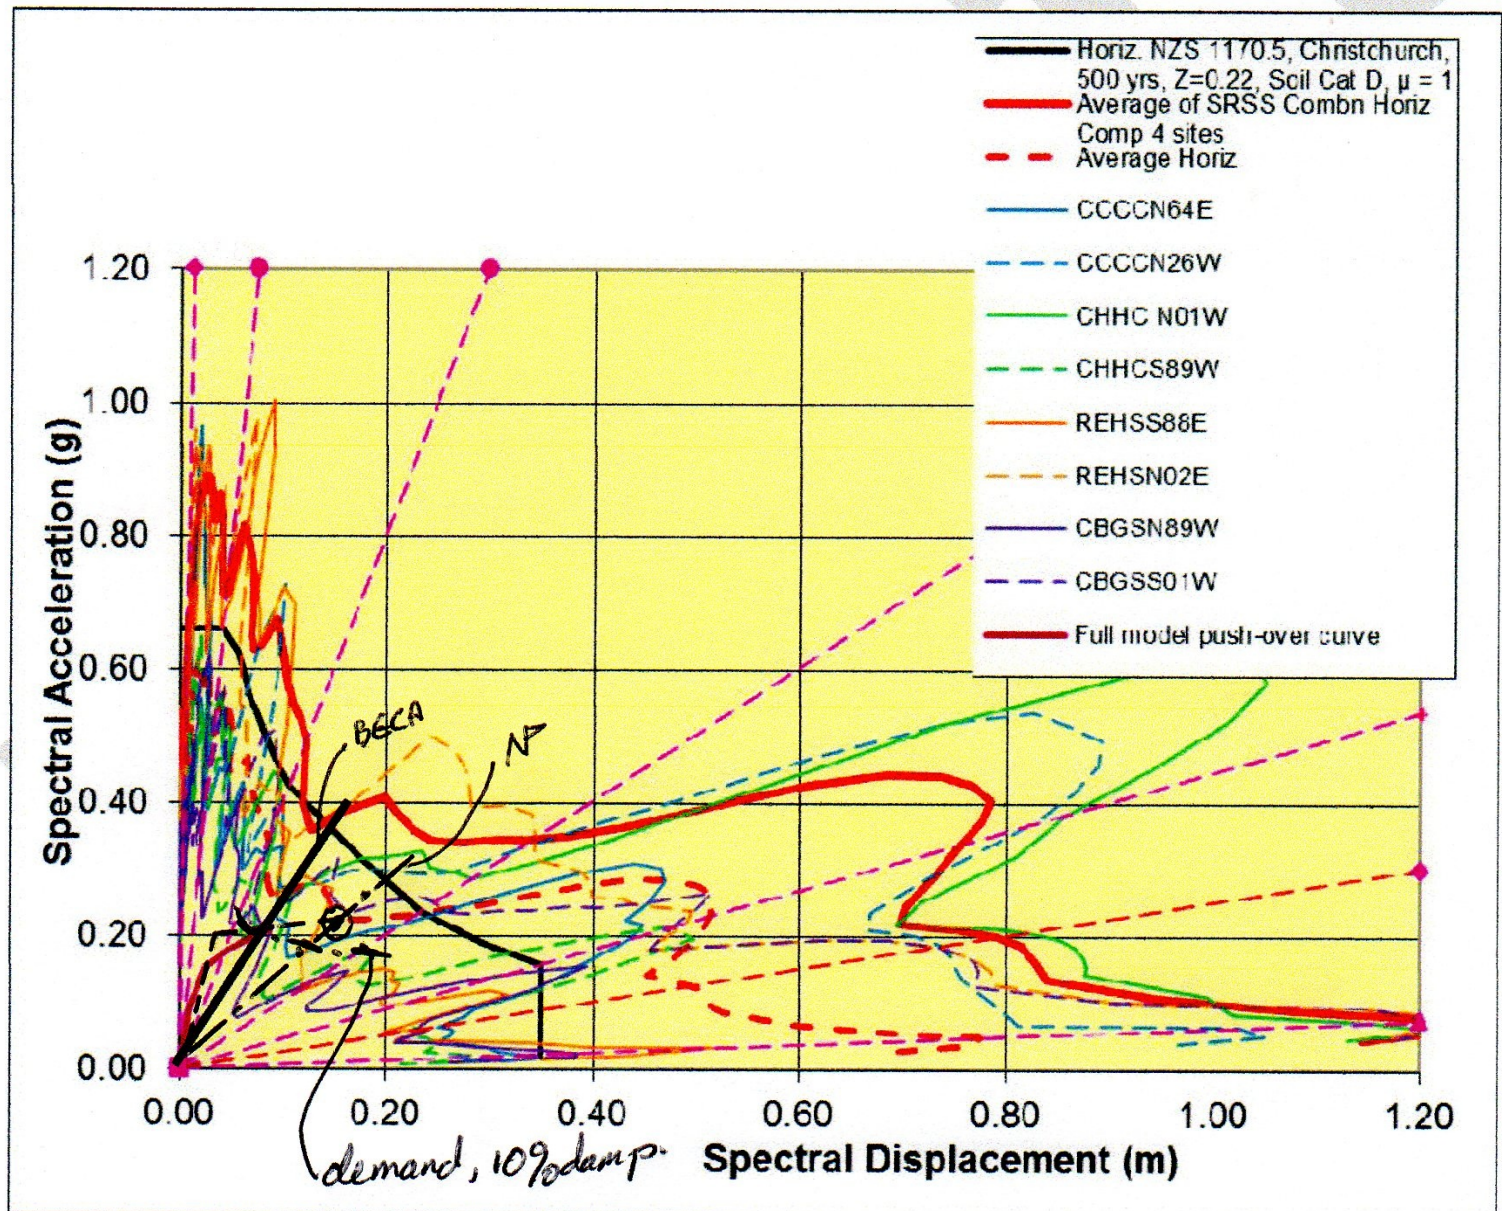
Figure A4.7.1: Push-Over Curve and Spectral Plots for 4th September 2010 Earthquake Compared

$D/C = 1.3$ (Beca, ave); = 1.9 Beca (SRSS) = 0.81 NP (Ave)

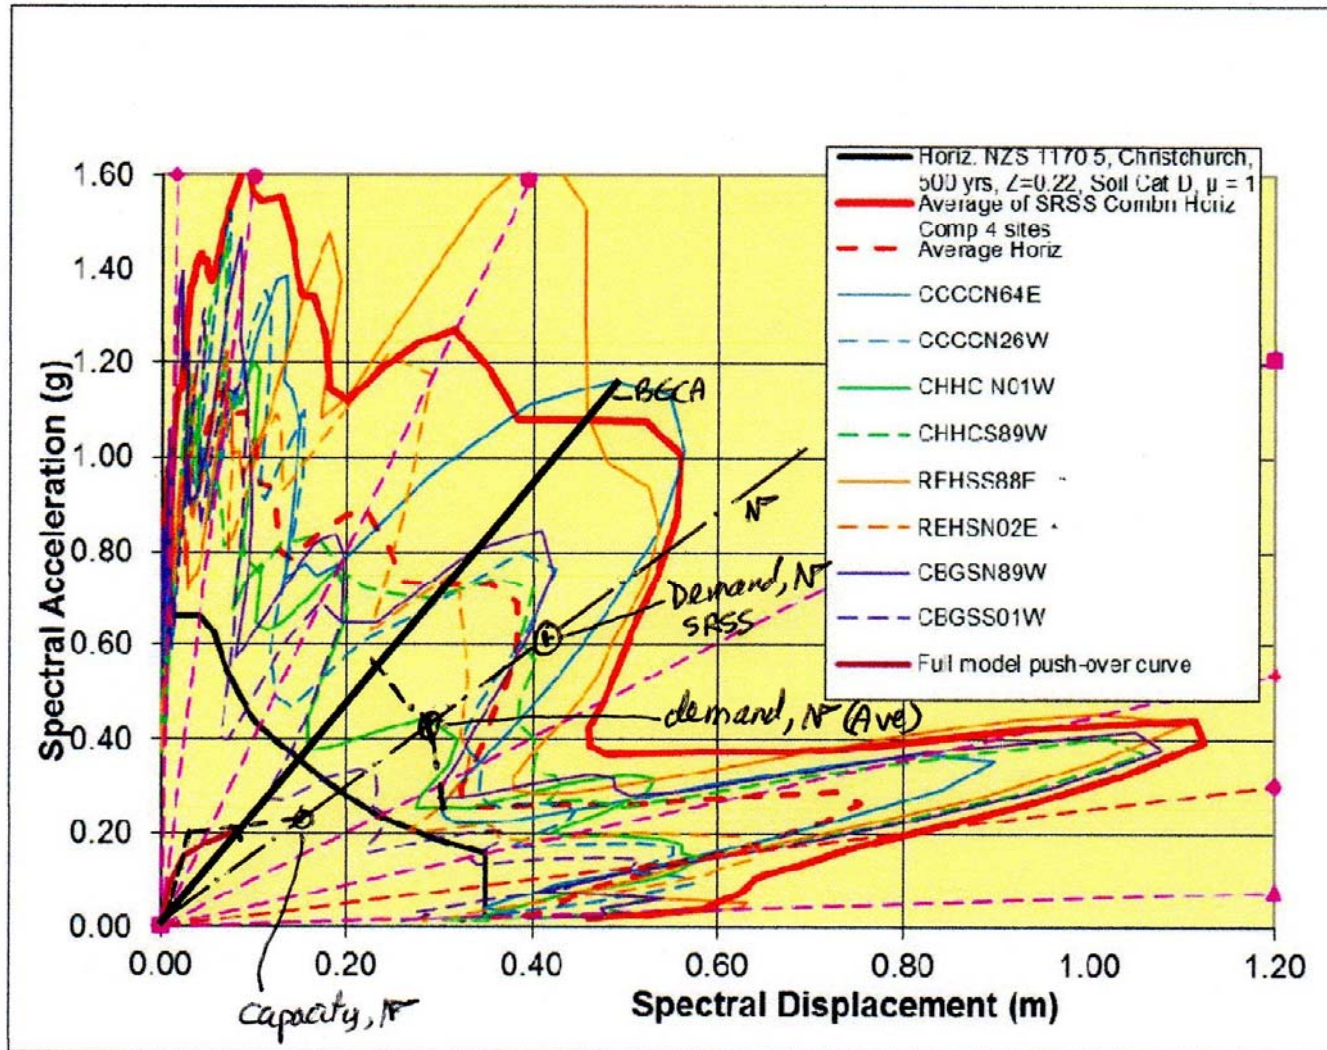
Figure A4.7.3: Push-Over Curve and Spectral Plots for 22nd February 2011 Earthquake Compared

$$D/C = 3.8 \text{ (Beca, ave)} = 5.9 \text{ (Beca, SRSS)} = 2.0 \text{ (NP, ave)} \\ = 2.7 \text{ (NP, SRSS)}$$

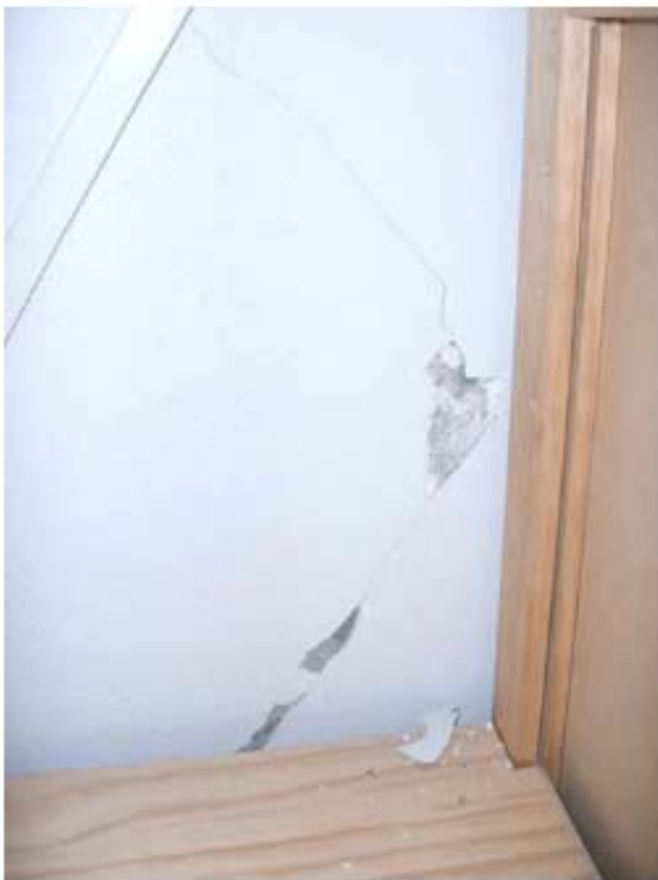
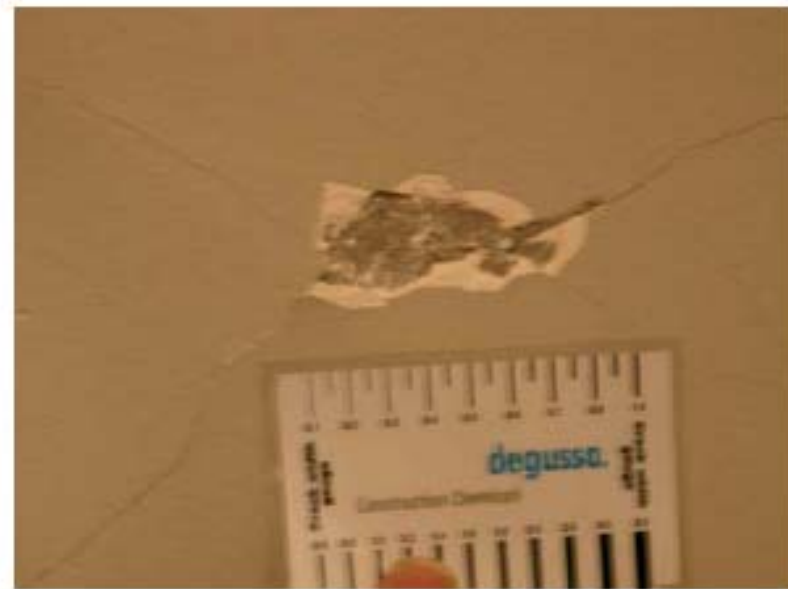
- Beca response spectrum analysis indicate $D/C > 1$ (failure), but NLTHA (and NP analysis) indicates no failure, but yield of wall.
- Eye-witness accounts indicate increased “liveliness” of building, post-Sept 4.
- Damage inspection indicates diagonal cracking and spalling in shear wall, and cracks at bottom of some columns.
- Crack widths were small after Sept 4, but reinforcement ratio in wall is so low that gravity loads would close cracks after shaking ceased, maybe giving a false impression of safety.
- Spalling of surface concrete in shear wall indicative of sliding on cracks - significant damage.
- Even if wall reinforcement had fractured in Sept (considered unlikely), this would not necessarily be apparent - again due to very low reinforcement ratio in wall (compare with Academy Towers).

(a) Cracking to Level One Shear Wall in Storeroom (inside the Southern End of the Shear-Core). Crack Widths between 0.2 and 0.6 mm.

(b) Cracking to Level One Shear Wall. Typically less than 0.2 mm.

Shear core cracking after Sept.4 EQ (Beca report)
