FORSYTH BARR TOWER POST-EARTHQUAKE ASSESSMENT AND REPAIR REPORT

This report covers the structural damage sustained by the Forsyth Barr Tower at 764 Colombo Street, Christchurch, as a result of the Darfield Earthquake that struck at 4:36am on 4th September, 2010.

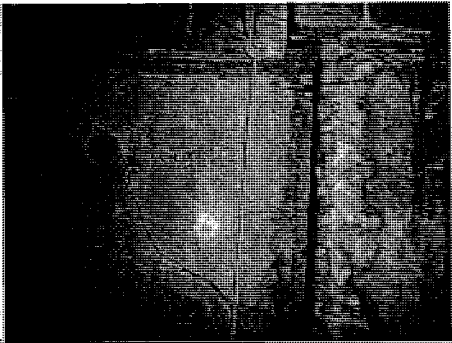
Damaged Item	Example
<p>1. Minor flexural cracking was observed in the concrete beams at the beam-column joints on all floors inspected (cracking shown in example photograph highlighted by permanent marker). All cracks measured were less than 0.2mm.</p>

Damaged Item	Recommendation	Sketch reference
1. Minor cracking to the beam at the beam-column joint at all floors inspected	No repair required as all cracks measured less than 0.2mm	No Repair Required
