**INDEPENDENT ASSESSMENT ON EARTHQUAKE PERFORMANCE
OF
Boundary Wall to 90 Coleridge Street
(Classique Furniture)**

**FOR
Royal Commission of Inquiry into building failure
caused by the Canterbury Earthquakes**

**Report prepared by Peter C Smith and Jonathan W Devine
OF
Spencer Holmes Ltd**

November 2011

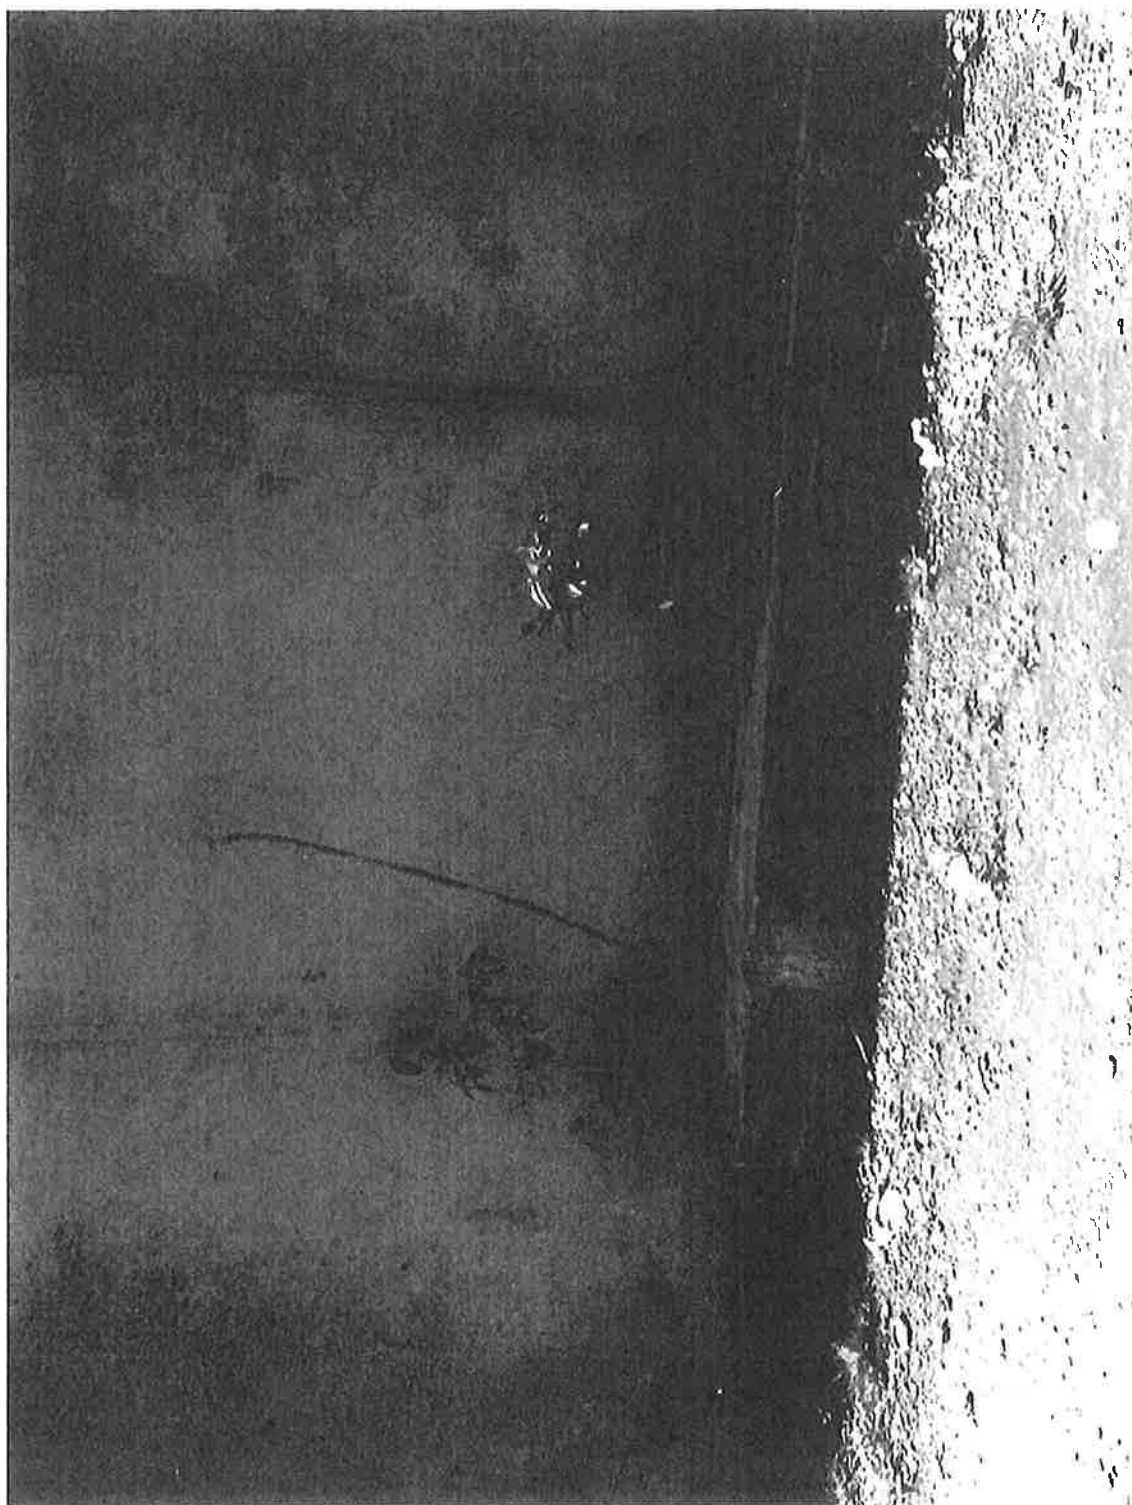
Photos recording aspects of construction of masonry wall.

We understand that the wall was reinforced with 1 - D20mm reinforcing rod at each end of the wall. Photos of the foundation following demolition of the wall show little or no concrete adhering to the reinforcement and the bent shape of the reinforcement indicates that the cells containing reinforcement were either not filled or filled with poor quality concrete. (Refer Appendix 2)

The dislodging of the top two courses of the wall would also suggest that the upper portion of the wall was not reinforced.

A review of the photos of the wall after the 22nd February, 2011, earthquake established that the wall was inadequately reinforced and that the infilling of the reinforced cells of the wall was either of low quality or did not exist. The extent of reinforcement was sufficient to meet the minimum reinforcement ratios of NZSS 95, but did not meet spacing requirements or strength requirements. Failure of the wall was inevitable under the severe shaking of the 22nd February, 2011 earthquake.
