**INDEPENDENT ASSESSMENT ON EARTHQUAKE PERFORMANCE
OF
7 Riccarton Road**

**FOR
Royal Commission of Inquiry into building failure
caused by the Canterbury Earthquakes**

**Report prepared by Peter C Smith and Jonathan W Devine
OF
Spencer Holmes Ltd**

November 2011

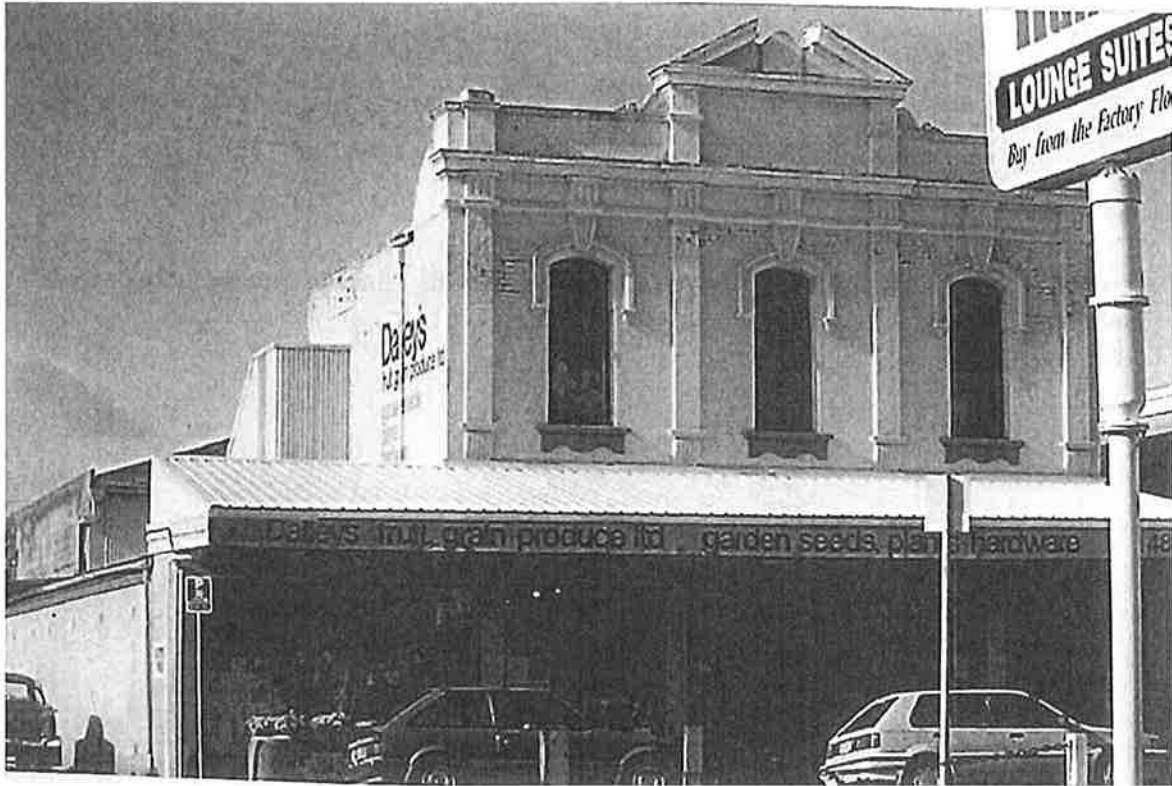
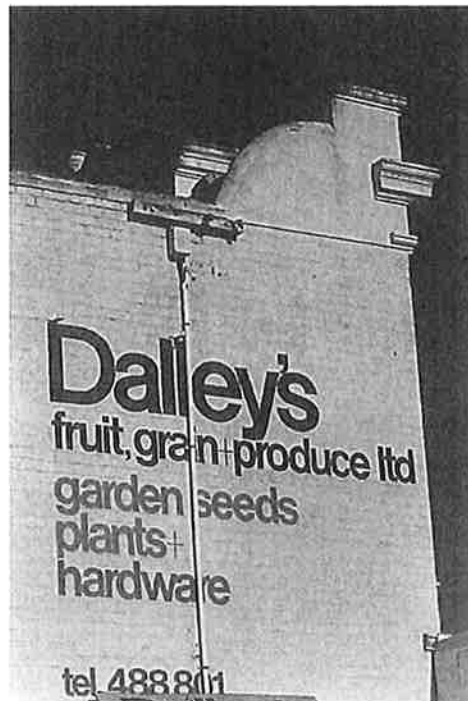
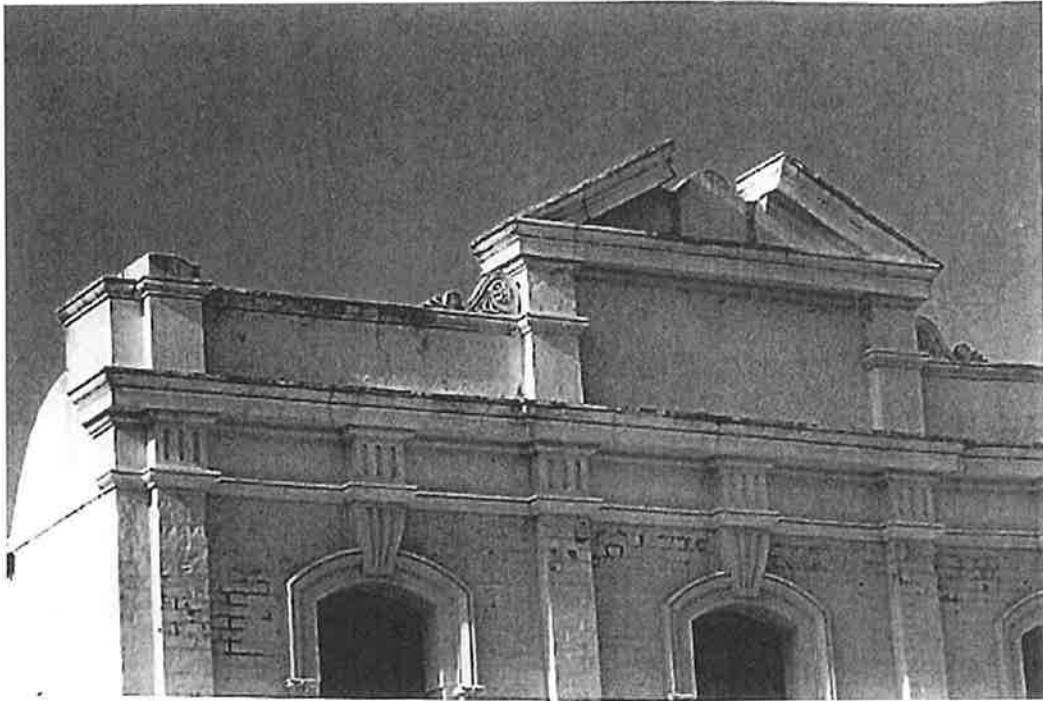
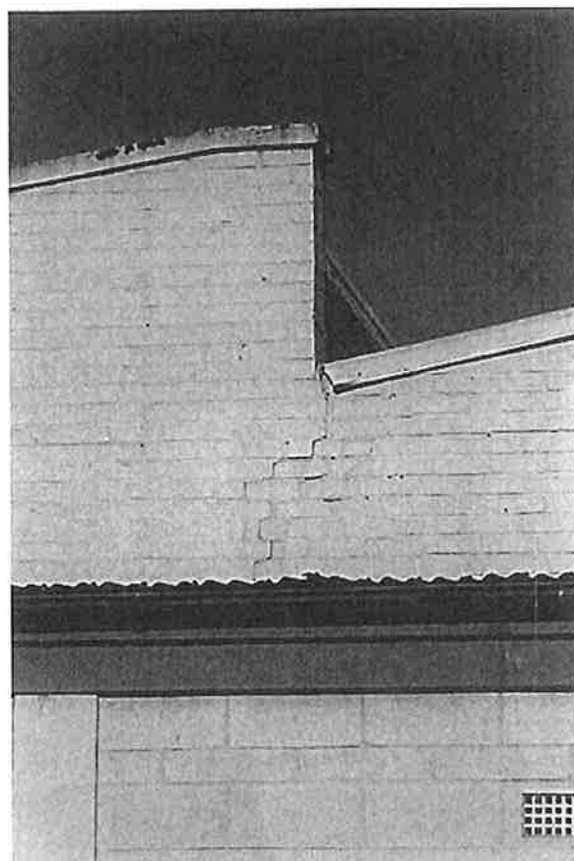
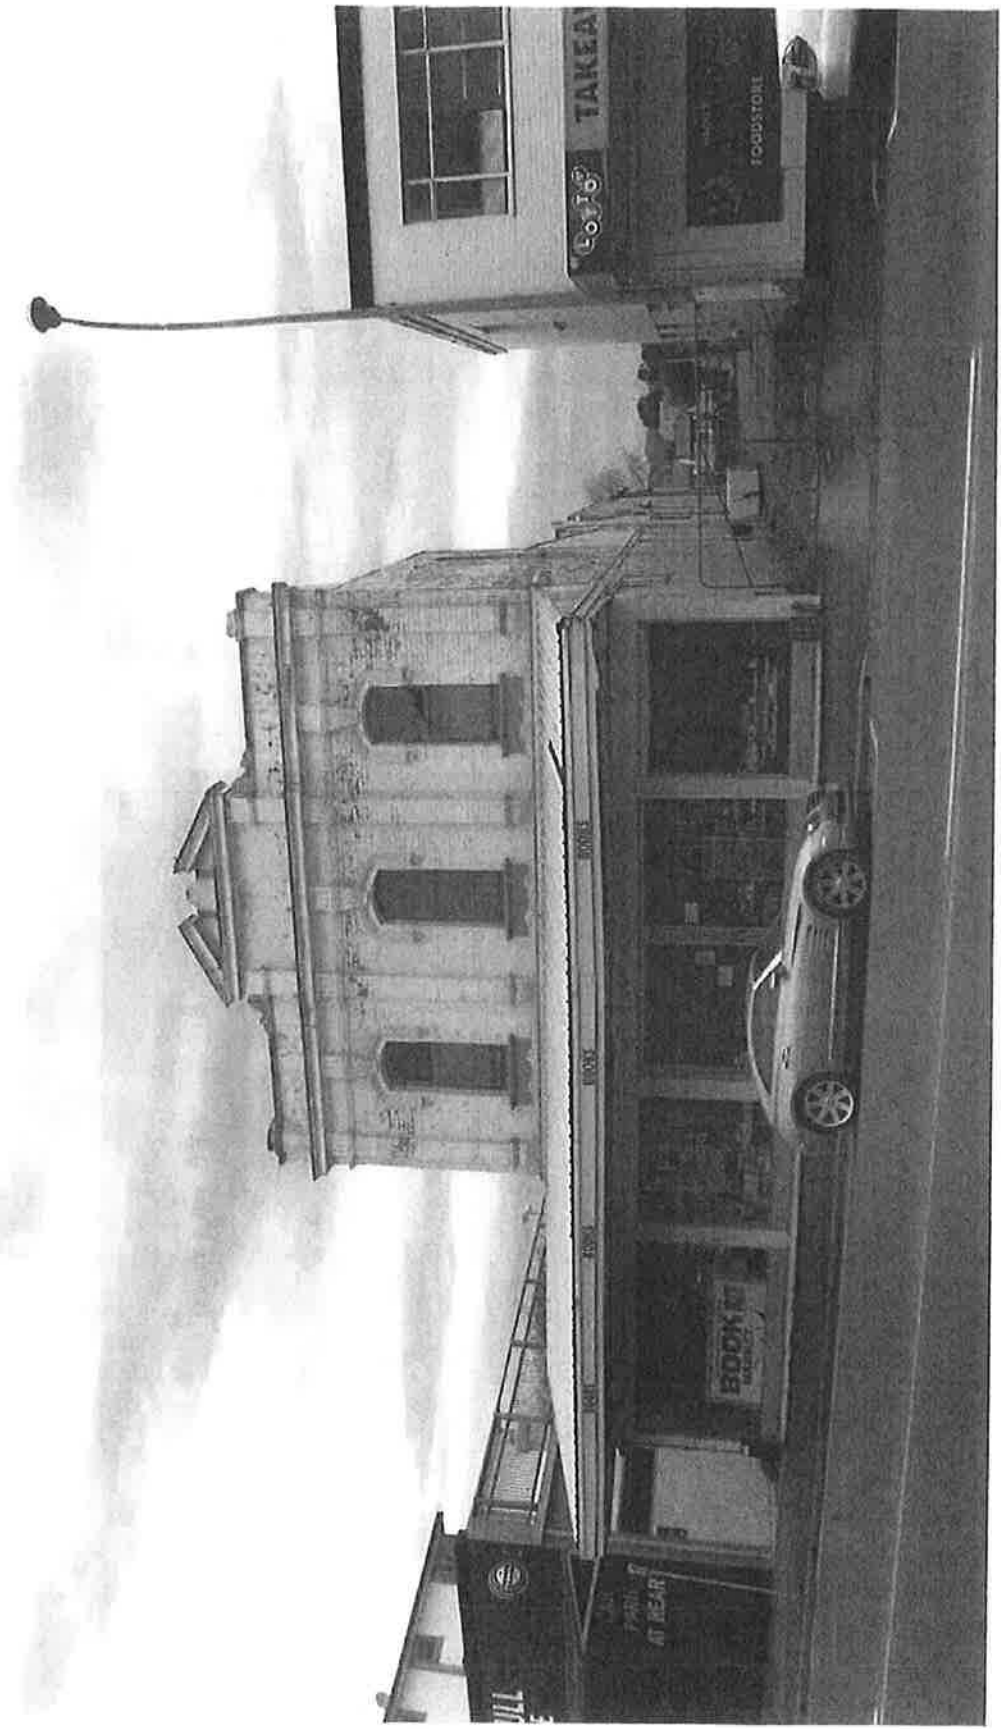
APPENDIX 2

In 1991, the Christchurch City Council identified cracks in the parapet and side walls to the building when it undertook a Seismic Risk Buildings Survey. Photographs of the building were included with a Hazardous Appendage Survey in 1993, clearly identifying that the majority of the cracks existed in the front parapet to the buildings at that time. (Refer Appendix 2).

It is evident that cracks in the front façade did exist prior to the 4th September, 2010 earthquake and that these cracks were likely to have been extended by the earthquake. There is less certainty in relation to the crack behind the parapet on the east wall.

Record of photos taken in 1993 by the Christchurch City Council during Seismic Risk Buildings Survey

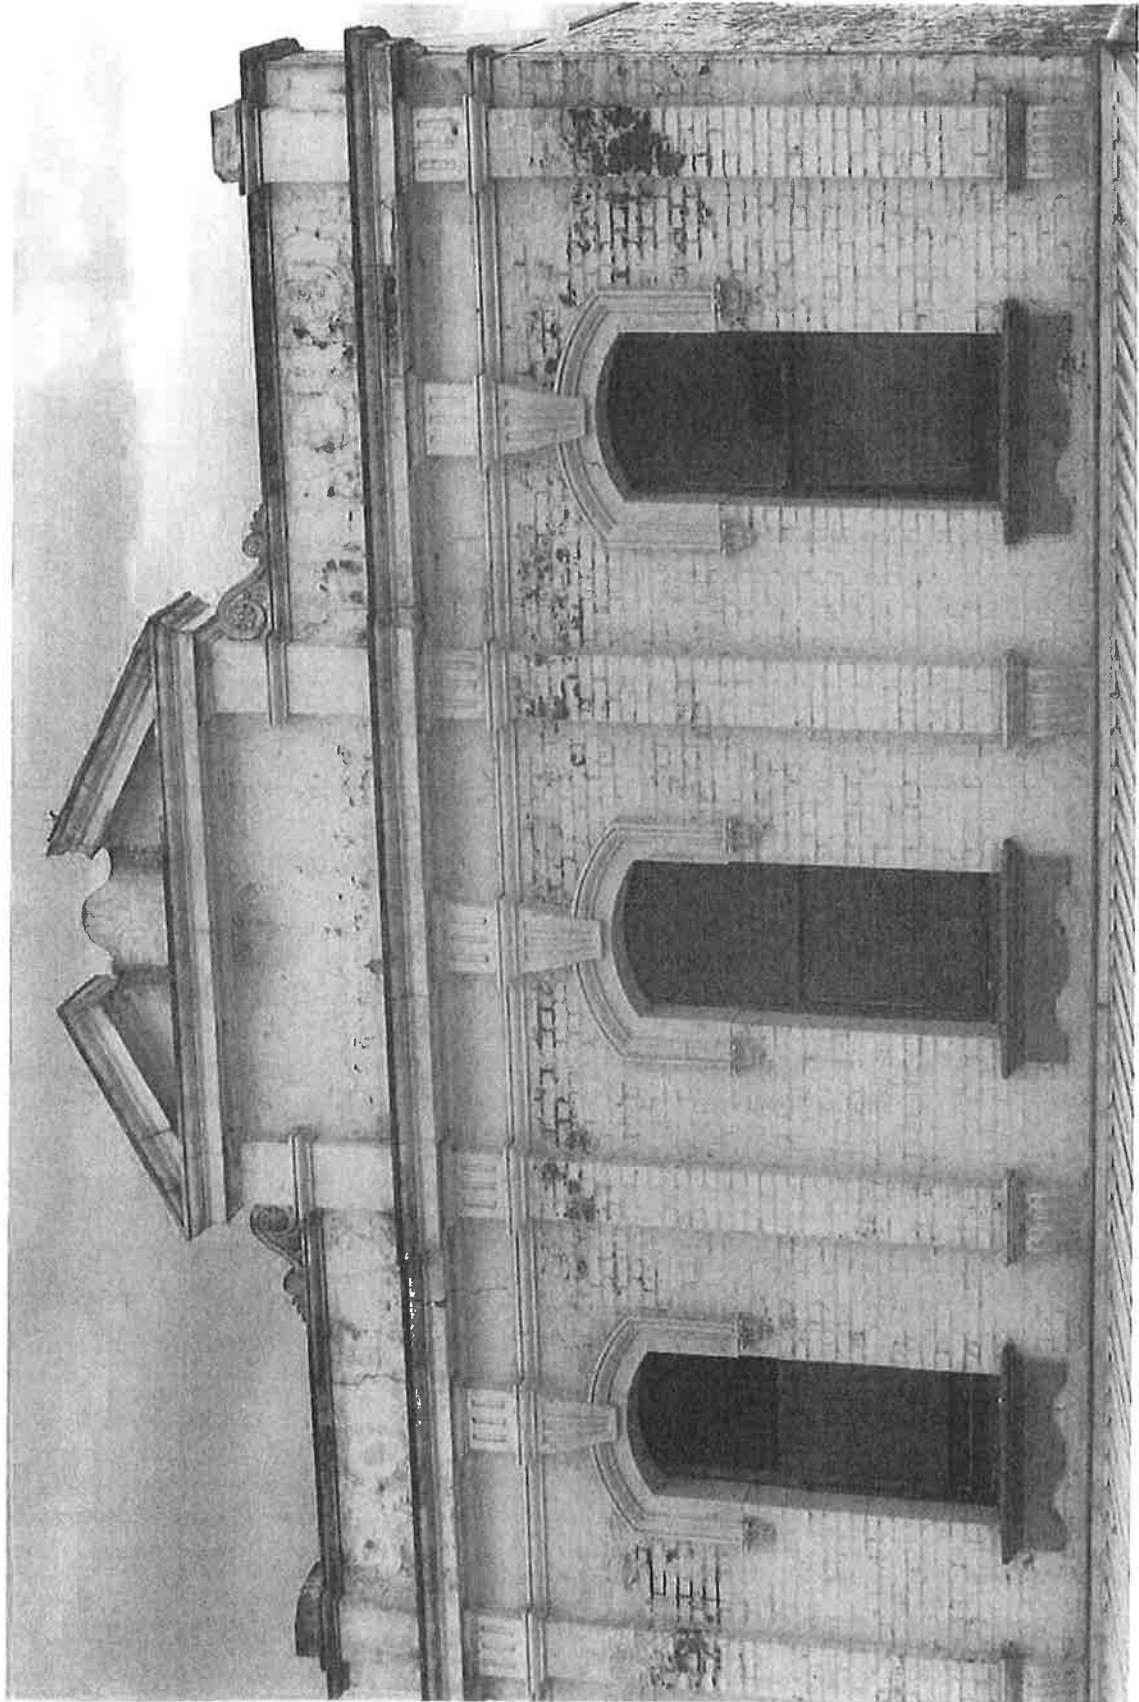
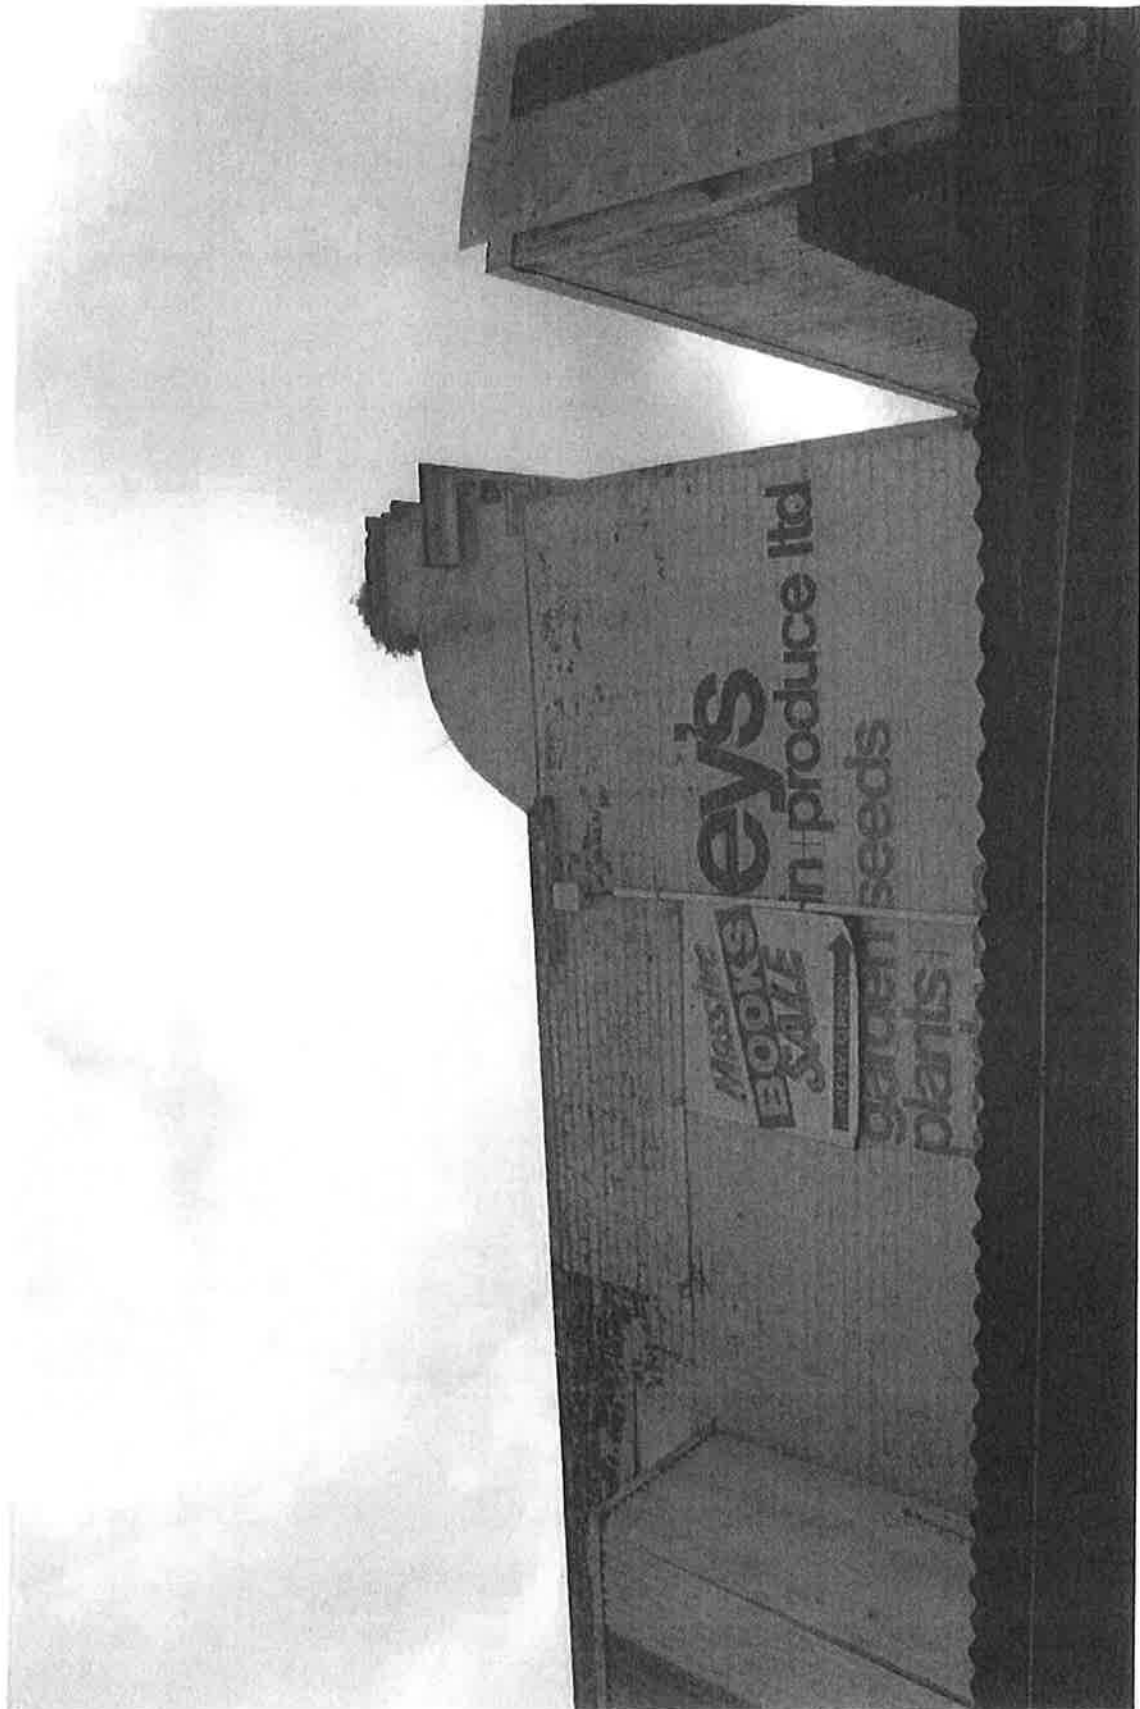
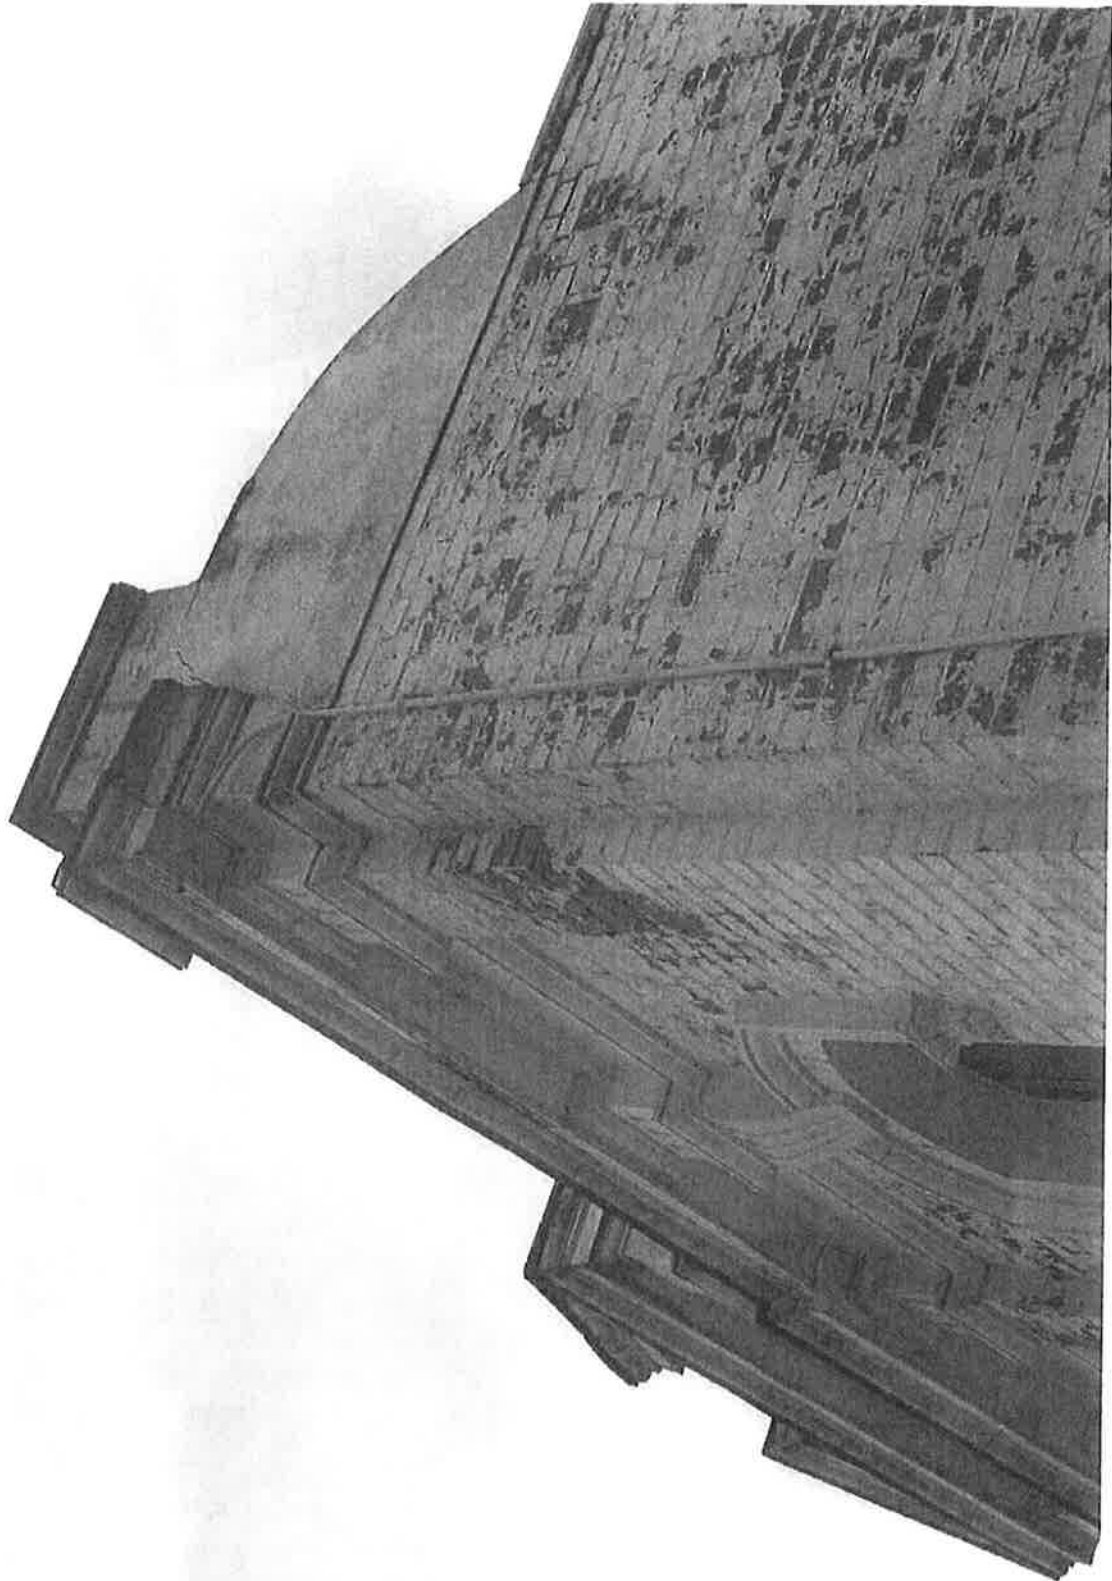
APPENDIX 3

Review of the photos taken by Mr Elliott on 7th September, 2010 indicates that there had been some additional cracking as a result of the 4th September, 2010 earthquake. (Refer Appendix 3). Given the extent of cracking evident in the 1993 photos, some extension of these cracks would be expected in the severity of shaking that occurred in the 4th September, 2010 earthquake. David Elliott has also commented that “During my inspection of the building, cracks in the brick walls were noted. Owing to the age of the building, I discussed the condition with Mr North who had been an occupier of the building for some time and appeared quite familiar with the condition of the building. He informed me that the cracks were pre-existing. This was also substantiated in my mind, when I observed that the cracks had mould within the joint and the edges of the cracks had fretted away at the corners of the crack interface due to weathering.”

Photographs taken after 4th September 2010 earthquake

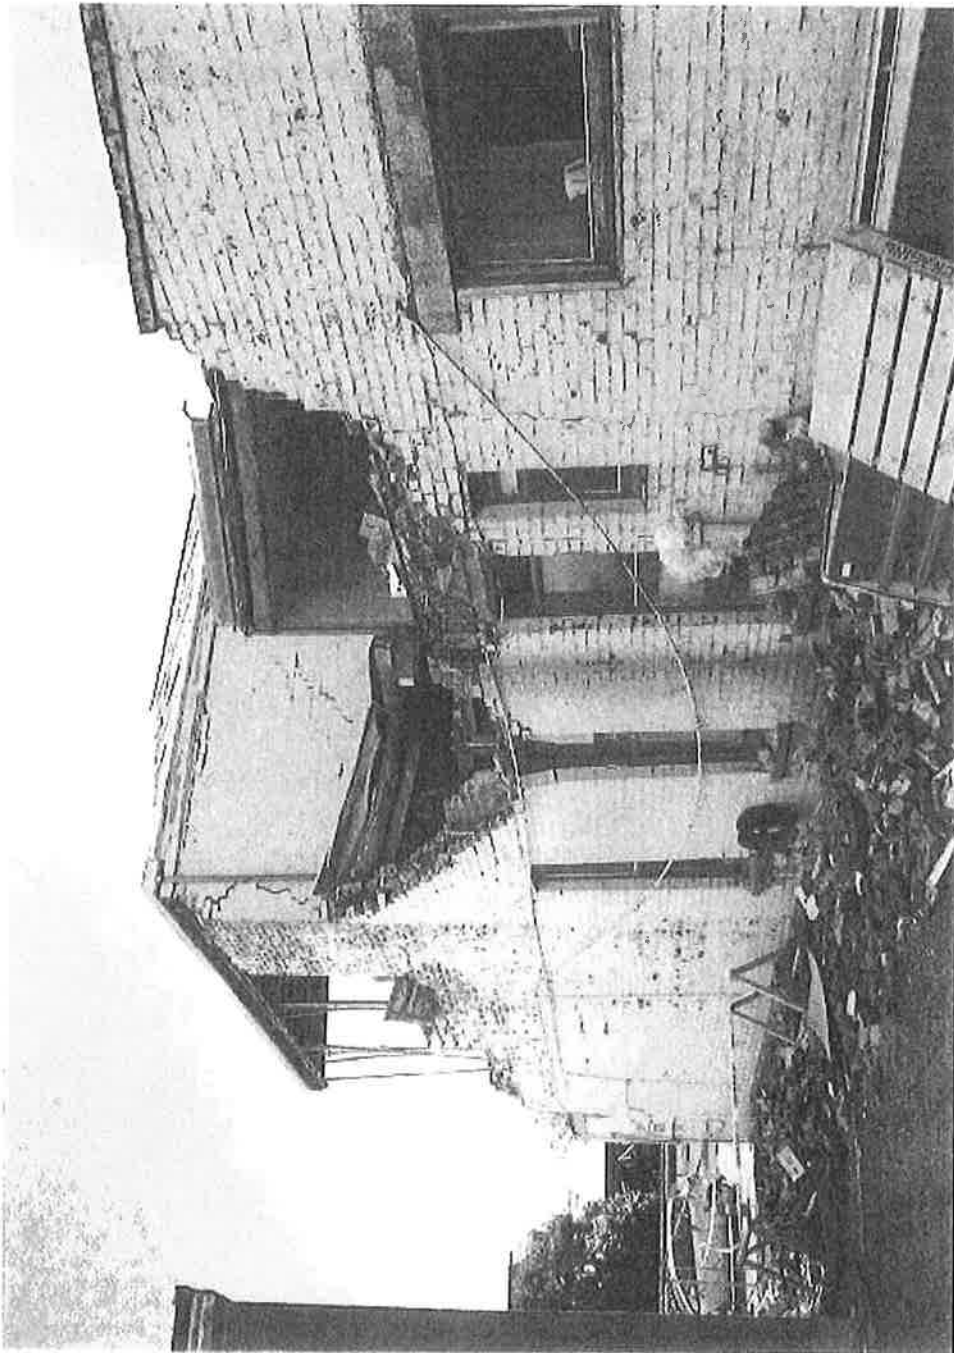
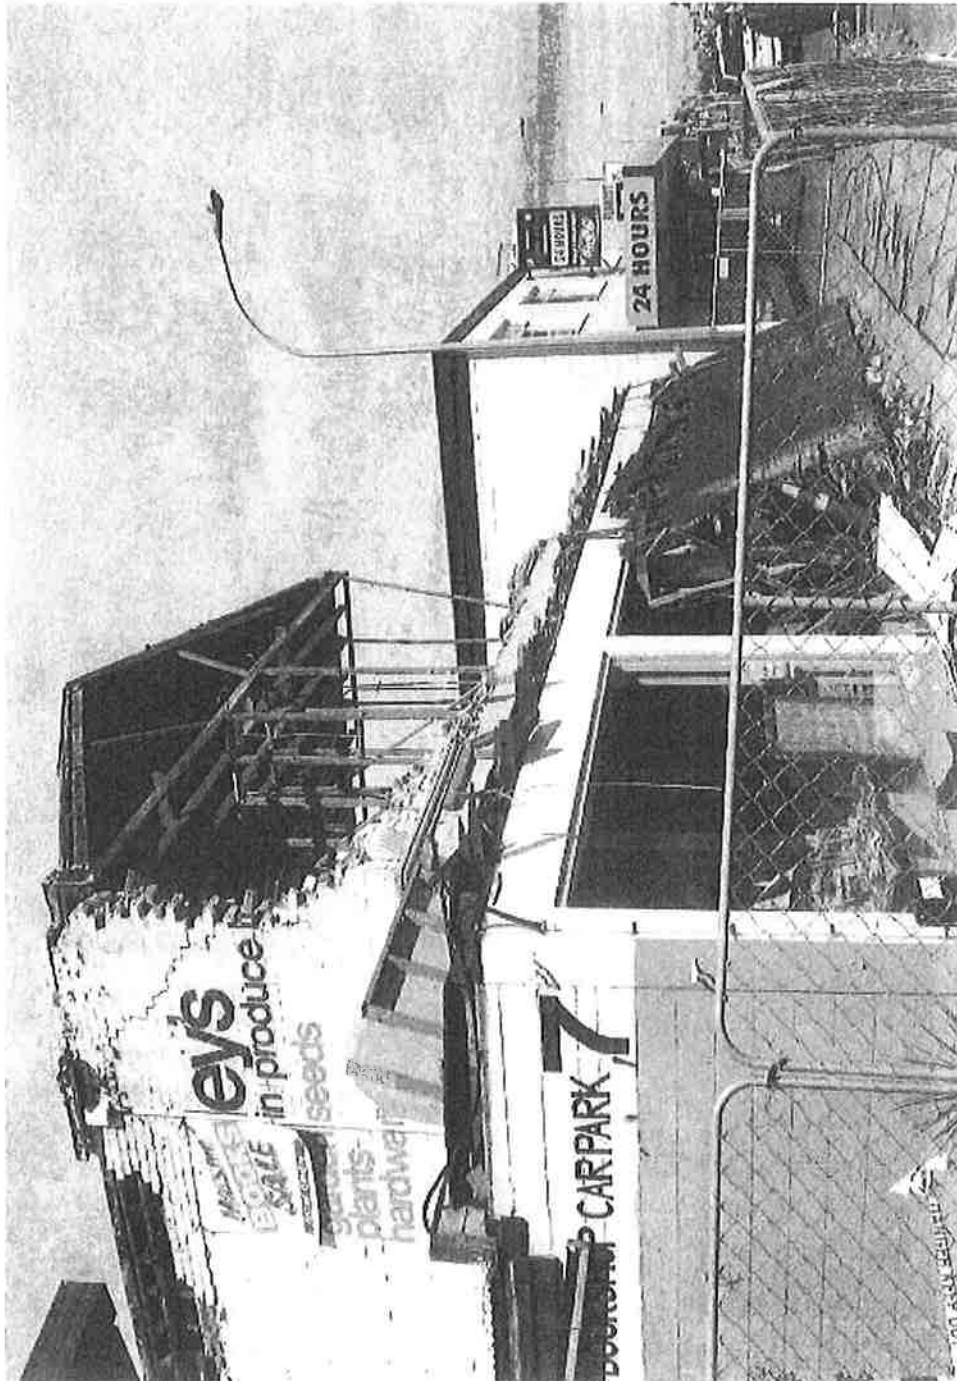
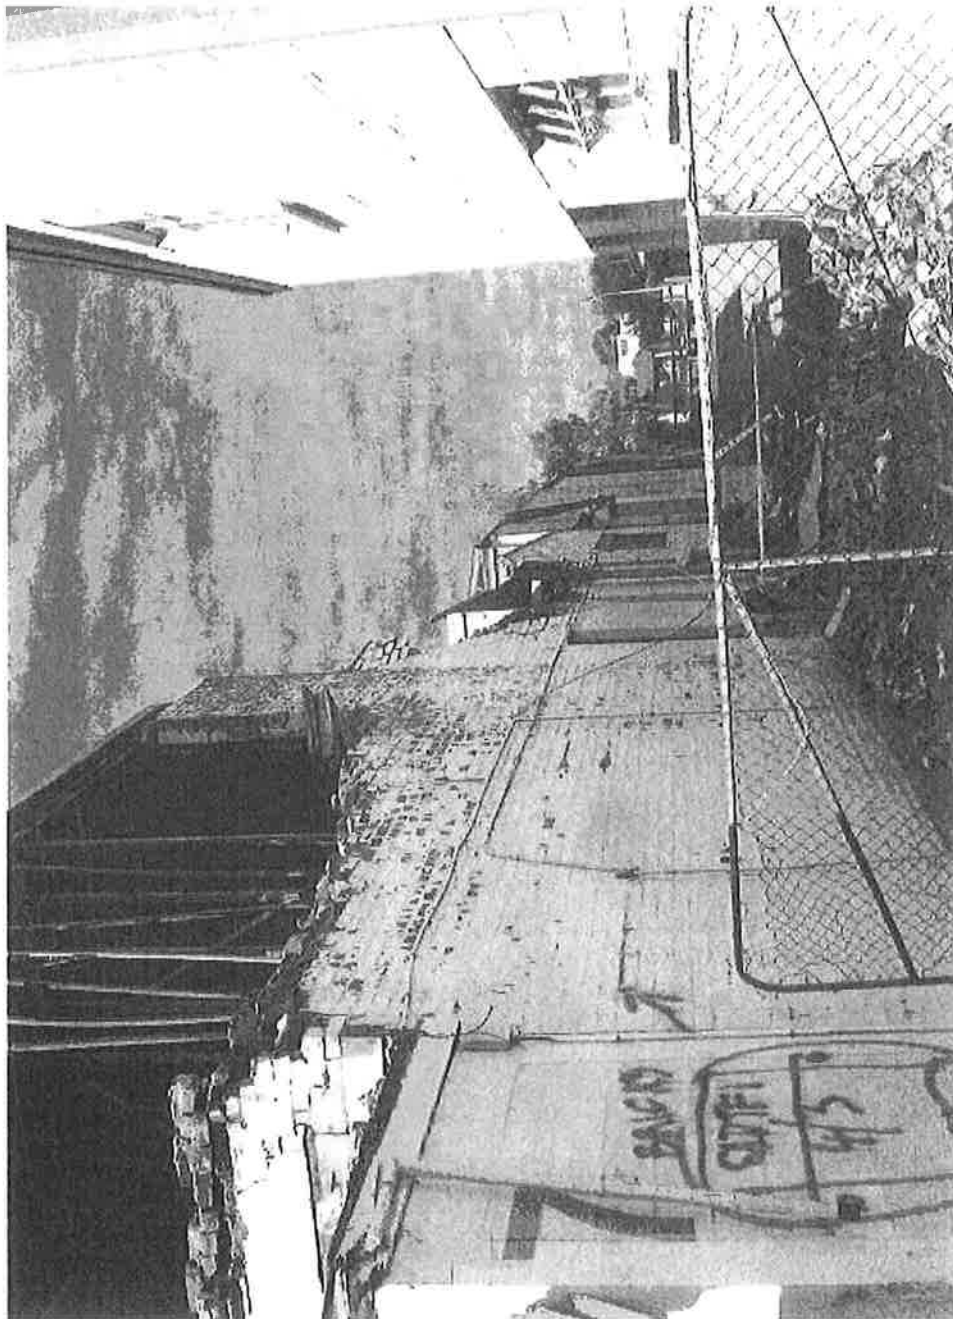
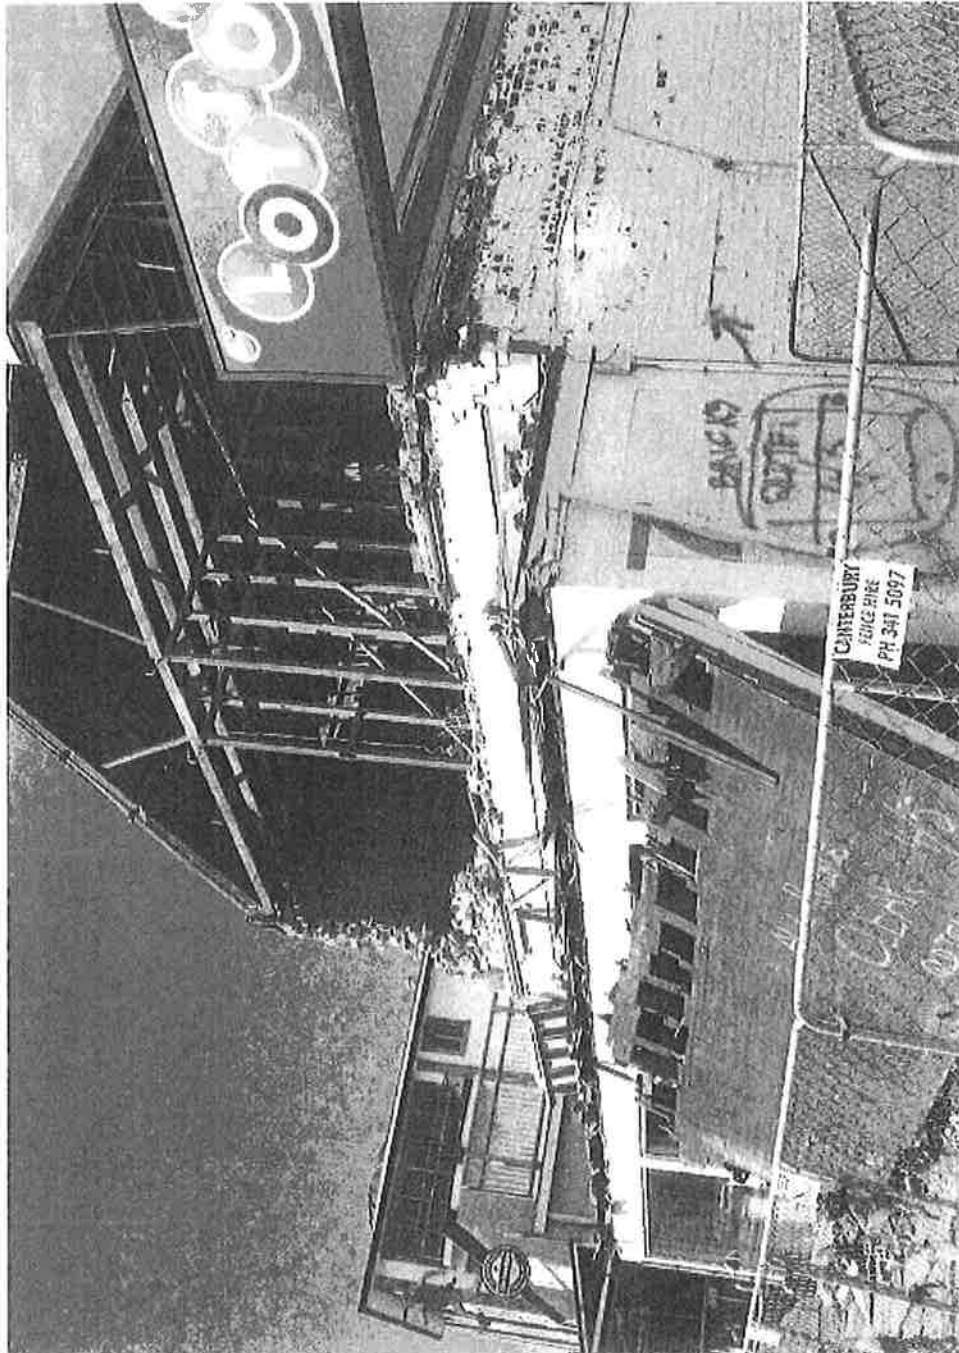
APPENDIX 4

The building at 7 Riccarton Road suffered a substantial collapse of the first floor façade to the north wall and the northern portion of the west wall as well as portions of the east wall following the 22nd February, 2011 earthquake. The building also suffered a collapse of the verandah on the Riccarton Road frontage. The building was assigned a red placard. Fencing was put around the shop front to the full extent of the footpath, kerbing, cones on road to provide temporary footpath. The building was approved for demolition on the 15th April, 2011. A Heritage Building Treatment Report prepared by the Christchurch City Council assessed the building as beyond repair.

The cracking present in the façade of the building at 7 Riccarton Road reflects the development of a failure mechanism involving the outward movement of the central portion of the façade. The outward failure of the central portion of the façade is restrained by arch action between the piers at the north-east and north-west corners of the façade. For the mechanism to develop further would require an in plane failure of the façade at the north-east and/or north-west corners of the building. We did not observe cracking of the façade at first floor level at either side of the façade in the photos of the façade following the 4th September, 2010 earthquake. We did observe a crack immediately behind the ornamentation at the north end of the west wall to the front façade in photos taken after the 4th September, 2010 earthquake (Refer Appendix 3). The crack appears aged and to relate to a potential front parapet failure. From the photos, the crack does not appear to extend below parapet level. It is unknown the extent to which the cracking was developed on the west side prior to the 4th September, 2010 earthquake. Photos of the east wall after the 22nd February, 2011 earthquake show that the failure at the north end of the east wall is located approx 800mm back from the front of the northern façade. The failure interface on the east wall appears fresh, indicating that no significant crack existed immediately prior to the 22nd February, 2011 earthquake. We consider it likely that the failure mechanism in the 22nd February, 2011 earthquake was an outward rotation of the entire Riccarton Road façade about its first floor support, primarily due to inadequate restraint at roof level.

In a poorly secured condition, failure of the wall was almost inevitable in the severity of shaking experienced in the 22nd February, 2010 earthquake.

Photographs of damage following the 22nd February, 2011 earthquake
