BUILDING - 617 COLOMBO STREET/  
143 TUAM STREET

SEISMIC RISK BUILDINGS - SURVEY

HAZARDOUS APPENDAGE SURVEY.

EQ COLOMBO STREET 617

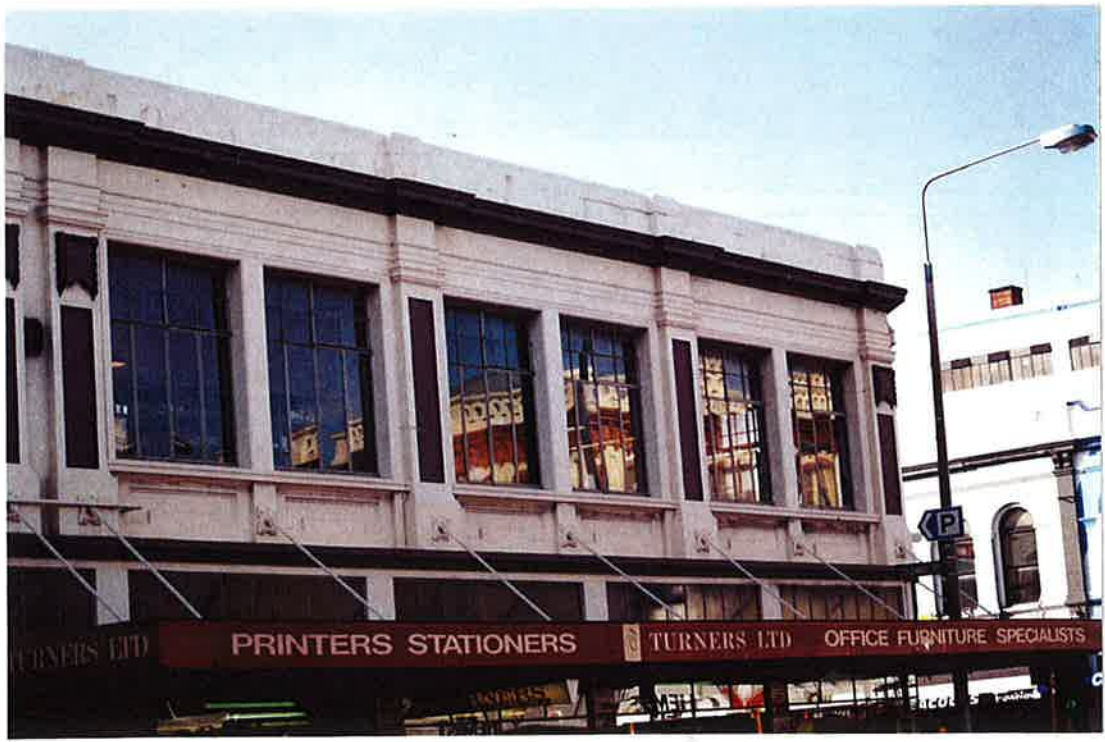
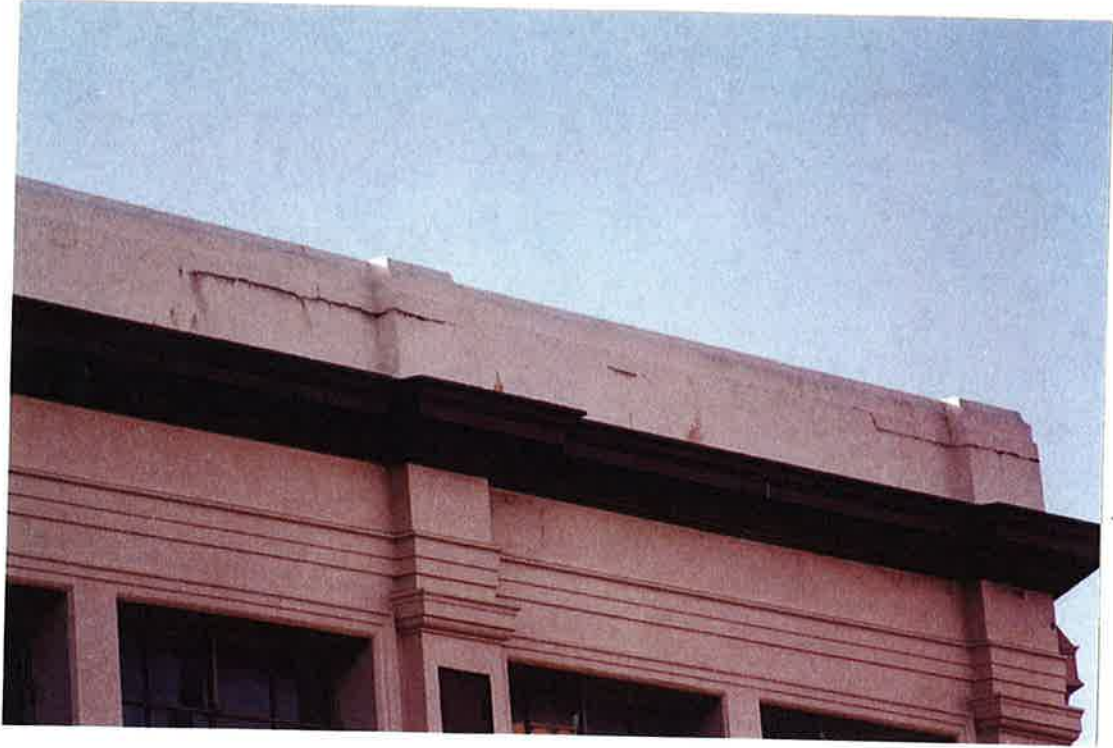
GENERAL Cracked parapet (horizontally)  
needs grouting through  
Numerous horizontal cracks through  
columns. significant proportion of ground  
lev is plate glass, little shear resistance.

Address: 617 Colombo St. (Turners Hd).  
 Legal Desc.:  
 Owner:  
 Date: 19/5/92 Date Building Built: 1929  
 BU/40/  
 Parapet: ~ 1.0 m (see notes below).  
 Chimney:  
 Cornice: ~ 400 m o/m (well weathered).

Comments: 2 storey office. slag (corr).  
 rendering of parapet (see photos).

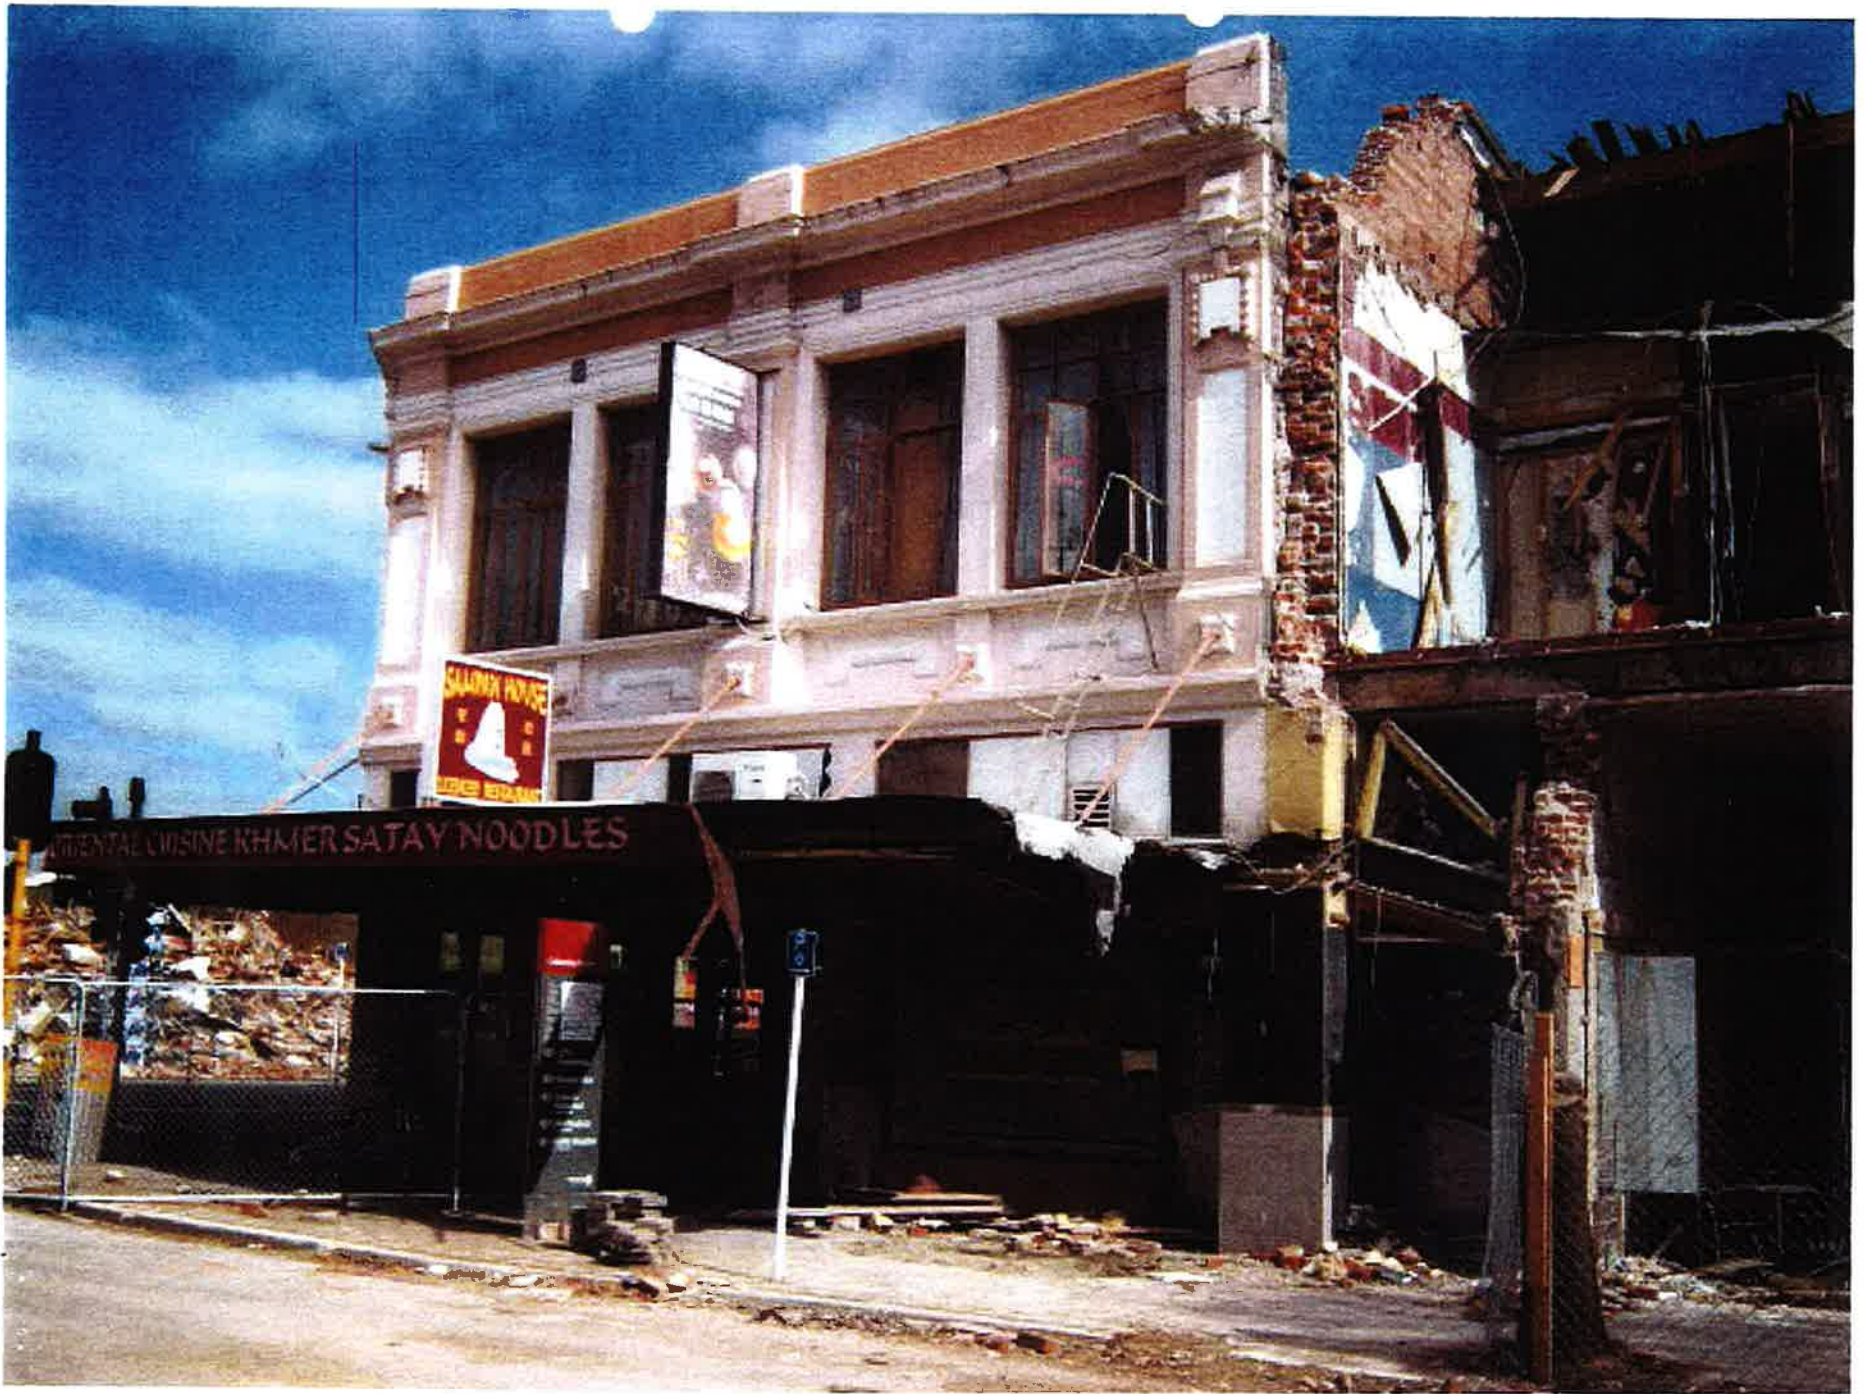
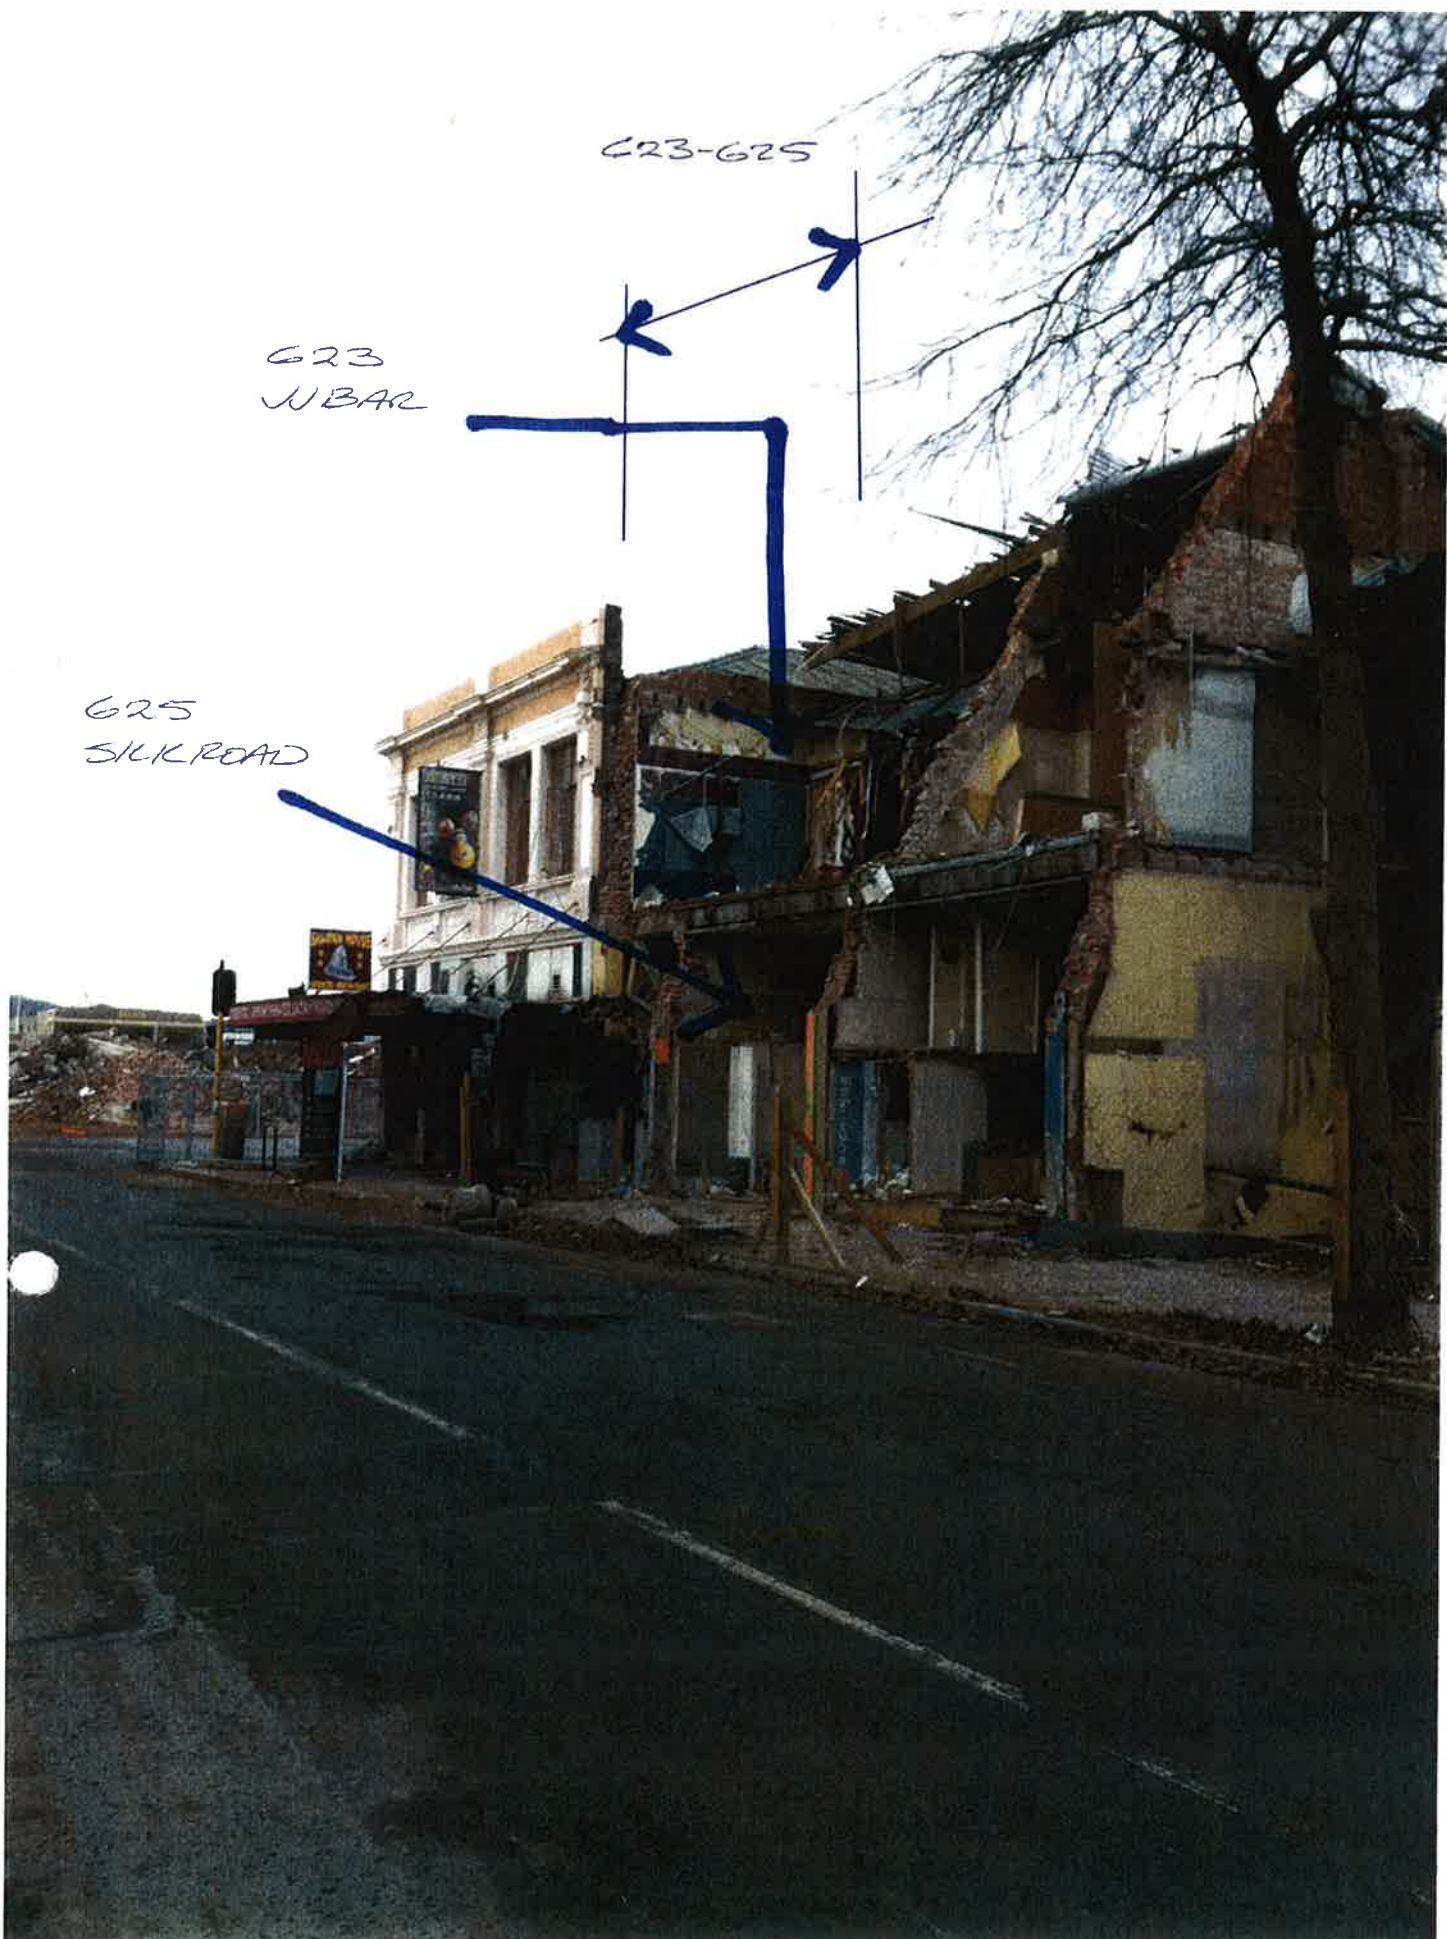
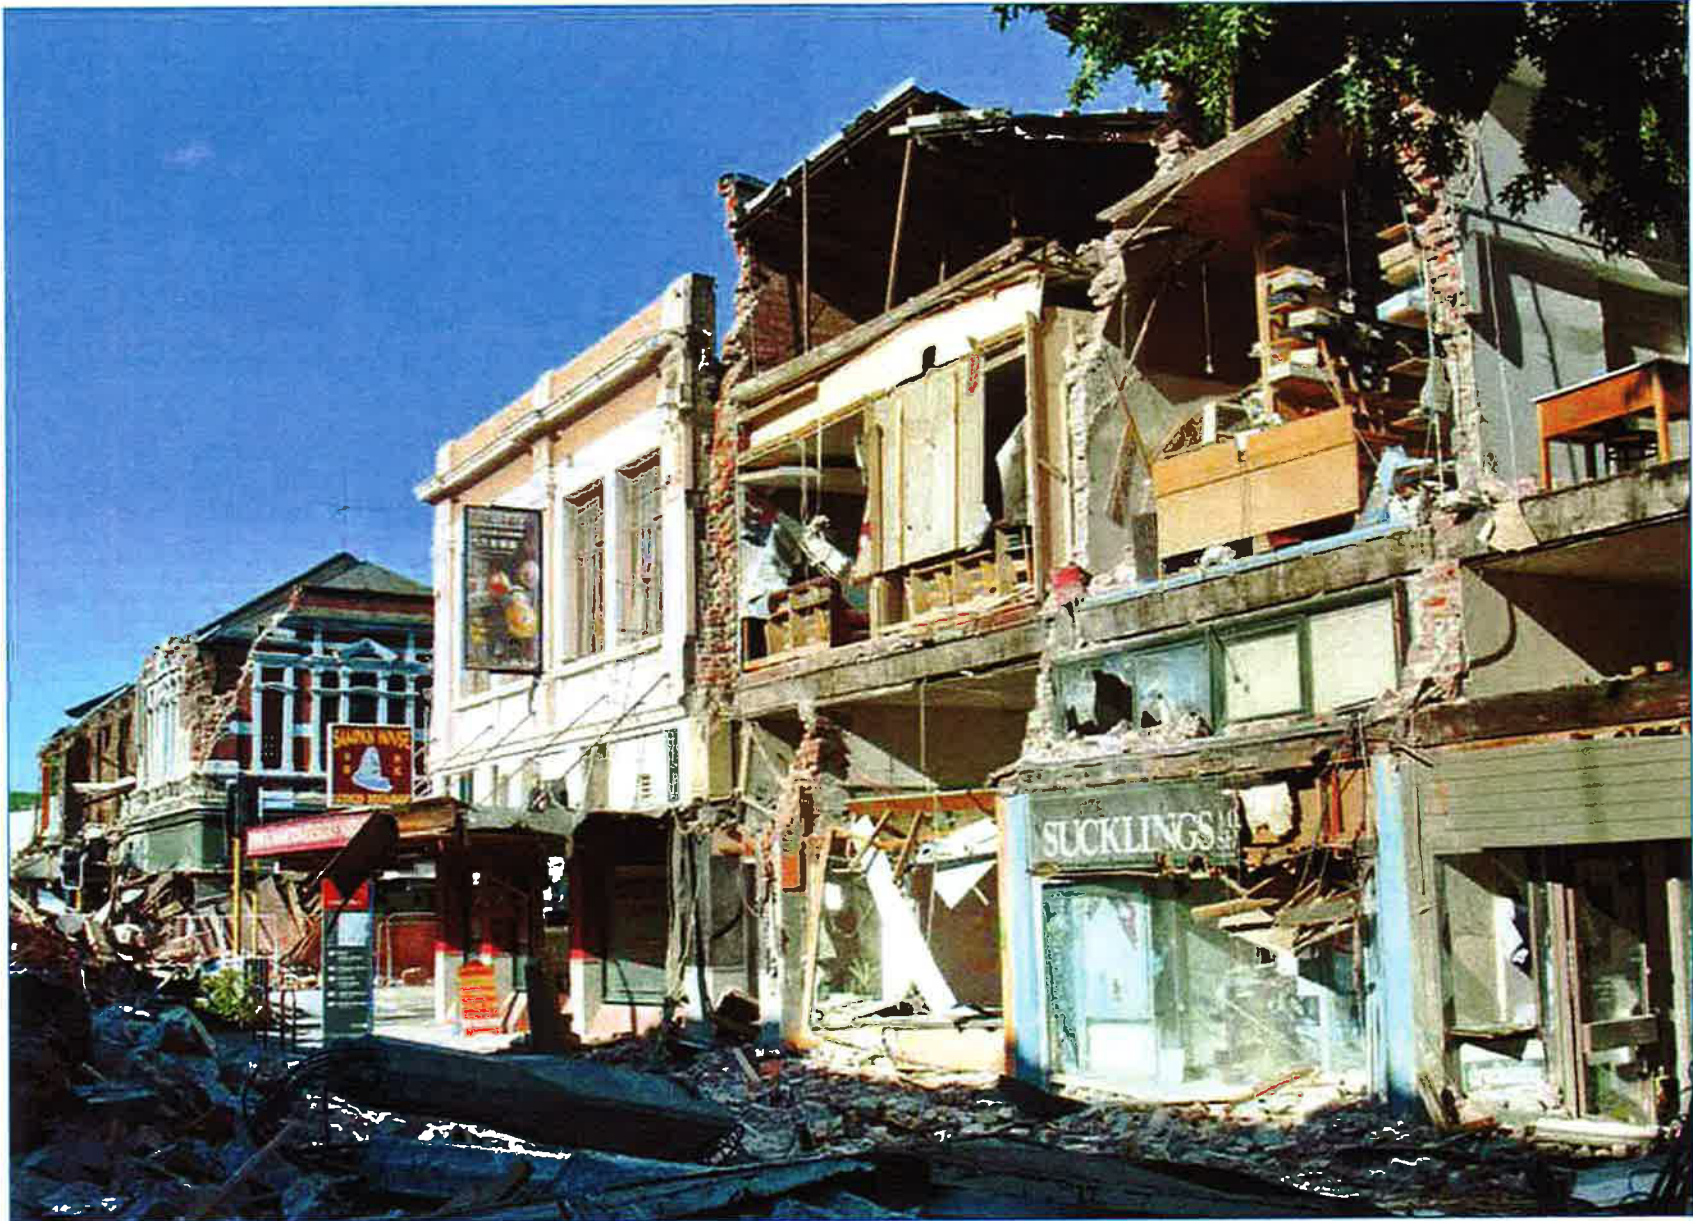
623/625 COLOMBO ST

Front facade completely collapsed onto street. Roof partially down. Back party and internal walls severely damaged. Building is hazard to street and must be demolished. Too dangerous to place placard.
